# **Observed Performance of Concrete Dams during Earthquakes**

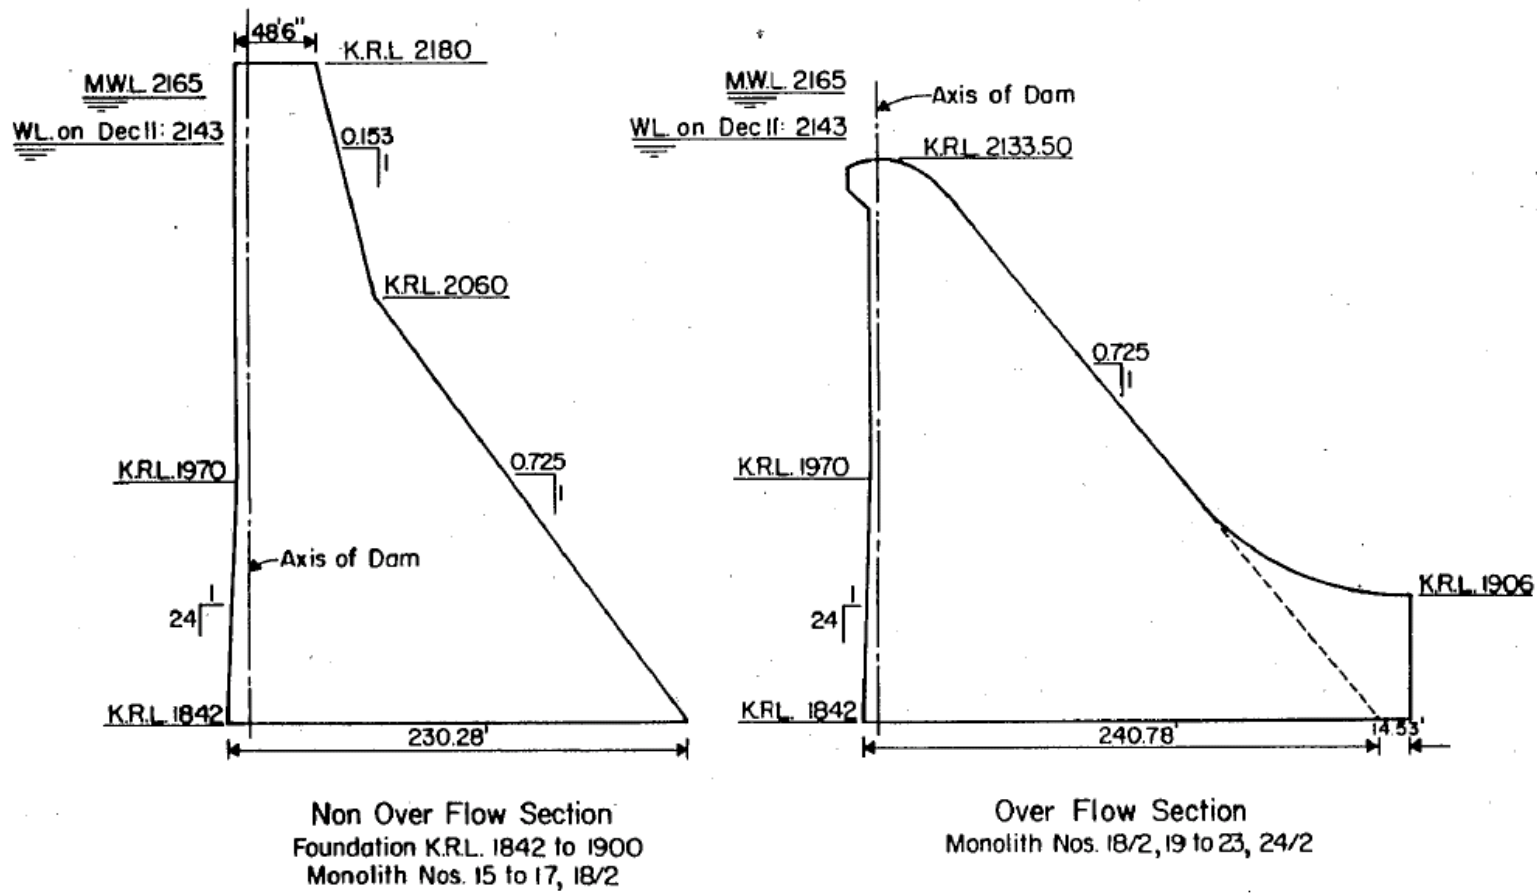
Figure 2: Koyna Dam - Sections

The non-overflow and overflow (spillway) sections of the dam are shown in Figure 2. The cross-section of the non-overflow blocks is not typical of gravity dams (Figure 3). Departure from a typical section was the result of changes in design that were introduced while construction was in progress, because it was decided to combine the originally planned two stages of construction into one.

The most important structural damage to the dam was horizontal cracks on the upstream and downstream faces of the higher non-overflow blocks (Blocks 13 to 18, and Blocks 25 to 30, Fig 1). On the downstream face of these blocks, an approximately horizontal crack developed at the level where the slope of the downstream face changes abruptly (level KRL 2060 of Figure 2). Horizontal cracks were also observed on the upstream face of these blocks, especially near KRL 2060.

In view of the increase in seismic activity in the vicinity of Koyna Dam and the weakening of the dam by the 1967 earthquake, it was considered necessary to strengthen the entire dam. The non-overflow monoliths were strengthened by increasing the section over the entire width of the monolith from the base up to KRL 1970 (refer Figure 2), and providing buttresses above this level.

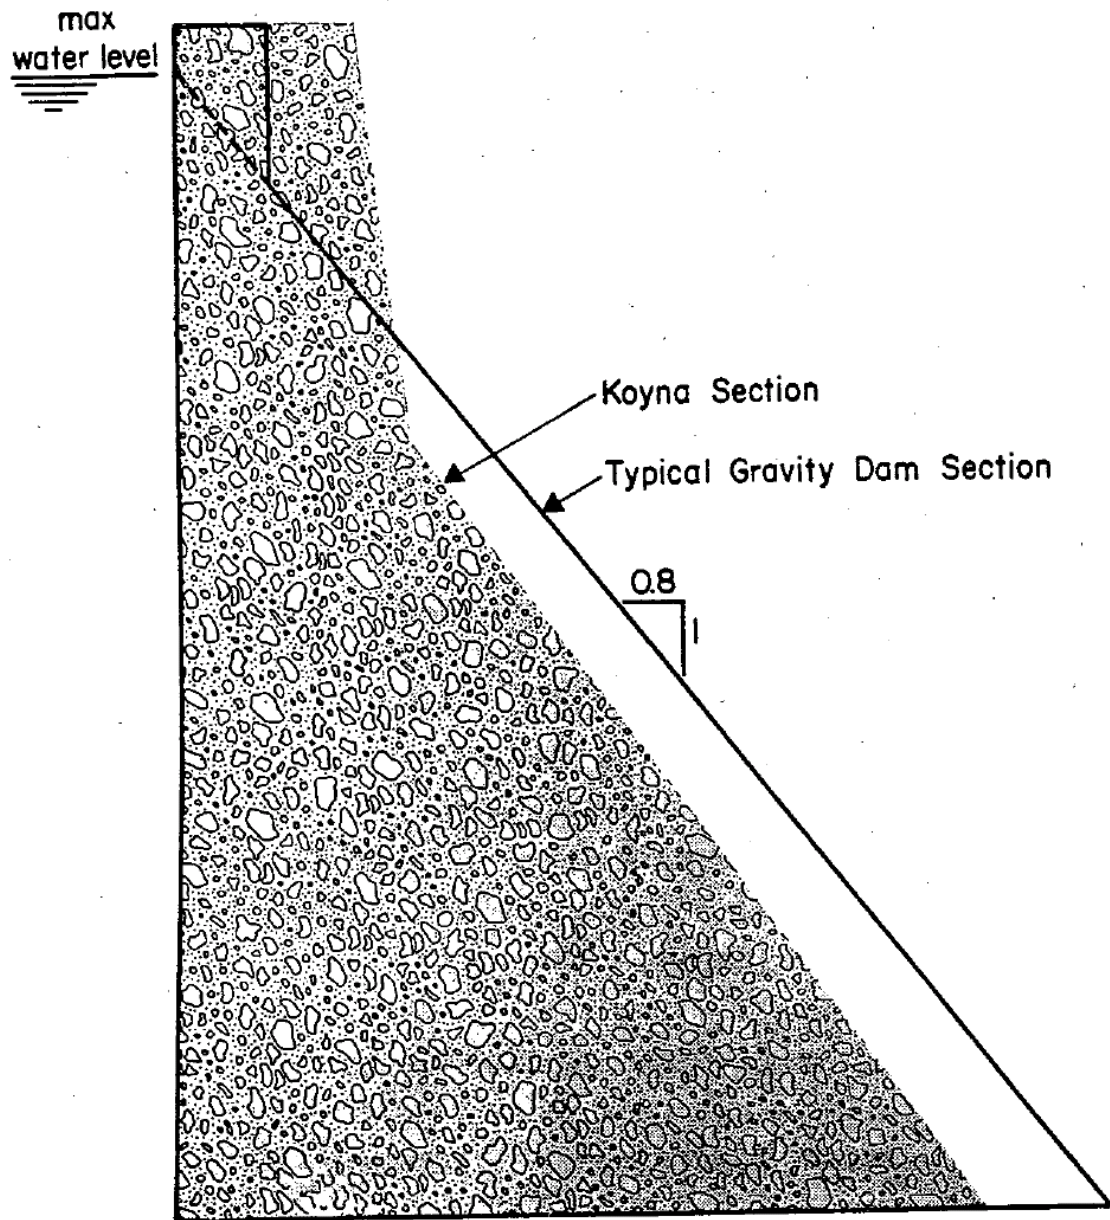
**Figure 3: Koyna and Typical Gravity Dam Sections**

The cracking that occurred on the non-overflow blocks of Koyna Dam, when the dam was subject to about 0.5g upstream-downstream shaking, can be attributed to its unusual sectional profile. In contrast, the overflow dam blocks did not suffer any significant damage. The proposed Mokihiui dam will have a similar section geometry to the Koyna overflow blocks, indicating that its seismic performance will be satisfactory.
