Liquefaction Records For Buller District

Liquefaction Hazard Information West Coast

Assorted papers held at WCRC as of August 2008

LIQUEFACATION IN THE BULLER REGION IN THE 1929 AND 1968 EARTHQUAKES

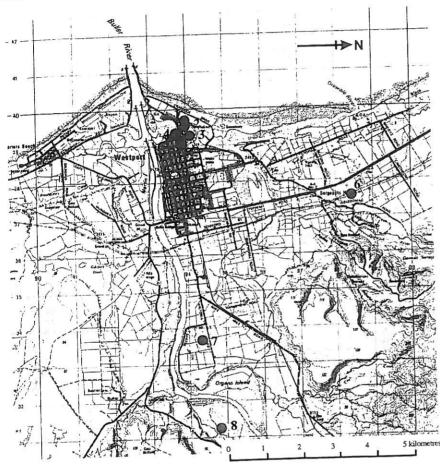
Figure 4-4. Sites of Liquefaction in Westport following the 1968 Inangahua earthquake (Base Map from Topomap, 2001)

The areas of the town built on the old sand dunes and near the Orowaiti Lagoon seemed to be affected considerably more by the earthquake than other areas, effects similar to those observed following the 1929 Murchison earthquake. The known sites of liquefaction in the Westport area are detailed on the map in Figure 4-4 below.

- 1. Shelswell Street
- 2. Kilkenny Park
- 3. Patterson Park
- 4. Salisbury Street
- 5. Derby Street
- 6. Keoghan's Farm, Sergeants Hill
- 7. Reedy's Farm, Victoria Road
- 8. O'Connors Farm, Buller Gorge
