Managing and adapting to coastal erosion on the West Coast: Ngakawau & Hector

NIWA Client Report: HAM2007-007

January 2007

West Coast Regional Council

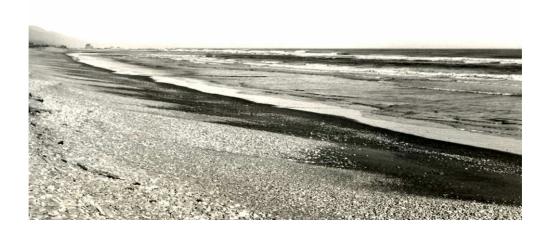
Figure 2: Hector coastline looking south sometime in the early 1970s when the underlying gravel barrier was exposed (Mangin, 1973)

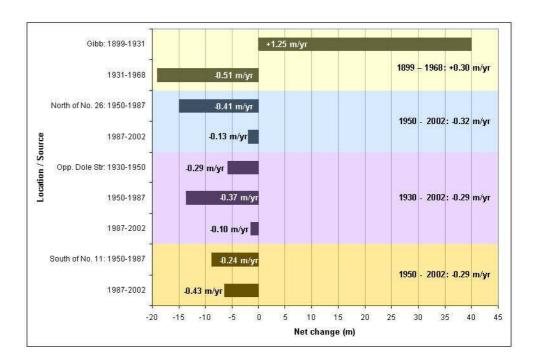
Figure 3: Summary of erosion and accretion net change and average rates at Ngakawau. Note the exact location for the values provided by Gibb (1978) are not known. All other values are from DTEC (2003).

• It would appear that long-term net erosion rates are typically of the order on average of 0.3 - 0.4 m/yr at Ngakawau, and a little more variable along the Hector frontage. This erosion is likely to occur episodically, being primarily caused by storm events. However, over the last couple of decades there appears to have been little net change in the position of the coastline at Hector, and a reduced rate of erosion at Ngakawau. Why this is so, is difficult to say with any degree of confidence without long-term periodic monitoring data.

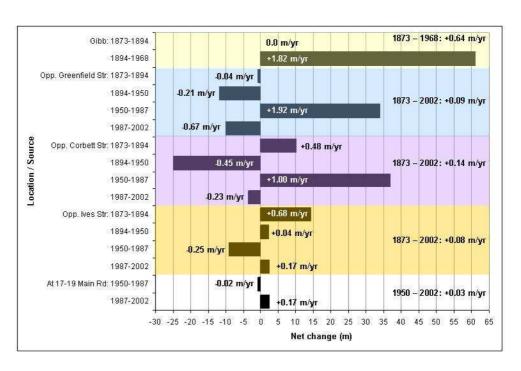
Figure 4: Summary of erosion and accretion net change and average rates at Hector. Note the exact location for the values provided by Gibb (1978) are not known. All other values are from DTEC (2003).

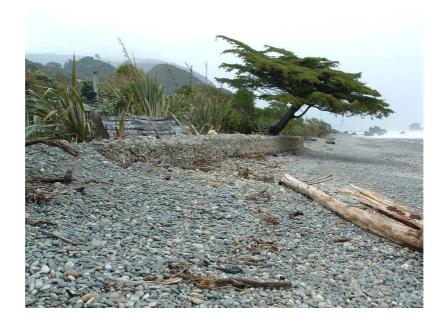
Gabion revetment at 11 Main Road, Ngakawau. The wall is not aligned with the coastline and is likely to suffer outflanking at the southern end. Also by not maintaining the upper gravel beach in front of the defence also makes it more prone to damage and undermining and less effective in preventing overtopping.

Gabion baskets (11 Main Road, Ngakawau and 35 Main Road, Hector) are not recommended for coastal defence works on an open coastline where waves can reach them on a regular basis. However, if constructed appropriately, for example as a backstop protection, they are much more preferable to other past attempts at coastal defences, such as dumped building rubble (13, 16 & 17, Main Road Ngakawau and 29 Main Road Hector), old coal wagons or similar (17 Main Road Ngakawau and 29-31 Main Road, Hector), cemented sand bags or beach cobbles (31 Main Road, Hector), or other low cost approaches using waste or dumped material.

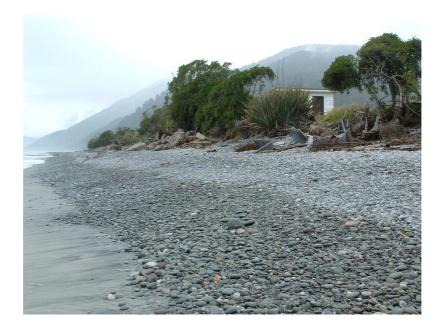
Figure 10: Dumped rubble at and to the north of 16 Main Road, Ngakawau.

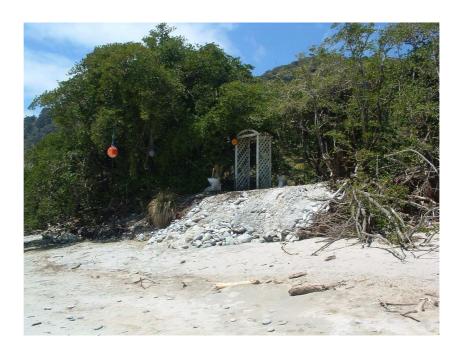
Figure 11: Rubble fill tipped over the upper beach at 29 Main Road, Hector which will be eroded away the next time waves reach the fill material.

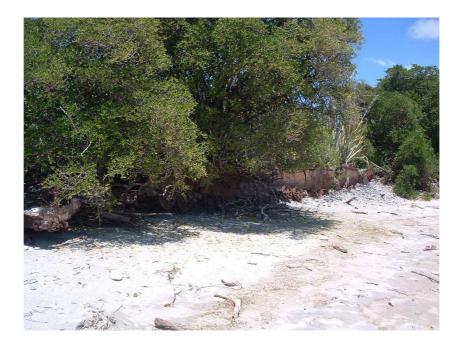
Figure 12: Old coal wagons at 31 Main Road Hector, Again these will do little to prevent ongoing erosion during storm events.

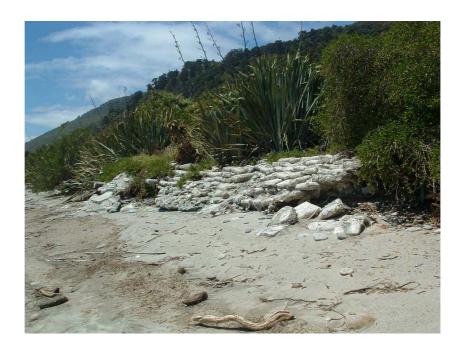
Figure 13: Concrete filled bag revetment at 31 Main Road Hector. This shows the results of an inadequate construction including inappropriate construction material, lack of proper foundation, underlayer and end design. This wall is unlikely to survive much longer.

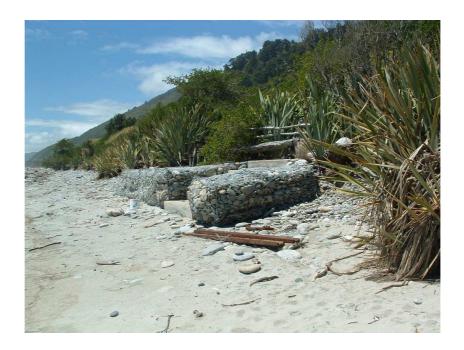
Figure 14: Gabion wall at 35 Main Road Hector. The wall has been built over the upper beach making it more prone to damage and outflanking.
