# The influence of structures on erosion of the north bank of the Mokihinui River mouth

*Prepared for West Coast Regional Council*

*May 2019*

NIWA CLIENT REPORT No: 2019103CH

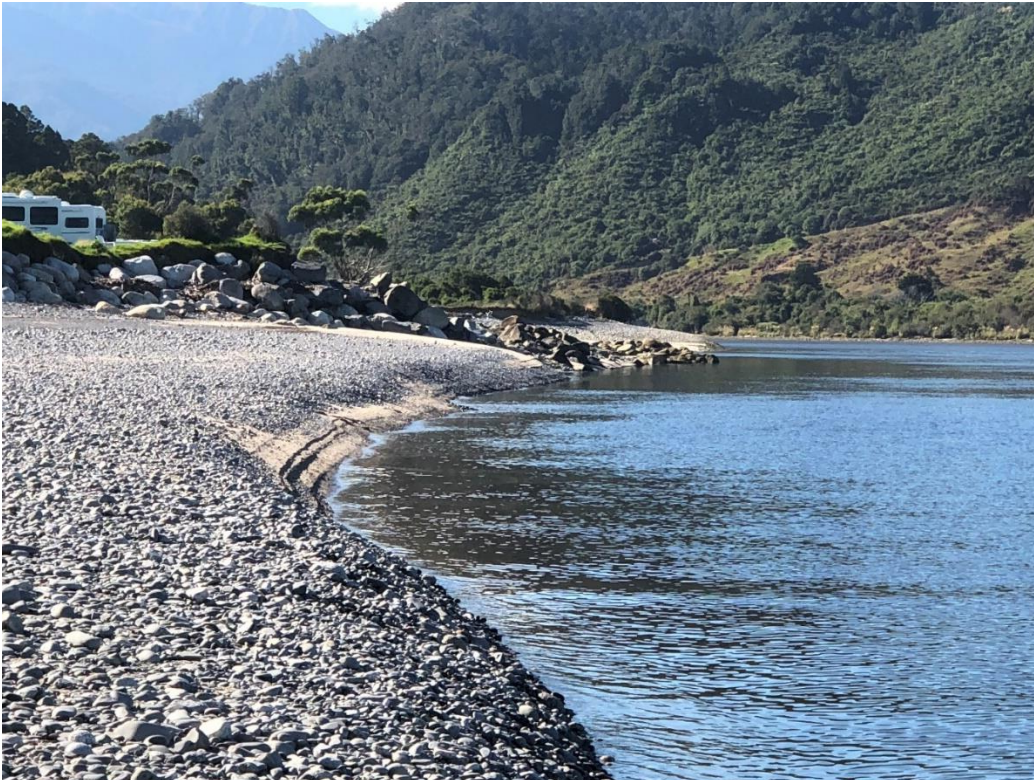
- The beaches adjacent to the river mouth appear to have abundant sand stocks (relative to my past observations over the period 2007-2010).
- The gneiss and granite boulder-grade road-verge protection at the elbow were collapsing down the bank (Figure 3-1), apparently due to undercutting by waves (because they face seaward and are sheltered from the river's current by the training wall just upstream).

**Figure 3-1: View upstream on north bank to the root of the training wall. Rock riprap in front of campervans has partially collapsed.**

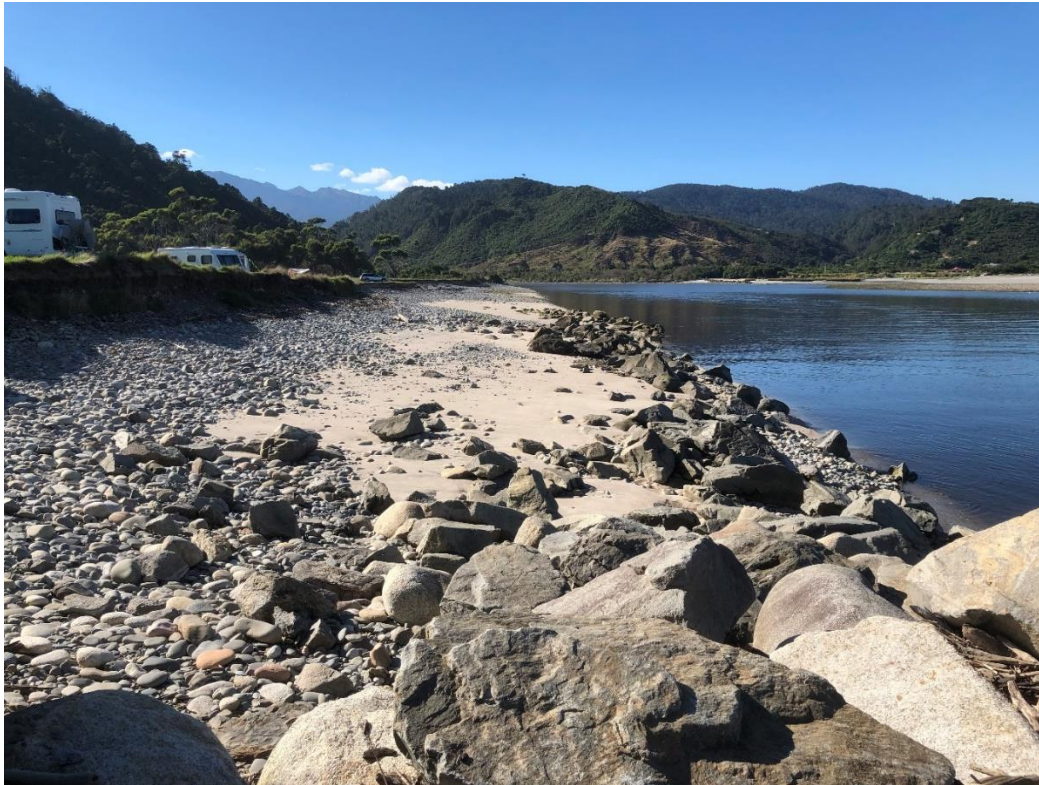
- Erosion embayment's occur in the north bank upstream from the remains of the north bank training wall (Figure 3-2); the erosion of the cobbly bank material has left a cobbly lag-beach in front of the bank which will be providing minor protection services; however, there is some danger that the remains of the training wall will soon be outflanked and isolated (like the upstream ends of the wall have been already).

- The river bank profile rises steeply from the channel bed (at about 40 degrees), then has a beach/berm up to 20 m wide before erosion scarps are encountered (Figure 2). The low tide channel bank-line is supported by the extended remnants of the north bank training wall (Figure 3-2), even if this is now submerged at high tide and flows. Thus, while direct river attack does not appear to be the mechanism by which the higher segments of bank are being eroded, the river will be helping clear the eroded material and it remains forced alongside the north bank.

**Figure 3-2: View upstream on north bank along remnants of training wall.**

Removing the riprap from the remnants of the north bank training wall would likely exacerbate the north bank erosion. This is because this material still provides some bank-stabilising function.

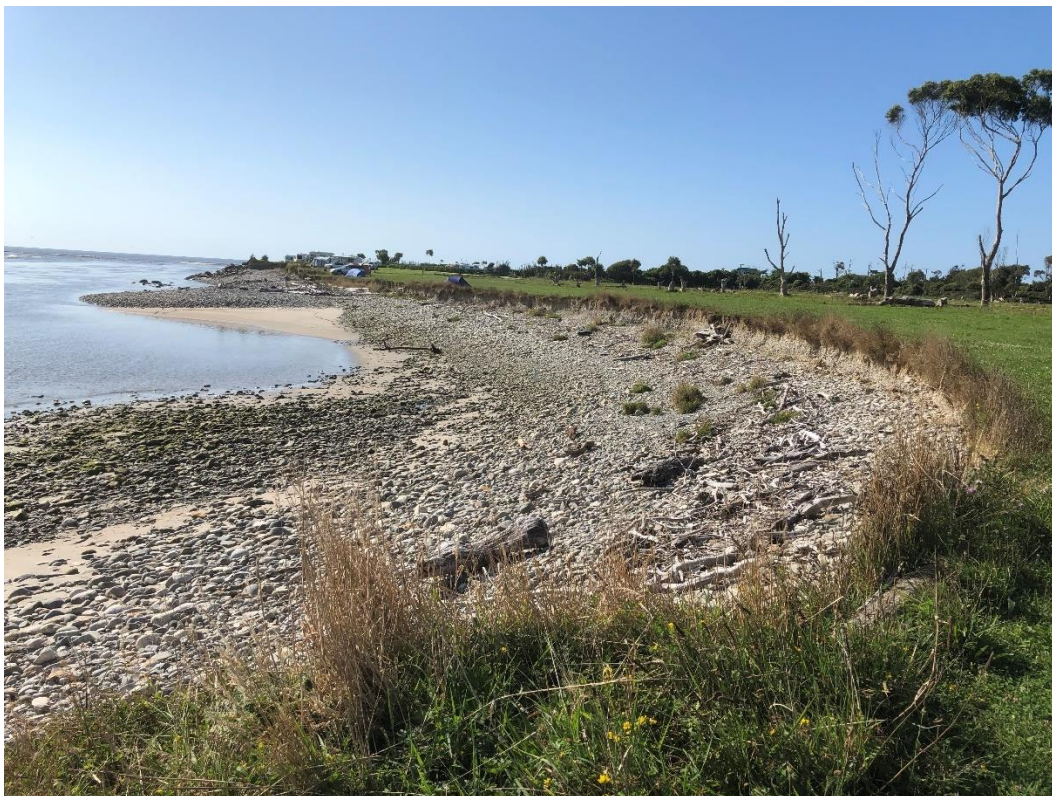
- The erosion seaward of the two stub groynes appears relatively recent (Figure 3-3), but the erosion upstream appears to be older, as evident by vegetation grown over the erosion scarp (Figure 3-4).

**Figure 3-3: View seaward on north bank, showing relatively recent erosion "bite" into cobbly terrace fronted by cobble lag beach.**

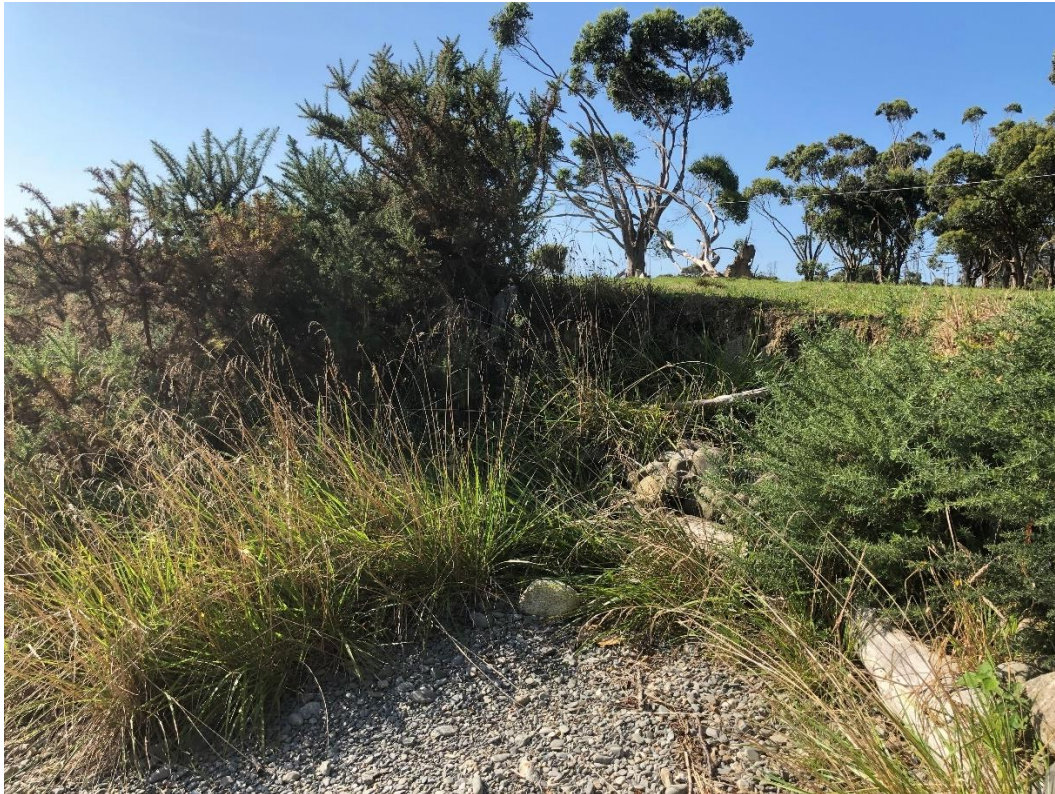
**Figure 3-4:** Close-up of vegetated-over erosion scarp between north bank stub groynes.

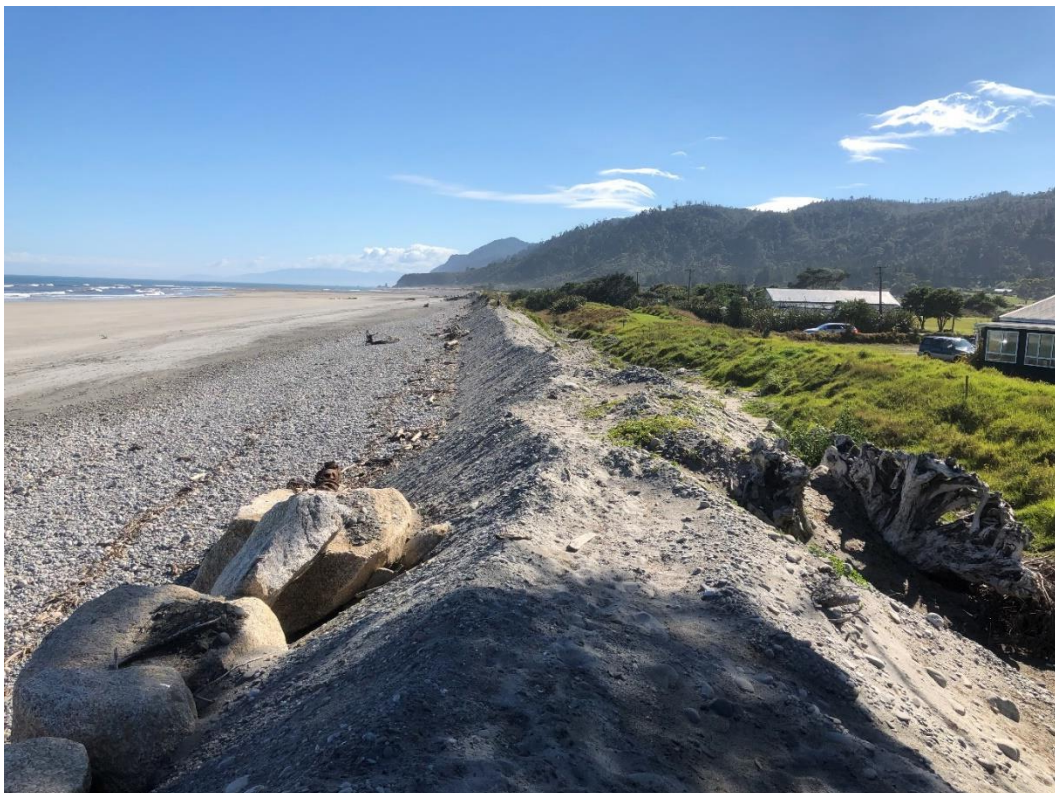
- The seaward bund is composed of gravelly sand scraped from the upper beach. Its face is steep, and around the access point at the end of Lewis Street it is at the repose angle, showing that it is being "chewed" by waves at high tide (Figure 3-5). The upper foreshore is formed by a narrow ramp of cobbles, while the mid-lower foreshore is wide and sandy.
- The four rock spur groynes (~ 10m long spur, ~ 20 m long base) keyed into the seaward bund appear to be having minor/minimal effects. I saw no sign of any sand/gravel impoundment wedge adjacent to the southern spur groyne (near the macrocarpa trees; Figure 3-6), but there was a narrow upper foreshore gravel wedge between the 2<sup>nd</sup> and 3<sup>rd</sup> spur groynes and between the 4<sup>th</sup> spur groyne and the spit-tip

**Figure 3-5:** Double bund fronting Mokihinui township. Note steep (at angle-of-repose) seaward face of seaward bund, cobble ramp on upper foreshore, and wide sandy lower foreshore.

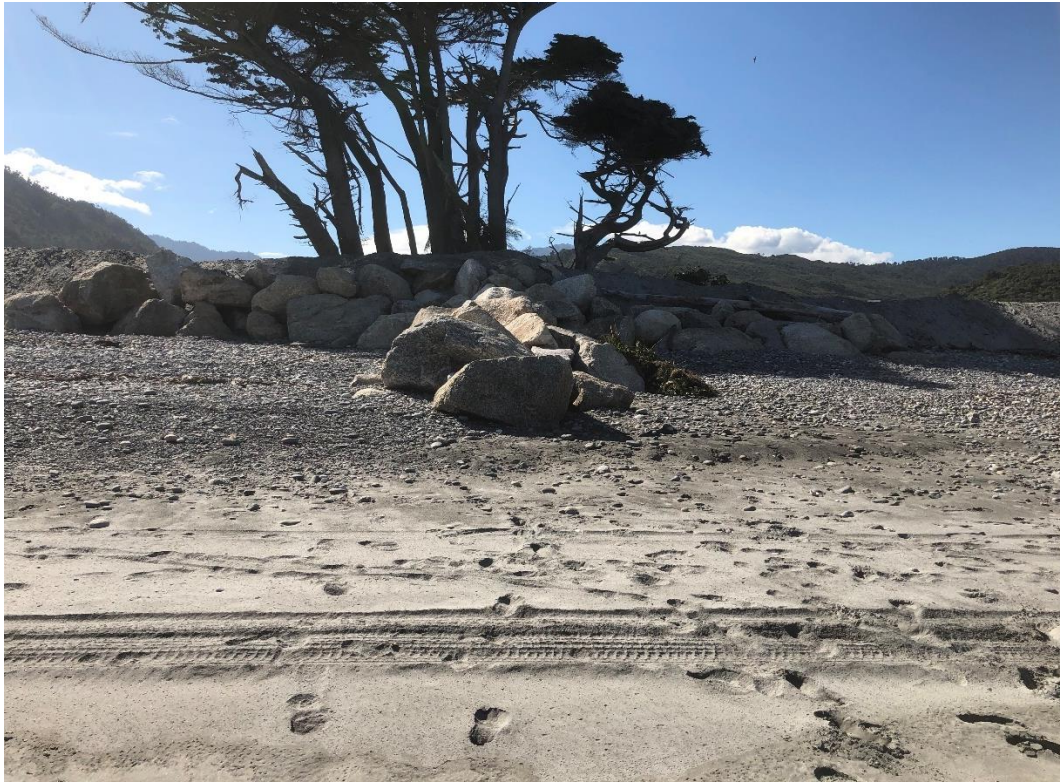
**Figure 3-6: The spur groyne south of Lewis Street.** Note no difference in width of cobble ramp either side.

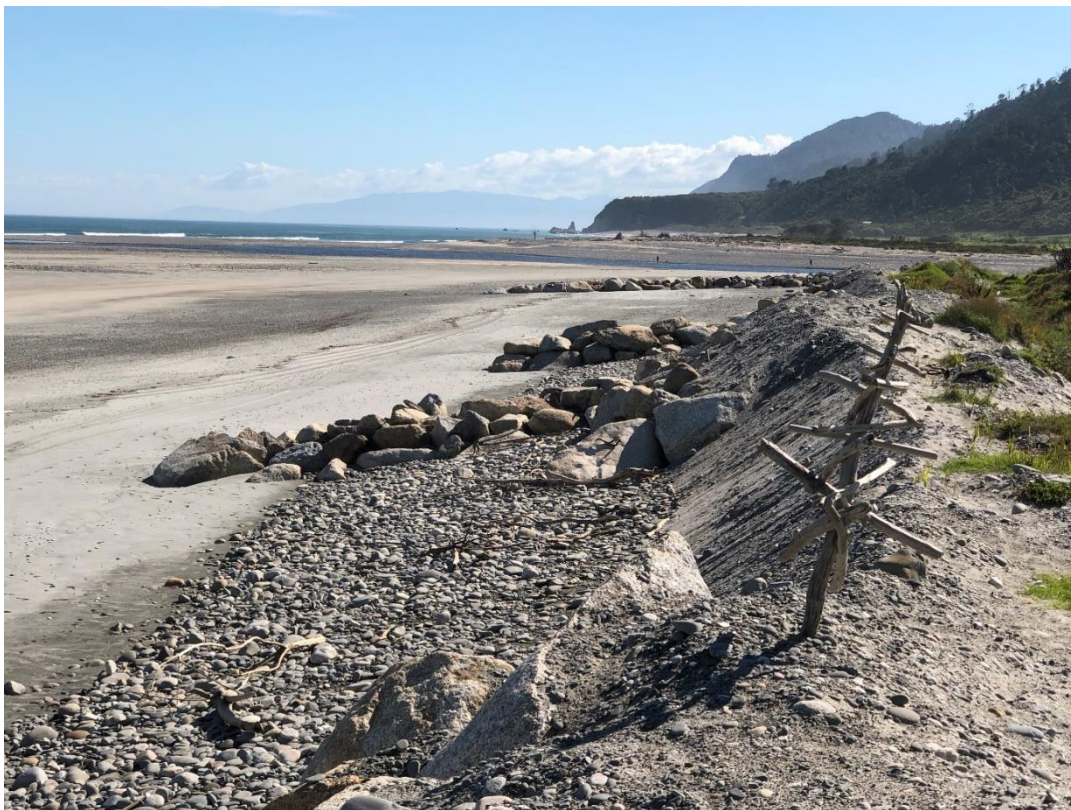
groyne (Figure 3-7). The wedge orientation indicated northward transport, as expected, but the “thick end” width was only several m, so the protective services developed will be minimal. Thus, these spur groynes appear to be too short to have any significant effect.

**Figure 3-7: The 3<sup>rd</sup> and 4<sup>th</sup> stub groynes and the spit-tip groyne in the background.** Note northward thickening of cobble ramp towards the nearest (3<sup>rd</sup>) groyne.

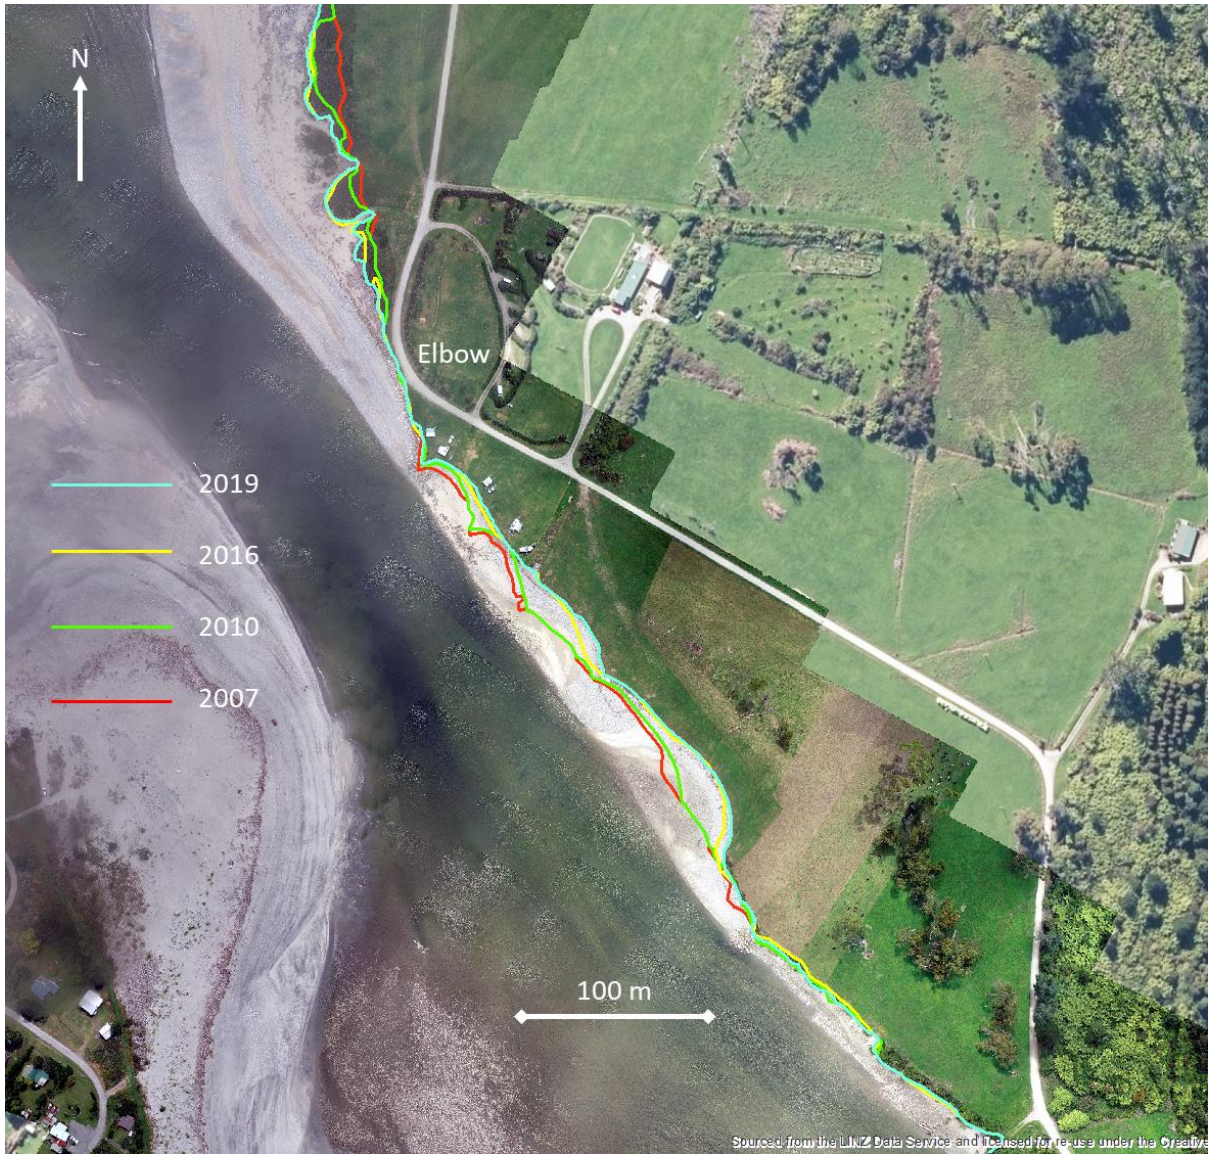
Finer details of the recent positions of the north bank are shown on Figure 4-2. On this, bank positions were mapped from georeferenced vertical aerial photographs taken in 2007, 2010, 2016, and February 2019. This shows an overall bank retreat of up to 21 m along the ~ 300 span of bank upstream from the 'elbow' between 2007 and 2019, but with most of this occurring between 2010 and 2016 (which included the two largest recent floods of late 2010 and late 2011) and a lesser amount between 2007 and 2010. The bank retreat shows a 'cusped' pattern, with retreat greater in shallow embayment's between cobbly headlands (similar to the pattern observed on cusped gravel beaches). Less overall retreat occurred between 2016 and 2019 (which includes Cyclones Fehi and Gita in February 2018), but 2-8 m of retreat over this period was focussed on WSW-facing banks on the seaward sides of the cusps – which suggests erosion by waves rather than high river flows.

Further upstream, the 170 m span of bank enclosed by the two stub groynes has remained stable since 2010 (within the 1-2 m level of detection afforded by the aerial imagery).

Seaward of the elbow, the bank (or at least the vegetation edge) has advanced up to about 20 m since 2007.

**Figure 4-2: North bank locations between 2007 and 2019 overlaid on 2019 imagery.** Bank/shore edge positions mapped off edge of vegetation on georeferenced imagery.

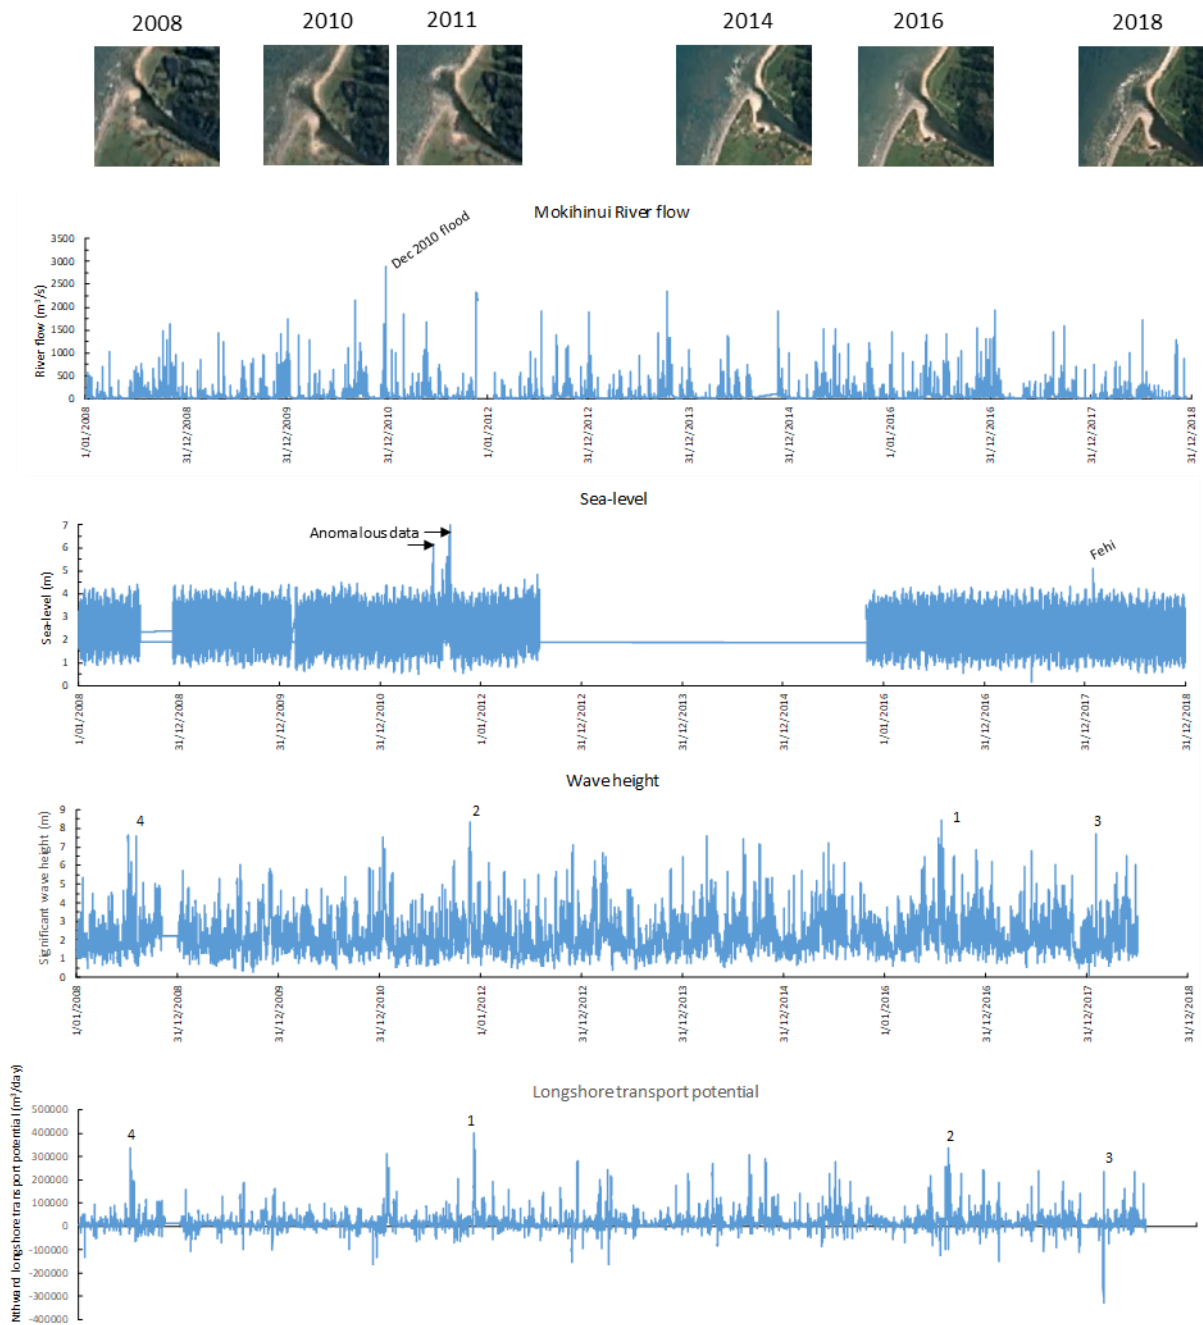
The largest river flood (peaking at 2875 m<sup>3</sup>/s) occurred in December 2010. Note on the 2010 and 2011 images at the top of Figure 6-1 how the sand “bulge” on the south side of the river mouth was largely trimmed off after this flood (but built back in subsequent years).

The highest sea level of recent years (~ 1.5 m above normal high tides) was the storm surge associated with Cyclone Fehi on 31 January 2018<sup>7</sup>. Fehi also provided the 3<sup>rd</sup> highest wave event since 2008, and so was the likely cause of the most recent erosion on the northern river bank (attack from seaward was also indicated by the westward aspect of the erosion “bites”). Higher wave events occurring in November 2011 and July 2016 (but with less storm surge) might account for the erosion recorded between 2010 and 2016.

The record of wave-driven longshore transport potential indicates to both north and south on a day by day basis but with northward transport dominant and the highest transport events all directed northward. This northward transport, and waves wrapping around south shore spit and pushing sand into the river mouth, are inferred to be the process driving the build-up of the sand bulge on the south bank of the river mouth.

**Figure 6-1: River flow, sea level, significant wave height, and longshore transport potential at Mokihinui since 2008.** River mouth images from Earthengine shown at top. Numbers 1-4 on wave height and longshore transport potential plots rank the four largest events. The 28 December 2010 river flood peaked at 2875 m<sup>3</sup>/s.

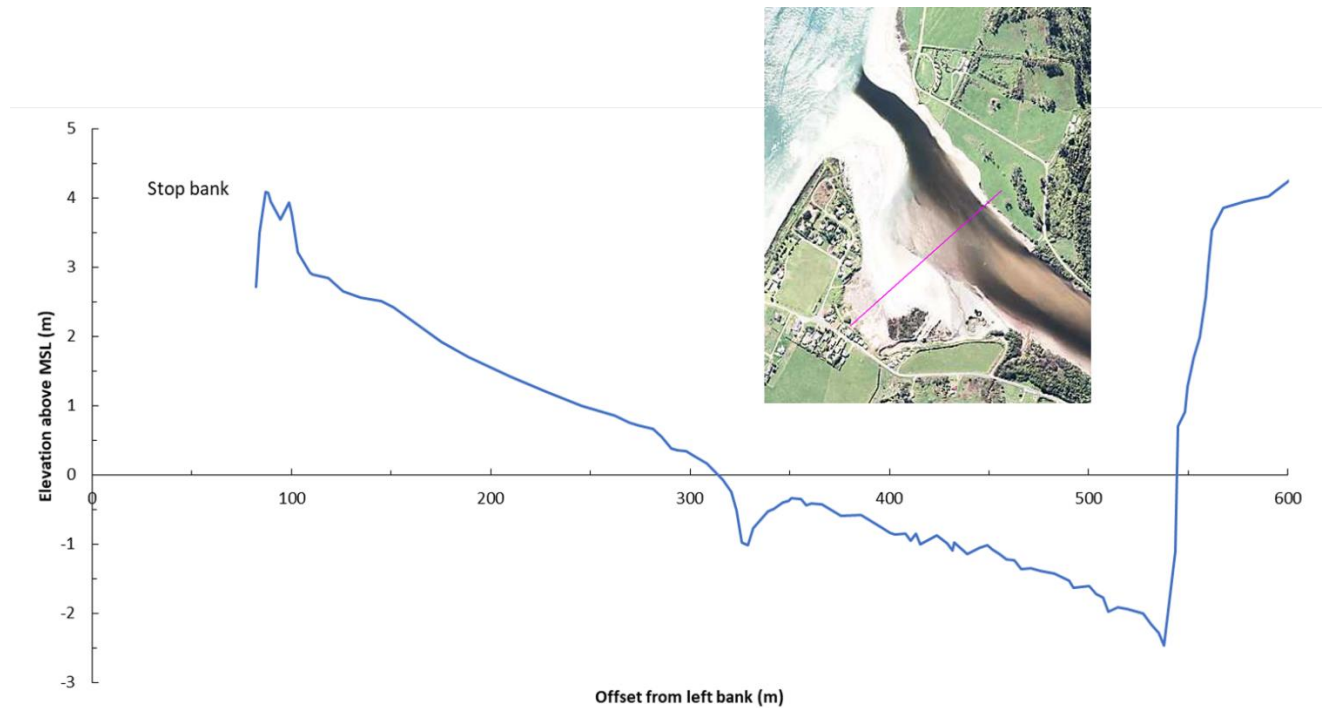
A further piece of useful information is an estuary cross-section that was surveyed by NIWA during the Mokihinui hydro-power investigations (Figure 7-1). This was surveyed in February 2011, shortly after the large flood of December 2010, and shows the channel midway down the estuary having an asymmetric shape, with the thalweg hard against the steep right bank. This provides evidence of the effectiveness of the left bank training wall at deflecting flood momentum along the north bank.

**Figure 7-1: Mokihinui cross-section surveyed in February 2011.** Section located by pink line on inset image. Wet part of channel surveyed by echo-sounder linked to RTK-GPS; dry parts from prior LiDAR survey. Source: NIWA.
