pp 174 – 189, Bulletin of the New Zealand National Society for
Earthquake Engineering, Volume 21, No 3, September 1988

Liquefaction in the Buller Region
in the
1929 and 1968 Earthquakes

J. B. Berrill¹, V. C. Bienvenu² and M. W. Callaghan³

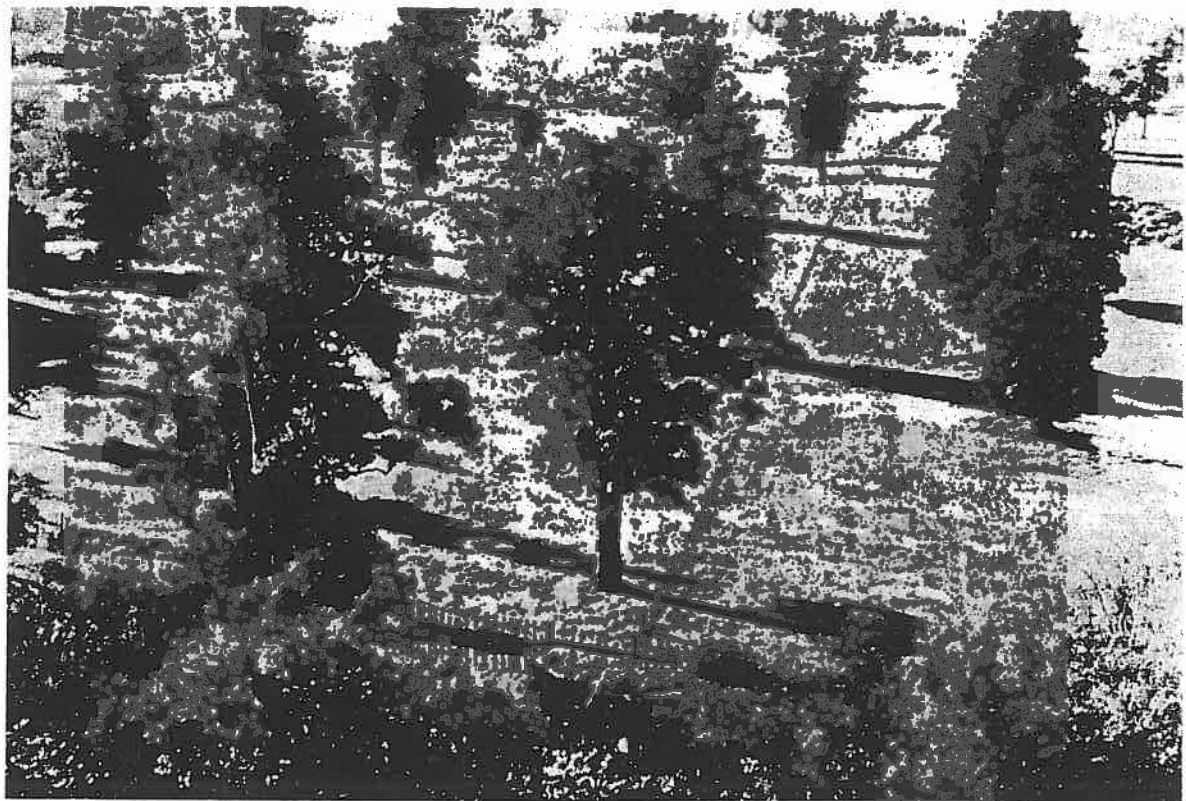
FIGURE 4: THREE CHANNEL FLAT, LOOKING NORTH FROM DEE HILL, THE DAY FOLLOWING THE 1968 EARTHQUAKE. NOTE THE EJECTED SAND AND VENTS VISIBLE IN THE FOREGROUND. (PHOTO: M. CALLAGHAN).

Extensive ejection of sand was observed at Three Channel Flat following the 1968 earthquake. The flat comprises a system of low terraces of Recent alluvium. The photograph shown in Figure 4 was taken on the day after the earthquake. The present owner of the land, Mr Warren Inwood, also remembers seeing the ejected sand, although he did not own the land himself at the time. The extent of sand ejection is clear from Figure 5, a vertical aerial photograph taken 5 days after the earthquake.

The flat comprises a system of low terraces of Recent alluvium. Extensive hand auger boring at the south end of the flat shows a layer of silt 3 to 4m thick overlying fine sands of variable thickness over gravels (Ooi, 1987; Adlam, 1988). Thickness of the sand layer increases towards the outside of the abandoned south channel evident in Figure 5, and decreases towards the inside of the channel, marked by the absence of sand boils. It appears that where there is sand, it was ejected in 1968.

The paddocks to the north of the central vehicle track have been extensively regraded since 1968 and their contours changed markedly. But to the south of the track the terrain is essentially the same, although some fences have been moved. The two paddocks at the south end of the flat (in the foreground of Figure 4) have been ploughed two or three times since 1968 yet

in them it is still possible to pick up lenses of fine grey sand, presumably the ejecta, starting at depths of up to 200mm below the ground surface. After ploughing, while the soil is still moist, Mr Inwood reports that the patches of grey sand stand out markedly from the darker silts. The sand possibly owes its being buried to the ploughing, but possibly also to a build up of silt since 1968, as the paddocks are flooded about once a year.

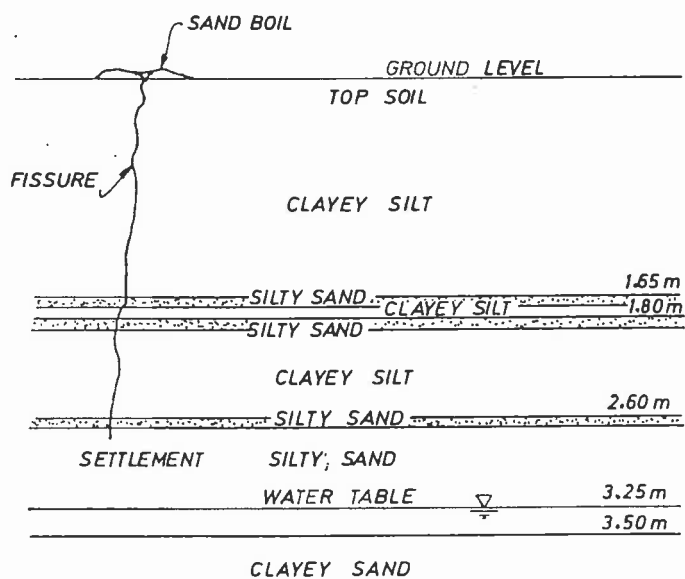
FIGURE 6: LOG OF TRENCH AND AUGER BORING BY DODD AND DUNLOP IN AUGUST 1968.

Dodd and Dunlop (Dodd, 1970; Dunlop, 1968) investigated sand boils at the south west of the flats with auger borings and sieve analysis. The log of their boring, starting from the bottom of a recently excavated trench, is shown in Figure 6; grain size distributions of the ejected and subsurface sand strata are shown in Figure 7. Note the similarity of the sand gradings. Presumably the ejected sand came from the lower layer, below the water table.

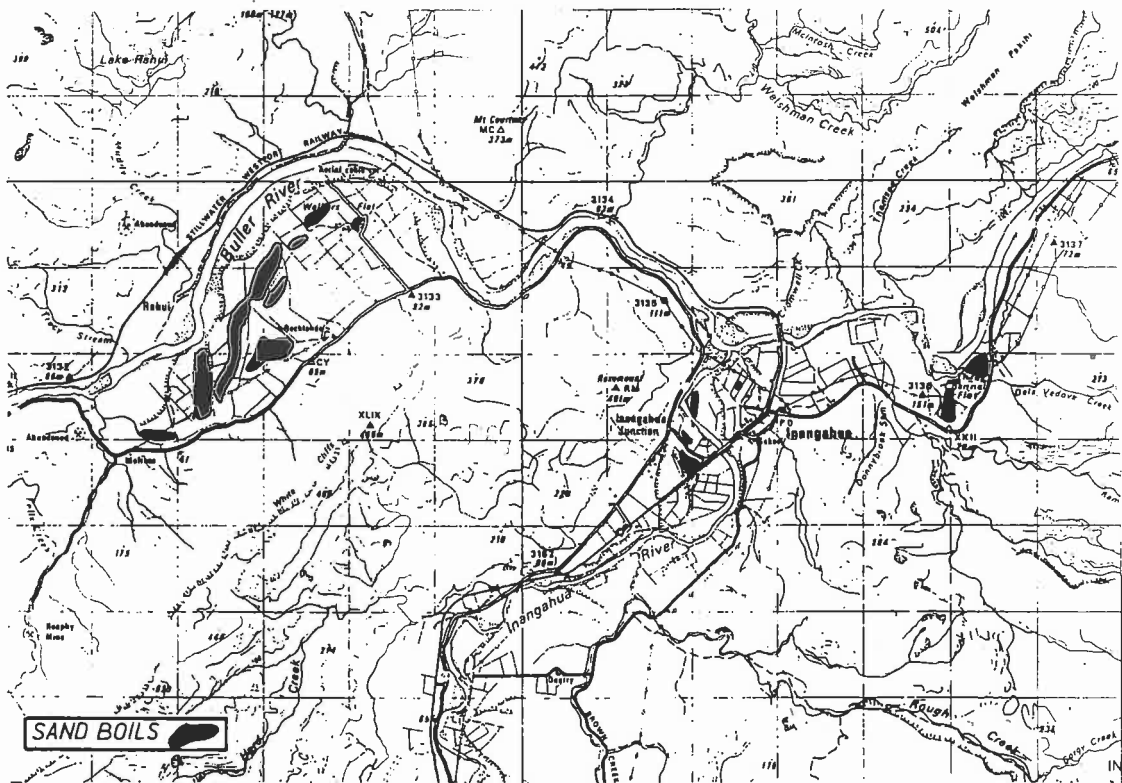
FIGURE 8: LOCATION OF EJECTED SAND SHOWING IN THE 1968 AERIAL PHOTOGRAPHS AT SITES NEAR INANGAHUA.

The confluence of the Buller and Inangahua rivers near the Inangahua township is marked by large areas of young alluvial river terraces. There are several contemporary reports (Lensen and Suggate, 1968; Adams *et al.*, 1968; Sutherland, 1970; Dodd, 1970) of sand boils on these terraces in 1968; and patches of sand show up well on the aerial photographs. Figure 8, drawn up from the photographs, shows the areas in which ejected sand is apparent.

Aerial photographs from runs C and D of the 1968 post earthquake photography show ejected sand over a large part of Walkers Flat. Figure 8 shows the extent of the 1968 sand boils.

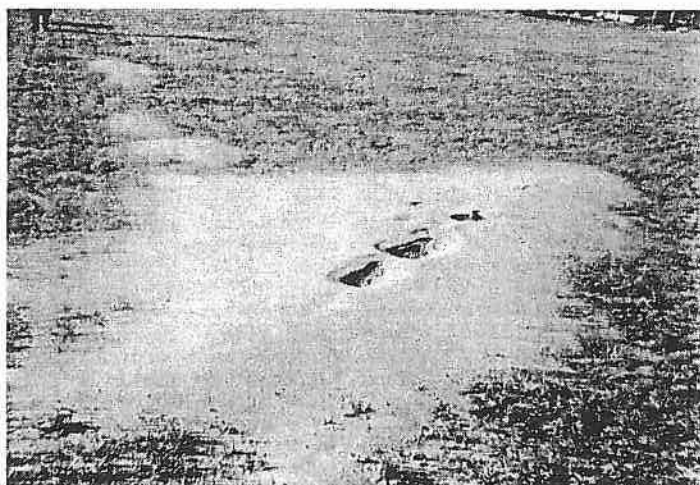
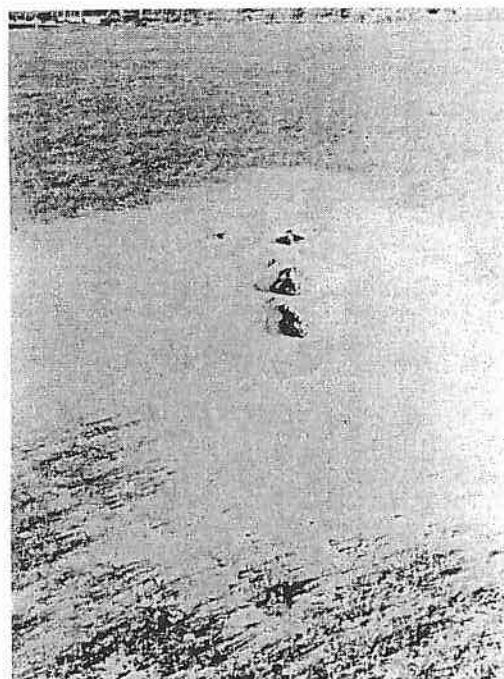
The eyewitness accounts and photographs taken near Mr G. Meddows' farmhouse at the east end of the flat are of particular interest. The photographs in Figure 9 show sand boils in the paddock immediately to the north of the farmhouse. Mr Meddows remembers sand and water being ejected from vents in the vicinity of the farmhouse and cowshed during some aftershocks as well as the main shock. But he did not notice any sand ejection in the area following the 1962 Westport earthquake sequence.

FIGURE 9A: SAND BOILS IN THE "BULL Paddock" MEDDOWS' FARM AT NORTHEAST END OF WALKERS FLAT, MAY 1968.

FIGURE 9B: DIFFERENT VIEW OF BOIL ABOVE. (PHOTOS: MRS WAYNE MEDDOWS, MR G. MEDDOWS).

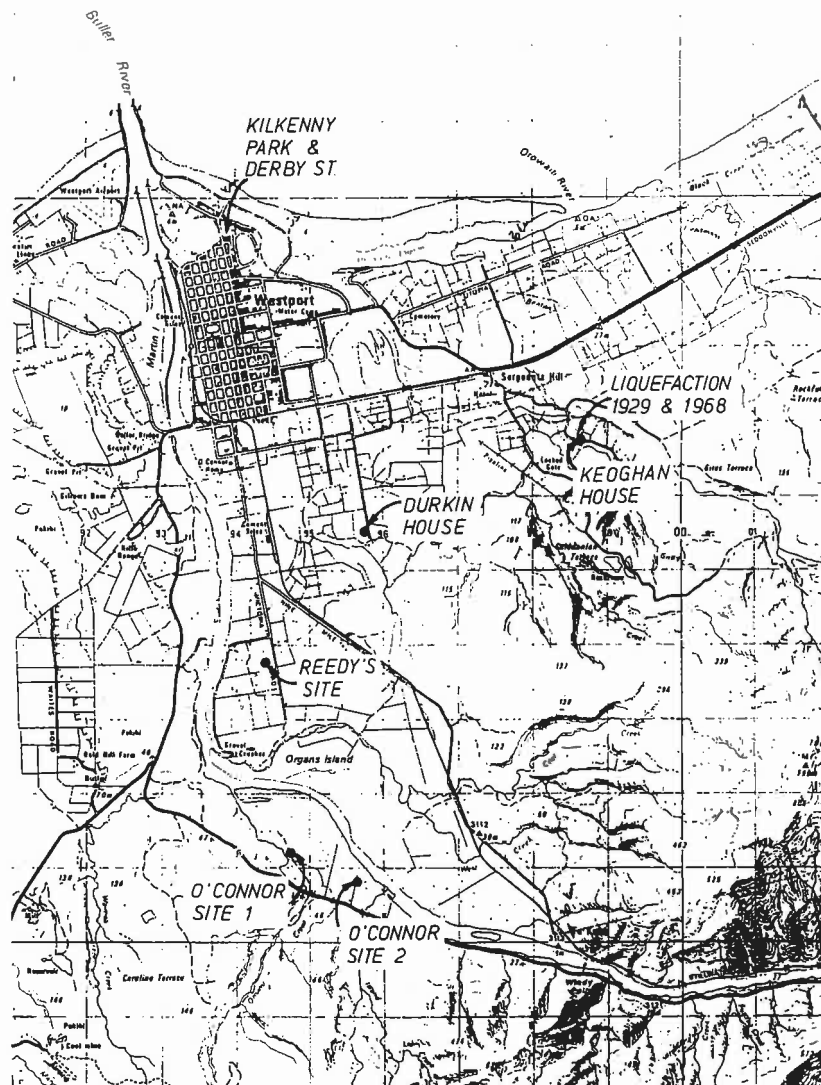
FIGURE 10: SITES NEAR WESTPORT.

Mr Noel Keoghan's farm is situated on the banks of the Orowaiti River, south east of Sergeants Hill. His house is marked on Figure 10. Mr Keoghan observed sand boils in the paddocks to the north of his house following the 1929 earthquake and again in 1968.

From 1929, when he was a boy of 11, Mr Keoghan remembers geysers of sand and water 5 to 6 feet high, leaving sand cones 2 to 3 feet high. In 1968, smaller cones were formed, about 6 inches high, in the same general area. Small sand boils were also observed by Mr Keoghan in the bed of the Orowaiti River immediately to the south of his house. Mr Keoghan's daughter, Mrs Wayne Meddows of Whitecliffs, also observed the 1968 boils in the Orowaiti River, known locally as Giles Creek.

Mr John O'Connor observed sand boils in two places on his farm following the 1968 earthquake. They were:

1. On the Buller River side of the farm road immediately beyond where it crosses Omanu Stream.
2. On the flat paddock near the mouth of the Buller Gorge, beyond the cowshed.

Mr James Durkin observed the ejection of sand in the backyard of his house (now occupied by his son Michael) on Excelsior Road. Mr Durkin was not sure whether this occurred in 1962 or 1968. However, Mr O'Connor, who first told us of this site, implied it occurred in 1968. The house is marked in Figure 10.

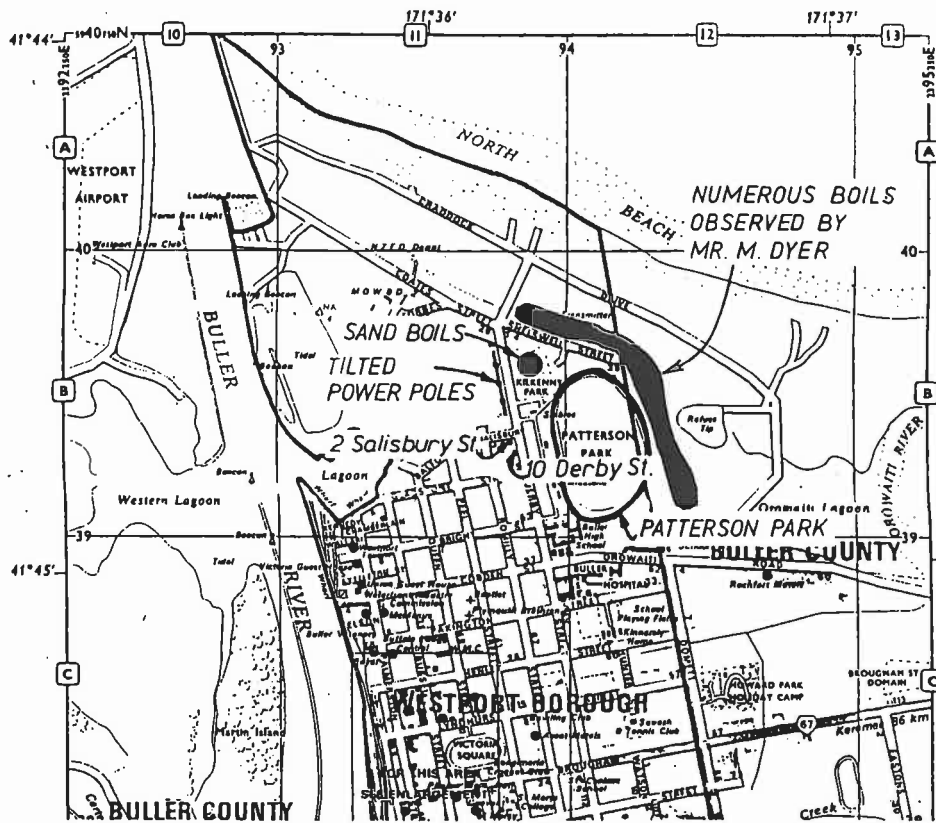
FIGURE 11: AREAS OF LIQUEFACTION IN 1968 IN THE KILKENNY PARK-NORTH BEACH AREA OF WESTPORT.

Mr M. Dyer remembers seeing numerous sand boils in the paddocks immediately north of Shelswell St and over the land to the west of Patterson Park south of Orawaiti Road, as shown in Figure 11. He also remembers boils along the east side of Derby St at Kilkenny Park. Several other eyewitnesses reported sand and water boiling from the ground in Kilkenny Park; these include Mrs McDonald of Morgan's Lane, and Mr and Mrs Bill Gaynor and Mrs Naylor of Shelswell Street, whose properties back onto Kilkenny Park. They do not remember seeing anything similar in 1962, but Mrs

Also, cracks opened in the ground passing through the Gaynors' house at 14 Shelswell Street and others on the south side of Shelswell Street. The cracks were roughly parallel to Shelswell St, (and to the nearby beach) and were of the order of a few hundred millimetres wide. Mr Gaynor, employed by the Westport Borough Council at the time, remembers having to add 1.2m of pipe to reconnect the broken water main running approximately north-south along Derby St, near Kilkenny Park. Taken together with the cracking, the broken water main suggests that a large mass of surficial soil had moved towards the coast on a layer of liquefied sand.

To the west of Patterson Park at 10a Derby St, sand erupted under a house with sufficient force to lift it, rotate it and leave it skewed on its foundations. (The house was subsequently demolished. The position of the 1968 boil and house was in front of the present house at number 10a).

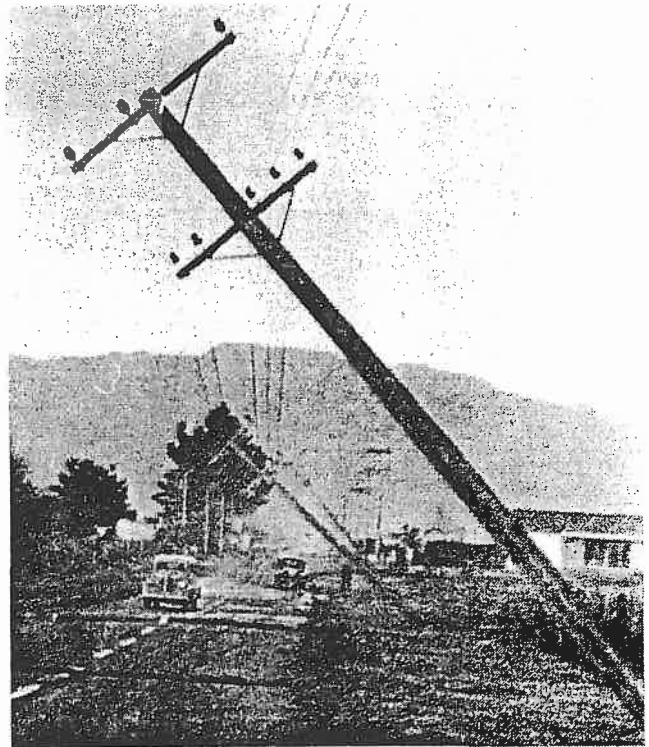
FIGURE 12: DERBY ST, WESTPORT, LOOKING SOUTH FROM KILKENNY PARK.

Figure 12 shows tilted electric power poles on the west side of Derby St adjacent to Kilkenny Park, also pointing to liquefaction at a shallow depth.

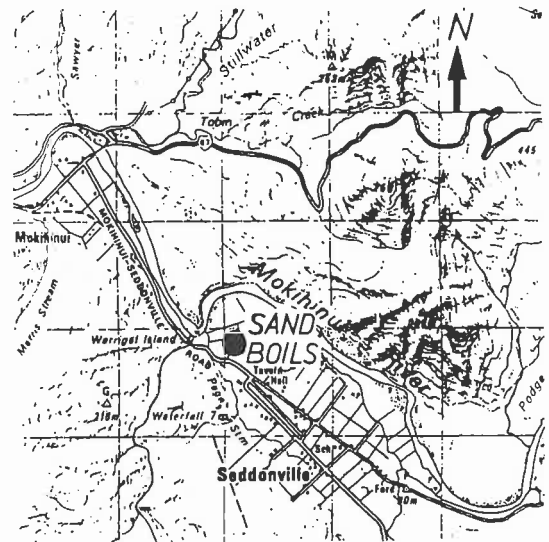
FIGURE 13: APPROXIMATE LOCATION OF SAND BOILS SEEN AFTER THE 1929 EARTHQUAKE.

Mrs Corby remembers seeing sand boils on the Mohikinui River terraces between the Corby homestead and the Seddonville road. She could not locate the boils precisely, after 57 years, but they were in the area shown in Figure 13.

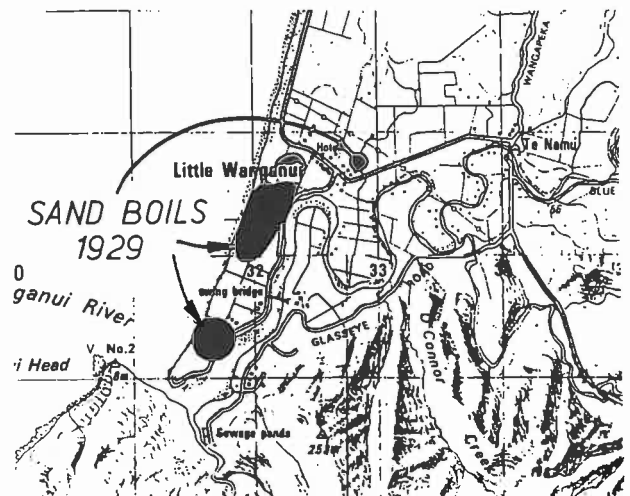
FIGURE 14: APPROXIMATE LOCATION OF SAND BOILS SEEN NEAR LITTLE WANGANUI IN 1929.

Mr and Mrs R. Duncan of Little Wanganui can both remember seeing sand boils following the 1929 earthquake, at the approximate locations shown in Figure 14.

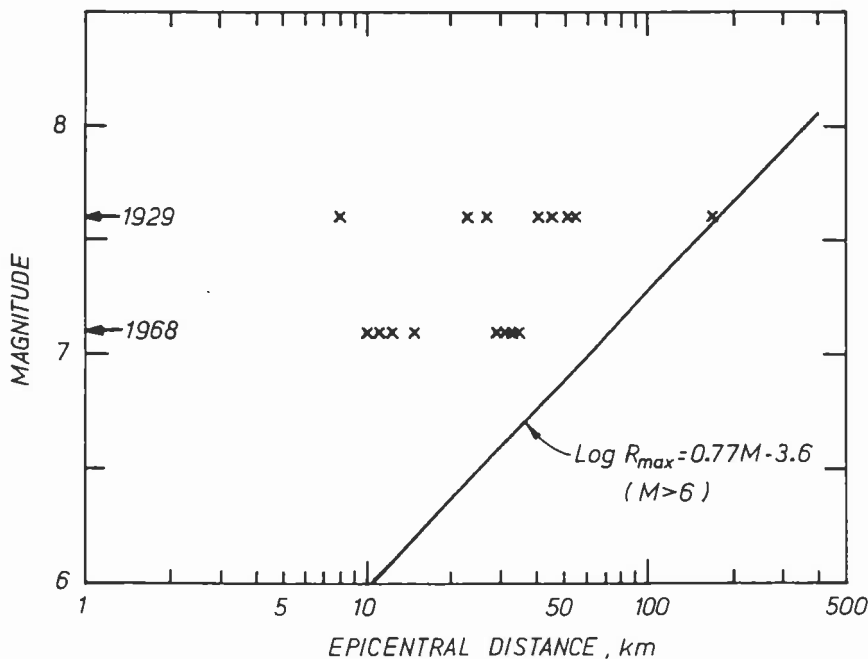
FIGURE 17: MAGNITUDE-DISTANCE PLOT OF THE 1929 AND 1968 SITES.

The 18 cases of liquefaction found in the Buller region are plotted on a magnitude-distance diagram in Figure 17, together with the Kuribayashi and Tatsuoka (1977) upper bound relationship for distance R_{max} to site of furthest liquefaction.

For the 1968 data, it is seen that liquefaction might have been expected at greater distances, especially towards the south, since the epicentre was at the northern end of the rupture surface. Enquiries were made of residents in the Reefton-Ikamatua area, but no further cases were found.
