OCEL CONSULTANTS NZ LIMITED

18 June 2006

REVIEW OF COASTAL EROSION - CARTERS BEACH

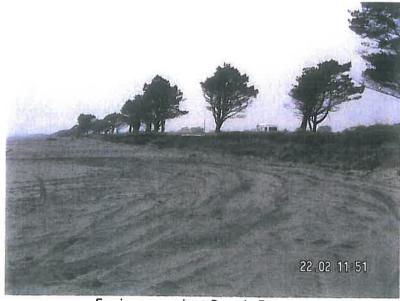
Erosion scarp along Domain Frontage

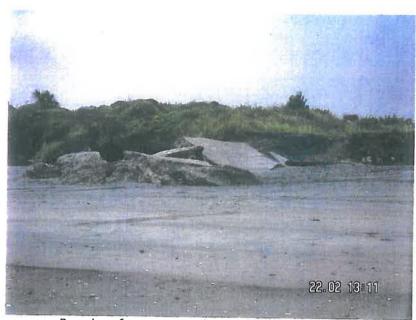
Remains of concrete used to fill accessway blowouts

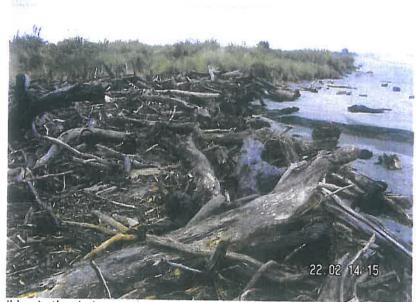
Driftwood buildup in the drain mouth to the west of the Domain. Note the flax and marram grass vegetation further west.

The interpretation of this is that the beach had recently been swept clear of driftwood by high seas which had forced some driftwood into the stream mouth, the remainder being swept along shore. A fresh and steep to vertical erosion scarp varying in height from 0.7 to 2.0 m was evident along the beach boundary. No sign of a developed dune system providing sand storage and interchange with the beach system was evident, rather the inshore land comprises a flat plateau above the beach vegetated with various areas of mown grass, scrub and pasture.

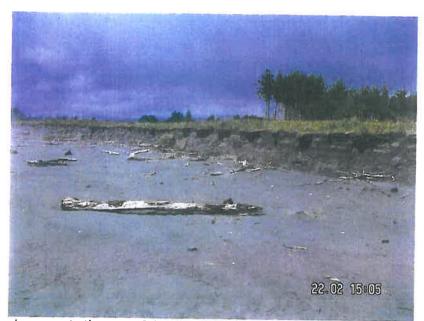
Erosion scarp to the east of the Domain, clean sand with thin vegetation layer

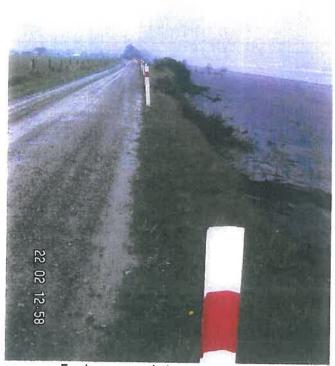
The erosion scarp was evident in varying degrees from Bradshaws Road in the west to opposite the airport terminal in the east, a 2 km length of coastline. The most significant evidence of erosion was over the central section between the Motor Camp and opposite the Golf Club clubhouse. Over this section Rotary Drive deviates towards the sea, and this section of the coastal road is now directly exposed to damage.

Erosion scarp relative to Rotary Drive

- realign the threatened section of Rotary Drive to remain consistently clear of the erosion scarp
- establish a planting and landscape programme with the objective of stabilising the erosion face, accumulating wind blown sand, and providing a degree of reinforcement to the top of the bank. Advice should be sought on planting preferences in terms of the use of particular species (nature spinifex and pingao vs marram) that will encourage dune formation
- establish a monitoring baseline that can be regularly compared to provide information on the success or otherwise of the work undertaken, and to provide ongoing assessment of the risk to assets (including the airport).

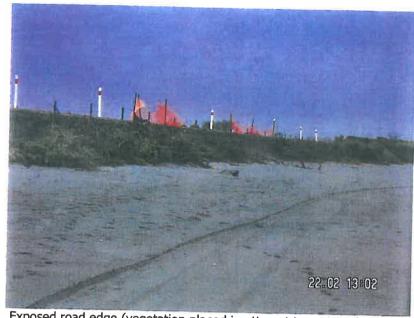
Exposed road edge (vegetation placed in attempt to protect the bank)

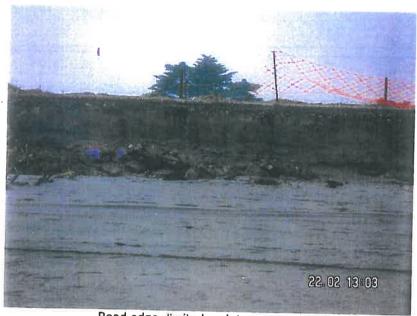
Road edge, limited rock toe protection

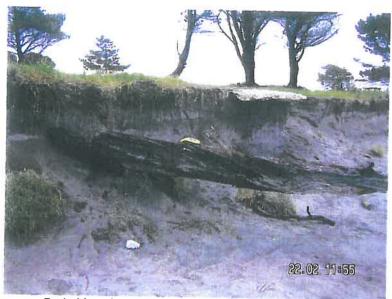
The eroding faces exposed along this foreshore comprise mainly clean sand, in some places including large logs that were incorporated as the foreshore built out under the influence of the breakwater extensions. Generally the vegetation on these eroding sections is confined to pasture grasses with shallow root systems and limited capacity to reinforce the exposed material under wind and wave attack. In areas where there is a more dense cover of vegetation the rate of retreat appears to be no different, any benefit being provided by more competent root systems being lost by the collapse of the bank as the trees fall when undermined.

Buried logs becoming exposed with foreshore retreat

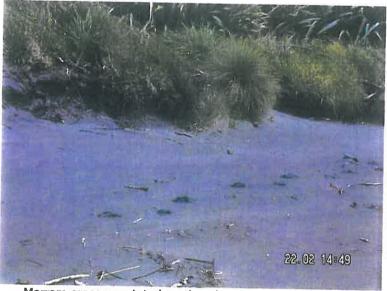
At each end of the eroded section dense and uncontrolled vegetation exists including sand binding marram grass. Where this type of material has been undermined, the vegetation has generally slumped down the face of the bank and remains in position to re-establish itself on the bank face.

Marram grass vegetated section showing signs of recovery
