Managing and adapting to coastal erosion at Cobden Beach

Prepared for West Coast Regional Council

May 2017

NIWA CLIENT REPORT No: 2017137HN
Report date: May 2017
NIWA Project: ELF17210

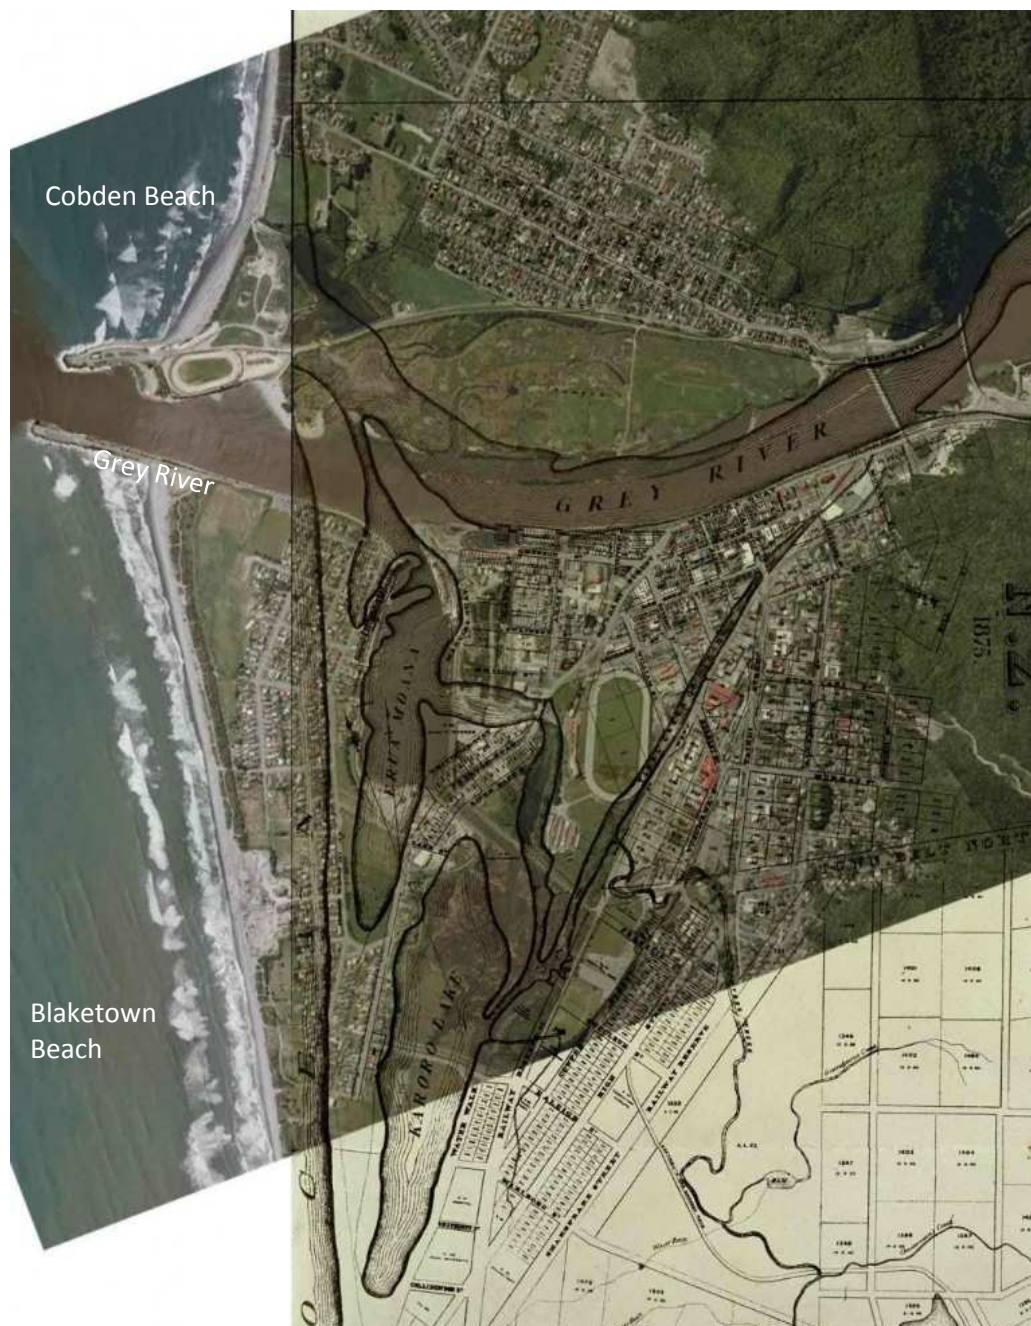
The Grey River training works, constructed over 100 years ago, extend approximately 1 km from the 1884 shoreline (see Figure 2-2), and they significantly altered the coastline by modifying sediment supply to the adjacent beaches. To the south of the river (Blaketown and South Beach), since constructed massive accretion occurred as the northerly littoral drift was trapped against the river training works. Conversely, to the north of the river at Cobden, significant historical erosion occurred as the beach was starved of the sediment that had been trapped on the south side of the river training works (Gibb 1978, Pfahlert 1984, Benn & Todd 2003).

Mapping of the coastline position from aerial photographs and cadastral maps showed that from 1884 to 1981 Blaketown beach prograded (advanced seaward) about 300 m at a rate of 2.9 m/year, while the southern part of Cobden Beach retreated about 130 m at a rate of 1.35 m/year (Pfahlert 1984).

Figure 2-2: Changes to the coastline at Greymouth 1875-2014. [Credit: West Coast New Zealand History¹].

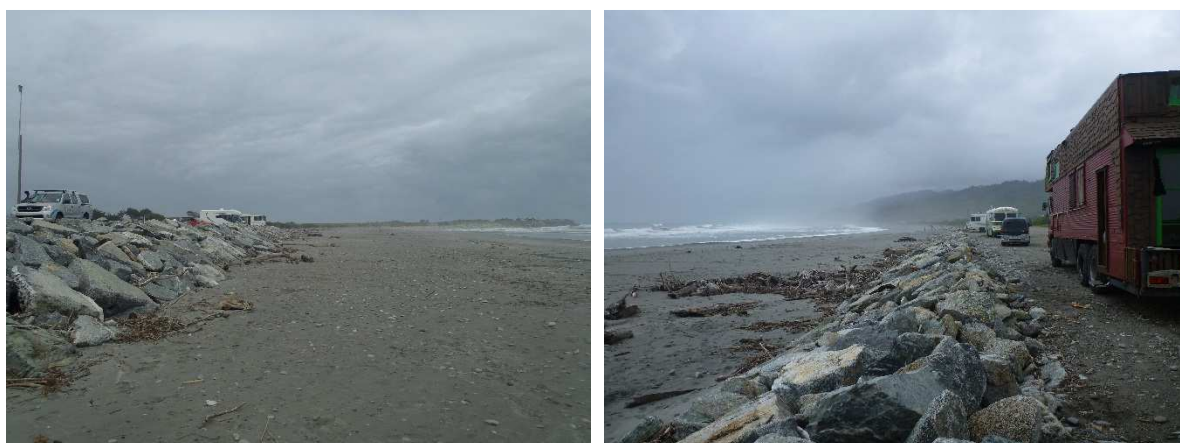
The carpark occupies the broad crest of the beach, with the car park surface approximately 1.5 m above the beach level (Figure 2-3). The seaward edge of the carpark is protected by a rock revetment composed of small-medium granite rocks (0.3-0.7 m diameter) at a slope of 1:1.5 to 1:2. We understand that the rocks were added when the carpark was resized in 2015, resulting in the seaward edge of the carpark being pushed further over the beach. No geotextile underlay is apparent beneath the rocks. The crest of the revetment is only one rock wide (0.5 m), and it sits nearly flush with the carpark elevation (Figure 2-3). The carpark now protrudes onto the active beach face 3-5 m from the adjacent vegetation lines and adjacent beach crest. There is no vegetation on the beach in front of the carpark. The seaward edge of the carpark has been repaired several times after storm erosion has undermined the rubble revetment (pers. comm. P. Birchfield). The carpark remains a popular overnight stop for freedom campers.

Figure 2-3: Jellyman Park rock protection and beach front. Left: view south to tiphead from northern end of structure. Right: view north towards Point Elizabeth from southern end of structure. [21 Nov 2016. Credit: M. Allis (L), M. Hicks (R)].

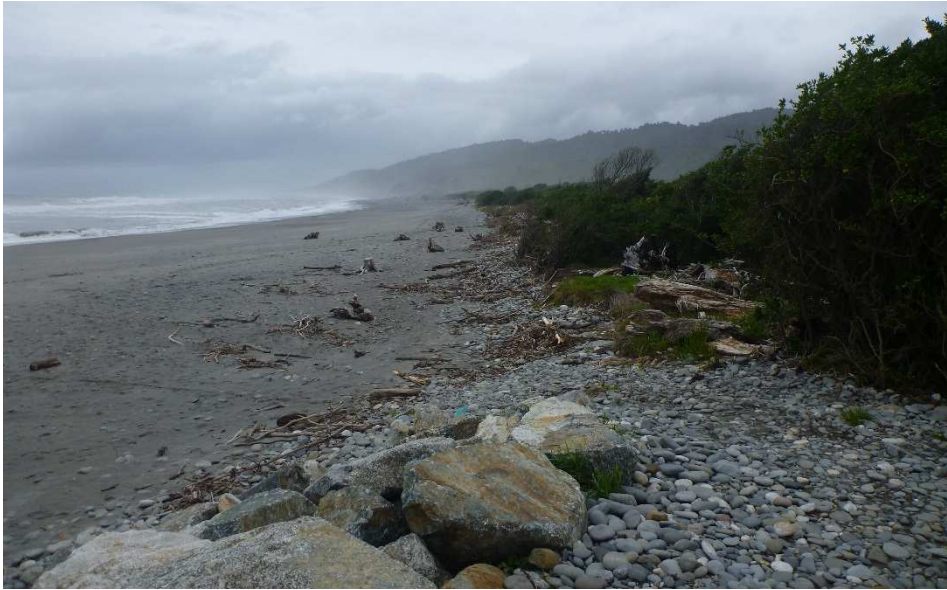
To the north and south of the carpark, the beach shows evidence of wave/gravel overwash and vegetation dieback. Immediately north of the carpark, retreat of the beach crest has caused vegetation dieback (gorse/flax, see Figure 2-5). This retreat is likely due to overwashing events, with overwashed gravels reaching 5 m inland from the beach face and up to 10 m inland at access paths. There is also vehicle access at the northern end of the carpark structure, with wheel rut disturbances to sediment and vegetation (Figure 2-4).

Figure 2-4: Cobden Beach at 0.6 km from the tiphead, (at carpark), looking north towards Point Elizabeth. Note vehicle tracks past the end of carpark protection rocks [Credit: M. Hicks, 22/11/2017].

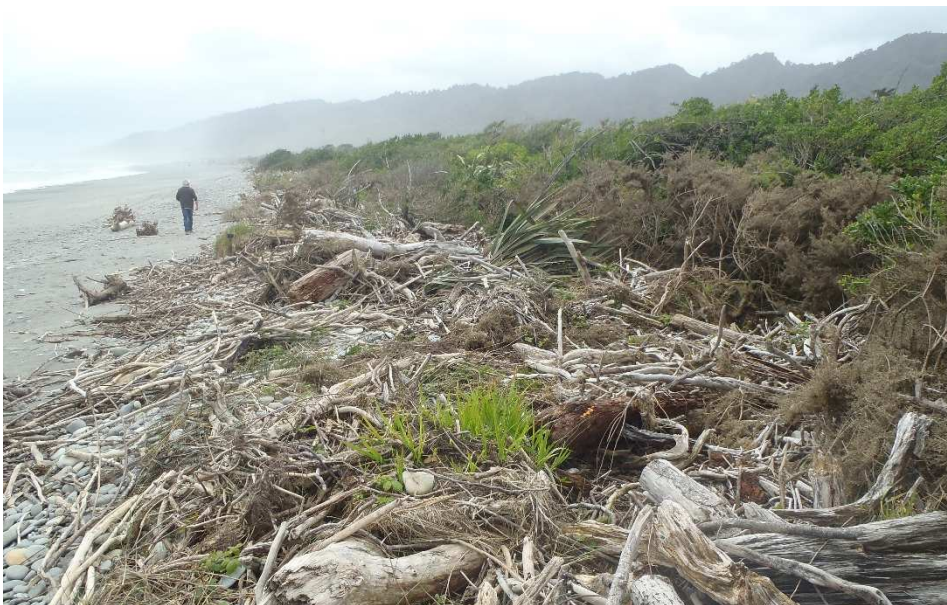
Figure 2-5: Cobden Beach at 0.7 km from the tiphead (100 m north of carpark), looking north toward Point Elizabeth. [Credit: M. Allis, 22/11/2017].

Between Jellyman Park and Monro Road the beach has been recently exposed to large waves (either a single storm or series of storm events), with driftwood/gravels being cast into and onto the vegetated beach crest (Figure 2-5). The vegetation dieback indicates there may be some short-term shoreline retreat. There remains at least 20-30 m of vegetated setback to Domett Esplanade.

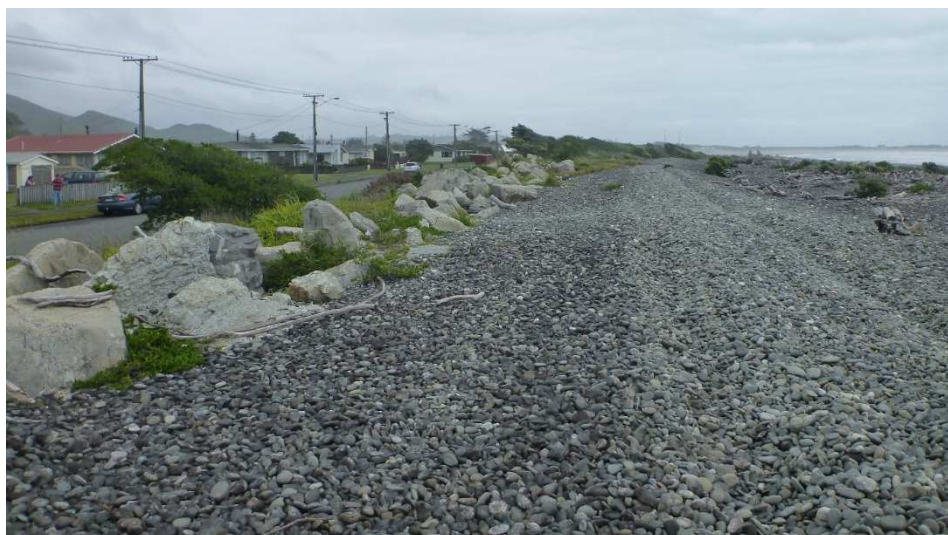
Closer to Monro Road, there are historic protection works alongside North Beach Road (Figure 2-6), however, these have been buried by more recent accretion and growth of the beach. At present, the inner gravel is elevated 1.5-2 m above the roadway, with one or two storm-berms (terrace-like ridges parallel to the shoreline). Vegetation and lichen (slight discoloration on gravel) have colonised the gravel berms (Figure 2-6), suggesting that these gravels have not been re-worked for over 30 years (other than vehicle and foot traffic – see Figure 2-6).

Figure 2-6: Cobden Beach at 1.4 km from the tiphead (opposite Monro Road) looking south. Note dark-grey lichen growth on gravel outside vehicle tracks, and note historic rock protection alongside roadway [Credit: M. Hicks, 22/11/2017].

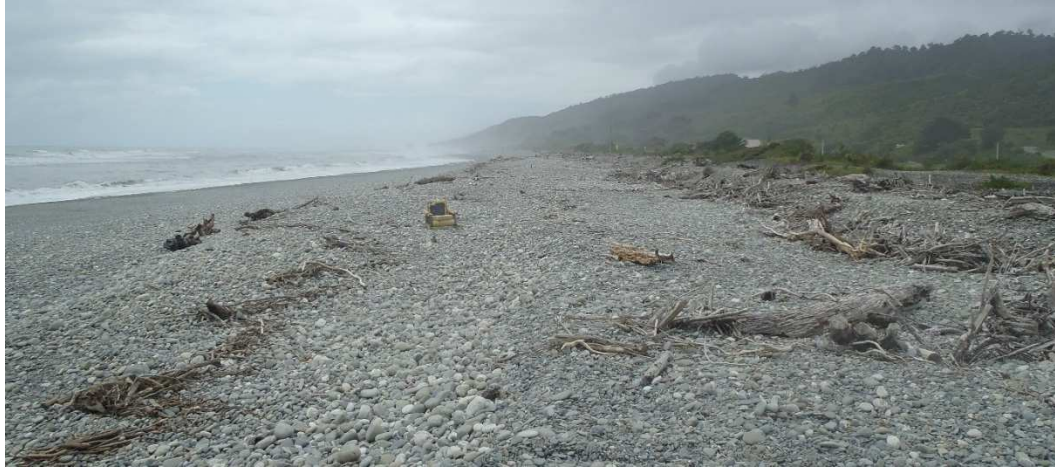
Figure 2-7: Cobden Beach at 1.4 km from tiphead (opposite Monro Road) looking north towards Point Elizabeth. [Credit: M. Allis, 22/11/2017].

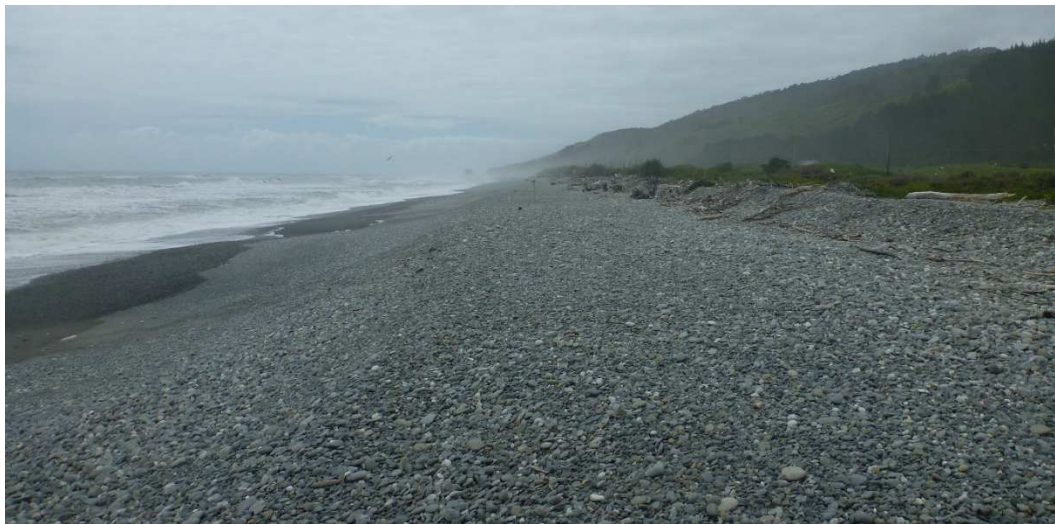
Figure 2-8: Cobden Beach at 2.9 km from tiphead (opposite 162 North Beach Road) looking north towards Point Elizabeth. [Credit: M. Hicks, 22/11/2017].

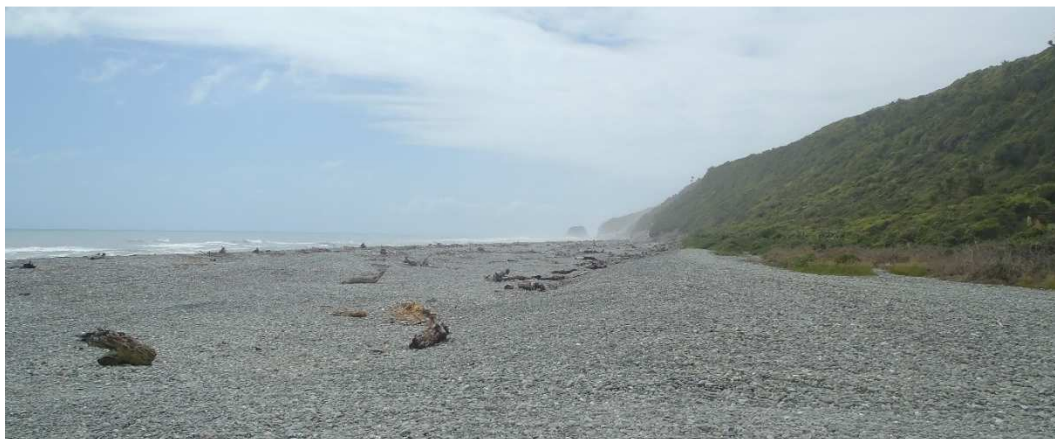
Figure 2-9: Cobden Beach at 5 km from tiphead (end of North Beach Road) looking north towards Point Elizabeth. [Credit: M. Allis, 22/11/2017].

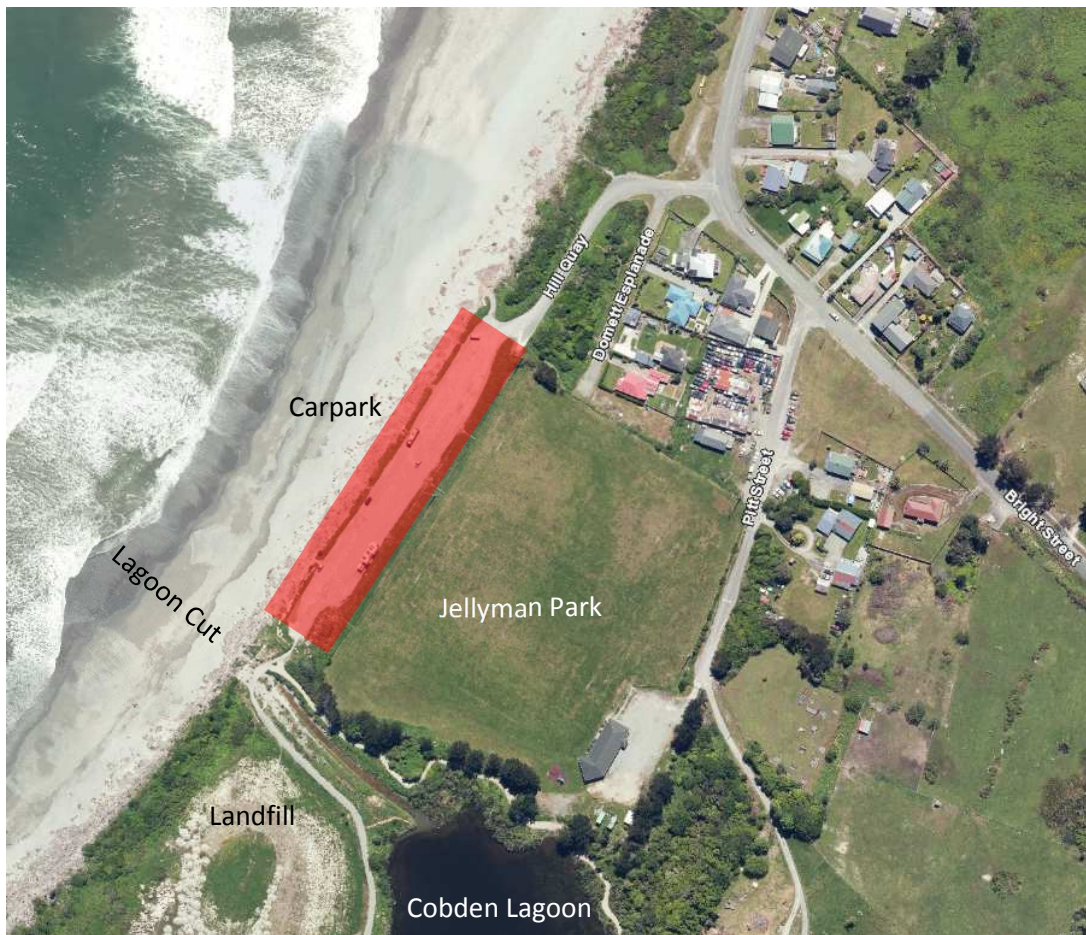
The Jellyman Park carpark (Hill Quay) occupies the seaward edge of Jellyman Park, as shown in Figure 3-1 (red shading). The carpark acts as both a vehicle carpark, freedom camping site, and coastal defence for the Cobden community and Jellyman reserve. The carpark stretches approximately 200 m along the shoreline between from Cobden Cut (a mechanically-managed channel for drainage of the Cobden Lagoon during high rainfall or river floods) and connects to Hill Quay.

We understand the carpark was previously² a narrow gravel extension to Domett Esplanade positioned on the vegetated gravel barrier. This has been gradually enlarged, with the vegetation lost (either through vehicular trampling or deliberate removal)³ so the gravel barrier berm no-longer had the capacity to accommodate natural fluctuations in shoreline position due to storm events. We understand that the seaward rock protection was added when the carpark was resized in 2015.

Figure 3-1: Jellyman Park, Cobden. Background photograph dated 2013. [Credit: WCRC Westmaps].

Despite the accretion that has occurred along this section of coast, the carpark and associated infrastructure has been placed too close to the active beach to accommodate episodic storm events that can cause beach crest overwashing and beach crest cutback. No natural beach crest buffer width has been maintained to enable these short-term erosion events to be accommodated. As such, the carpark suffers from common issues with rock protection placed on beaches. These being the process of lowering of the beach level in front of the structure (a reduction in beach elevation caused by loss of sediment from wave reflections off the structure face) and edge effects eroding around the flanks of the structure (caused by waves wrapping around the structure).

1. The Cobden community and council discuss their values, objectives and expectations for the carpark, and its future as an amenity or coastal defence.
2. Consideration be given to relocating the car park and access further landward and a minimum 10 m beach crest vegetated buffer reinstated (ideally this would be wider and closer to the 30 – 40 m width occurring along much of Domett Esplanade).

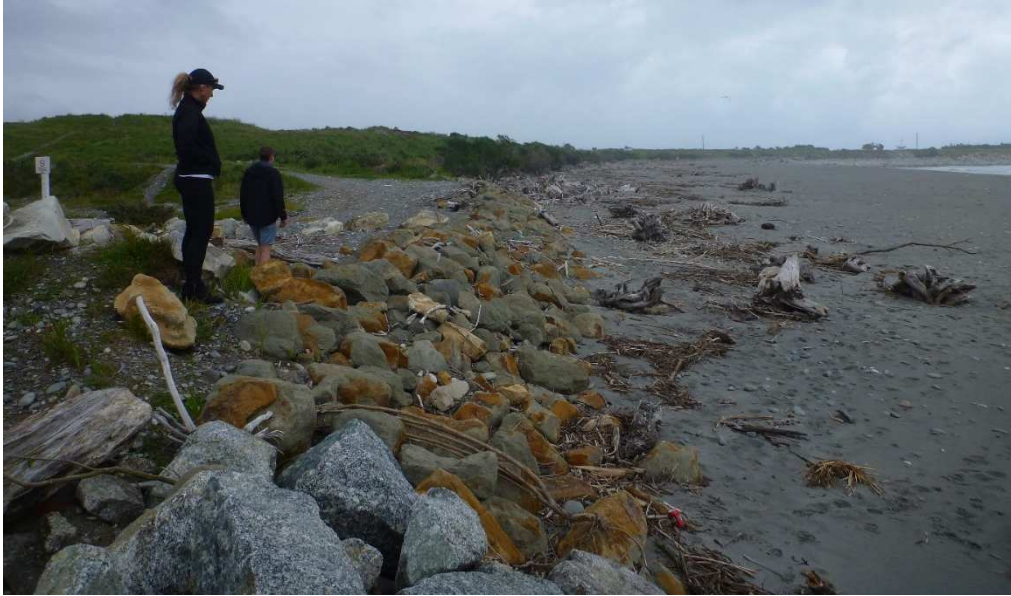
- To the south of the carpark structure, the edge effects are less pronounced, perhaps due to increased wave sheltering from the tiphead. However, GDC have extended the rock protection at the Lagoon Cut (Figure 3-2) to prevent waves eroding the cut and entering the lagoon (pers. comm. P. Birchfield). The rock protection has a slope from 1:1.5 to 1:2 and is comprised of small (<0.4 m diameter) rocks.

Figure 3-2: Rock extension south of the carpark to protect the Lagoon Cut entrance. [Credit: M. Hicks, 21/11/2017].
