**GREYMOUTH FLOOD WALL
UPGRADE DESIGN
GEOTECHNICAL REPORT**

Report prepared for: Good Earth Matters

Report Reference: 09828-A

Date: 9 November 2009

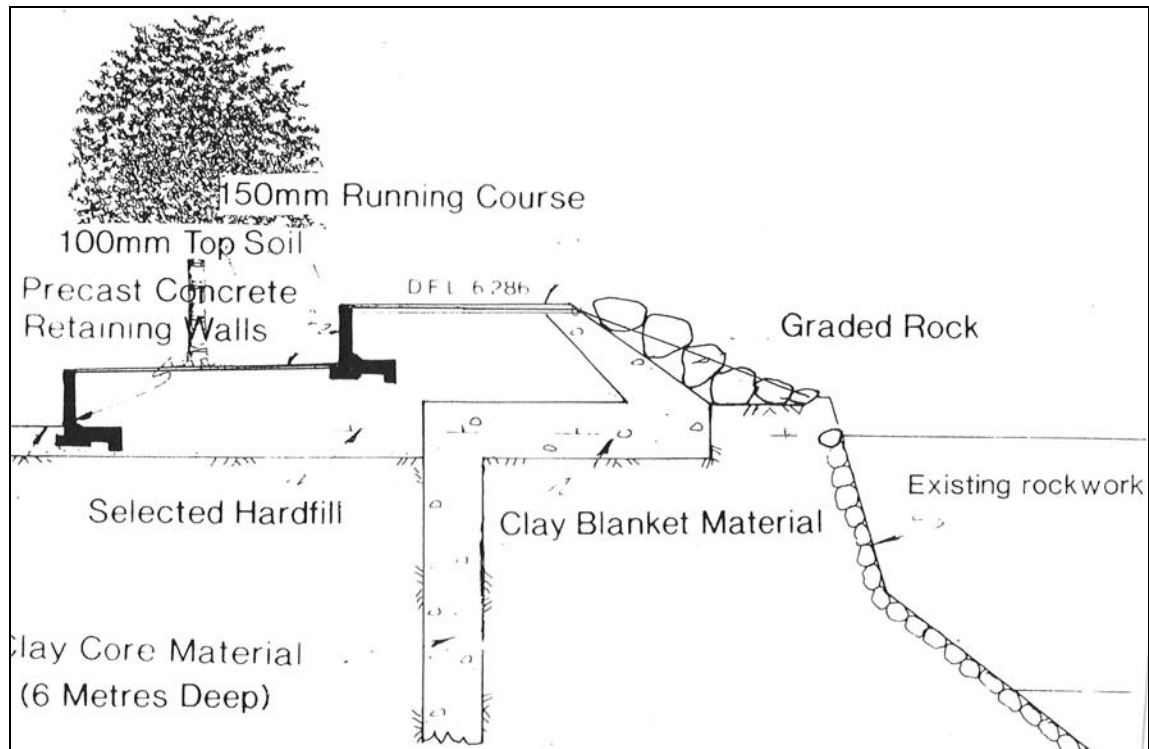
Figure 1: Original Design Section for Mawhera Quay Flood Wall

The design stopbank cross section is known from a drawing supplied by the WCRC (reproduced in figure 1). This incorporates a sloping, low permeability upstream core zone extending around 2.5m vertically. The core then runs horizontally into the centre of the stopbank, and ties into a “clay core” cutoff indicated to be 6m deep within founding soils. The landside batter is supported by 2 low precast concrete retaining walls. The main potential issues associated with the floodwalls are seepage along or near the interface with the underlying soils, and foundation resistance to various potential failure modes. Due to the low height of these walls settlement or bearing capacity are not likely to be issues.

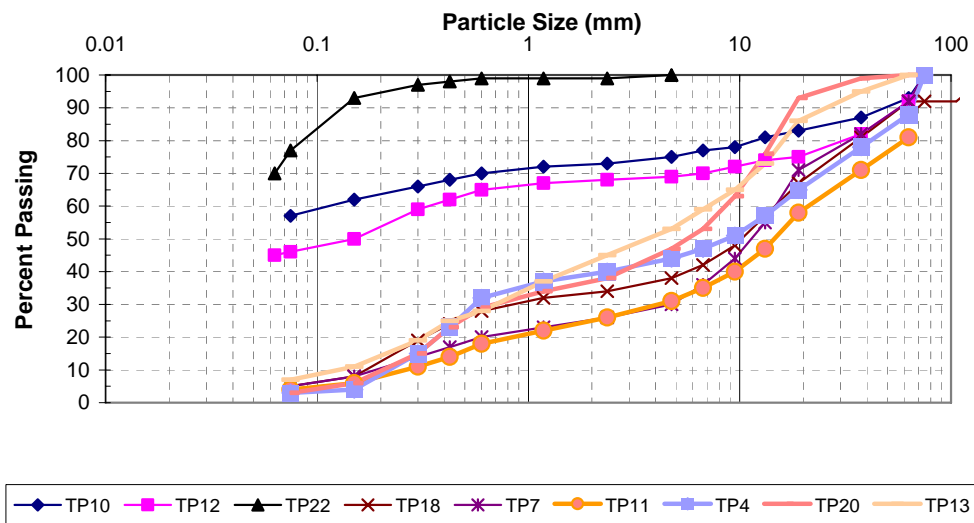
Figure 2: Plot of Laboratory Grading Curves

Generally the supplied design stopbank profile was confirmed by the investigation, although pits only extended to around 0.5m deep to ensure damage to the existing stopbank was minimised. Laboratory testing including 2 particle size distribution tests on each of the sloping silty gravel core and general fill zone were completed in addition to a standard compaction test on core material. Grading curves for the samples are indicated in figure 2. Laboratory testing indicates the low permeability upstream core is a silt with sand and gravel that is expected to effectively limit seepage flows. The grading of the adjacent gravel fill has been checked for filter compatibility with the core, and is found to generally comply with the “no erosion” criteria. The materials exhibit a degree of gap-grading, however given the short duration of any seepage flow through the upper part of the stopbank, it is considered unlikely that piping features or internal erosion would develop.

The permeability of the founding soils at this location are likely at the upper limit of the hardfills tested, as the nature of the founding gravel soils is similar. Based on various correlations from grading curves the permeability is assessed as in the range 4 to 8×10^{-4} m/s. This is significantly higher than the in situ permeability test, but this test appears to give an unrealistically low permeability.

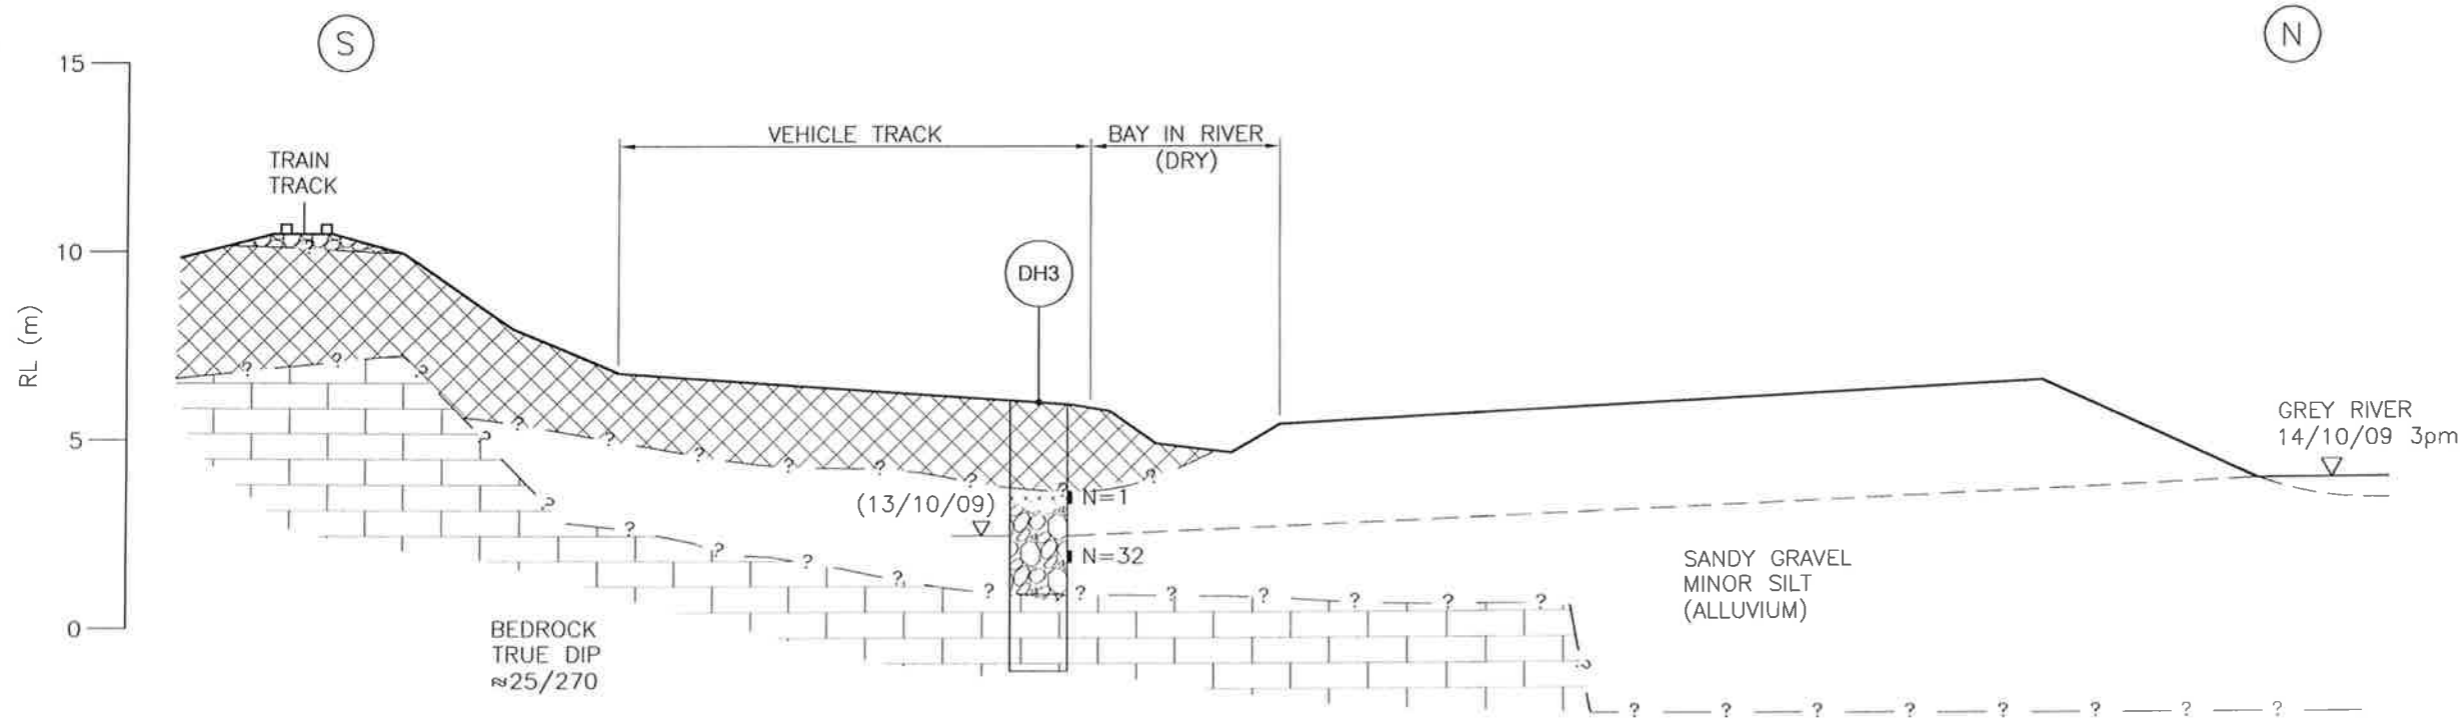
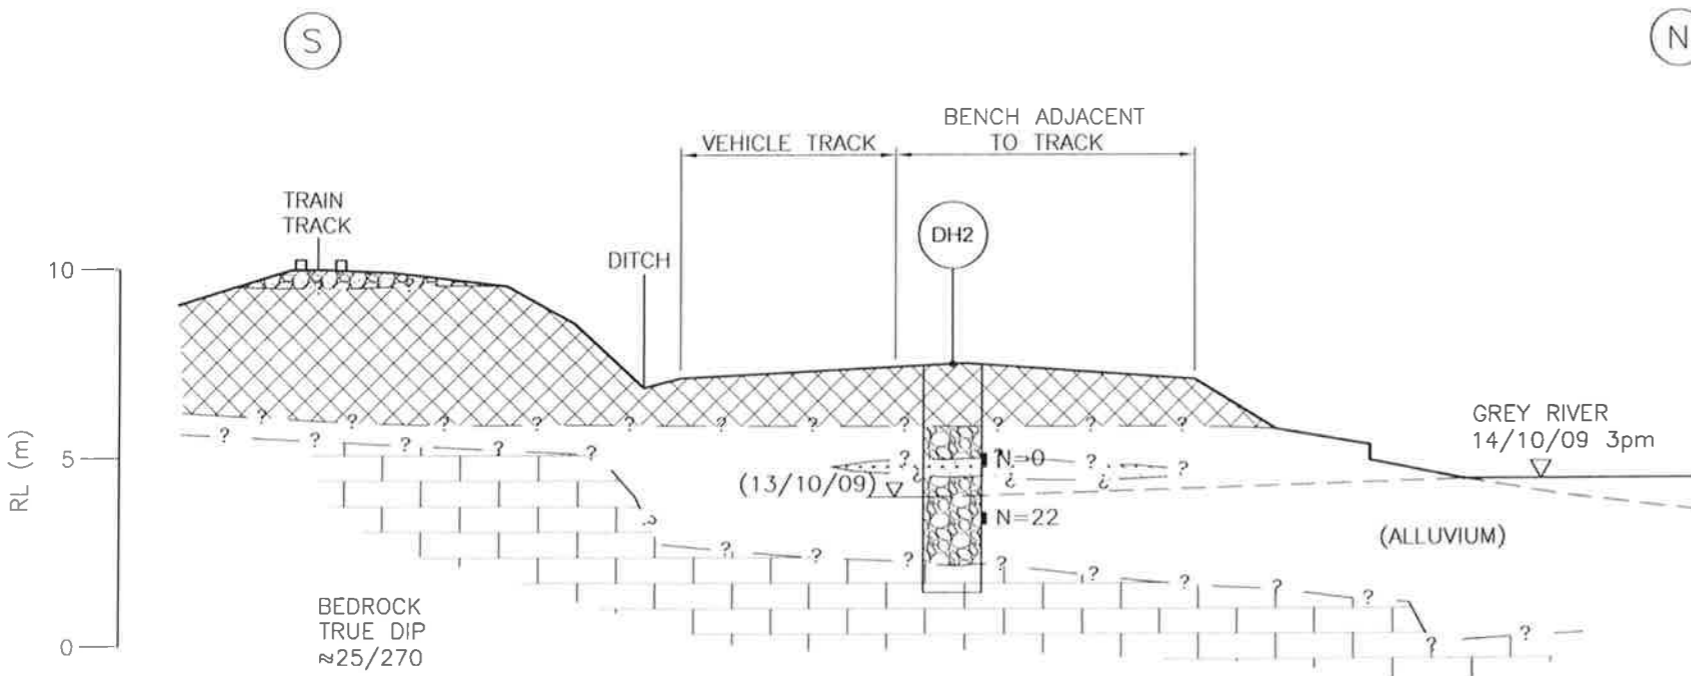
Four test pits and two boreholes were completed in the two bridges area. Ground conditions generally comprise limestone bedrock overlain by dense river gravels 1 m to 2 m deep, overlain by soft river sediments around 1 m thick, overlain by a minimum of around 1.5 m of granular fill. SPT values in the soft river sediments are very low (as low as 0) increasing to typically in excess of 30 in the denser gravels. The fill is variable in composition and in places contained wood fragments, steel and brick inclusions. Groundwater seeps were noted near the base of the test pits, but flows were only modest. Groundwater level within the pits and boreholes was similar to the level of the adjacent river. However, during drilling of DH3 a higher water table was observed within the underlying rock. The water pressure was not artesian (i.e. stabilised below ground level) however was some meters higher than the piezometric level in the overlying alluvium. It is inferred that interconnected defects within the limestone bluff adjacent to the site provide conduits for water from the bluff, which exit at various locations including the two open drains observed on site, as well as sub-surface seepage points, and possibly higher elevation drainage points at times of heavy rainfall and high water pressures within the bluff.

A stability assessment of the proposed fill embankment slope has been completed using a two-dimensional limit equilibrium model. The assessment indicates that the presence of the soft alluvial sediment underlying the existing fill results in acceptable factors of safety under the additional loading of the proposed stopbank fill. However in the event of elevated groundwater levels within the stopbank such as may occur in the event of heavy rainfall locally resulting in seepage pressures from beneath/behind the stopbank from the limestone bluff, factors of safety approach 1 (i.e. a state of failure). Removal of the existing fill and underlying soft sediment, and founding on denser alluvial sediments was then modelled. The resulting factors of safety are around 1.7 for the normal (observed) groundwater profile, and 1.5 for a postulated adverse groundwater profile associated with high seepage rates from the underlying bluff or a rapid drawdown scenario from recession of river flood level. The results are summarised in table 1, and printouts of the stability analysis are included in appendix 4. Note that high water levels in the Grey River do not represent a critical load case for this section of stopbank on the landward side, which is well buttressed by the railway on the landward side.

In addition liquefaction and excessive settlement are significant risks. Liquefaction of this very loose soil is likely in even a moderate earthquake with subsequent major slumping and settlement of the fill embankment. It is therefore recommended that the existing fill and soft underlying sediments be undercut, and the stopbank fill founded on the dense underlying sediments.

1. The strength of the sand/silt in situ river sediments is low, and it is recommended that the area be undercut to allow founding of the stopbank and proposed culverts on dense materials. Some of the existing fill may be able to be re-used. The plan and depth extent of undercutting will require confirmation on site.

2. Seepage flows from the bluff must be adequately drained to ensure that seepage pressures do not build up within the stopbank fill. The old culverts are scheduled for replacement, and the new culverts should be carried through to interface with the rock bluff. Detailed logging of the rock bluff should be undertaken at the time of construction, and drainage works installed for any open defects in the rock face, so that all seepage flows are collected and passed through the culverts beneath the stopbank fill. Free draining fill materials should be used up to the level of the existing railway, as the lower portion of the stopbank will not be required to retain water due to the site geometry.

5. The existing fill embankment where it supports the railway is relatively steep, and design concepts should aim to avoid any significant destabilising effects. It is recommended the existing fill is not undercut except for minor trimming of the face and that temporary slopes do not exceed the existing slope.

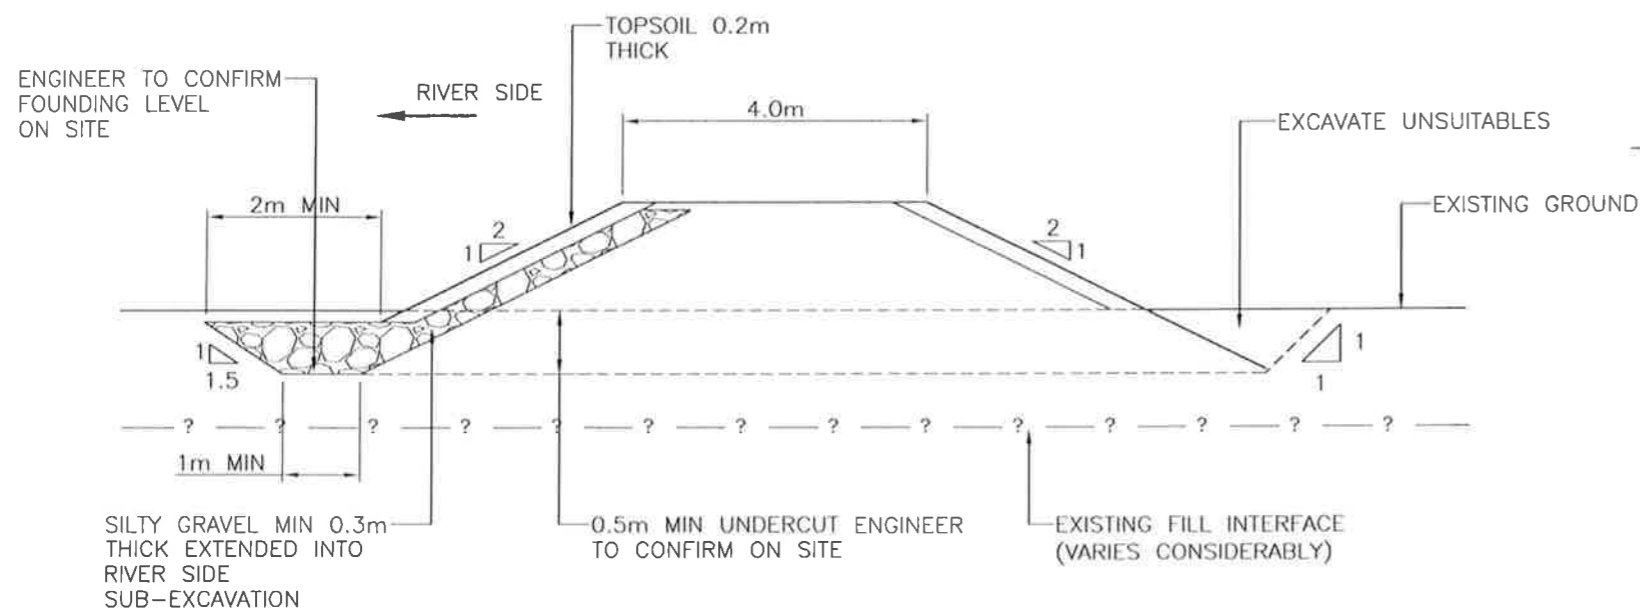
NEW STOPBANK AT GOODS SHED ≈ 1m HIGH
SCALE 1:100 (APPROX)

Three test pits up to 4 m depth were completed in the Goods Shed area. Fill comprising variable silt, sand, gravel and boulders and was encountered to at least 2 m depth. The soils encountered are generally considered to be an appropriate foundation for the proposed stopbank in terms of strength and potential settlement. Some permeable materials were encountered along with boulders.

The new stopbank requires a competent foundation, and an appropriate detail for keying the low permeability upstream core zone into the foundation to limit foundation seepage.

All loose, permeable or soft materials require removal from the stopbank footprint, an undercut over the whole footprint of 0.5 to 1 m is envisaged. In places a deeper sub-excavation may be required either over the whole footprint or as a cut off for seepage control. The typical cross section for the new stopbank should incorporate an upstream silt core and downstream free draining shoulder similar to the existing stopbanks in the area. The upstream core zone should be keyed into in situ ground. The recommended new stopbank cross section is indicated in drawing 09828-5.

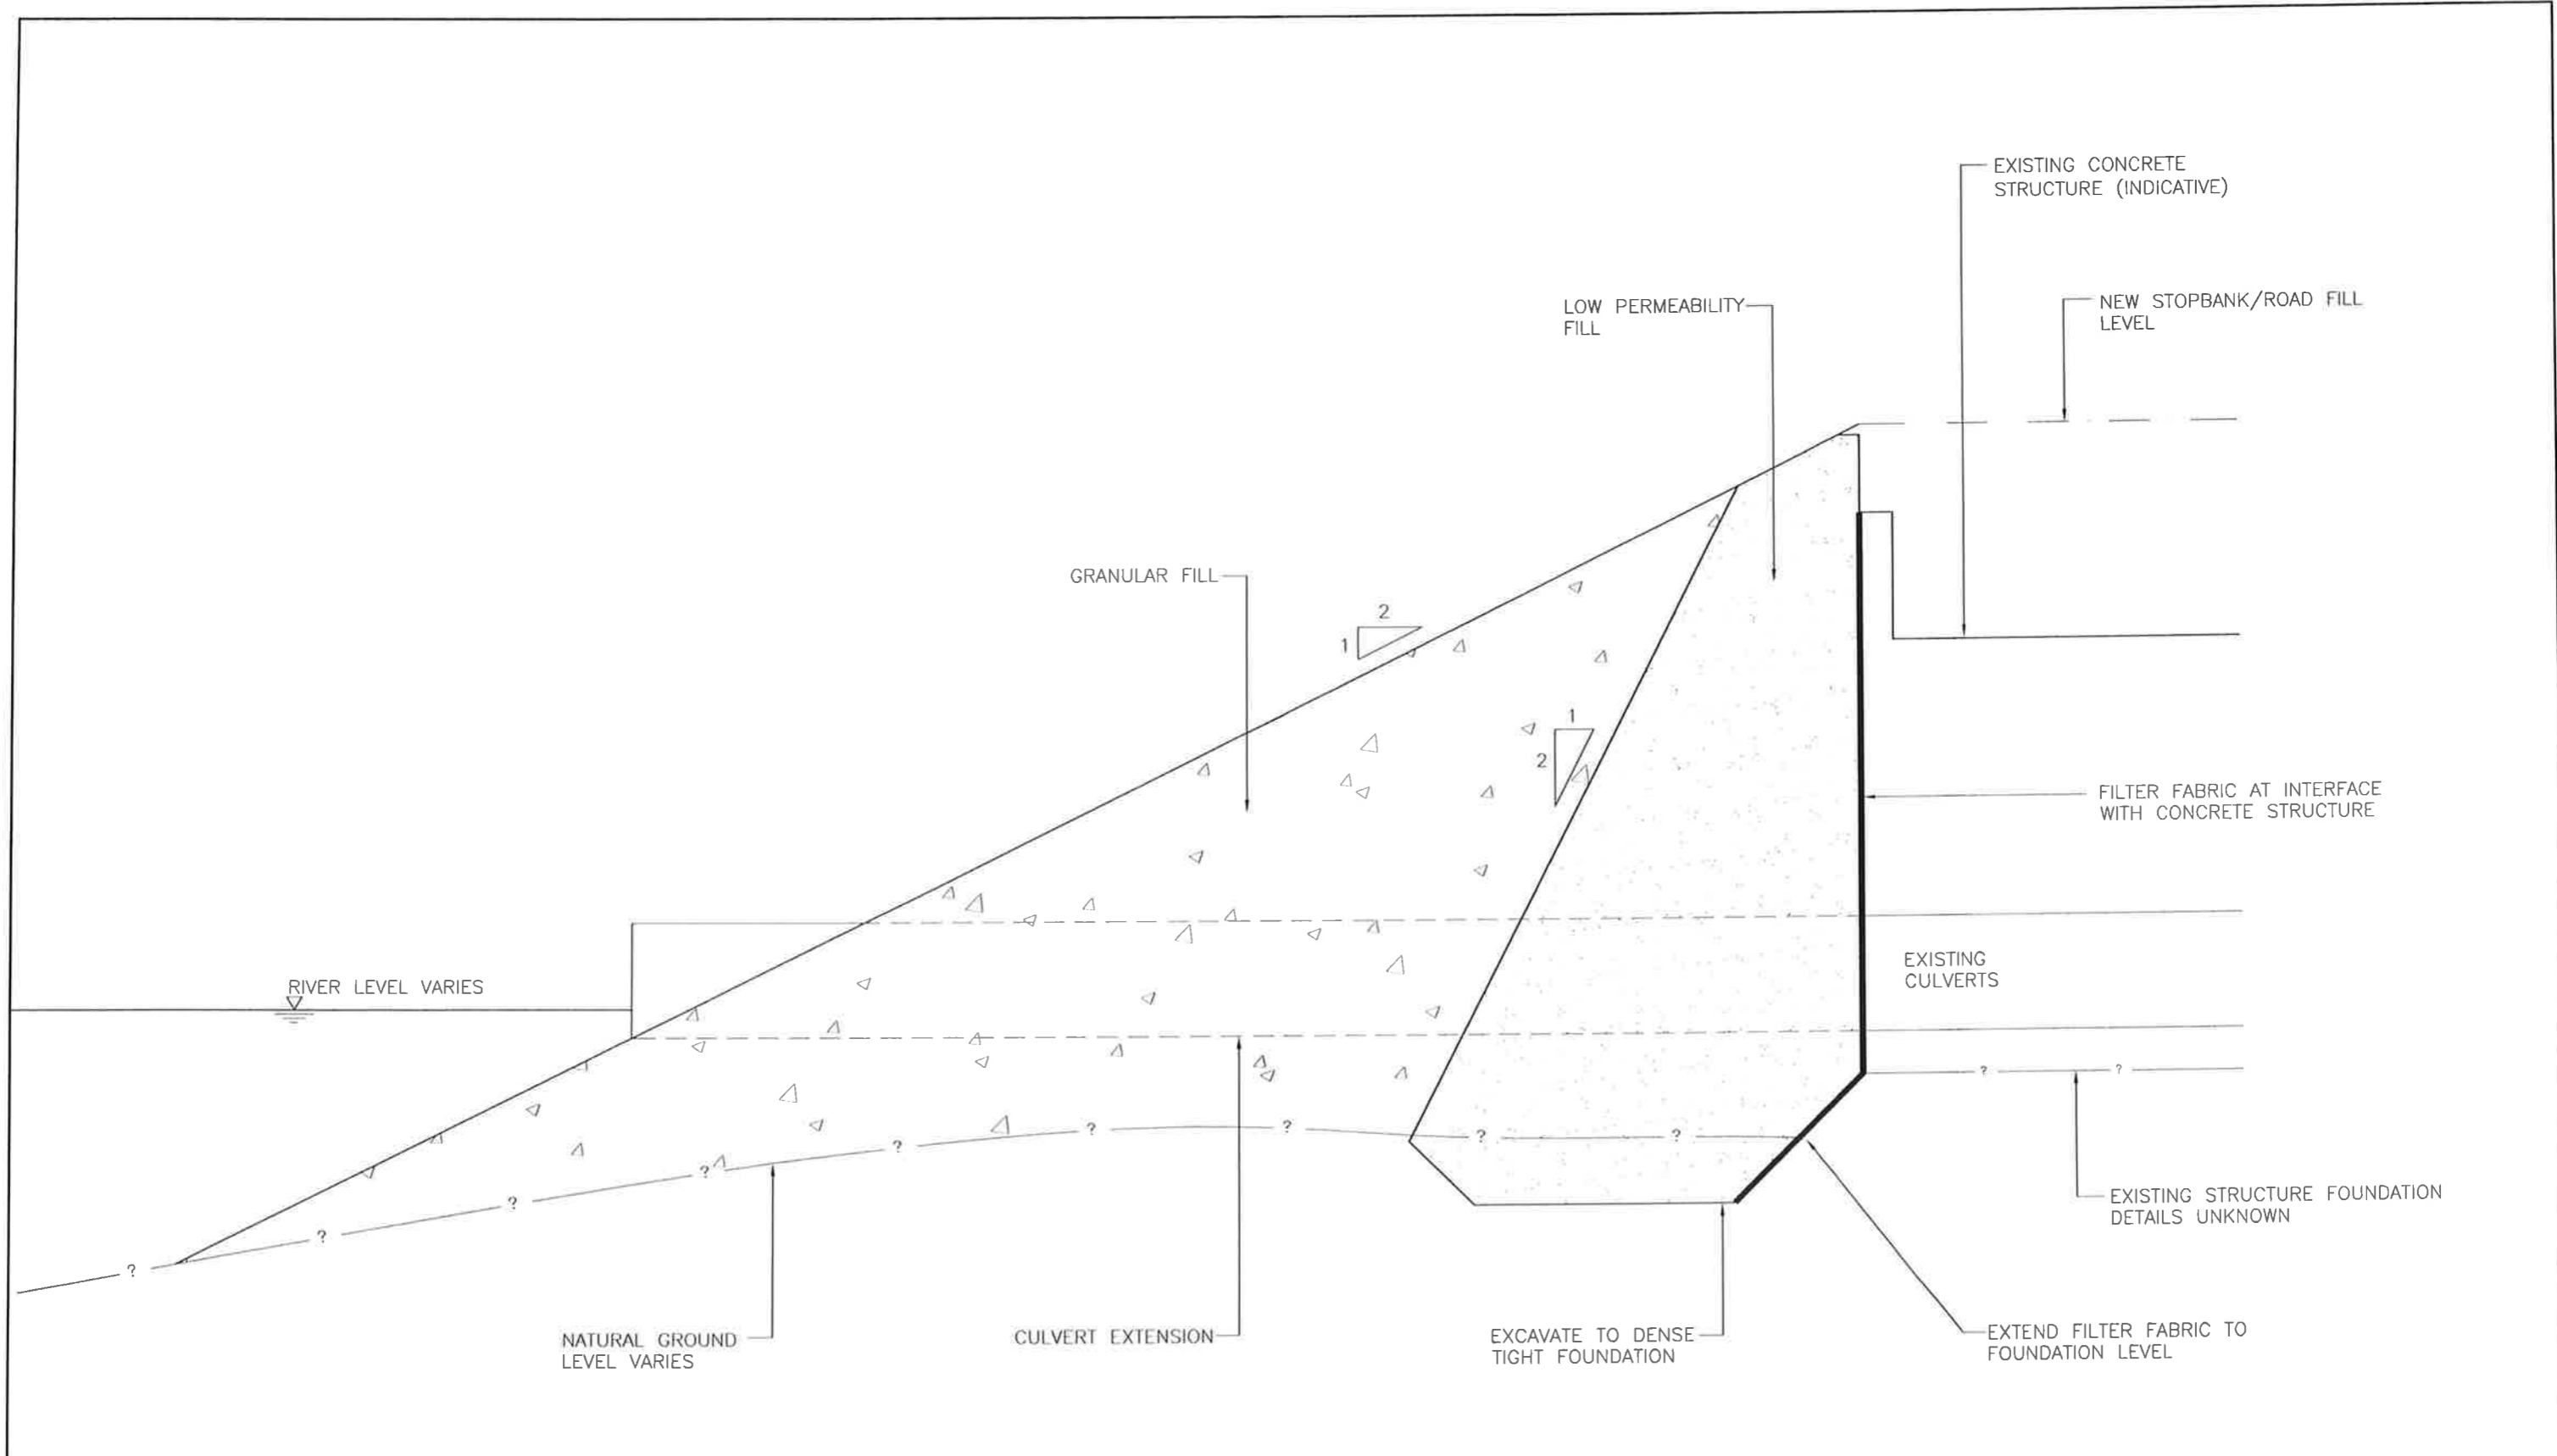
CONCEPTUAL RANGE CREEK CULVERT UPGRADE
SCALE 1:50 (APPROX)

The existing stopbank in the area within around 300 m upstream of the existing Range Creek culvert is very steep, and has a narrow cross section and crest width due to the constraint of the adjacent road. Seepage has been noted around and/or beneath the culvert, and remediation of this structure has been raised as item for consideration in our brief. During the site visit, seepage was observed exiting adjacent to the culvert toward the Grey River. It is therefore likely that the seepage direction will reverse during flooding of the river, and the seepage flows will exit toward Cobden.

The drill hole identified sandy gravel beneath the culvert level (base of stopbank fill). The in situ foundation material is likely to be highly permeable, and it is also considered likely that seepage along the interface of the culverts with natural ground and backfill is occurring. Design details of the wing wall extensions have been sighted, but nothing of the original wing wall and culvert installation which apparently predates the stopbank upgrade of the late 1980's. No internal inspection of the culverts was undertaken however it is considered likely that settlement of the culverts has occurred to some extent, as the stopbank height has been raised at least once following original construction.

At the culvert location, the recommended detail for limiting seepage is a new earth liner layer within the fill surrounding the culvert extension. There is the potential for seepage pressure from either direction (i.e. the Grey River side during flood, and the Cobden side during normal operation/local rainfall events). Therefore the recommended detail incorporates an

internal low permeability core zone on the Grey River side of the culvert, with a supporting shoulder of general stopbank fill material. This arrangement is indicated in drawing 09828-6. It is important that the low permeability core zone is well keyed into the existing low permeability facing layer on the river-side stopbank batter. The previously noted possibility of culvert settlement raises the potential for seepage originating from pipe joints, and it is recommended that an internal inspection of the culverts be completed as part of the structure upgrade.
