Shore protection options for Rapahoe Beach – revised report

**For discussion by the Department of Conservation, Greymouth District Council
and West Coast Regional Council**

7 October, 1999

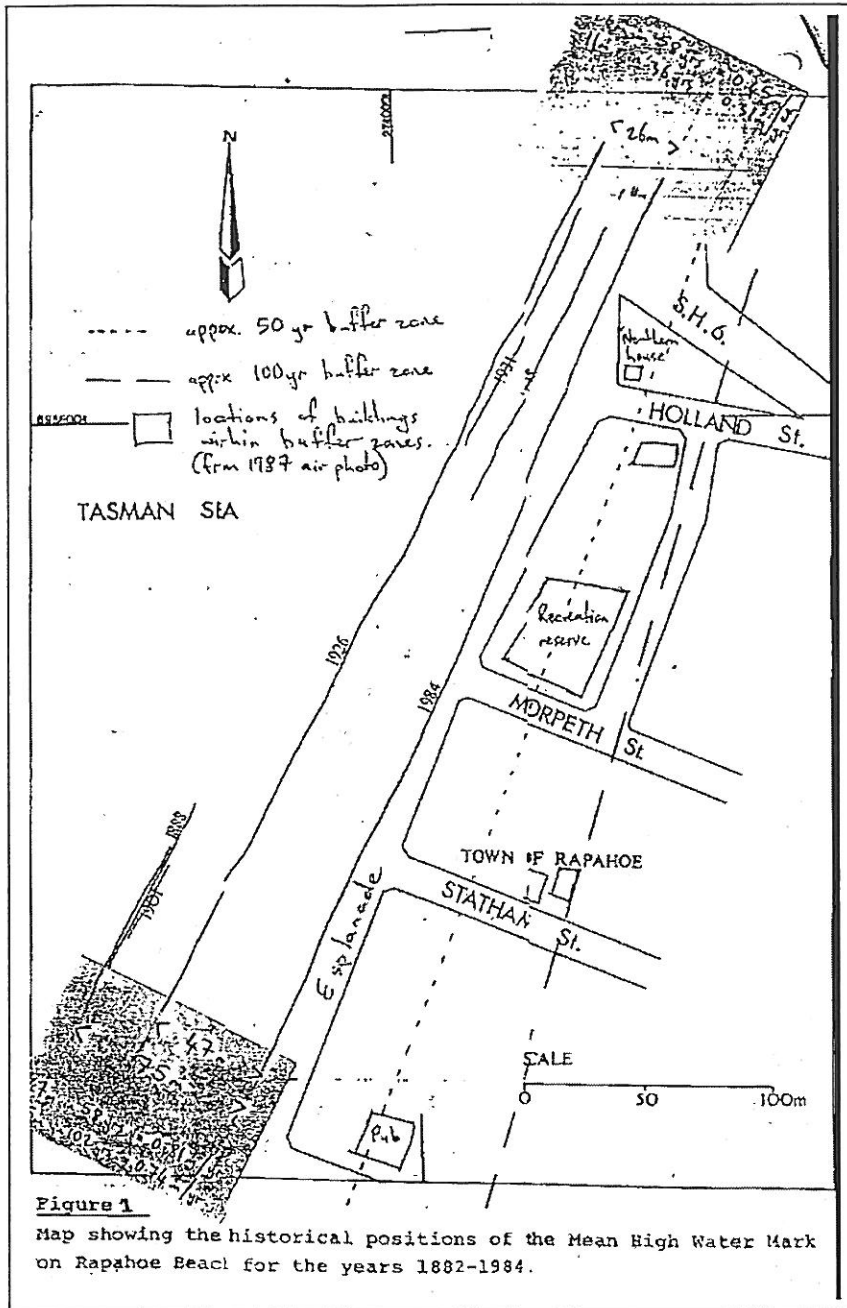
Figure 1 – erosion History and Affected Properties

Figure 1 from Pfahlert (1984) indicates the erosion rates on Rapahoe beach over the period 1882-1984 are c.0.4m/yr at the north end of the town, and c. 0.8 m/yr at the south end. Put another way, this is 10m erosion every 12.5 years (north) to 25 years (south).

Listed below are all of the developed properties in Rapahoe (indicated in Figure 1) that, if the rate of erosion continues, are likely to be directly affected by wave inundation in the next 50 years. The approximate minimum distance of each building/asset to the top

Figure 1 has been copied over from the 1996 report. The figure illustrates those properties that are expected to be directly affected by erosion within the next 50 years. Figure 1 also shows the history of coastal erosion dating back to 1888.

The shaded areas at each end of the beach provide estimates of actual erosion rates.

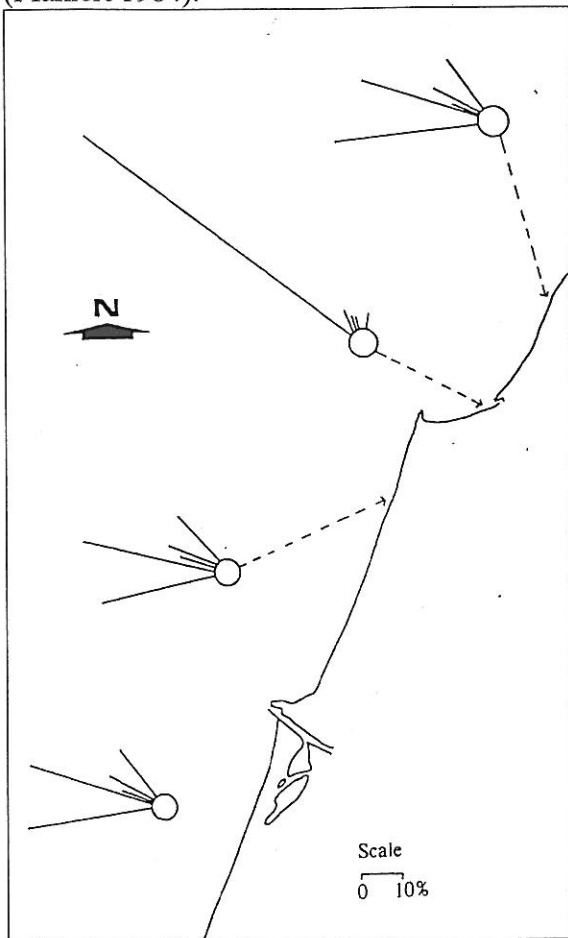
Figure 2 – Wave direction and frequency (Pfahlert 1984).

1. *Wave direction and frequency* – figure 2 shows the wave direction and frequency for Rapahoe. Note that the predominant wave at the southern end of the town is from the north-west while and from the west/south-west at the northern end. This affects the flow of sediment within the bay and needs to be carefully considered, especially if groynes are to be used as protection.

Figure 2 shows the direction of waves along the coastline. The length of the line indicates the percentage frequency of the waves.

The predominant wave direction at Rapahoe is north-west. This direction varies considerably from the predominant west to southwest direction along the coast and should be taken into account in the management of coastal erosion.

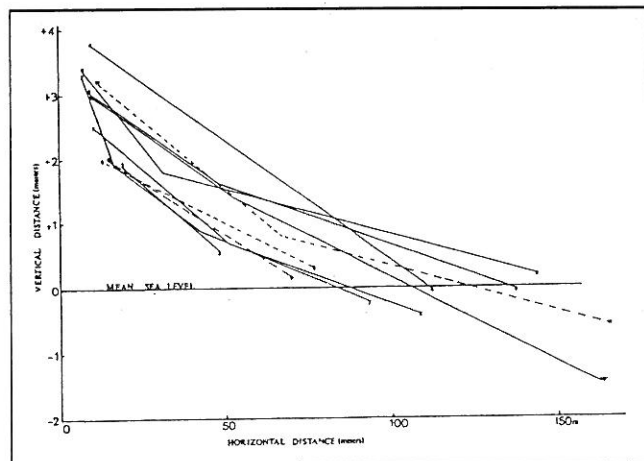
Figure 4 – Beach Profile (Pfahlert 1984)

2. *Localised sediment movement* – figure 3 shows beach profile changes through a year adjoining the township. This is where local sediment is simply moved from the beach to the seabed and is returned again, as a continuous process. Local sediment movement is approximately two metres at Rapahoe; that is, the height of the beach may fluctuate up to two metres within any one year. This fluctuation is further lowered by the loss of sediment each year as noted above. Any protection works, particularly sea walls would have to be set considerably deeper than two metres into the beach and set back as far as possible against the shore if under-cutting is to be avoided for any length of time. Where a protection structure is under-cut, its life will be minimal.

Figure 3 shows the beach profile over one year between May 1983 and May 1984. This profile was recorded on that area of the beach adjoining the township. A beach profile is an illustration of the beach as if one were looking along the beach. The vertical scale illustrates the changes in the height of the beach while the horizontal scale illustrates length of the profile in metres.

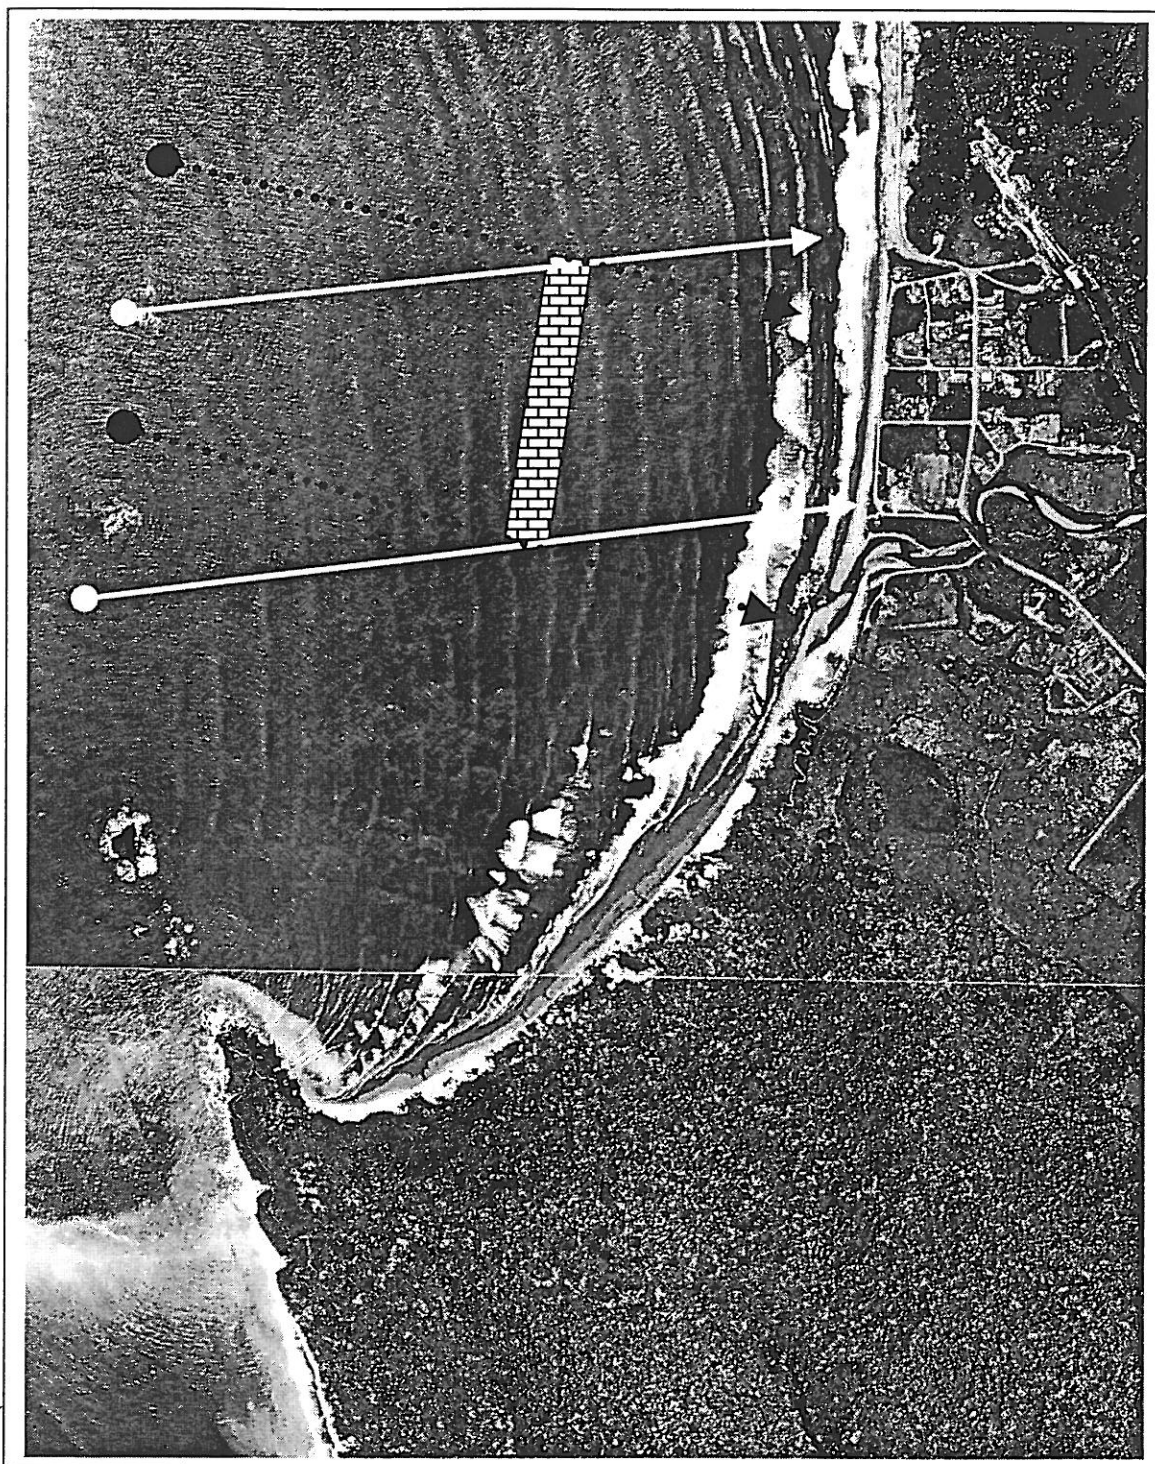
Figure 4 – Possible Offshore Breakwater

An example of an offshore breakwater is shown in figure 4. The structure would shelter the shore from the heavy wave action enabling sediment to build up in the sheltered area. The design and construction of an offshore breakwater would have to be carefully considered to ensure that it was correctly located to be most effective.

Figure 4 shows the potential shelter that a solid structure would provide from a north-west and a southwest swell.

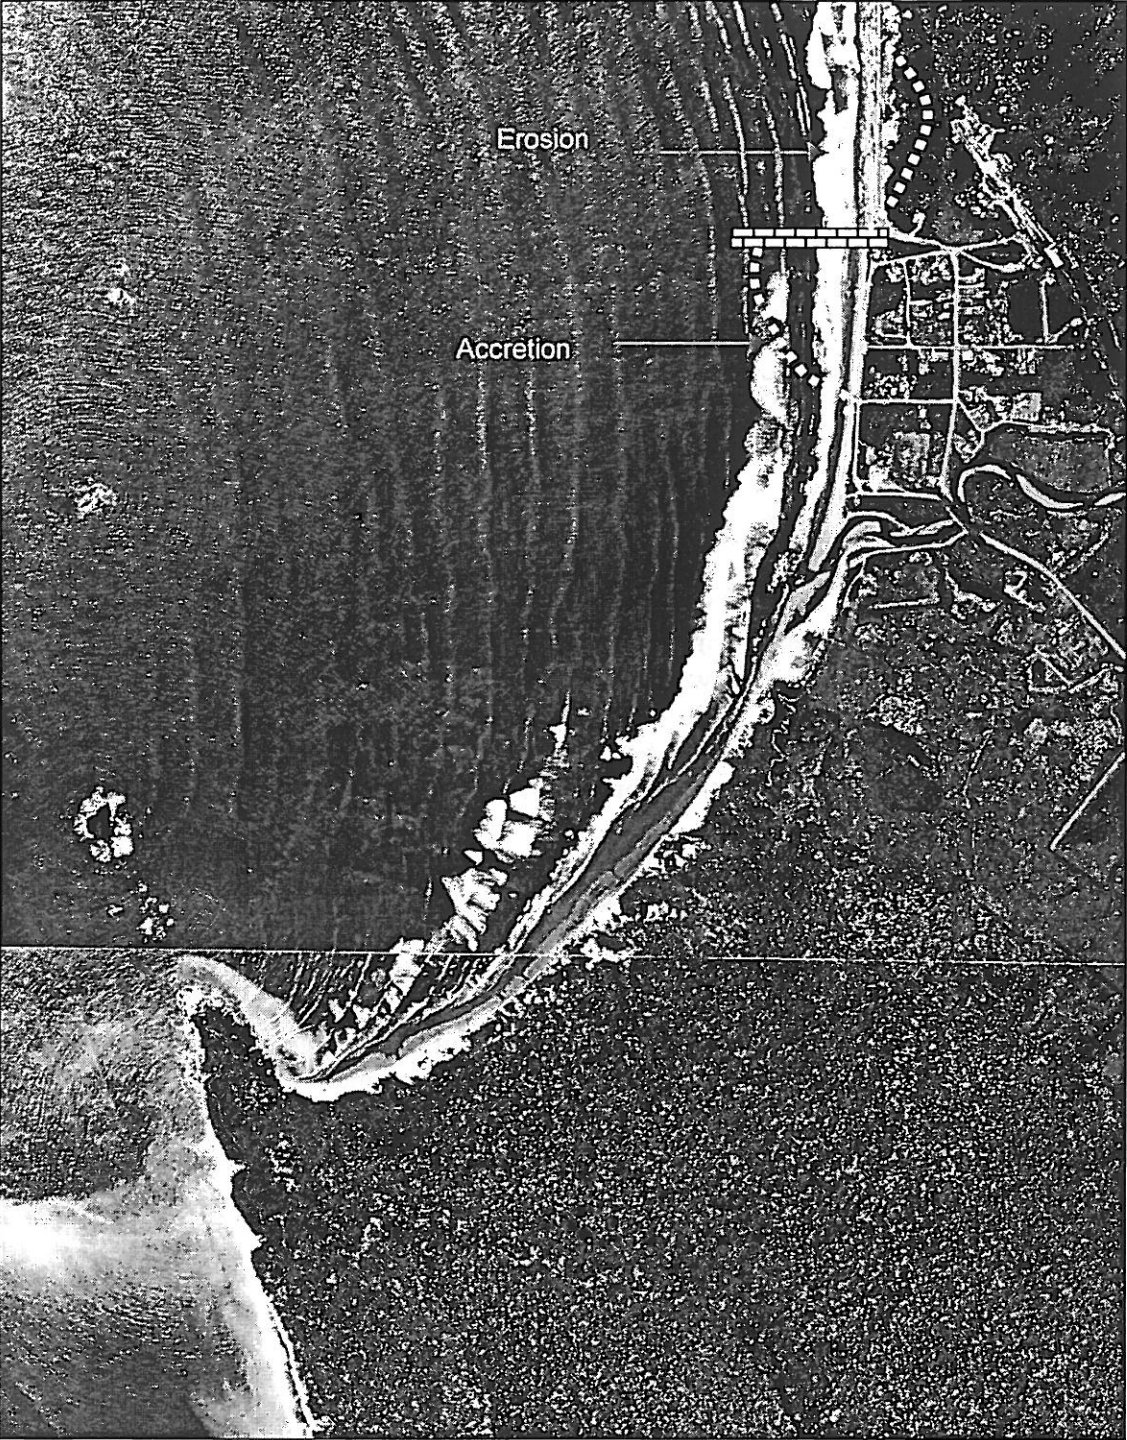
Figure 5: Example of possible Groyne Effect

Beach erosion at Rapahoe has been occurring since at least the late 19th Century. It is thought that it is caused, or at least exacerbated, by the groyne effect of the Grey River tipheads (refer to figure 5 for an example of a typical groyne effect).

Assuming a northward drift of sediment, the construction of a groyne at the northern (downdrift) end of the township would cause accretion (or at least reduce the erosion) of the beachfront (refer to figure 5). However, it would also cause an equivalent amount of erosion of the beach frontage of State Highway 6. Should SH6 be relocated inland (as Transit NZ are considering), and if it is acceptable to have an accelerated loss of the land where SH6 is presently located, then the groyne option should be investigated further. I suspect that a groyne here might not give effective protection to the south end of town. It might not be able to continue to maintain a stable shoreline in light of the significant erosion of this coastline but it is likely that it would be beneficial, even if only for the northern end of the town.

Because the northward drift of sediment is weaker at the southern end of the town, a groyne placement there would be more likely to cause an adverse effect on the town.

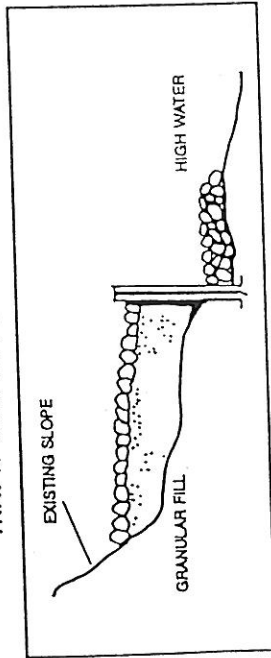
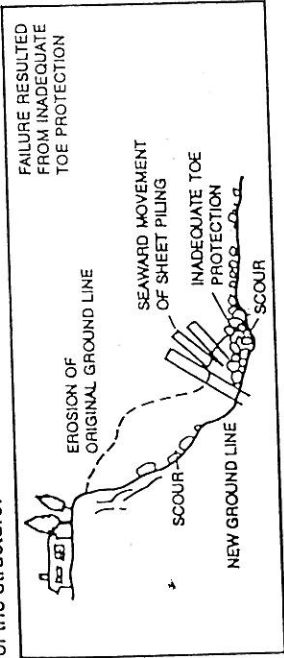
RULE 1 PROVIDE ADEQUATE TOE PROTECTION FOR THE TOE OF THE STRUCTURE SO THAT IT WILL NOT BE UNDERMINED

CHECK FOR SIGNS OF FAILURE
Most failures of shore protection works result from "toe failure". Failure of the structure under the lowest part of the structure. Failure of the bulkhead can be prevented with adequate toe protection. Toe protection must be substantial enough to prevent the original ground under it from washing through the toe protection blanket and extend far enough seaward of the structure to prevent undermining. Check for signs of failure such as seaward movement of the wall, erosion behind or at the toe, or at the end of the structure.

MAINTENANCE OR REPAIR PROCEDURE
Re-establish support by underpinning, tie-backs, systems of anchor piling, walers and tie rods. Place larger stone or rock-filled mattress at toe of structure to prevent scour. Backfill where necessary.

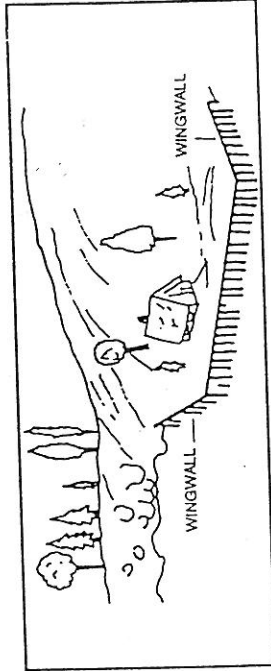
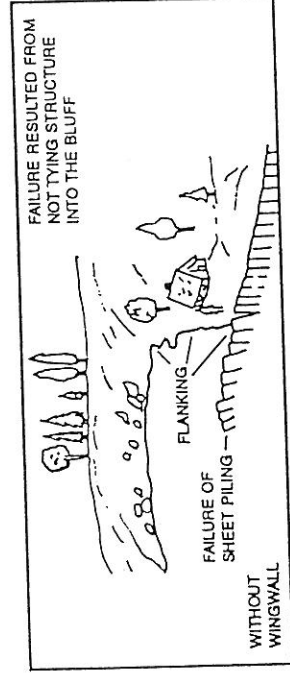
RULE 2 SECURE BOTH ENDS OF THE SHORE PROTECTION WORKS AGAINST FLANKING

CHECK FOR SIGNS OF FAILURE
Erosion will continue adjacent to your works. If an existing structure has been flanked such as the one shown below, correct it by placing additional material at the ends and tying your works directly into the bluff. Check for signs of failure such as seaward movement of the ends and erosion at the ends of the structure. The illustration below shows the result of not constructing wingwalls and not tying the ends of the structure into the bluff.

MAINTENANCE OR REPAIR PROCEDURE
Place additional material at the ends and tie structure directly back into the bluff.

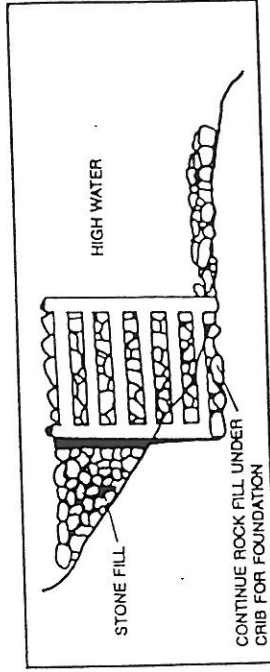
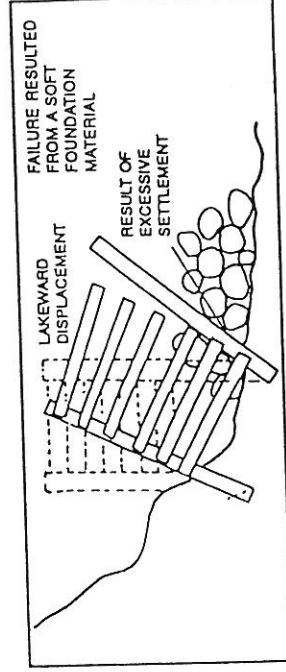
RULE 3 CHECK FOUNDATION CONDITIONS

CHECK FOR SIGNS OF FAILURE
Soft foundation material may result in excessive settlement of the structure. Soft underlayers may allow all or part of the structure to slide. Check for settlement and excessive displacement. Hydrostatic pressure due to groundwater seepage may cause seaward movement of some types of impermeable walls.

MAINTENANCE OR REPAIR PROCEDURE
Re-establish support by construction underpinning, foundation protection and backfilling. If the structure was impermeable such as a steel wall, add or reopen weep holes.

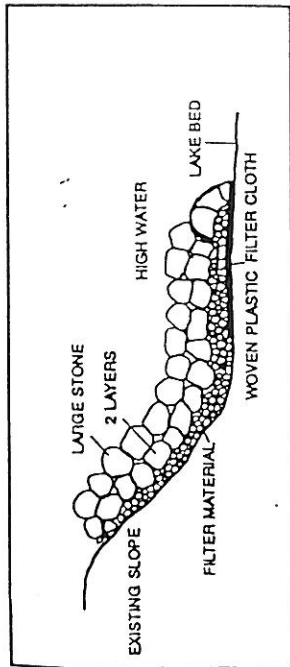
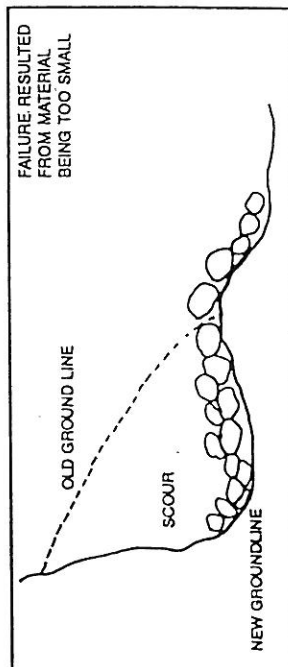
USE MATERIAL THAT IS HEAVY AND DENSE ENOUGH THAT WAVES WILL NOT MOVE INDIVIDUAL PIECES OF THE PROTECTION

A cause of common failure is to use undersized material; waves have tremendous power and can move a lot of material in a short time. Small stones, or pieces of concrete will be moved around and carried away by small waves. Larger waves will do it even faster. The bank revetment below was constructed of undersized stone and was carried down the slope by large waves. Excessive settlement, increase in voids, loss of filter material, erosion behind or at the ends of the structure can result due to the use of small stone. A layer or two of filter material may be inserted between the underlying ground and the protective material.

Place additional stone at toe, restore to original elevation, section and thickness, reduce excessive void ratio, backfill behind structure; extensive upgrading in size of material may be required.

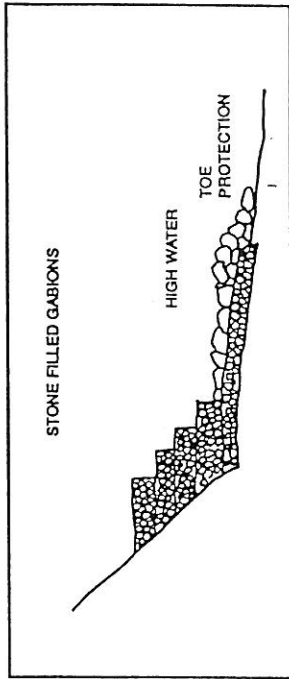
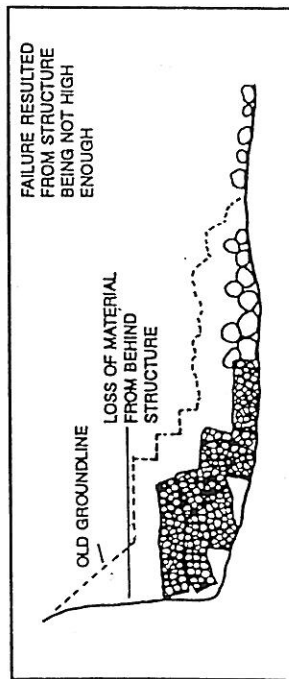
BUILD REVETMENT HIGH ENOUGH THAT WAVES CANNOT OVERTOP IT (SPRAY OVERTOPPING IS ALRIGHT, BUT NOT 'GREEN' WATER)

Many failures have happened because the structure was not built high enough and erosion could then continue behind the structure as if it were not there. Check for broken wire, excessive movement, and erosion behind or at the ends of the structure.

Restore to higher elevation, backfill behind structure, add filter cloth and splash apron.

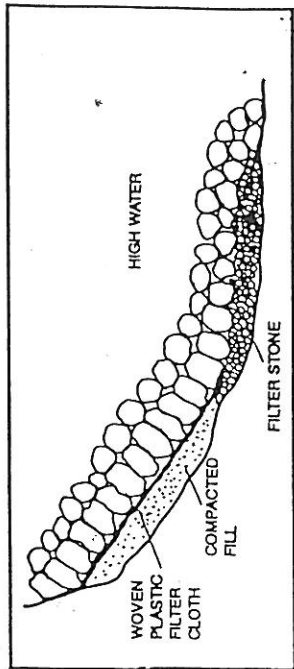
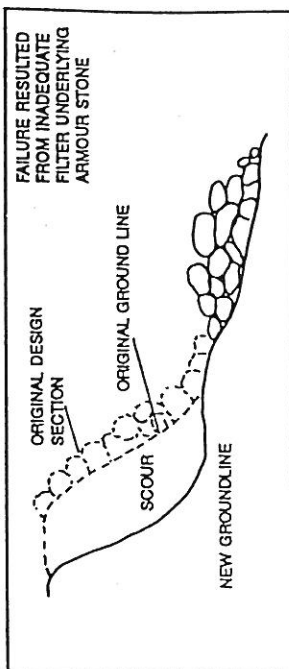
MAKE SURE THAT VOIDS BETWEEN INDIVIDUAL PIECES OF PROTECTION MATERIAL ARE SMALL ENOUGH THAT UNDERLYING MATERIAL IS NOT WASHED OUT BY WAVES

A filter material such as woven plastic filter cloth must be placed on a highly erodible embankment to prevent the fine material from washing through the voids in the structure. The protection material must be thick enough to make a long passage for dissipation of wave energy prior to reaching the underlying materials. In the case below, woven plastic filter cloth was not included. As a result, fine bluff material was washed out by waves.

Rebuild to original elevation, use at least two layers of stone, use a stone filter or woven plastic filter cloth, fill behind structure.

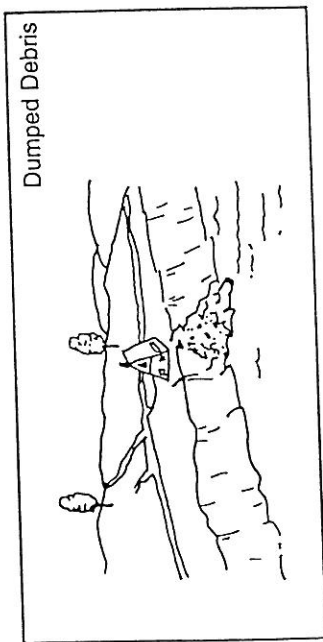
Violates Rules 1, 2, 4, 5 & 6

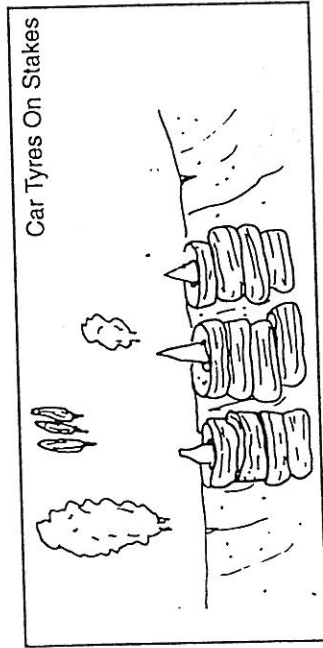
Violates Rules 1, 2, 3, 4, 5 & 6

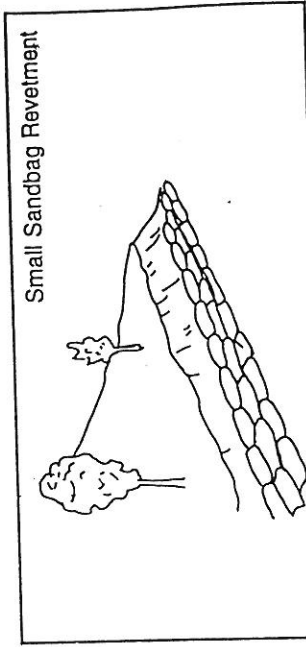
Violates Rules 1, 2, 4 & 5

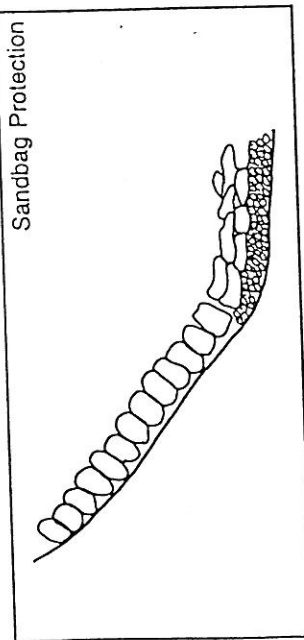
Violates Rules 1, 4 & 6

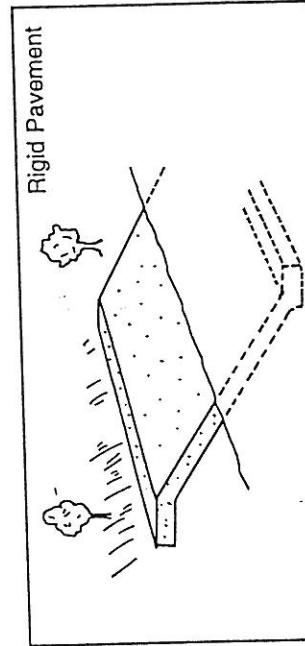
Violates Rules 1 & 2

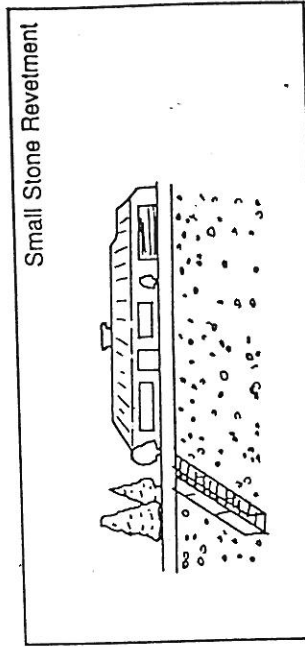
Violates Rules 1 & 4

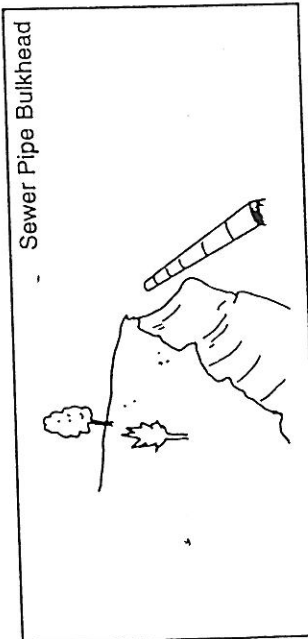
Violates Rules 1, 2, 4, 5 & 6

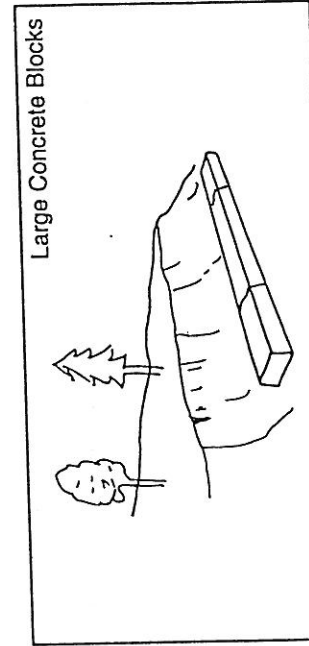
Violates Rules 1, 2, & 5

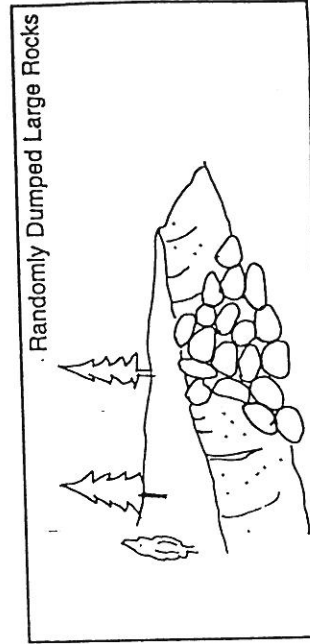
Violates Rules 1, 2, 3, 5 & 6
