**Section 92 letter RFI-Hokitika Seawall RC-2022-0039 AND RC220053**

Prepared for West Coast Regional Council  
Prepared by Beca Limited

The new revetment extension covered by this report extends from Stafford Street to Richards Drive (refer to Figure 1), replacing the 16,000 tonnes of rock placed as emergency works. Suitable rock from the emergency works will be re-used in the revetment extension (potentially some 8,000 to 10,000 tonnes re-used), with remaining rock removed and made available for maintenance of the existing groynes and local projects.

# HOKITIKA REVETMENT EXTENSION

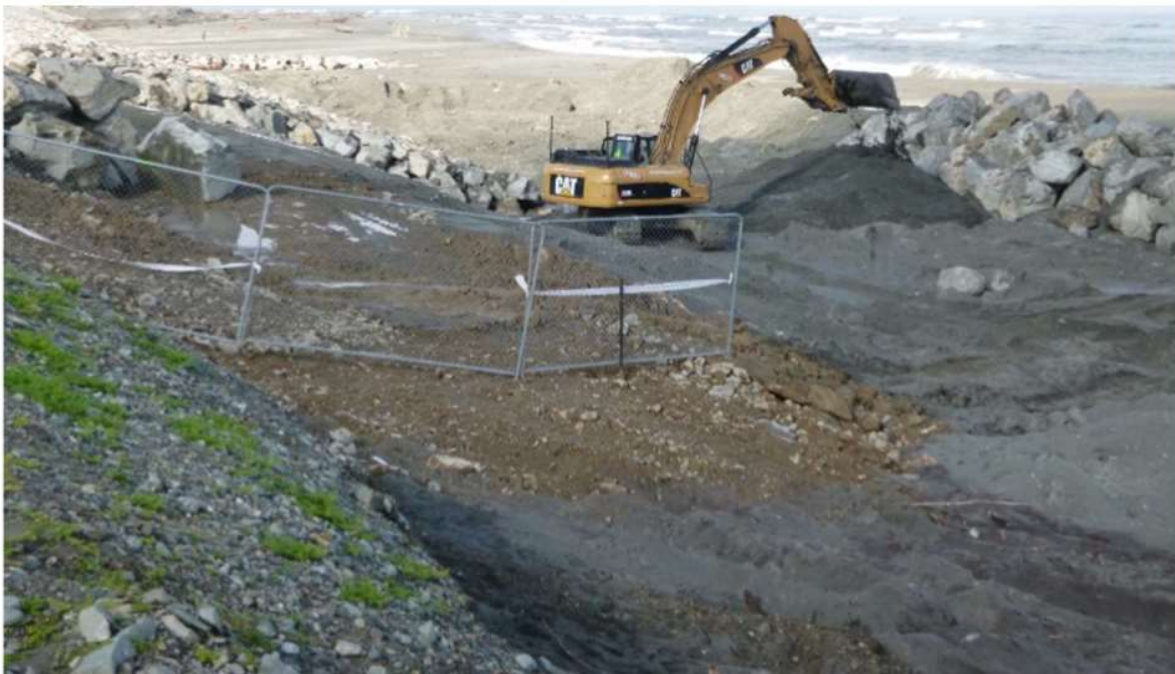
Figure 3-4 Installation of existing seawall showing temporary sand bund and rock stockpile

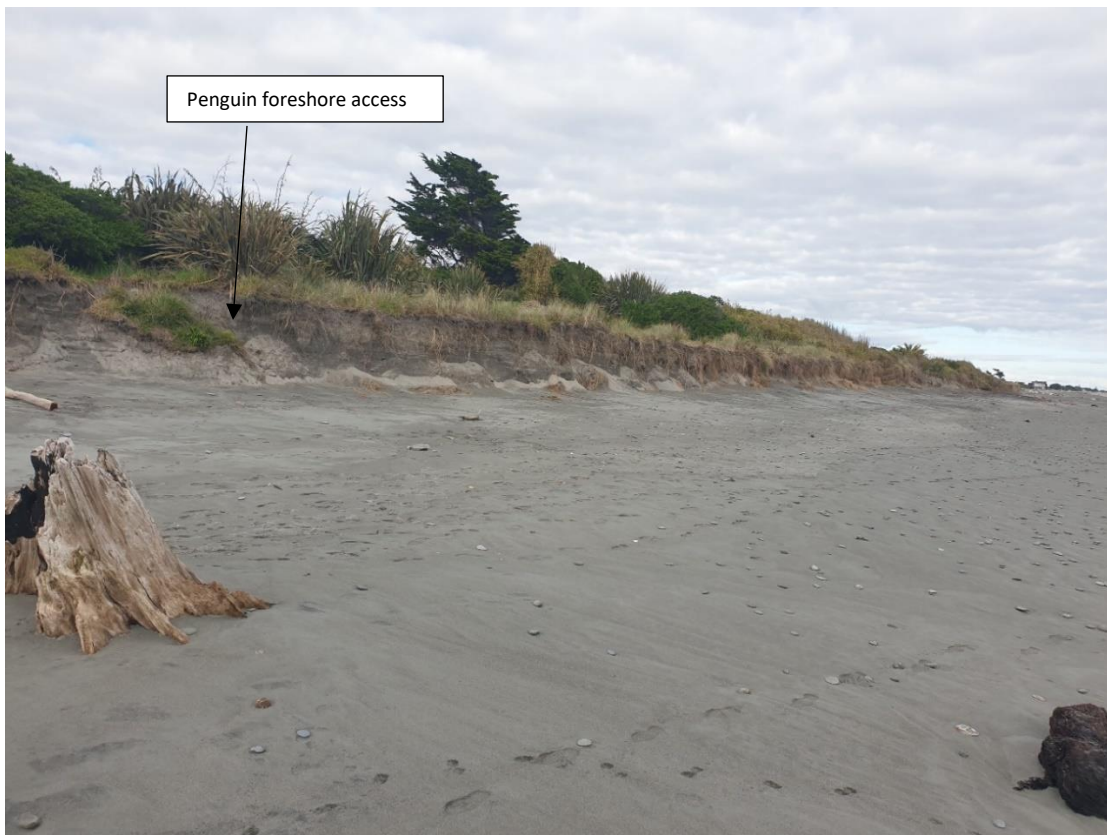
**Plate 1:** Hokitika Beach. Steep sand dune banks caused by coastal erosion illustrate the reason for consideration of a rock seawall and the current tenuous penguin access to foreshore habitat. Residential property behind vegetation.

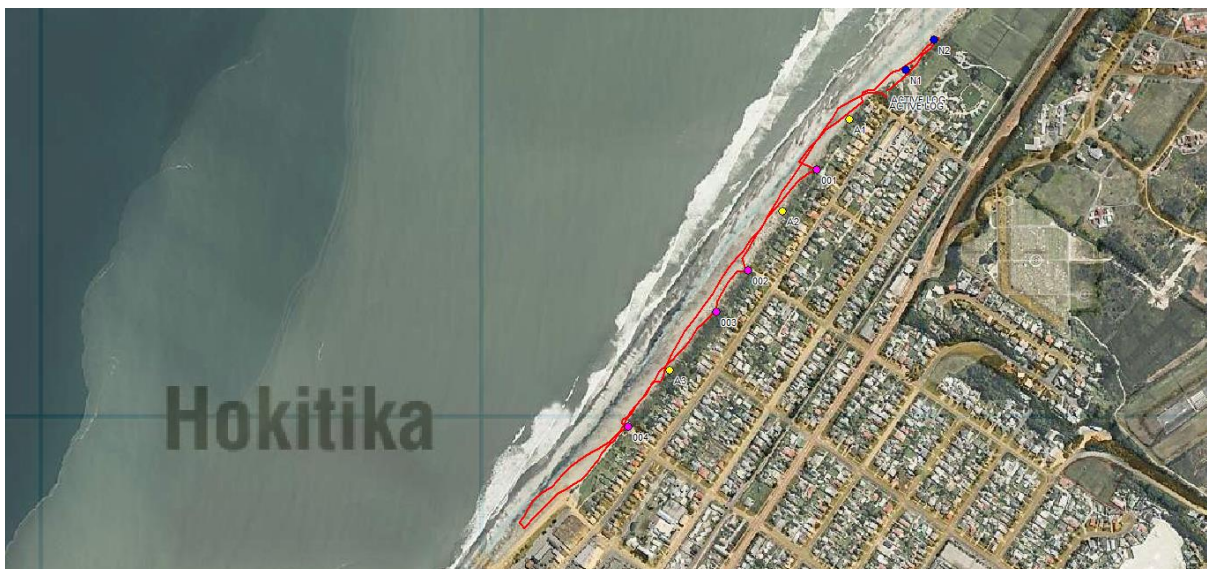
**Plate 4:** Penguin survey May 03, 2021.

**Red** = survey track

**Yellow** = proposed additional foreshore access sites to foreshore habitat

**Blue** = penguin foreshore access sites to the north

On the morning of May 03, 2021, Matt Charteris (WCPT Ranger) visited the site. It was low tide and weather conditions were excellent for the survey. The location of the proposed seawall was investigated as was part of the existing seawall and 250m north of the northern end of the proposed seawall. Sign of penguin use on the beach and in the adjacent foreshore area was searched for. Foreshore access sites for penguin were recorded with gps. The value of a seawall to protect both the foreshore habitat suitable for blue penguin refuge and breeding, and the residential property behind, was obvious. The area to the north of the proposed seawall was seen to be used by penguin. This area may be affected negatively by water movement off the northern end of the wall.

No penguins were encountered but sign of penguin activity was observed in the penguin foreshore access areas.

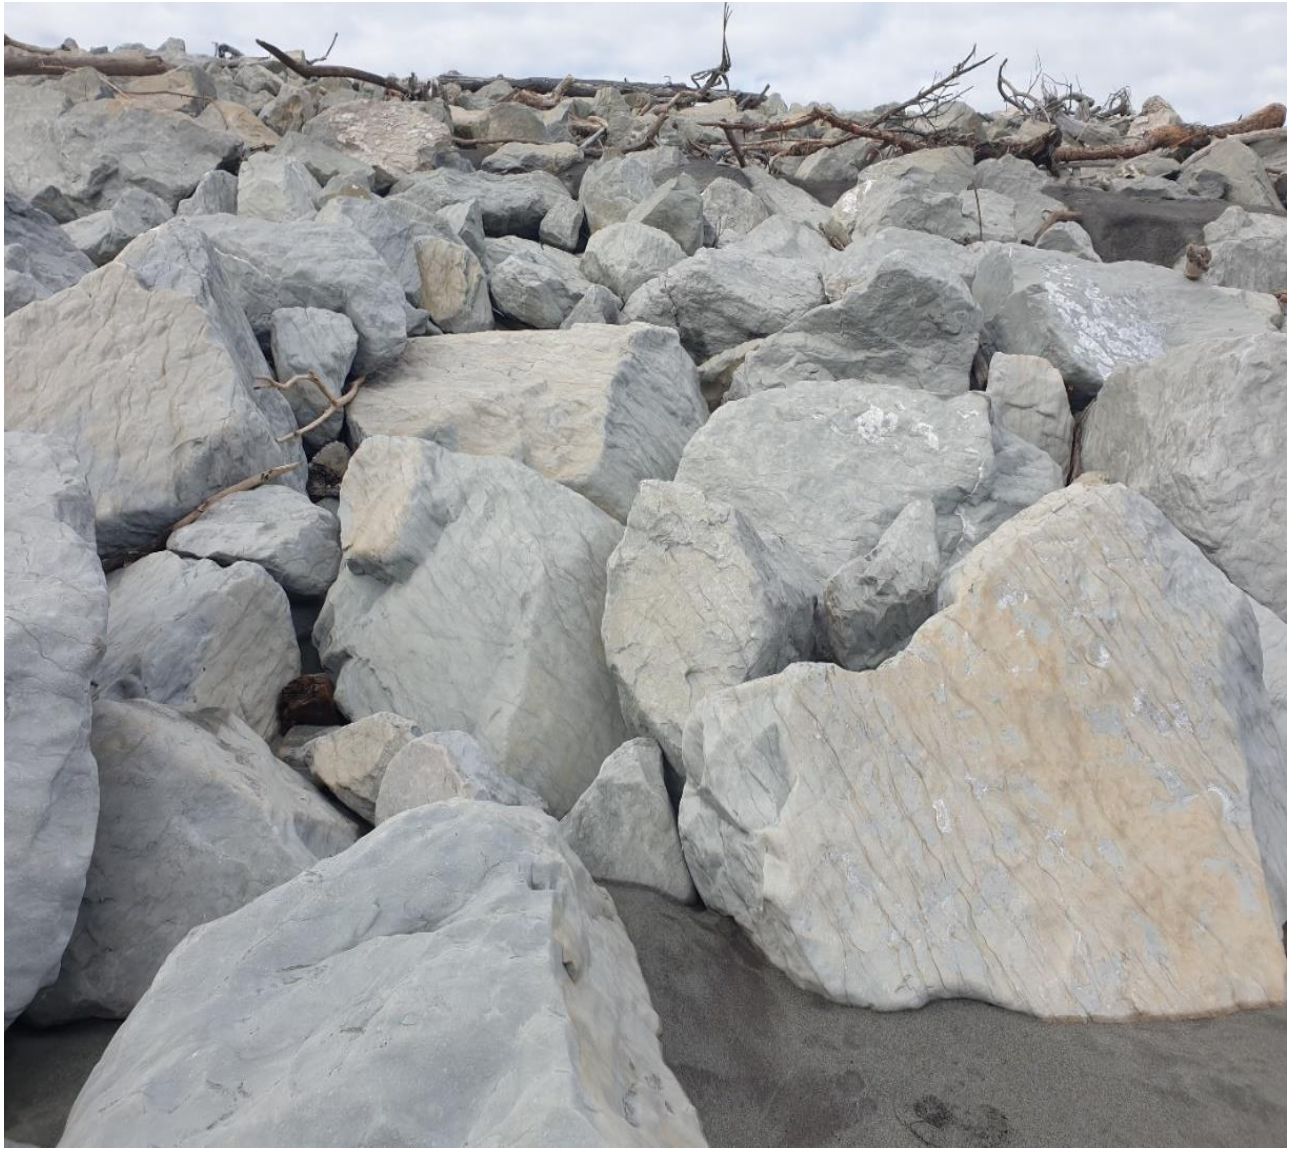
**Plate 5:** Existing seawall (May 2021), Hokitika Beach. Not suitable for blue penguin due to steep angle and hole size between boulders.

The existing seawall was found to be made with rocks and in a manner not suitable for providing safe access for penguin over to the foreshore habitat, or for internal refuge sites for penguin (however noting that this site is not suitable for internal refuge due to wave action), (Plate 5). Access over the wall to the foreshore habitat is imperative if blue penguin is going to continue to breed on Hokitika Beach. If the same rock in terms of type and size will be used to extend the rock protection, safe access for penguin to suitable refuge sites in the foreshore habitat will be severely compromised. At access sites on the proposed seawall extension, suitable surface modification to the seawall rocks to allow penguin safe access to the foreshore habitat would need to be made.

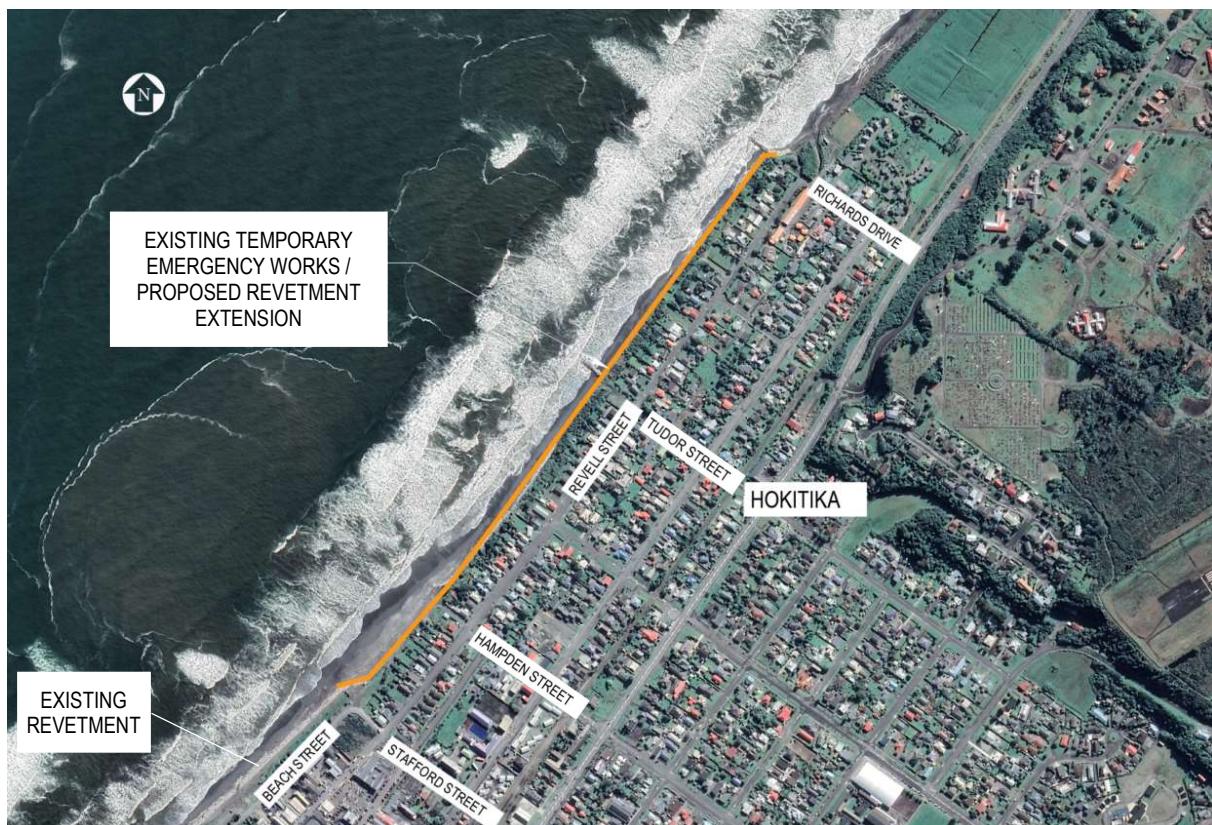
Figure 1: Hokitika Revetment Extension Project location

The West Coast Regional Council (WCRC) is proposing to construct an approximately 1.2km long extension of the existing Hokitika revetment between Stafford Street and Richards Drive (see Figure 1). The existing revetment is a 1000m long rock structure, that protects a portion of the township between Hokitika River mouth and Stafford Street. Temporary emergency works have been undertaken in sections to the north of Stafford Street from October 2019 up until early October 2021, with rock now placed on the upper beach for all almost the full length of the Stafford Street to Richards Drive frontage (approximately 1.2km).

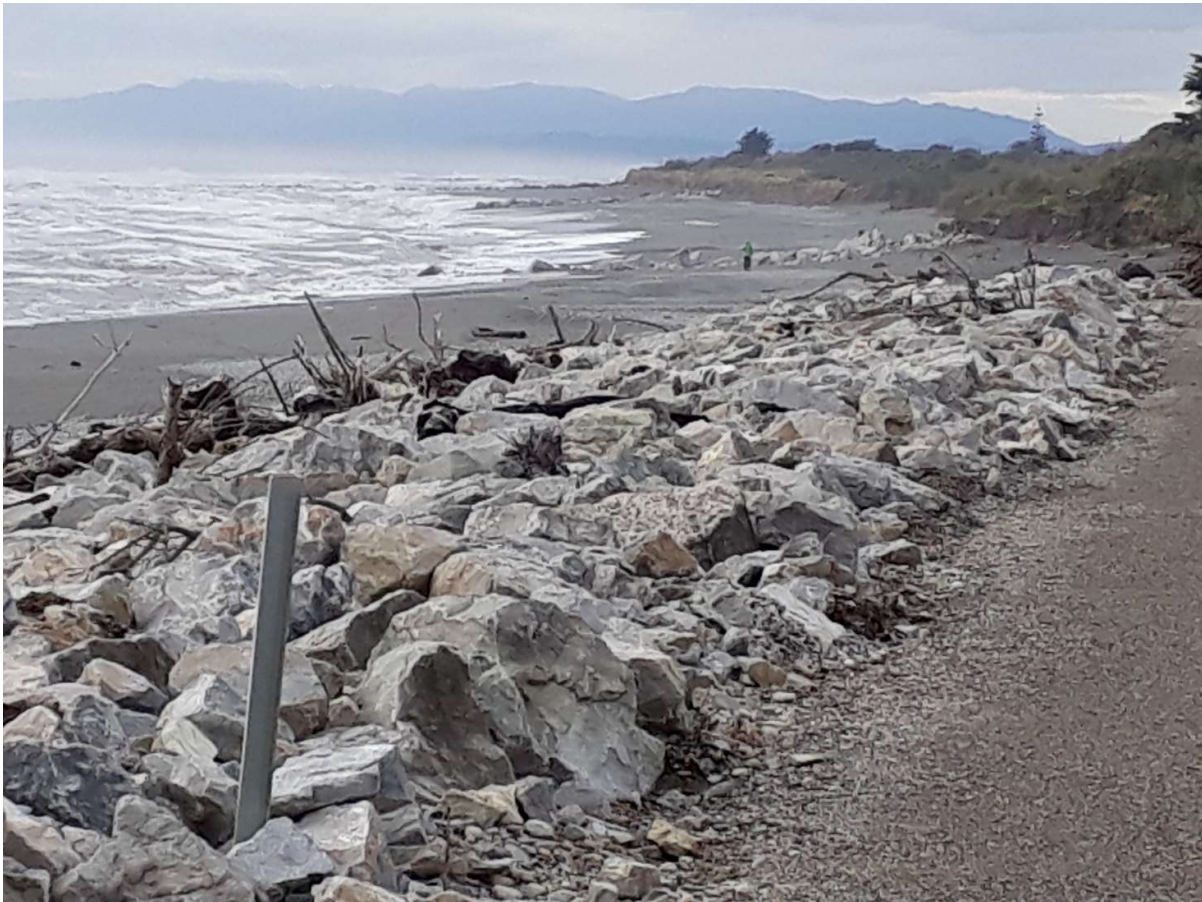
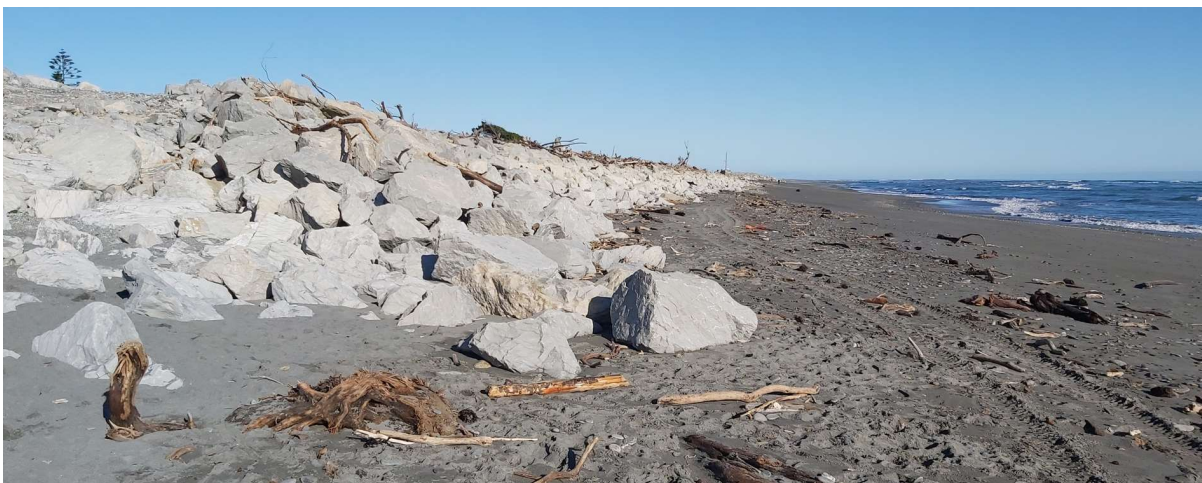
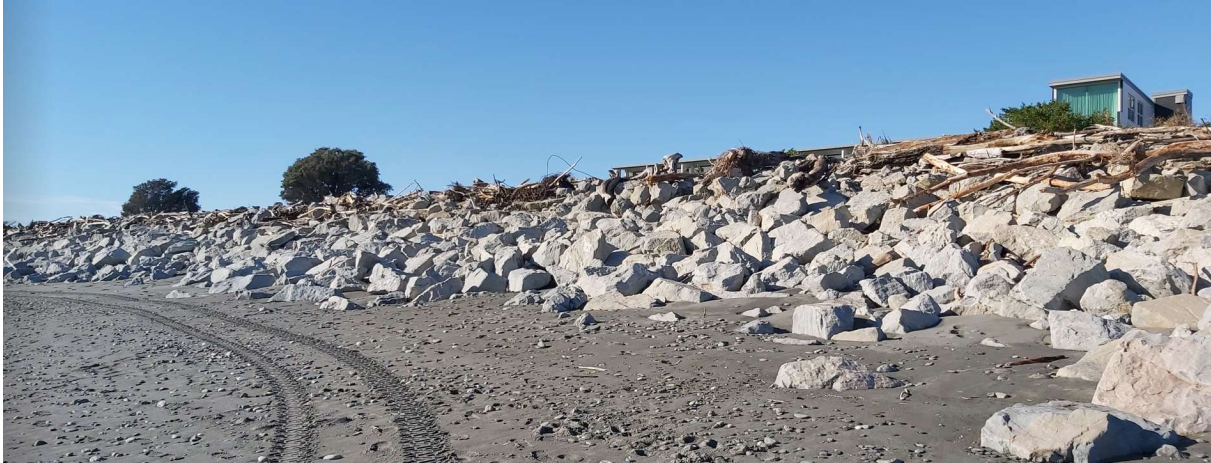
Figure 3 Existing 2013 revetment showing rock breakage, rock displacement, profile and debris line near crest

The 2013 structure shows some rock breakage and limited displacement of smaller and non-interlocked rock, although the revetment profile generally appears to have remained relatively stable (refer to Figure 3). Surveys indicate the crest level has remained at the upgraded 5.5m NZVD16 level. It would appear from debris on the structure that this crest line was overtopped or close to overtopped in some events (refer to Figure 3 photographs below).

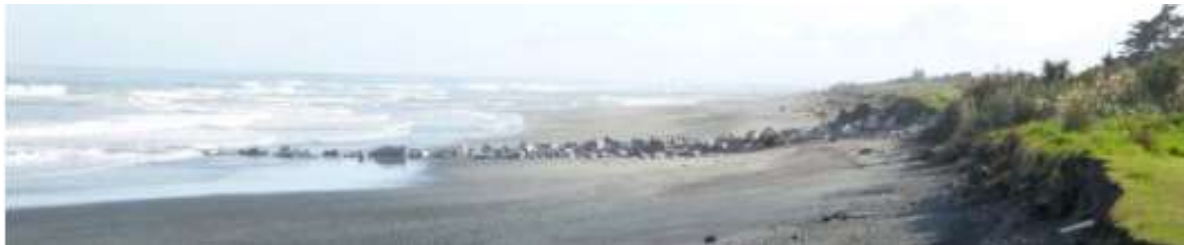
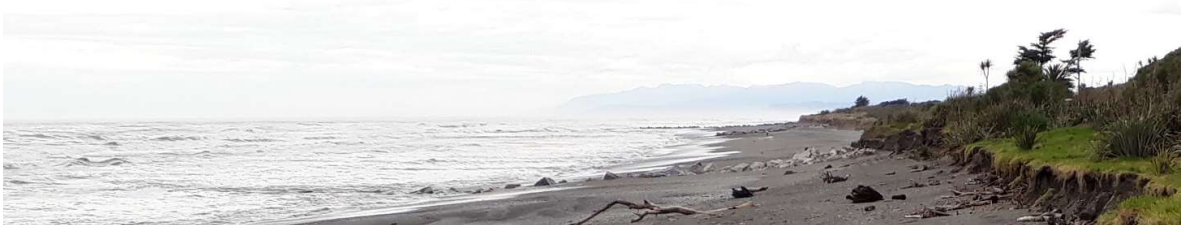
Figure 4: Hampden Street groyne in 2013 with lower beach levels (top photograph) and 2019 with higher beach levels (bottom photograph)

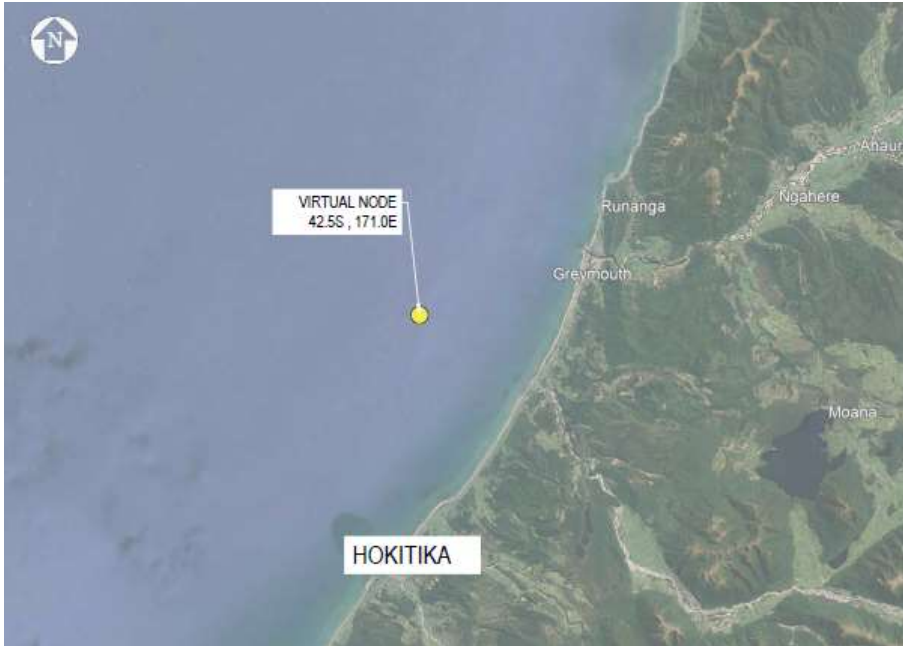
Figure 5: Location corresponding to offshore wave data

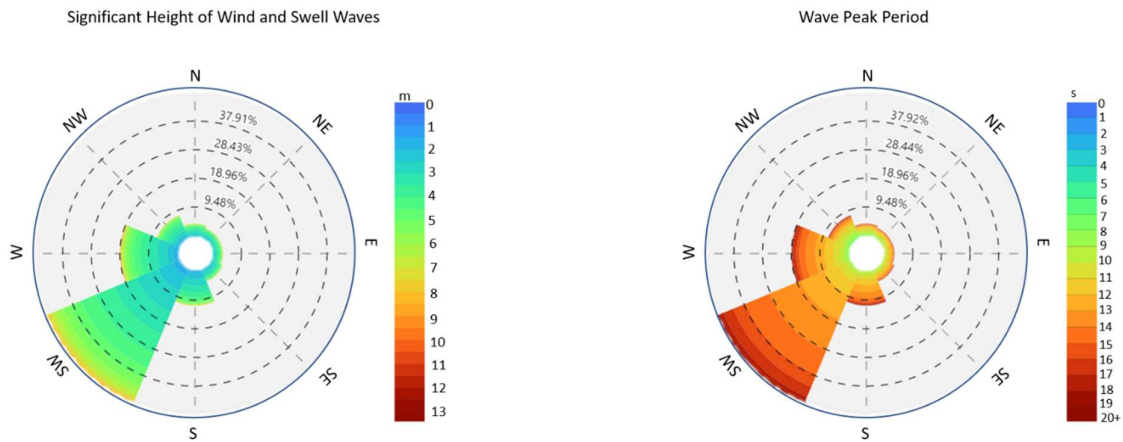
Figure 6: Offshore wave rose at Hokitika at MetOcean wave station (virtual point 42.5S, 171.0E)

Figure 6 shows the wave rose at the offshore location. The dominant offshore wave direction is south westerly.

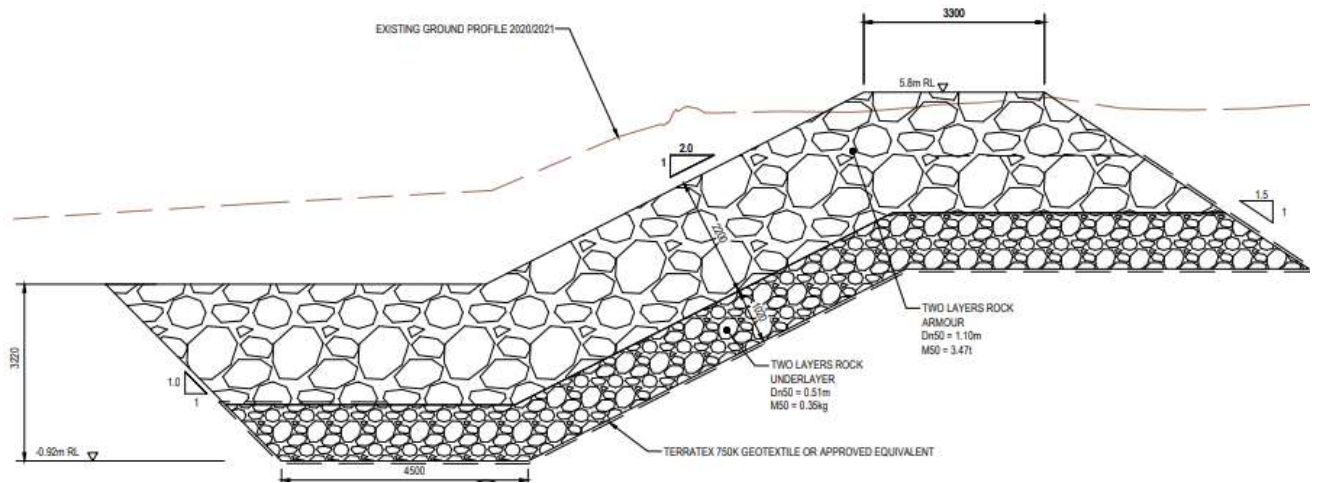
Figure 7 – Rock revetment section – higher toe level

The new 1160m long rock revetment is an extension to the existing Hokitika revetment from approximately Stafford Street to Richards Drive. The revetment extension will largely be constructed as a buried revetment, landward of the beach. The design incorporates two sections with two fixed toe depths (refer to Section 6.4). For both sections the crest width and height, revetment slope angle and toe lengths are all constant. The only change between the sections are the length of the slope and toe level. Design sections are illustrated in Figure 7 and Figure 8.

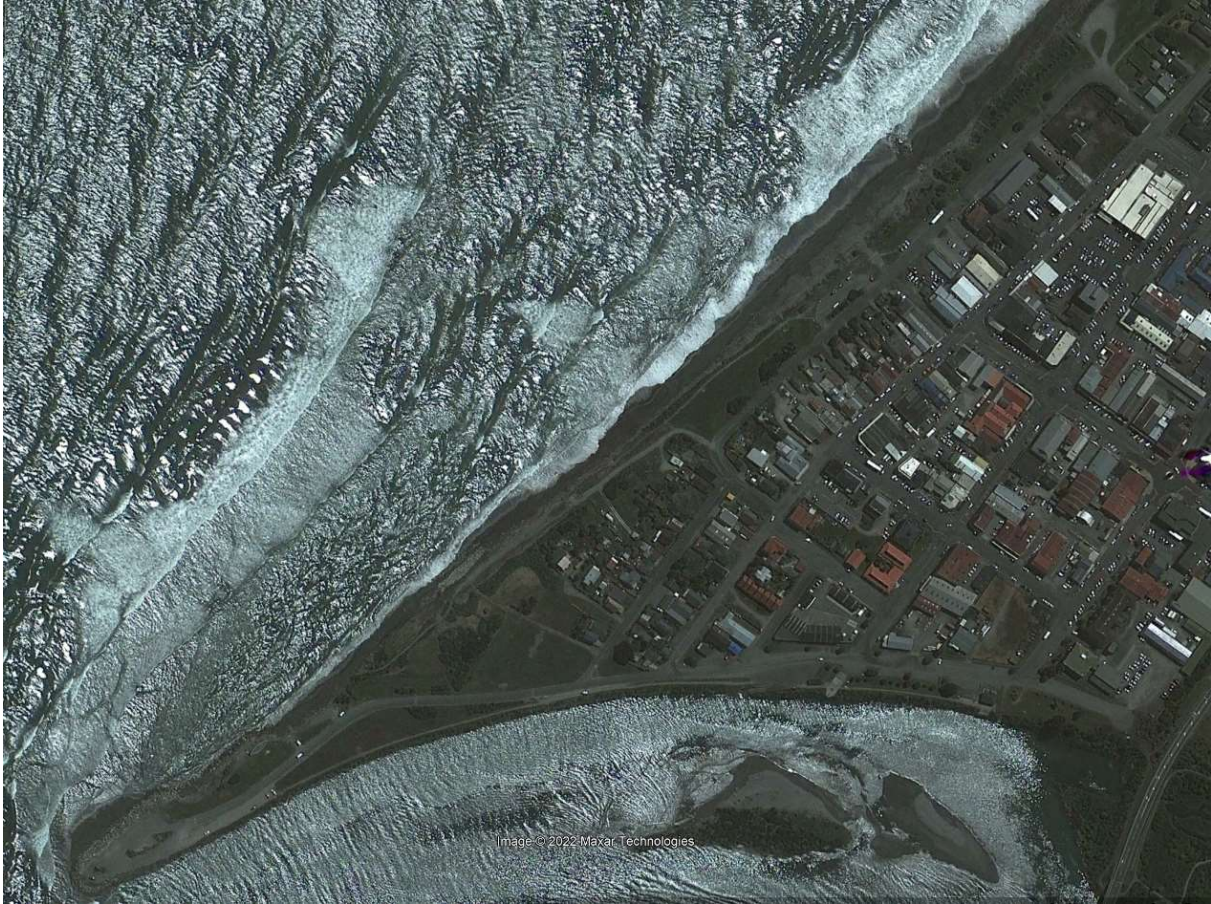
Figure 1a: Existing revetment, December 2012 (from GoogleEarth)

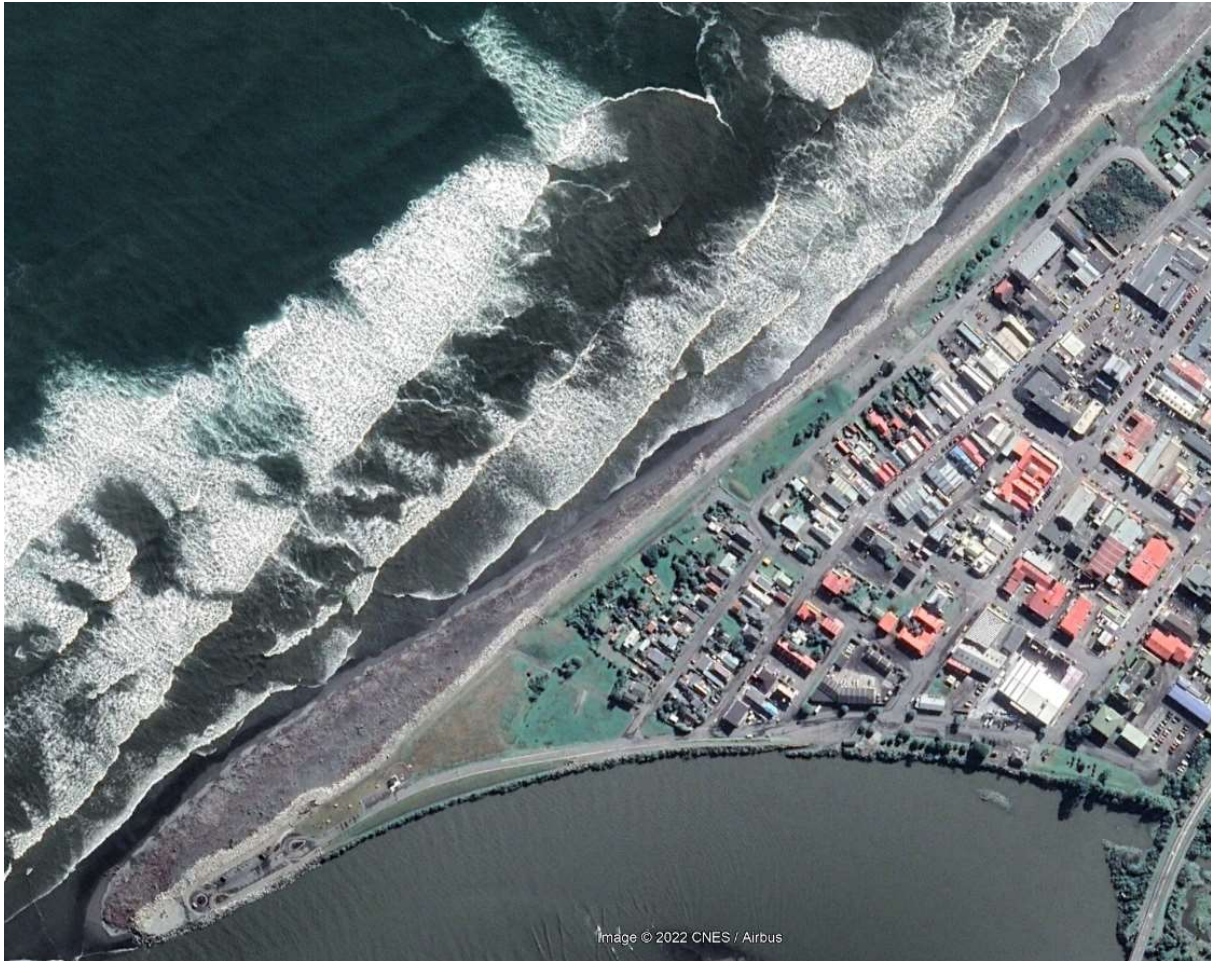
Figure 1b: Existing revetment, April 2021 (from GoogleEarth)
