Franz Josef Stopbanks

Preliminary Design Report

OCTOBER 26, 2021

Client: WCRC
Report by: Matthew Gardner
Land River Sea Consulting Ltd
www.landriversea.com

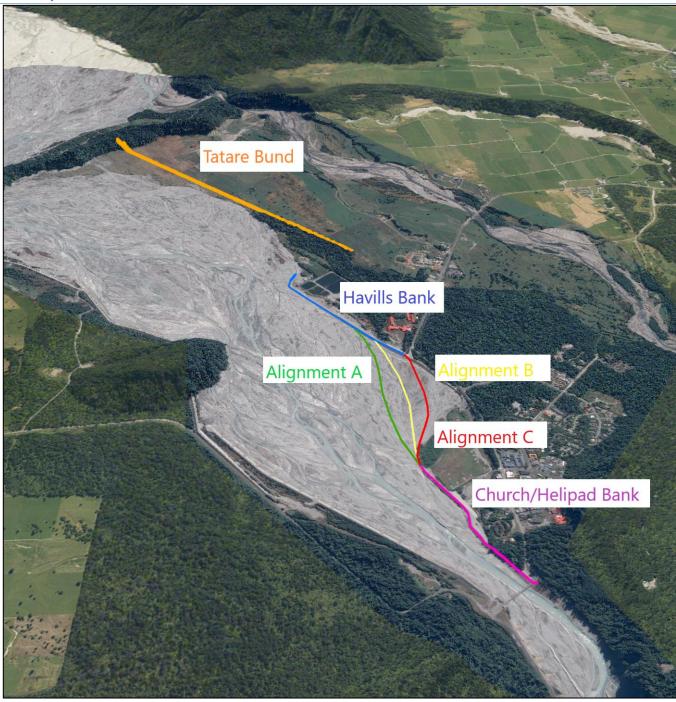
Figure 1-1 - Stopbanks to be raised / constructed

A 3-D visualisation of the area if interest highlighting the different sections of stopbank is presented in Figure 1-1 below.

Gary, Dai and myself have workshopped a range of potential alignments internally and selected three alignments for further analysis, the results of which were used to select a preferred alignment (Figure 1-1).

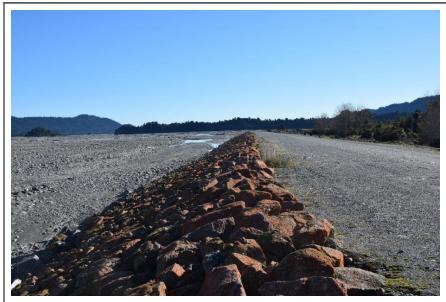
Figure 1-2 - View downstream of the existing rock on the Havill Wall Bank.

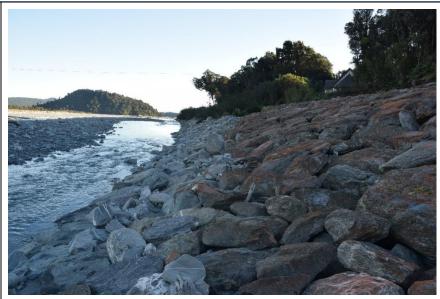
Figure 1-3 - Rock lining on the Church bank

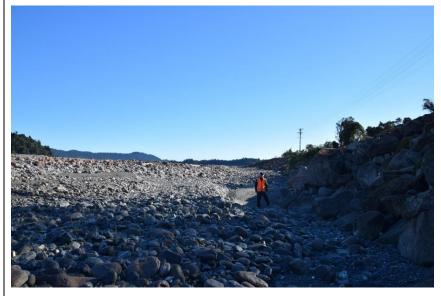
Figure 1-4 -Scour from a recent braid adjacent to the bank

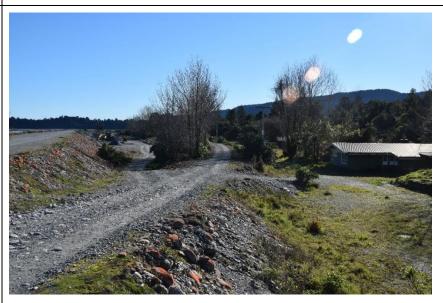
Figure 1-5 - Old bank adjacent to new Havill Wall Bank

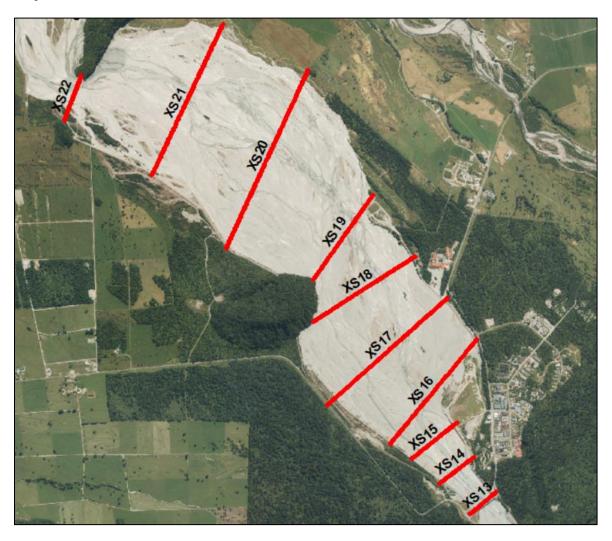
In addition to the DEM data, cross sections 13 to 22 were re-surveyed by Coastwide Surveys Ltd in May 2021 (Figure 2-1) The survey data covered the full width of the active channel of the river, but did not include the below water portion due to health and safety reasons, although a few below water points were collected near the edge of the water. As a result, the Mean Bed Levels (MBL) collected in 2021 will slightly overestimate the MBL, in particular in the confined reach between from State Highway bridge and the end of the Helipad Bank.

Figure 2-1 - Location of surveyed cross sections surveyed by Coastwide Surveys Ltd in May 2021

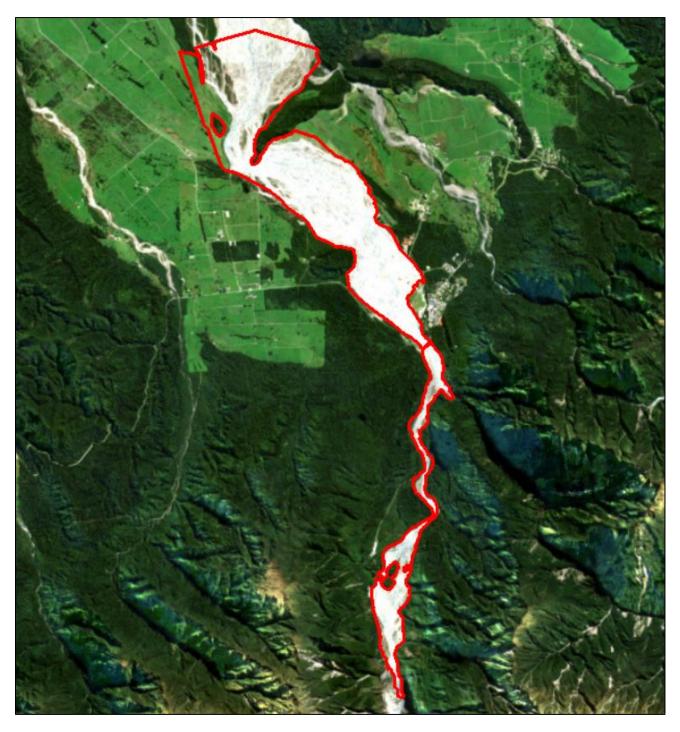
Figure 3-1 - Area of interest for GCD study

In order to gain a detailed spatial understanding of the dynamics of the system, a change detection analysis (GCD) analysis was performed the using 2021 Satellite DEM and the 2019 LiDAR DEM the area of interest (AOI) is shown on Figure 3-1. The method is the same as applied to the previous study in 2019 which analysed the difference between the 2019 and 2016 LiDAR DEMs (Gardner & Brasington, 2019).

Overall the analysis has shown that over the AOI, there has been a build-up of gravel in the system in excess of 1 million cubic metres between April 2019 and March 2021. A summary of volumetric changes for each cross-section reach is presented in Figure 3-2. Of particular note is the significant aggradation in the reach from XS2 to XS4 as well as the degradation from XS0 to XS2. This likely indicates that the material which filled up the valley during the 2019 flood events, is slowly working its way down the system and will be likely to be causing ongoing aggradation for many years to come.

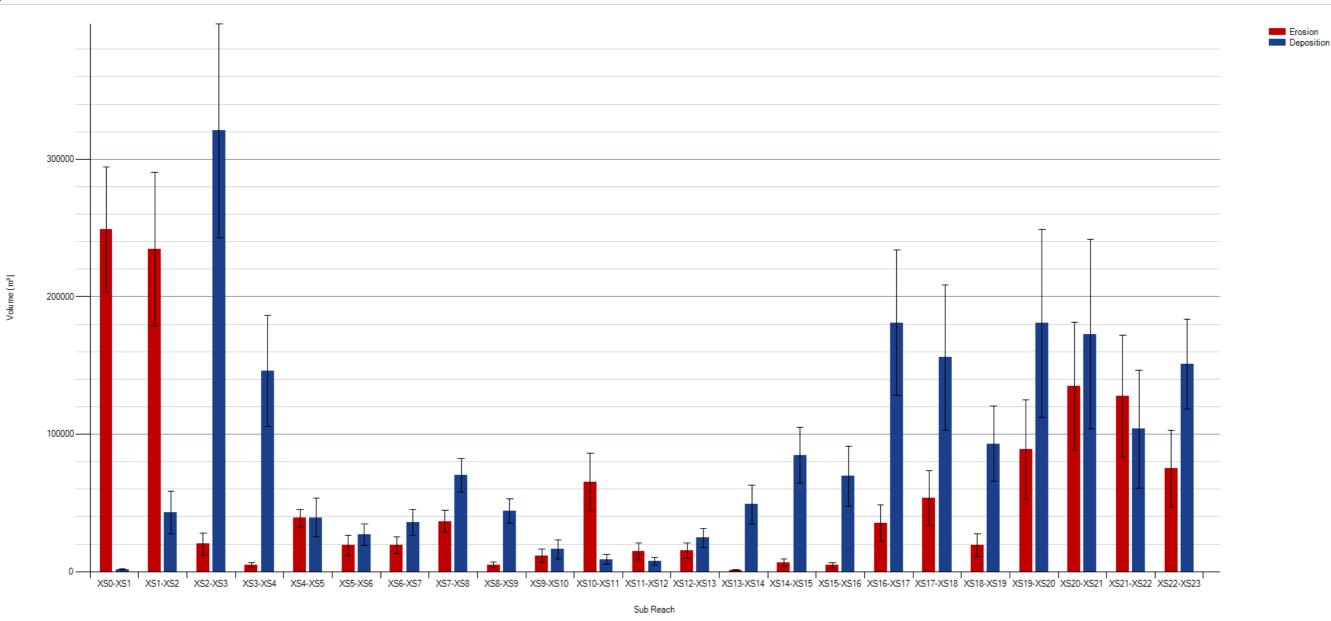
Figure 3-2 - Change in volume for each cross section reach for time period 2019 to 2021 based on 2019 LiDAR DEM and 2021 Satellite DEM

A visual presentation of the change detection is presented in Figure 3-2a and 3-2b on the following pages.

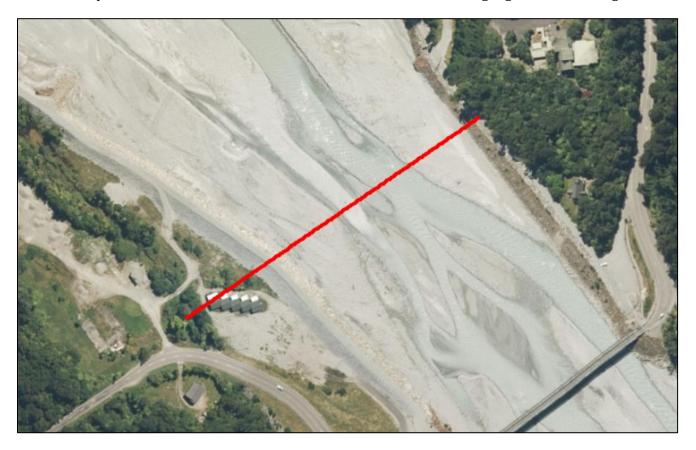
LiDAR is available in this location from 2011, 2016 and 2019 as well the satellite DEM from March 2021. A cross section profile has been extracted from each dataset in the location highlighted in red in Figure 3-3.

Figure 3-3 - Location of extracted cross section

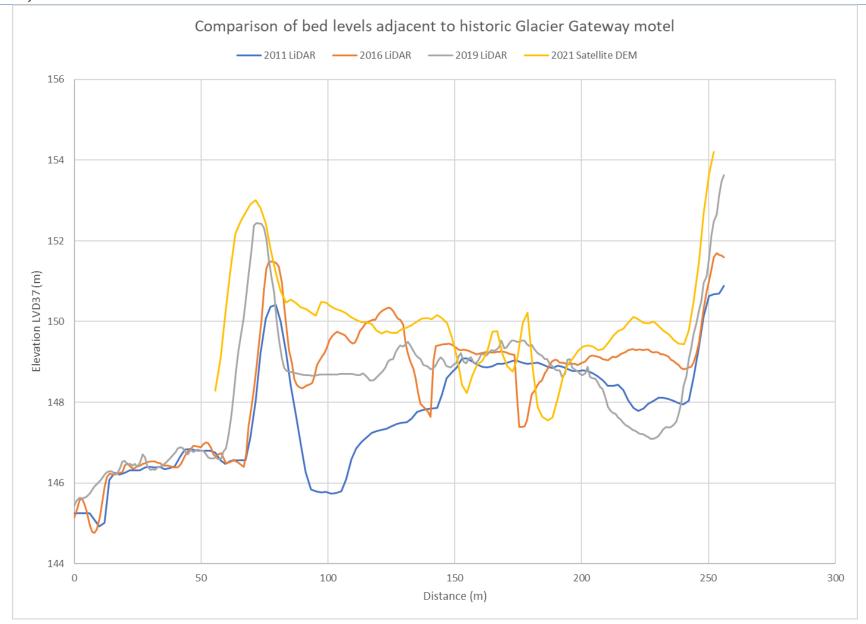
The cross section profiles presented in Figure 3-4 show very clearly that although the stopbanks have been raised on several occasions, the river bed has continued to aggrade along the true left side by over 4m over a 10 year period.

Figure 3-4 - Cross section profile plot adjacent to Glacier gateway hotels

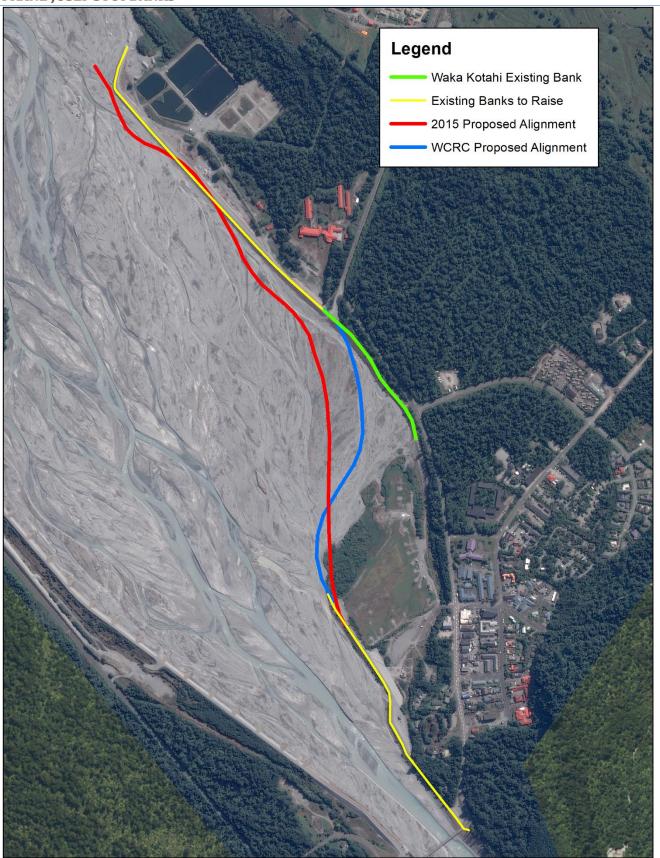
The preliminary design submitted to the government as part of the application for provincial growth funding has assumed an alternative alignment. A summary of the existing banks is shown as well as the proposed design alignments in Figure 0-1 below.

Figure 0-1 - Proposed design alignment for new section of stopbank

On review of the alignment submitted as part of the funding proposal, we have concern that the alignment is less than ideal due to the following reasons:

- The stop bank alignment has a significant expansion with the potential to cause sediment deposition midway along the bend
- The bend alignment will likely cause flow to impact the stopbank at a sharp angle upstream of the hotel and have an associated increase in velocity and shear stress against the bank, with the potential for increased toe scour and bank erosion.
- There is potential to significantly increase the velocity near the stopbank upstream of the hotel
- There is excessive fall towards the 55km corner

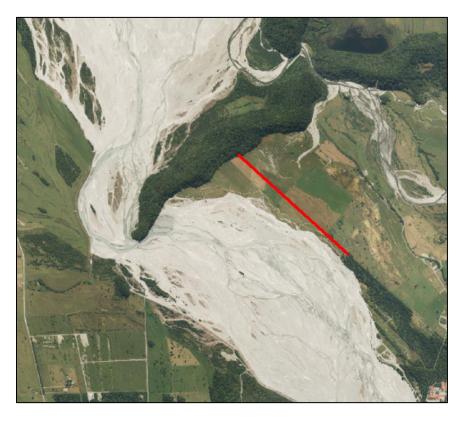
In addition to raising the existing banks, the proposal includes the construction of a rock lined bund to prevent flow into the Tatare River. Due to the aggradation in the Waiho River, there is potential for the Waiho River to avulse into the Tatare River, which could create significant threat to the township as discussed in previous reports (Hall, 2012). Floodwaters have already been spilling over this area in recent flood events, with significant scour and headcutting occurring each time. The construction of a bund to prevent an avulsion at this location is considered to be highly prudent. The location of the proposed bund is presented in Figure 0-2 below.

Figure 0-2 - Location of Tatare overflow bund

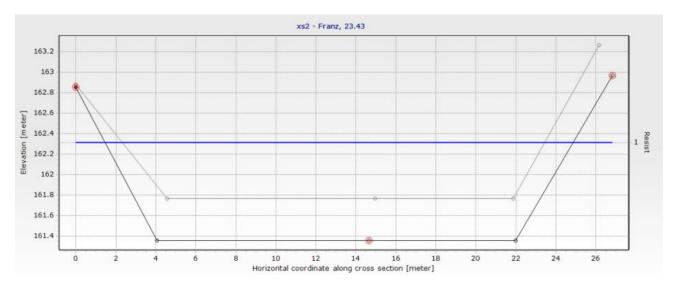
Figure 5-2 - Example of typical trapezoidal channel shape in MIKE Hydro River

The model bathymetry has been interpolated using points generated at a 2m grid resolution from the satellite DEM. Because the DEM did not contain the subaqueous portion of the river, the DEM was modified by burning in a 1.5m deep by 18m wide trapezoid channel (Figure 5-2, Figure 5-3, Figure 5-4). The channel edges were designed to tie in with the DEM elevations.

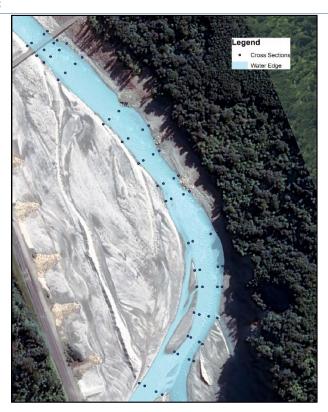
Figure 5-3 - Example of cross section locations in relation to main channel

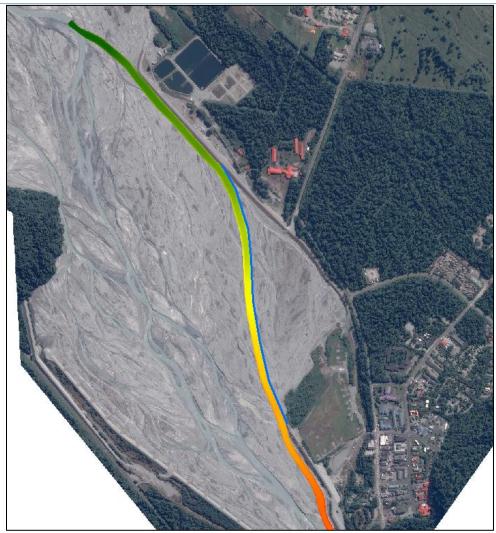
In addition to the existing river setup, three potential stopbank alignments (A, B and C) were simulated, The banks were represented in the model using 1D dike features in MIKE21fm. To simulate a likely braid set up at the base of each bank alignment; a 30m wide, 2m deep trapezoidal braid has been burnt into the DEM for each stopbank alignment. These dimensions have been based on site measurements of braids that have clearly formed adjacent to the existing stopbank in the vicinity of the 55km corner. An example of the braid for alignment A is presented in Figure 5-5 below.

Figure 5-5 - Example of braid channel burnt into terrain for alignment A

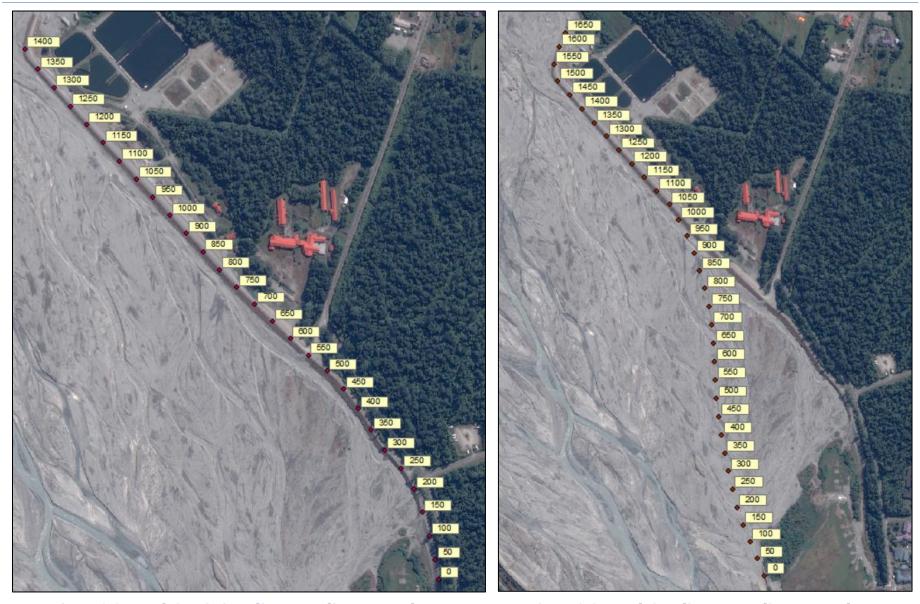
Figure 0-2 - Bank 2, Existing Alignment, distance markers

Figure 0-1 to Figure 0-5 show the location used for the distance marker for each of the longsection profiles presented in the following pages.

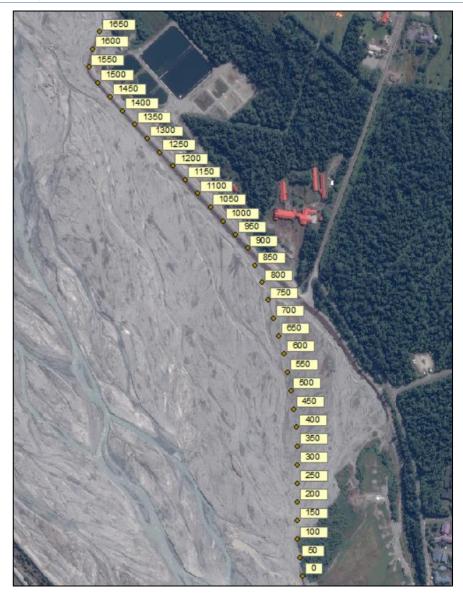
Figure 0-4 - Bank 2 - Alignment B distance marker

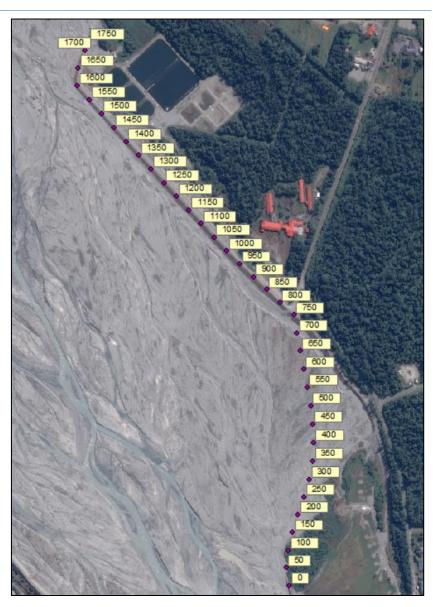
Figure 0-5 - Bank 2 - Alignment C distance markers
