1. FLOODING & RIVERBED AGGRADATION HAZARDS

FLOODING AND RIVERBED AGGRADATION

Excerpts from DTec Report pp 5-14

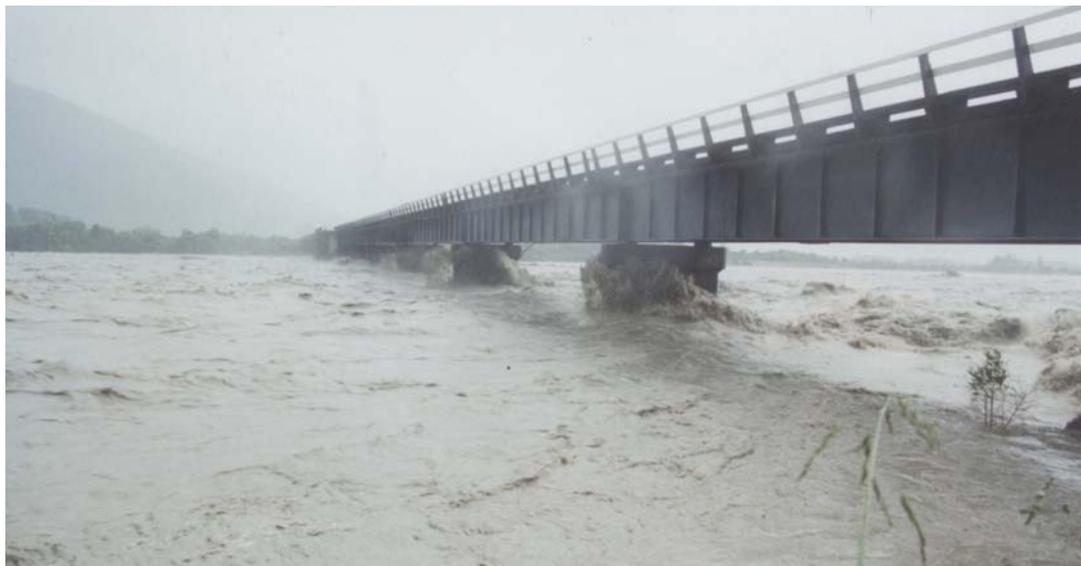
Wanganui River in full flood at the main road bridge, Hari Hari, December 1995
Photograph by M Shearer, WCRC Engineer

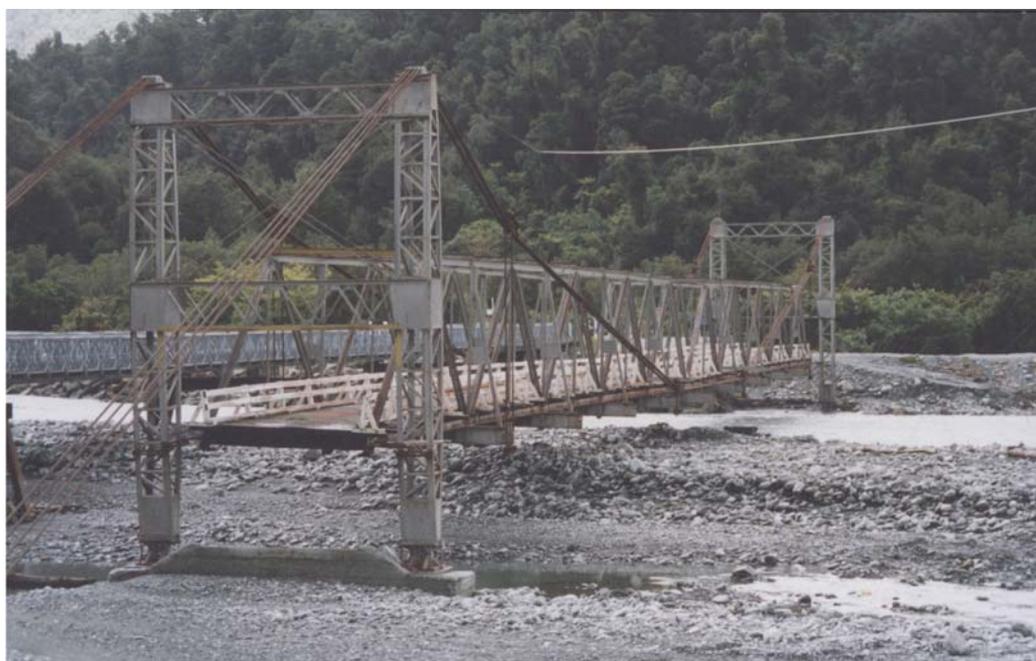
Note how low the suspension bridge, since removed, is to the water. Bailey bridge in background
Photograph taken by Mike Shearer, WCRC Engineer in November 1996.

By 1996 the Waiho River had aggraded so much there was very little clearance under the highway suspension bridge for river flow. When the river was flowing with ice melt off the Franz Josef Glacier, ice and boulders were coming very close to the underside of the bridge. In the end the suspension bridge was removed and replaced by a bailey bridge, these being easier to relocate or extend.

There are also other problems as a result of this aggradation because the riverbed is also higher than dwellings on the other side of the stopbank on the south side of the river. These dwellings and anyone in them are at extreme risk and as of 2003 the Ministry of Civil Defence & Emergency Management decreed that these dwellings should go. This has caused much friction between the businesses concerned and the Ministry, the Westland District Council and the WC Regional Council. As of July 2004 these issues are not fully resolved (refer West Coast Times and Westland District Council for ongoing information).

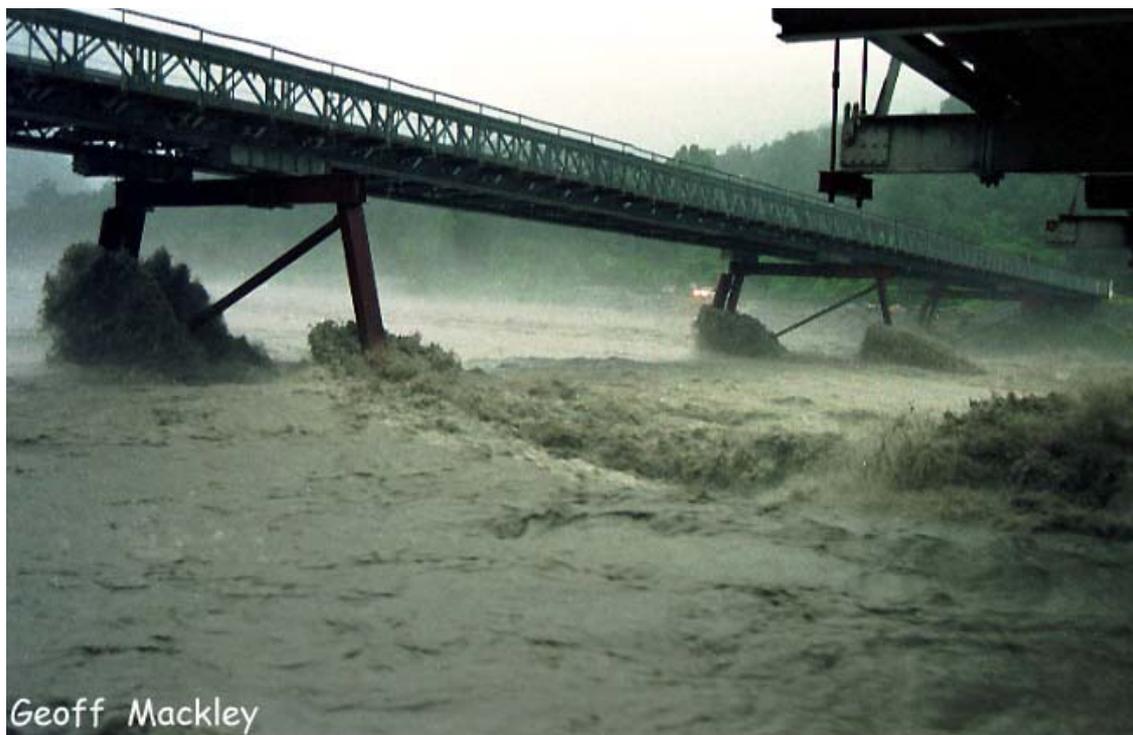
The Haast River in full flood at the highway bridge. *Photograph by G Mackley*

Haast: flood prone and remote. Residents in the Haast area of South Westland are hardy individuals whose contacts to the outside world become tenuous when the elements are at their worst. A long road bridge links them to places north while highway up the Haast valley and over Haast Pass is their only road link east. The heavy rain the region is well known for regularly damages these outside links. Repairing roads due to slips and flooding is an ongoing task in this part of the world.

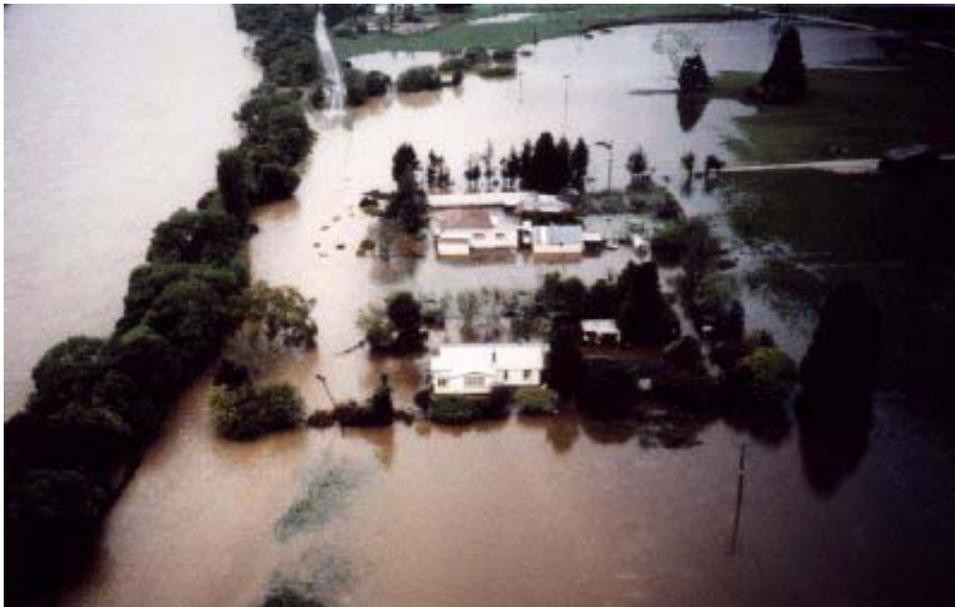
The Karamea River (left, looking upstream) floods houses and farmland at the Arapito upstream and on true left of the main road bridge, Karamea, 1998.

Karamea: flood prone and remote. The settled area at Karamea from Little Wanganui through to Karamea and North Beach is divided by the Karamea River. This is a "big river," with big rapids and large flow giving it a Grade 5+ category for commercial river rafting (a Grade 6 is well nigh impossible to raft). Many times in the past the river has flooded, even taking out the bridge, and basically cut off the town (shops, school, Information Centre) from the farming areas further south toward Little Wanganui. Local Civil Defence arrangements take this into account in the event of a flood with the district having separate Civil Defence officers and plans for the north and south areas.

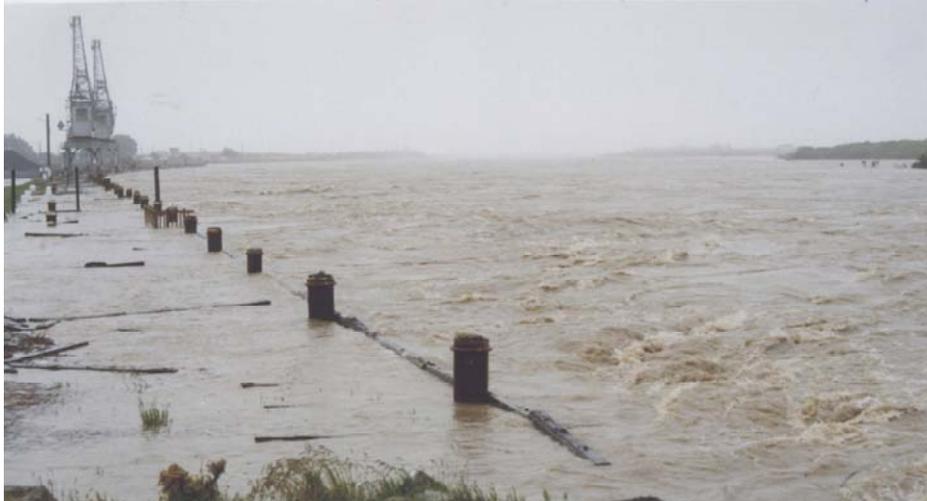
1. The floodwall just holds, Greymouth 1997. Built after the two disastrous floods of 1988 this was the first real test for Greymouth's much vaunted floodwall. Even so there were still major problems upstream at Kaiata and over the river at Cobden. The wall has since had further work because of leaks and it will be raised yet again in 2005 because flood modelling has shown this will be needed.

Looking out to sea with the Grey River awash, December 1997. *Photograph by M Shearer, WCRC Engineer*

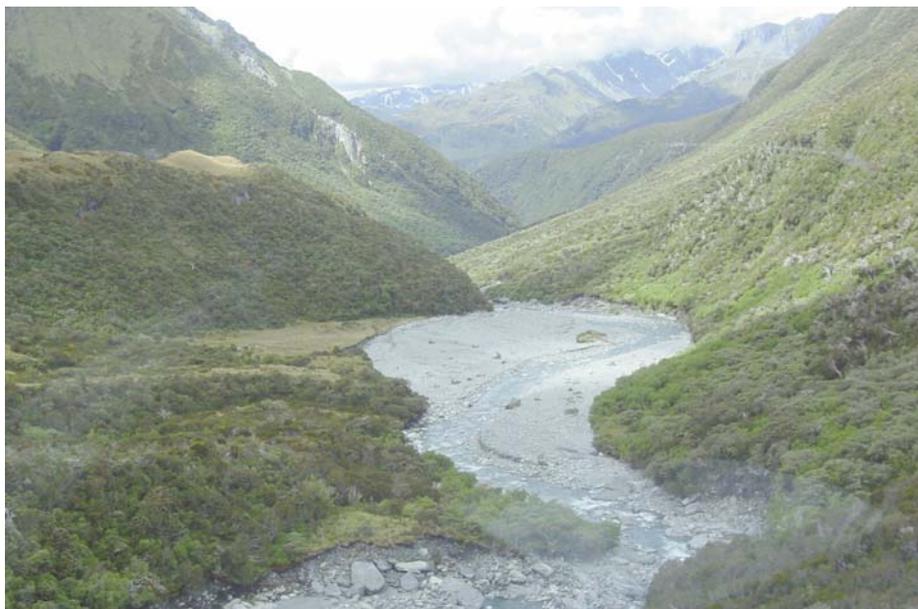
2. Cropp River Rain Gauge Site: This rain gauge, sited mid photo on a small rise at the true right of river before it drops into the gorge, records an annual mean rainfall of just over 10m. In February 2004 it recorded a record 99mm in one hour. The site is within the maximum precipitation zone at 860m above sea level and about 20 kms inland.

Looking down the Cropp River into the gorge. *Photograph by J Porteous, NIWA*

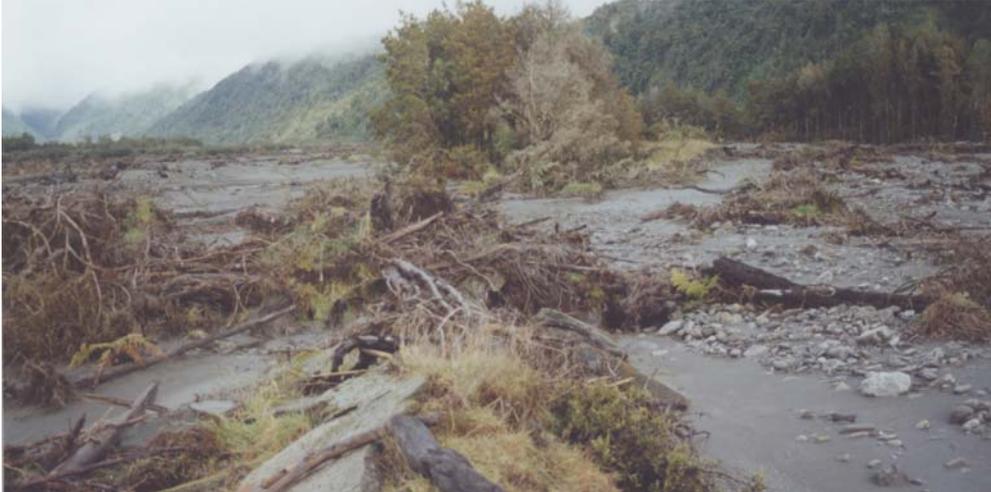
3. Poerua River flats below the Gorge: In June 2000 a huge landslide off Mt Adams dammed the Poerua River above the gorge. This then gave way and a large wall of water came down the river, breaching stopbanks at the first farm down the valley. The stopbanks which had been able to contain normal floods over a long period, were no match for this one and a large area of arable farm land was ruined.

The scene on June 29th at the topmost breach of the stopbank on the Poerua River post the Mt Adams landslide flood. *Photograph by M Shearer, WCRC Engineer*

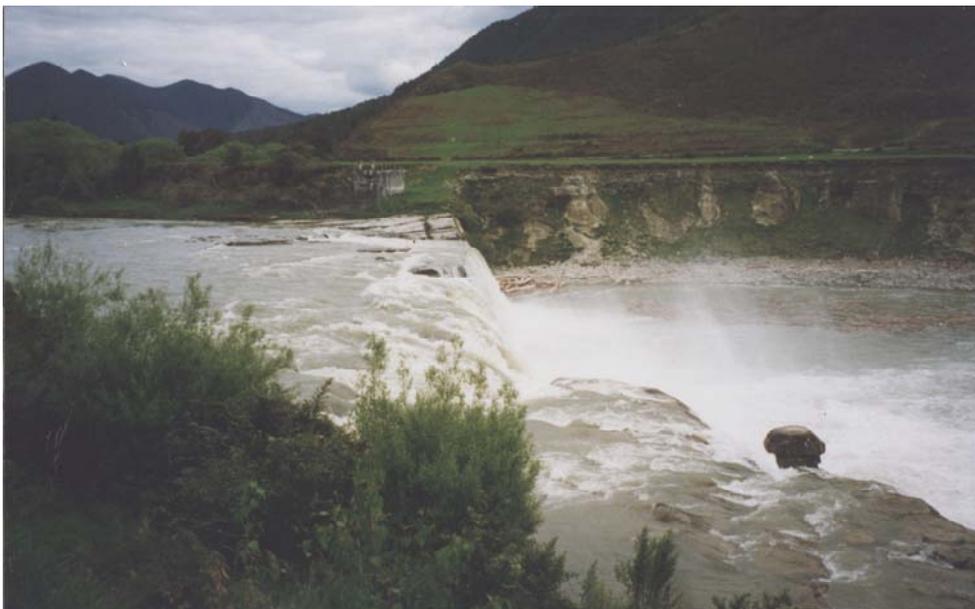
4. Maruia River at the Falls: the Maruia River is a main tributary of the Buller River which has a long history of flooding at Westport. Between Springs Junction and the falls, created in 1929 by the Murchison Earthquake, the Maruia River meanders for much of the time across a wide valley. Many of the farms have stopbanks in place for flood protection.

Maruia Falls in full flood state, October 23rd 1996. *Photograph by M Shearer, WCRC Engineer*

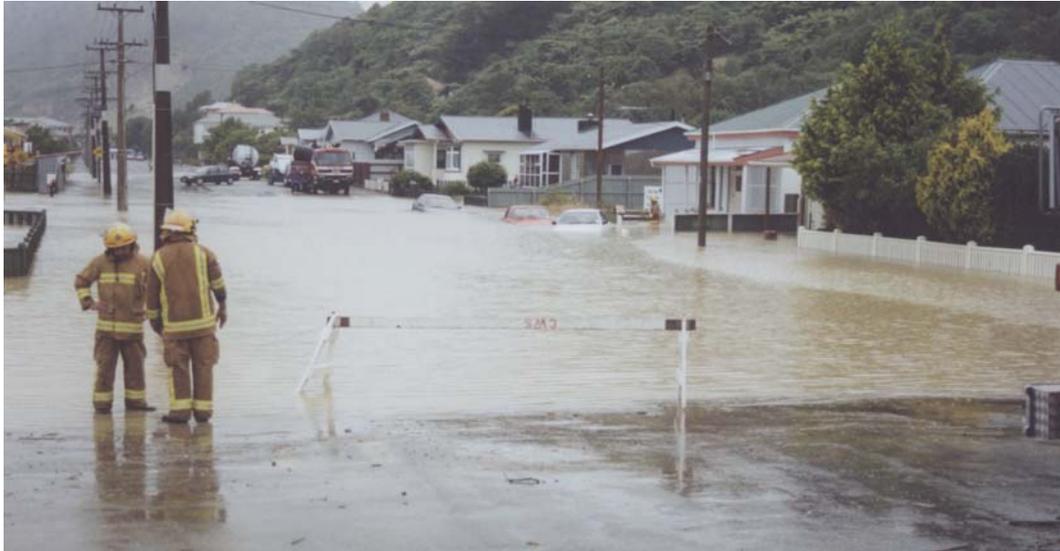
5. Sawyers Creek at Greymouth: Localised downpours can cause lesser West Coast streams to become raging torrents and when they flow through urban areas major flooding can occur. Sometimes these local creeks will be in major flood while nearby large rivers are not. The term “stormwater” is then aptly deserved.

The scene in Alexander Street, Greymouth on January 24th 2000, after a flash flood down Sawyer’s Creek from a localised downpour just east of Greymouth.

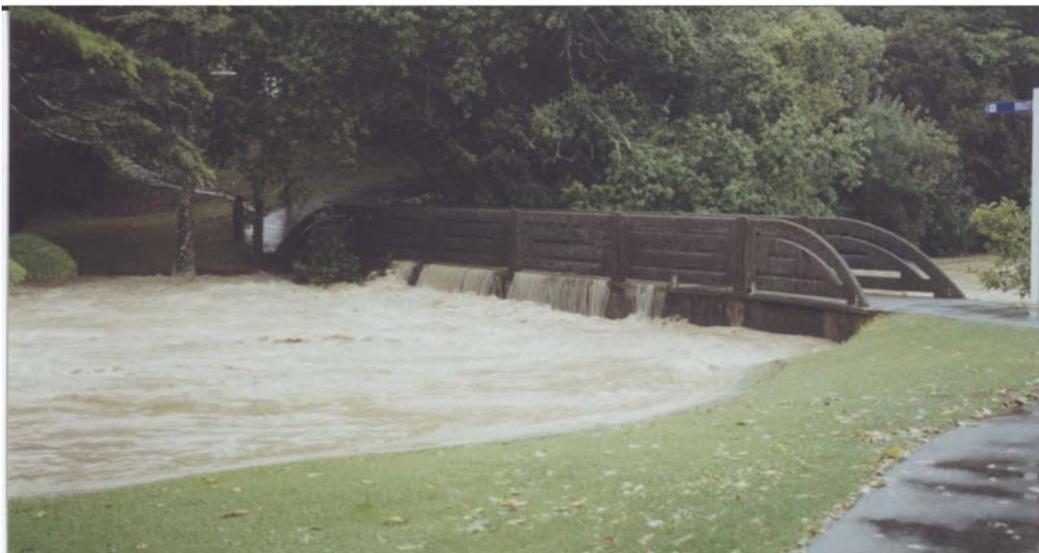
Sawyers Creek floodwaters lapping the footbridge in Dixon Park, Greymouth on January 24th 2000. Before major floodworks were completed upstream in the 1970’s this creek had been known to top this bridge. *Both photographs by M Shearer, WCRC Engineer*
