4. EARTHQUAKE HAZARDS

West Coast Regional Council: Natural Hazards Review 2002, DTec Consulting Ltd., Christchurch (the DTec Report)

EARTHQUAKE HAZARDS

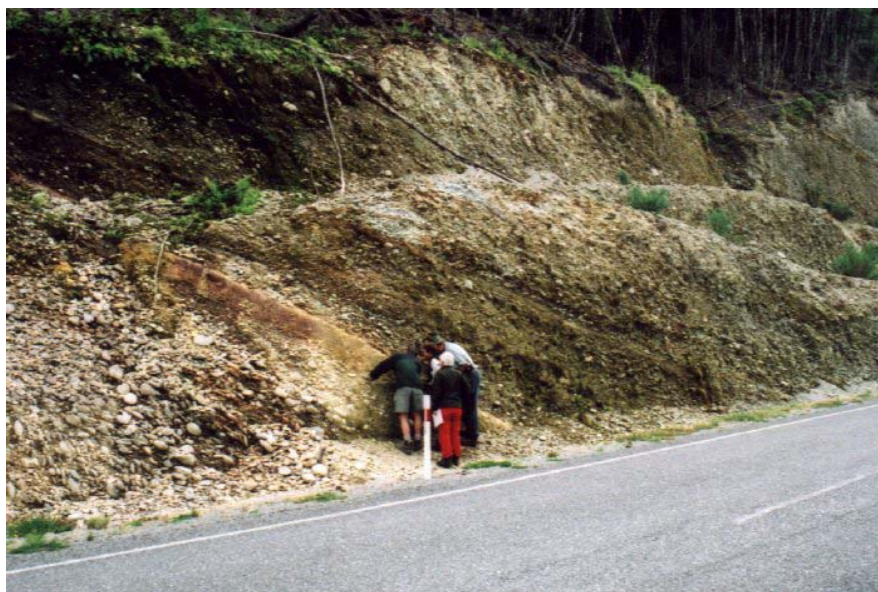
Geologists inspect a fault line running through the “Tilted Terraces” by the Atarau Rd. north Blackball.

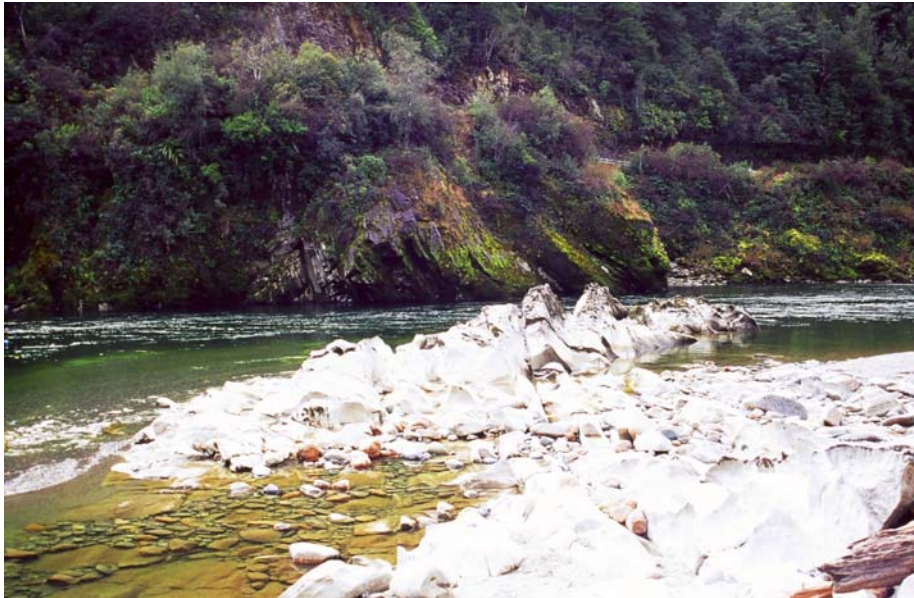
Limestone rocks in the Buller River just downstream of the “Longest Swingbridge.” The White Fault runs across the river in this vicinity. Across the swingbridge on the south side, there is an interpretation trail explaining about the degree of uplift and change in the area due to the 1929 Murchison Earthquake. *Photograph by M Traves, WCRC.*

Notable West Coast examples of surface rupture include the 1929 Murchison Earthquake (M7.8) and the 1968 Inangahua Earthquake (M7.1). Respective felt intensities of these earthquakes in the epicentre regions were MM9 and MM 10. Surface rupture on the White Creek Fault during the Murchison Earthquake was 4.5m vertical where the fault crosses the Buller Gorge Road (now SH6) (Ferrar & Grange 1929, Fyfe 1929, Hendersen 1932, Bastings 1933). Maximum uplift of 4.9m occurred about 503m east of the fault, and was recorded by Fyfe (1929). The uplifted block tilted gradually to the east, with the tilt becoming non-existent at about 19.5km from the fault. Hendersen (1937) detected the fault trace displacement for 8km, and Berryman (1980) recorded 2.1m of sinistral horizontal movement and 3.1m vertical movement at a fence crossing the fault scarp.

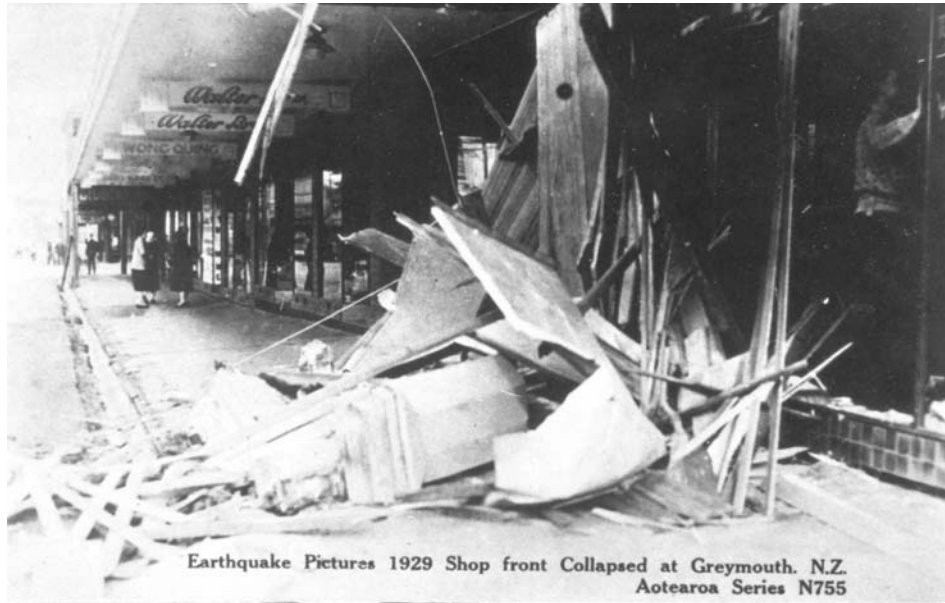
Earthquake Pictures 1929 Shop front Collapsed at Greymouth. N.Z.
Aotearoa Series N755

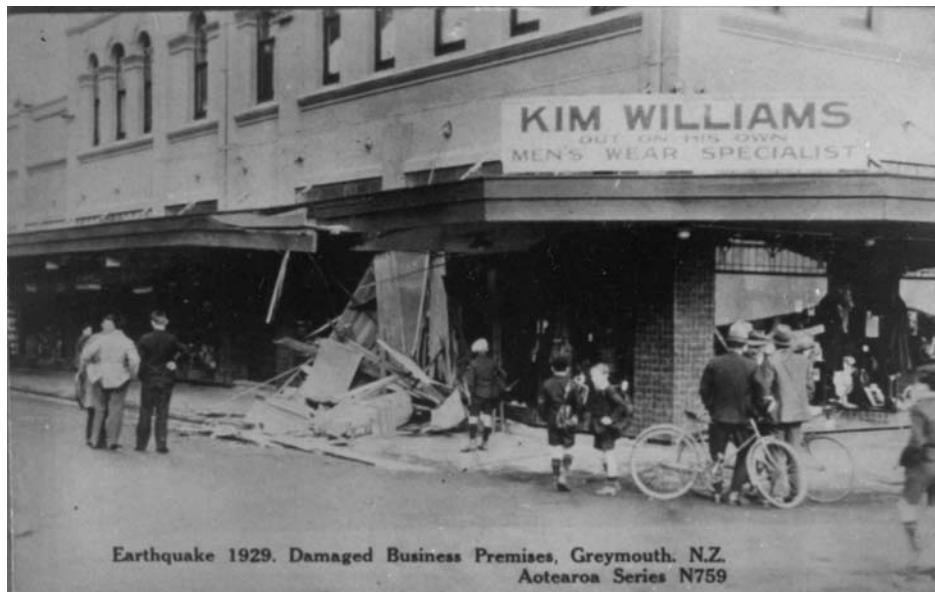
Earthquake 1929. Damaged Business Premises, Greymouth. N.Z.
Aotearoa Series N759

Collapses of shop frontages onto the footpaths were common in both Greymouth and Westport as a result of the 1929 Murchison Earthquake.

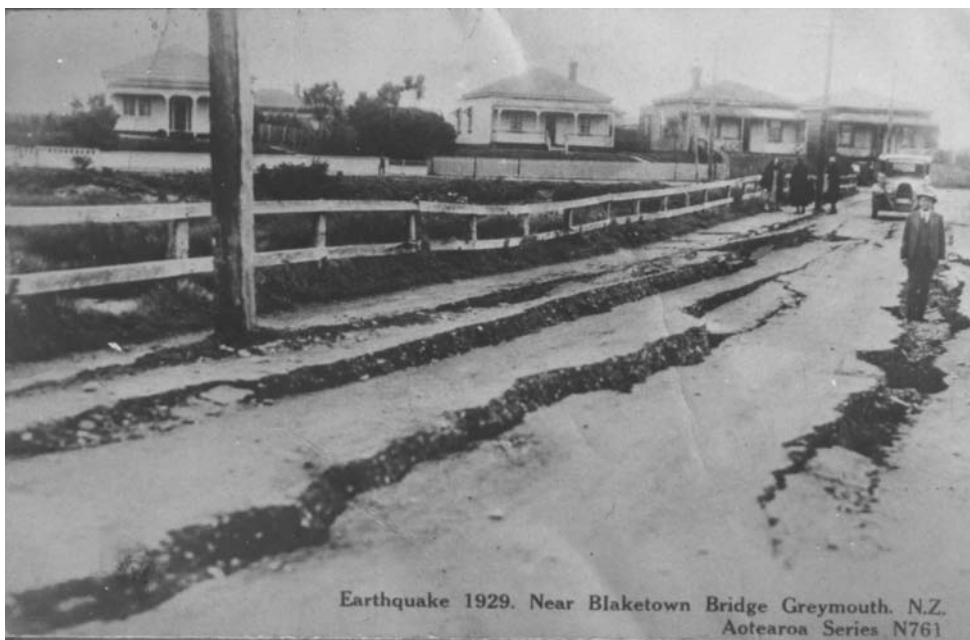
This picture was taken in Preston Road. The road fissures have been caused by liquefaction of the sandy soils in the Blaketown area.

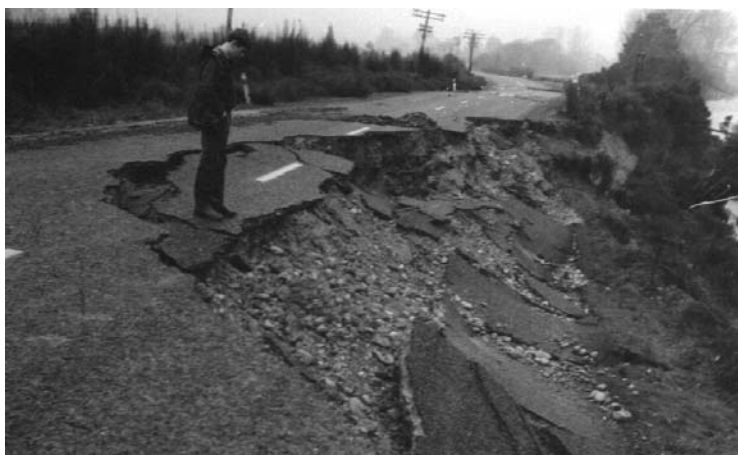
One of the biggest effects of the earthquake was slumping of roads which made communications after the earthquake very difficult. However the use of (for the first time after a major natural hazards event) did help to make it much easier to implement an emergency response

One casualty of the many slumps in the roads was this car, going nowhere.

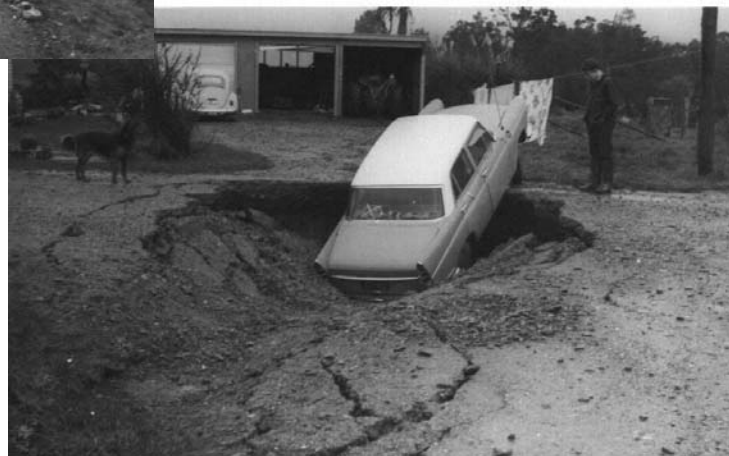
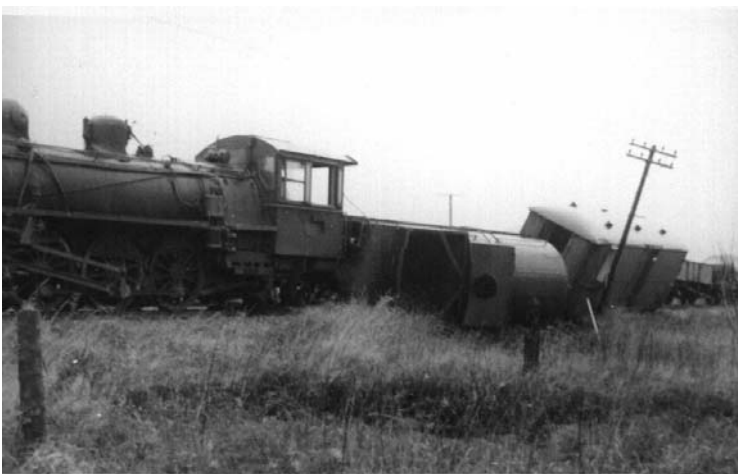
Rail communications were also badly affected as witnessed by this photograph of derailed rolling stock. In many places formerly straight steel rails were bent and twisted, testimony to the violence of the earth's movement
