Waiho River

Historic and Future Management Strategies

Client: West Coast Regional Council
Report by: Rose Beagley & Matthew Gardner
Land River Sea Consulting Limited
www.landriversea.com

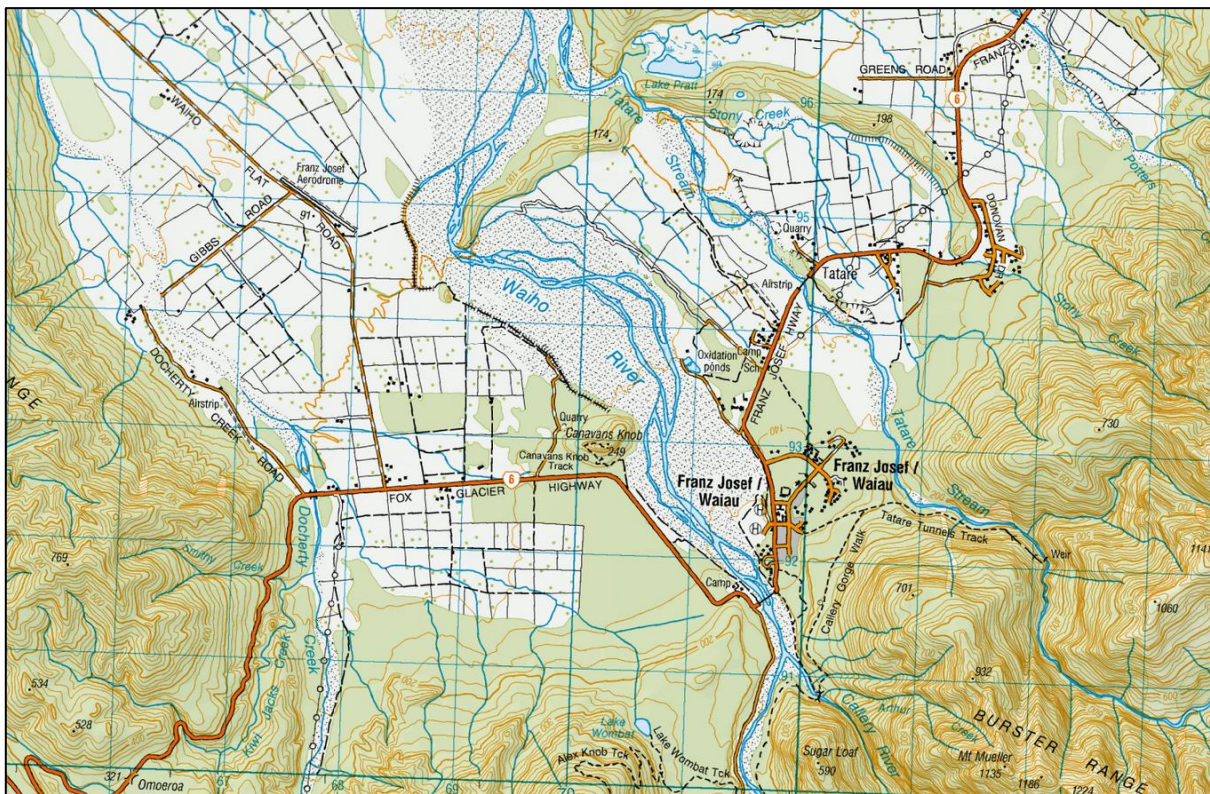
Figure 1-1 - Waiho River downstream of its junction with the Callery River, with the township of Franz Josef on the north side and surrounding farmland, community and SH6.

The only access by car to Franz Josef, is via the State Highway 6 (SH6) which passes through the township before crossing the Waiho River 750m downstream of its junction with the Callery River (Figure 1-1). It is the main and only traffic artery along the length of Westland and is vital to the economy of the township and area, providing the only means by which town supplies, tourists, residents, and agricultural produce can move.

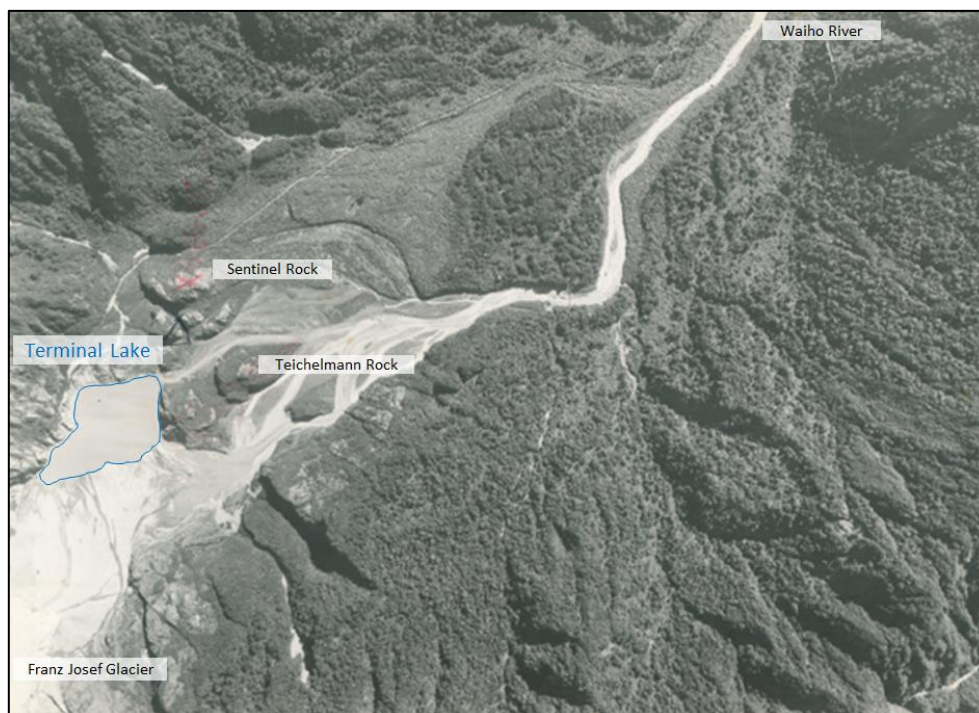
Figure 3-4 – 1948 aerial imagery showing the remaining part of the terminal lake on the south side just upstream of Sentinel Rock and Teichelmann Rock (imagery provided by Mark Healey, WSP).

- The river incision observed from European settlement through to the 1930s was related to the existence of a terminal lake that formed as the glacier retreated from its 1820's position between 1923 and 1950 (Figure 3-4). This created a large sediment trap therefore reducing the immediate supply of sediment to the river system.

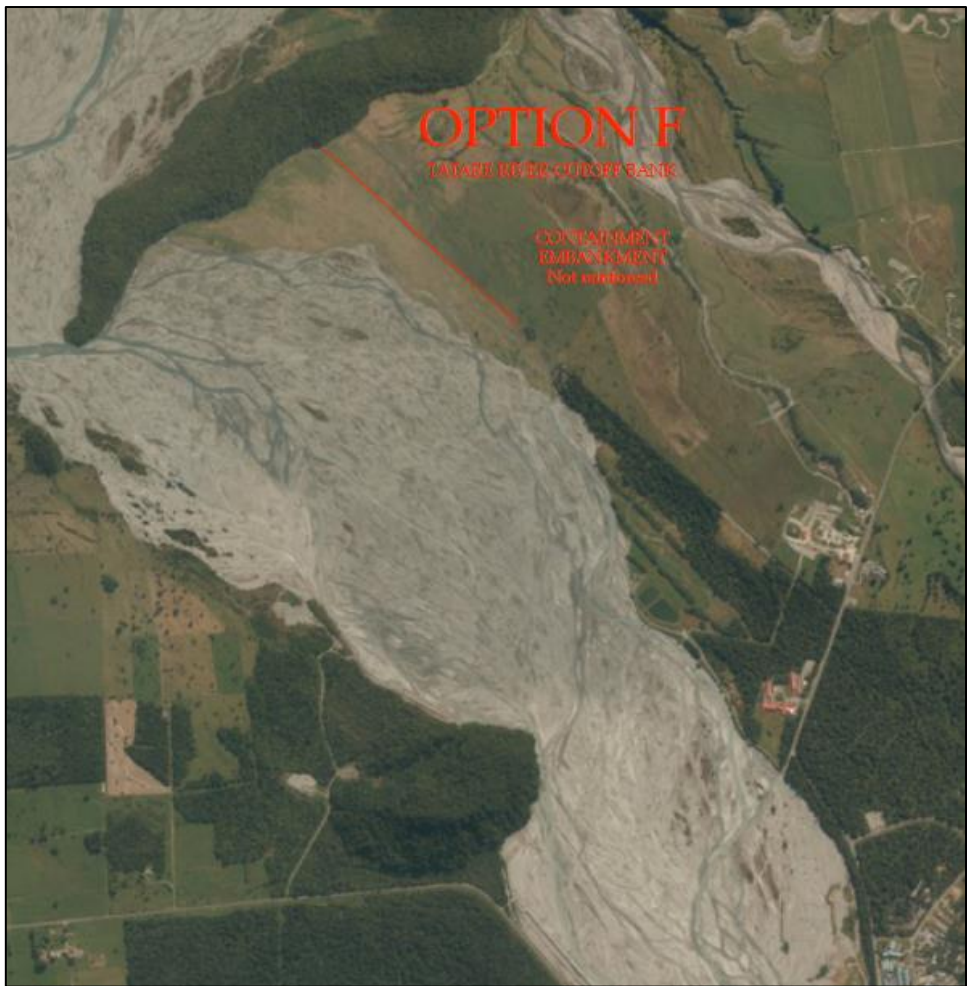
Figure 3-11 - The January 2015 proposed cutoff embankment to prevent the Waiho River avulsing into the Tatare Stream. (Gardner & Williams, 2015)

Over the last ten years, small breakouts from the Waiho River into the Tatare Stream have occurred, but the river was always able to be rediverted away from the Tatare stream and fan and these did not last. This activity did not go unnoticed, and in January 2015, during an emergency meeting held by the Franz Josef stakeholder group (i.e. Waka Kotahi, Scenic Circle Group, Rating District, WCRC, WDC, and Electronet) to look at options for future management of the river, Land River Sea Consulting and G & E Williams Consultants proposed a cutoff embankment be constructed to prevent the Waiho River from avulsing into the Tatare Stream (Figure 3-11)(Gardner & Williams, 2015). At the time, the natural high land (farmland) would have made for a relatively straightforward design and construction process.

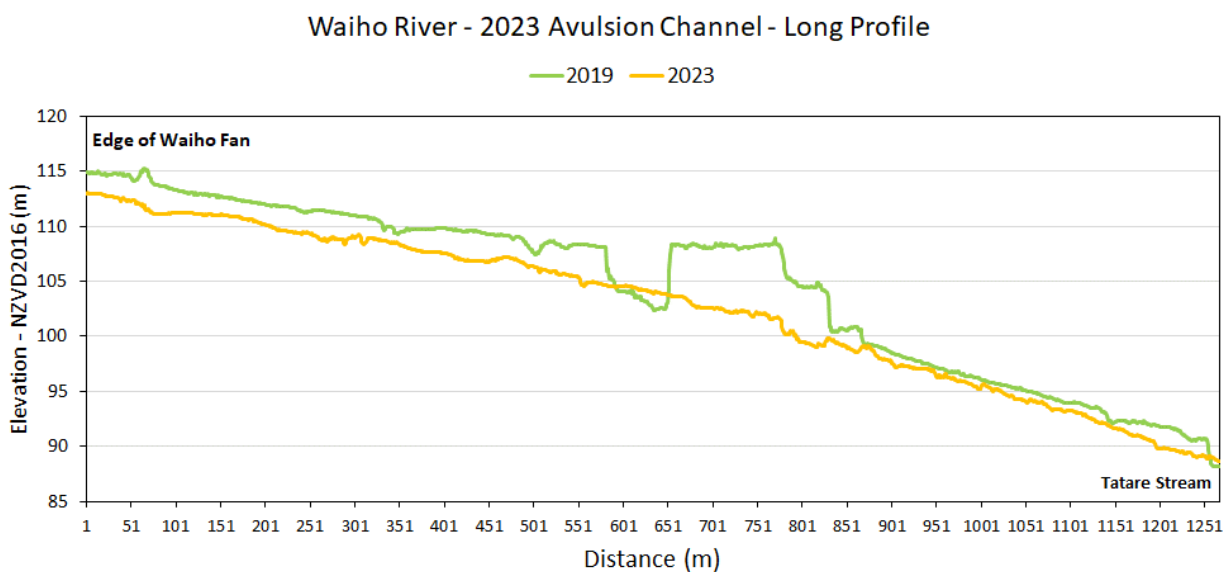
Figure 3-13 – Long profile of surface elevation data along the 2023 avulsion channel between the edge of the Waiho fan and the Tatare Stream.

This steep gradient (approximately 1.9%) is made obvious in a long profile of the 2023 avulsion channel (Figure 3-13). In Figure 3-13, surface elevation data from 2019 and 2023 has been taken from the top of the avulsion channel at the edge of the Waiho fan and down the channel (the yellow line in Figure 3-12) to where it joins the Tatare Stream. The Waiho River has eroded a considerable amount of farmland between the edge of the Waiho fan and the 851 m distance mark, creating a channel of relatively consistent gradient down to the Tatare Stream.

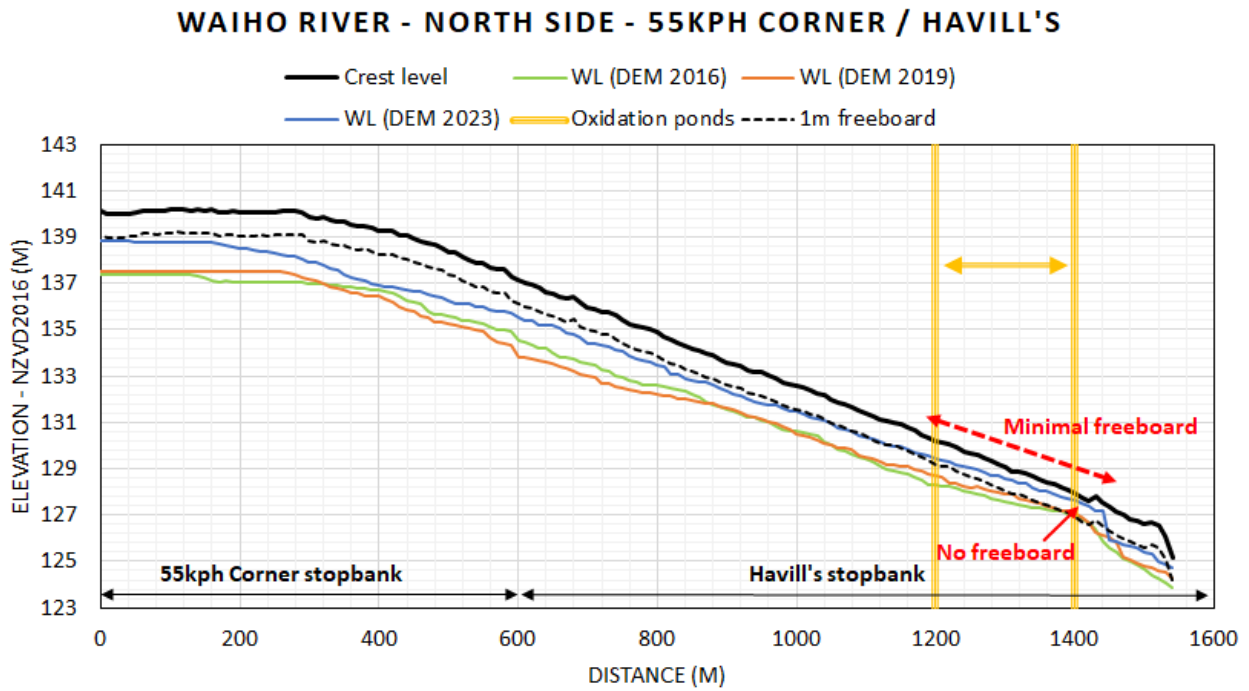
Figure 4-5 - Modelled peak water levels along the 55kph Corner/Havill's stopbank using the 2016, 2019 and 2023 bed surface elevations.

Further, the 2023 model results show that in places along the stopbanks on both sides of the river, the peak water level is within a metre of the crest level, putting it at risk of overtopping or failure. The upper end of the Waka Kotahi stopbanks and the lower end of the 55kph Corner/Havill's

stopbank have minimal to no freeboard, and are therefore very vulnerable to overtopping (Figure 4-3 and Figure 4-5).

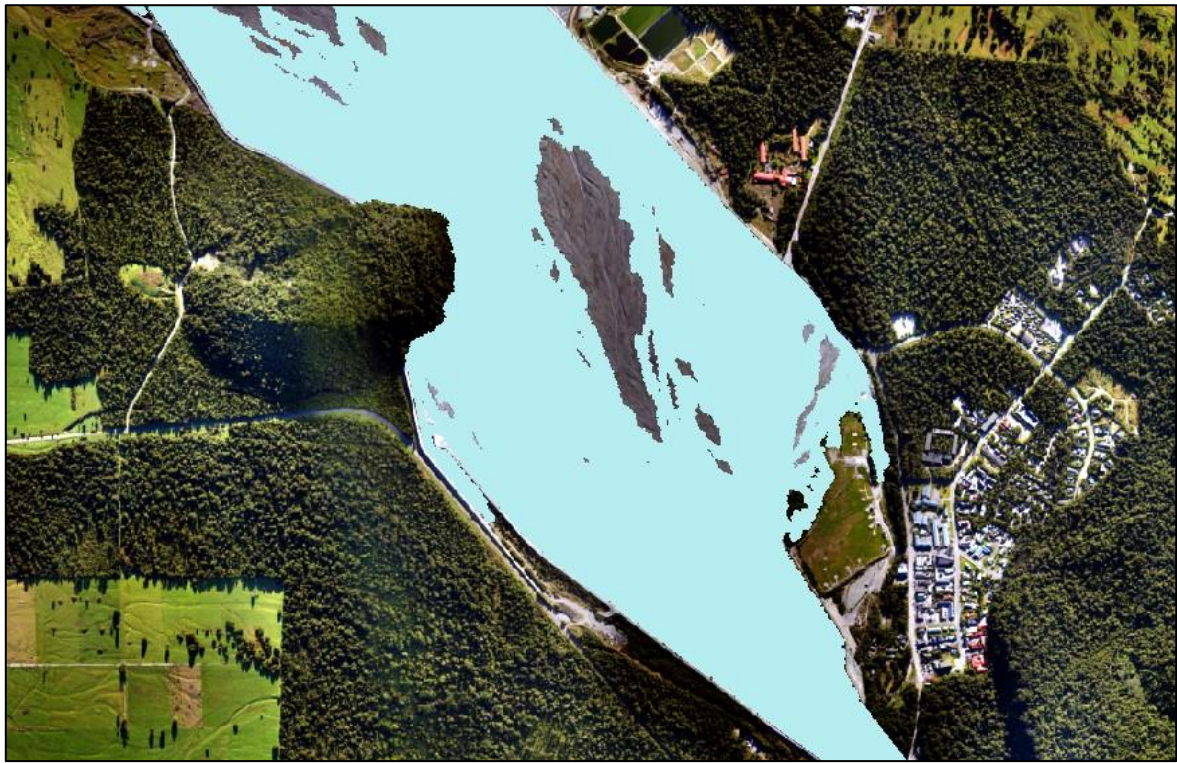
Figure 4-6 - 2021 hydraulic model base run (2500m³/s) using the 2023 LiDAR DEM.

An example of this can be seen in the Land River Sea Consulting hydraulic model results, which show how recent accumulation of sediment has formed an island in the middle of the river adjacent to the 55kph Corner/Havill's stopbank (Figure 4-6). As a result of this island, flow is diverted to the right, and forced up against the stopbank. It is likely that this island is causing the high water levels along the lower end of the 55kph Corner/Havill's stopbank and therefore the loss of freeboard discussed earlier. However, how the river will respond to this island to future flood events, is relatively uncertain as the hydraulic model uses a fixed bed, and therefore cannot account for the sediment movement that would normally take place during a flood event. It is worth noting though, that the March 2016 breach which saw the Scenic Circle Hotel flooded, occurred when the Waiho River was still confined within a single channel, but that channel was directed towards the 55kph Corner stopbank, forcing the water into it.

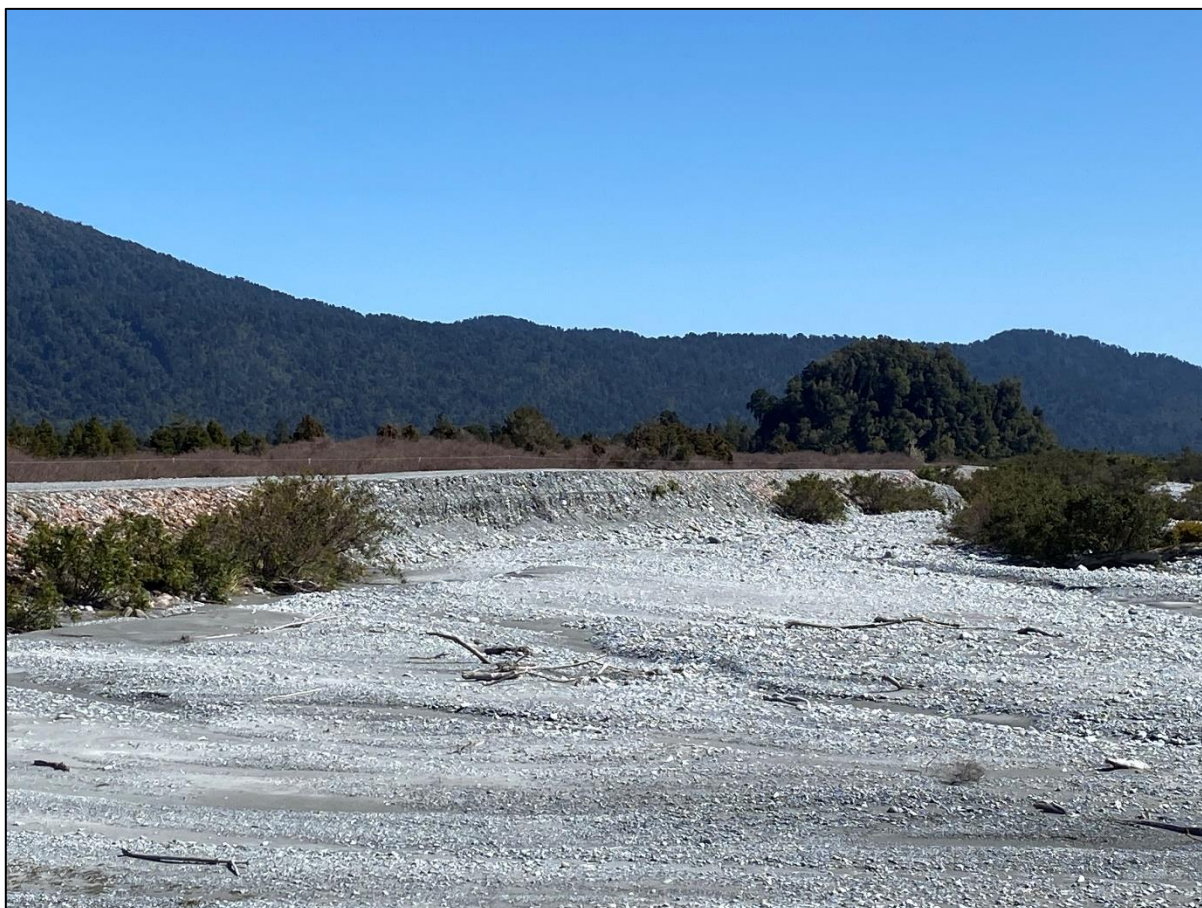
Figure 4-7 – Example of erosion on true left bank (photo taken in October 2022)

The main channel on occasion now runs alongside the gravel stopbanks between Canavan's Knob and Rata Knoll resulting in progressive erosion of sections of unlined bank which are very prone to failure. An example of recent erosion of the banks is shown in Figure 4-7. As a result of the threat to the stopbanks, there has been progressive lining with rock, resulting in a continuous rock lined wall that joins with the tightly confining Milton's stopbank.

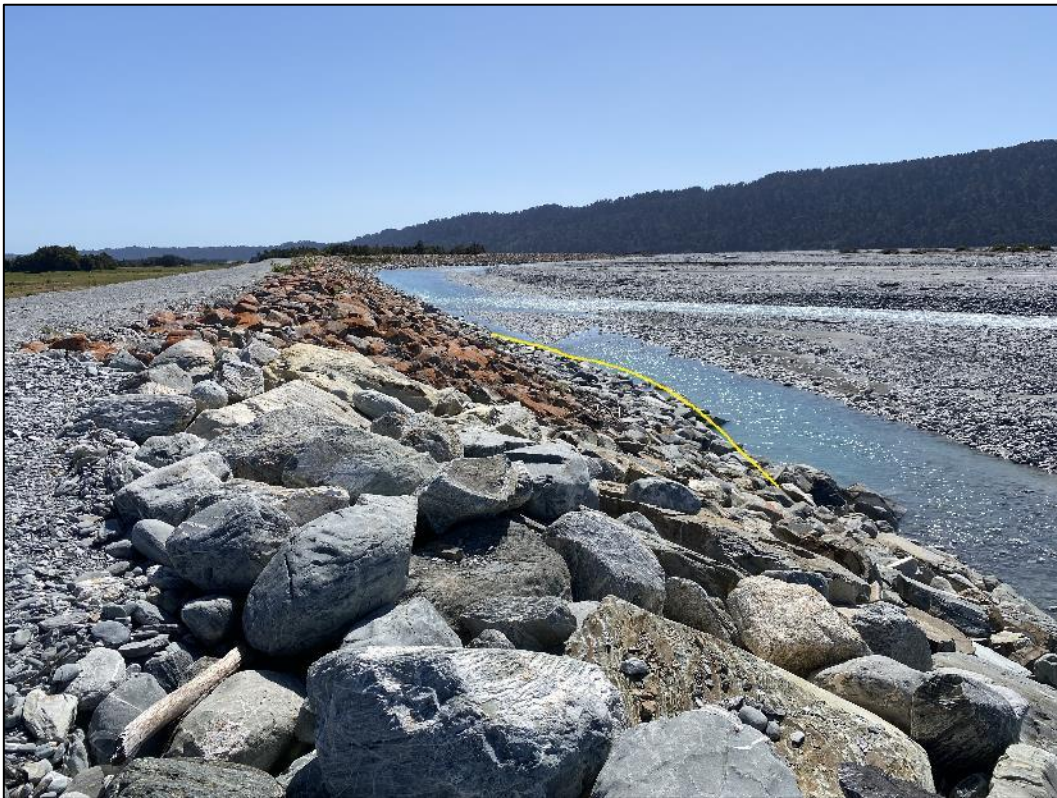
Figure 4-8 - Visible stopbank slumping (highlighted in yellow)

An example of relatively recent slumping on the Milton's stopbank is presented in Figure 4-8 where it can be clearly seen where the rock work is coming loose from the face and falling into the channel. This is likely a result of bed scour beneath the toe of the bank, and therefore the bank is settling into the scour hole and coming apart due to the nature of the rock placing.

This rock lining shows the disadvantages of a fixed rock lining, where bed scouring has given rise to (localised) dropouts of the lining rock, leaving a steep opened face, very vulnerable to direct damage from turbulent flood flows. While aggradation may cover over the lower parts of rock linings on the fan, the rock wall and the tight bend of Milton's stopbank are at risk of underscouring. Further, with the bend bar opposite Milton's stopbank building up, scour depths along the Milton's stopbank are likely to increase. Any scouring to the underside of the rock here will result in an immediate collapse of the stopbank, with a sudden release of floodwaters from a narrow channel carrying a substantial part of the flood flow. The failure and resulting flooding is likely to be catastrophic.

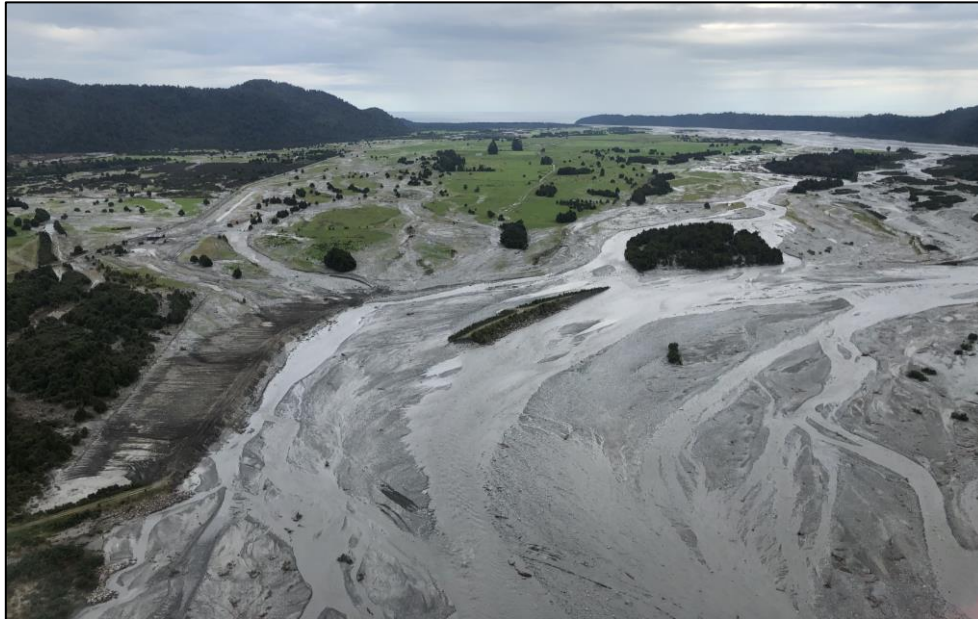
Figure 4-9 - Milton's stopbank breach location, and downstream inundation of farmland.

An incidence of such failure occurred in 2019 during the March flood which took out the SH6 bridge as well as breached Milton’s stopbank (Figure 4-9). Floodwaters from the breach destroyed the Franz Josef airstrip as well as a large area of farmed land (Figure 4-10).

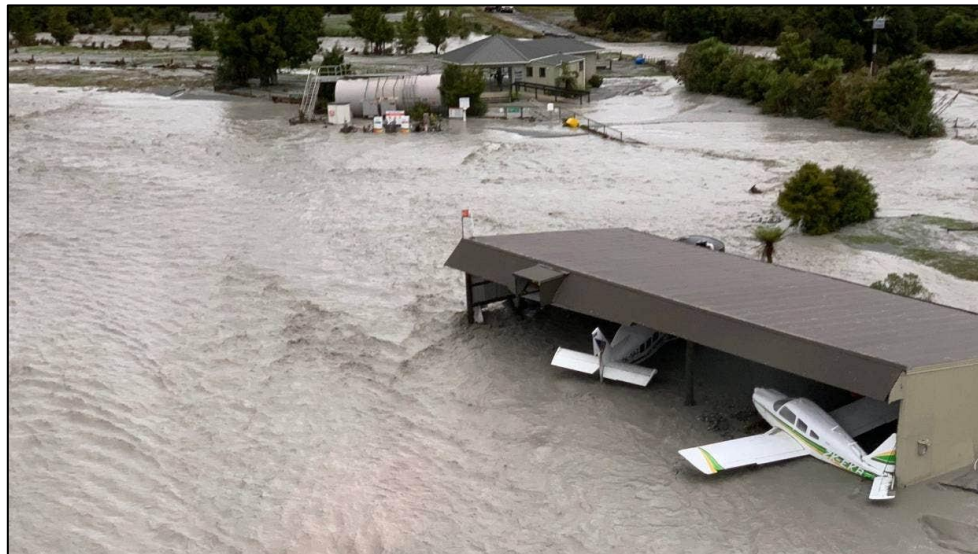
Figure 4-10 - Aerial image showing the flooding of the Franz Josef airstrip as a result of the Milton stopbank failure. Photo by Wayne Costello/DOC.

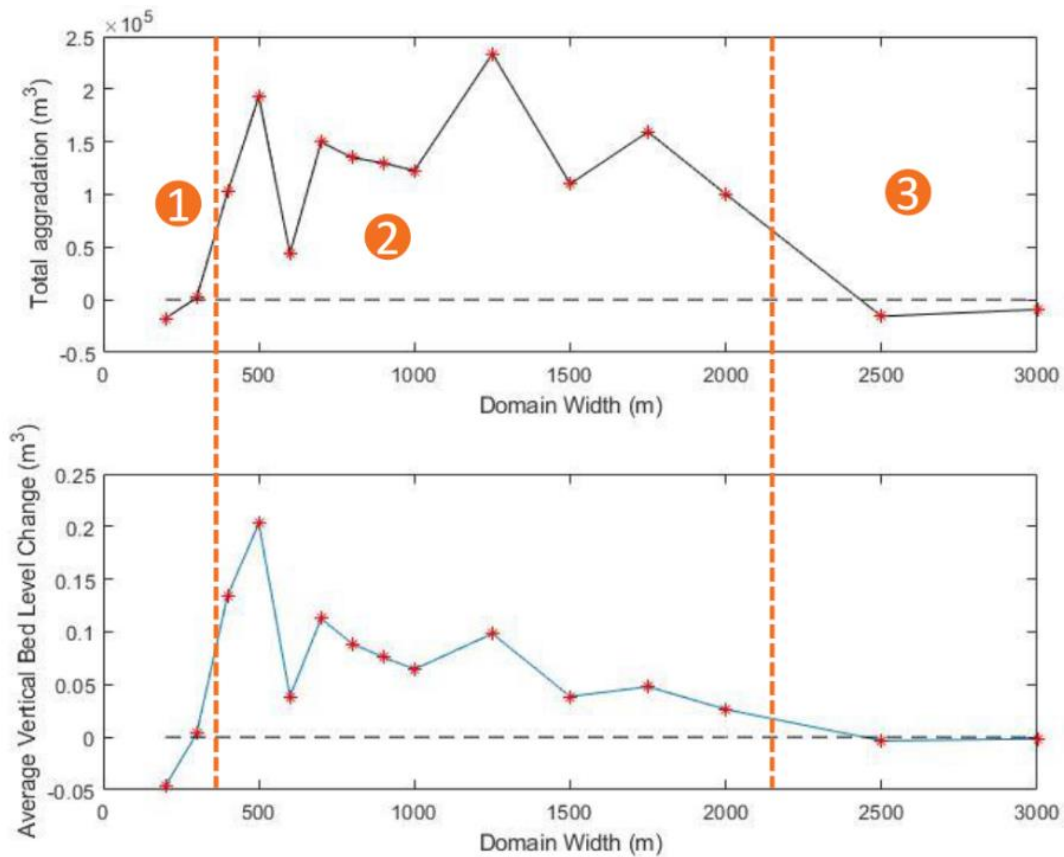
Figure 5-2 - Results from the different constant width experiments.

- The model showed that the widest widths (2500m and above) have higher transport rates and less aggradation. However, the modellers were uncertain as to whether or not the model was run long enough to fully develop the braided initial planform prior to starting the simulation.
