# Memorandum

Recipient Name: Tom Hopkins  
Recipient Organisation: West Coast Regional Council  
Issue Date: 29 July 2026  
Author: Rose Beagley

## SUBJECT: WAIHO RIVER – CHANGE ANALYSIS – JULY 2026 LIDAR

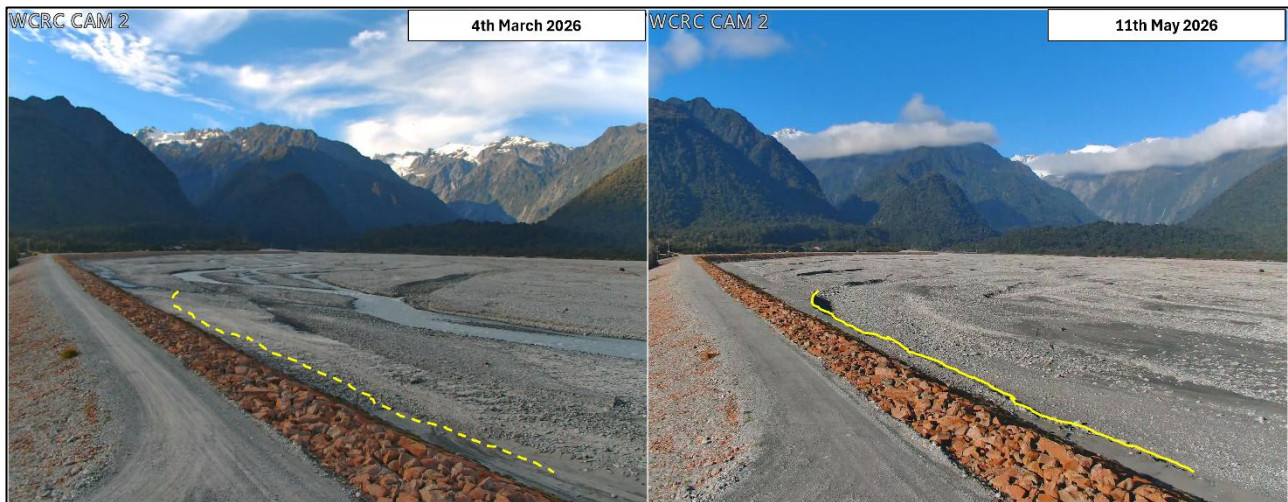
- The river cuts deeper along Havill's Wall during each of these flood events (Figure 7 and Figure 8).
- The bed has dropped by up to 3 m over the last four months (Figure 4).
- As of July 2026 the active channel has reached the stopbank along its middle section (photos b and c; Figure 8). At the upstream and downstream ends, 20 m to 50 m of bed remains between the active channel and the stopbank (photos a and d; Figure 9).
- The bed on the true right of the fan, between Canavan's Knob and the treatment ponds, is now lower than the bed on the true left. That difference will tend to draw more flow to the right, which would drive further erosion along Havill's Wall and into the higher bed area downstream of the ponds.

**Figure 8 - Lateral erosion at the upstream end of Havill's Wall over a two month period.**

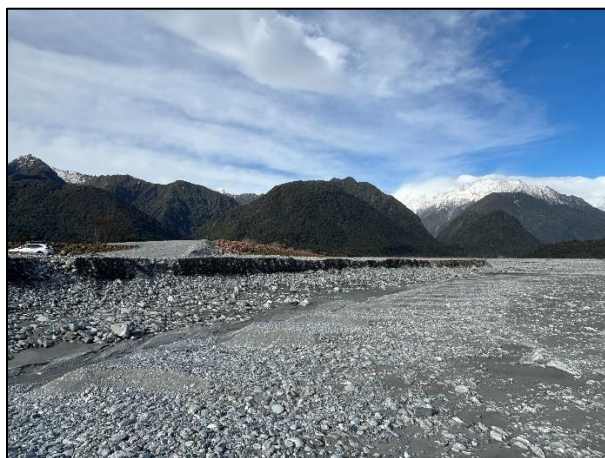
(a) Looking upstream at the end of Havill's Wall

**Figure 9 - Photos from the 6<sup>th</sup> July 2026 site visit (Ben Pasco, LRS).**

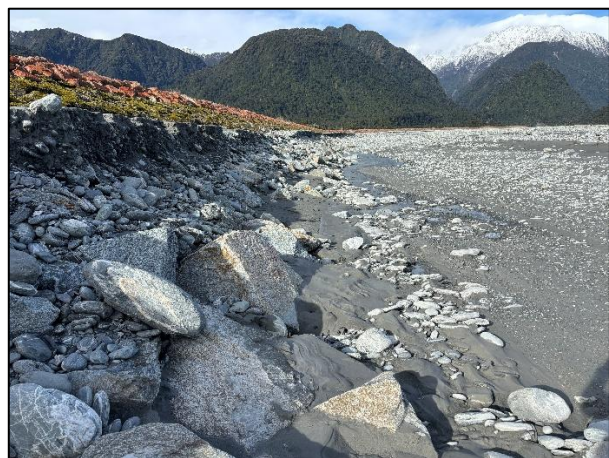
(b) Exposed stopbank toe at the downstream end of Havill's Wall.

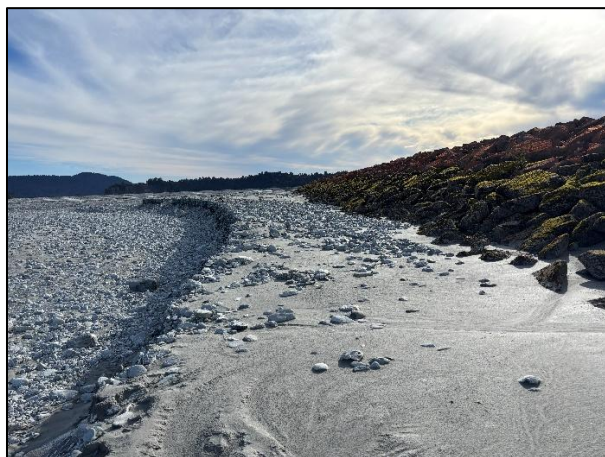
(c) 20 – 50 m buffer remaining between channel and a section of Havill's Wall

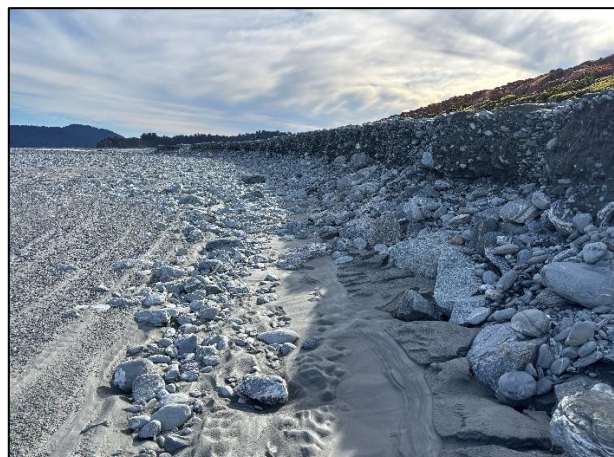
(d) Erosion along Havill's Wall.
