Mokihinui Township flood mitigation advice

Prepared for West Coast Regional Council

December 2023

NIWA CLIENT REPORT No: 2023182CH
Report date: December 2023
NIWA Project: ELF23502

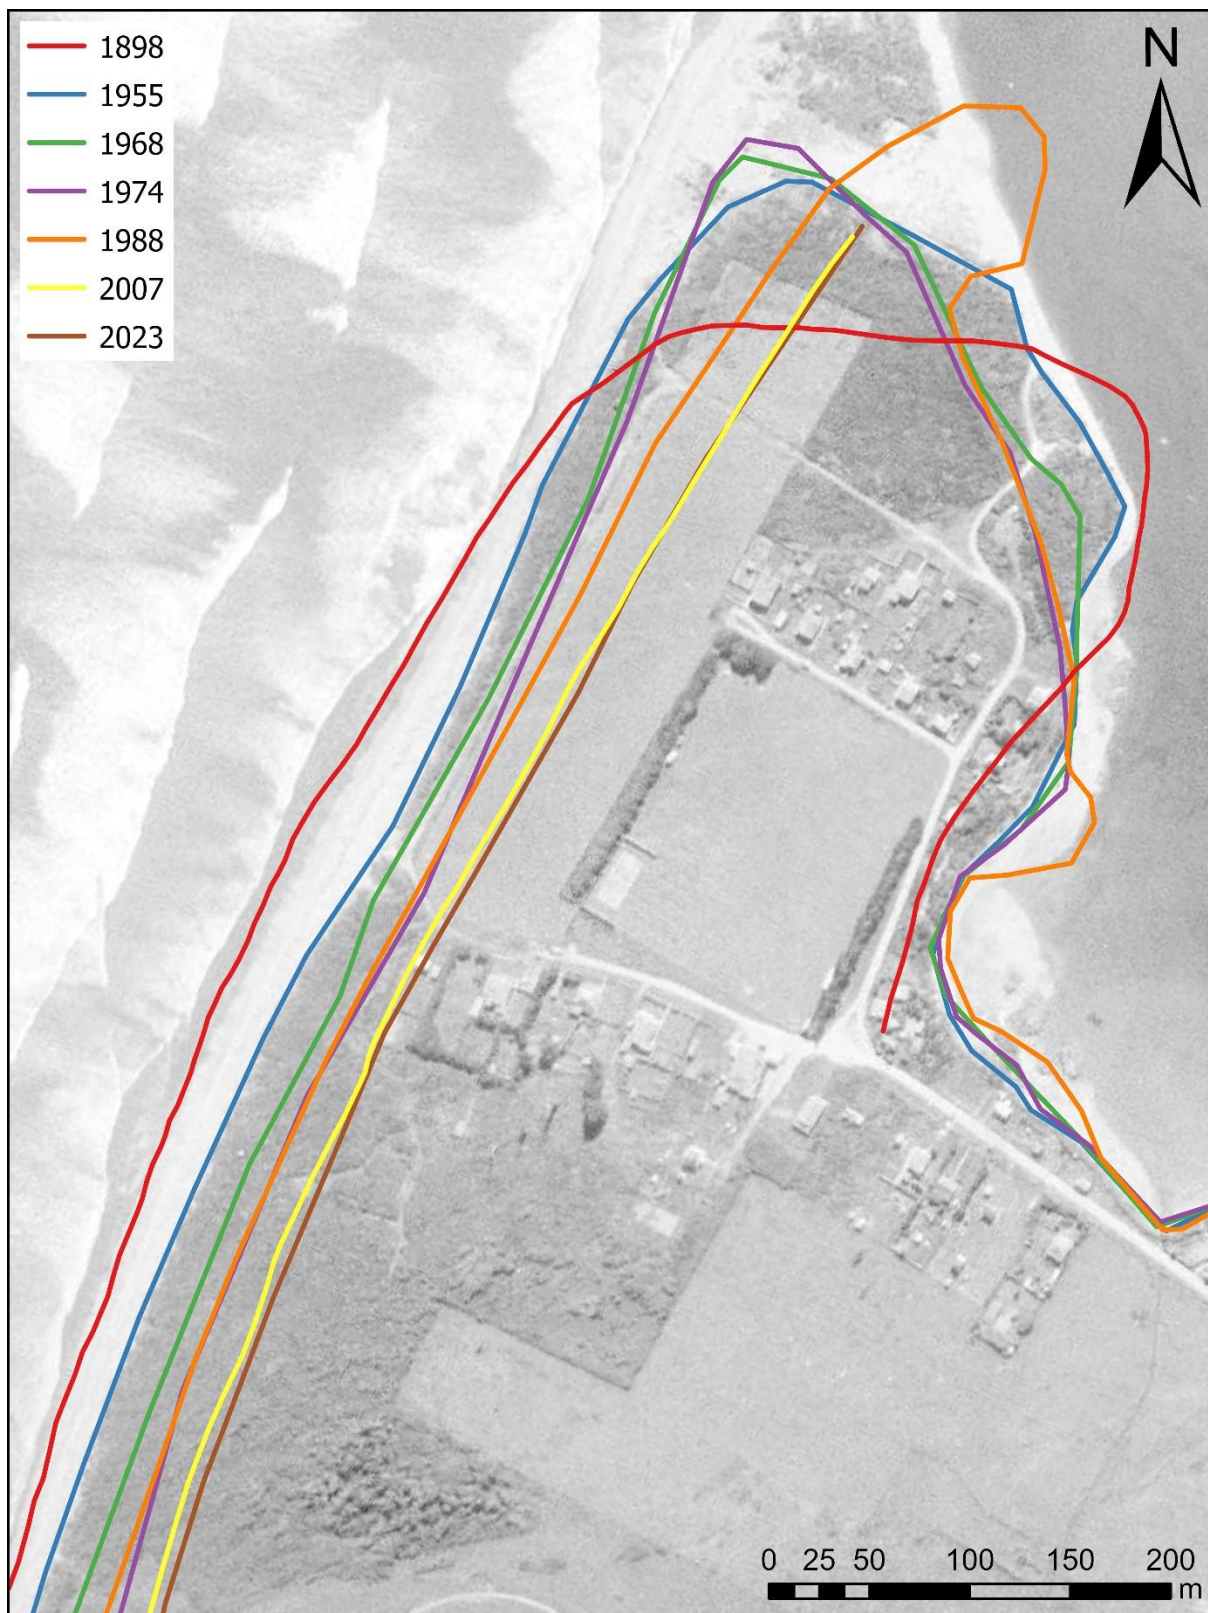
Figure 2-2: 1955 aerial photo of Mokihinui Township, showing selected historical shorelines. Figure uses some data from Hicks et al. 2007a.

For this report, the analysis of historic shoreline change by Hicks et al. (2007a) has been updated for changes over the period 2007 to 2023 (Figure 2-2). The analysis shows little new erosion at the north end of the sacrificial bund near the river mouth (less than 1 m erosion), with erosion increasing further south. Opposite Lewis Street, there has been approximately 5 m of erosion since 2007, and approximately 10 m at the southern end of the sacrificial bund. The average rate of erosion is approximately 0.5 m/yr over the full length of the bund. This rate of erosion is consistent with Hicks et al. (2007a), who found that the sacrificial bund slowed, but did not prevent, long term erosion. It is likely that the lower erosion rate at the north end of the bund is due to greater maintenance effort in this area, as well a higher concentration of the rock spur-groynes.

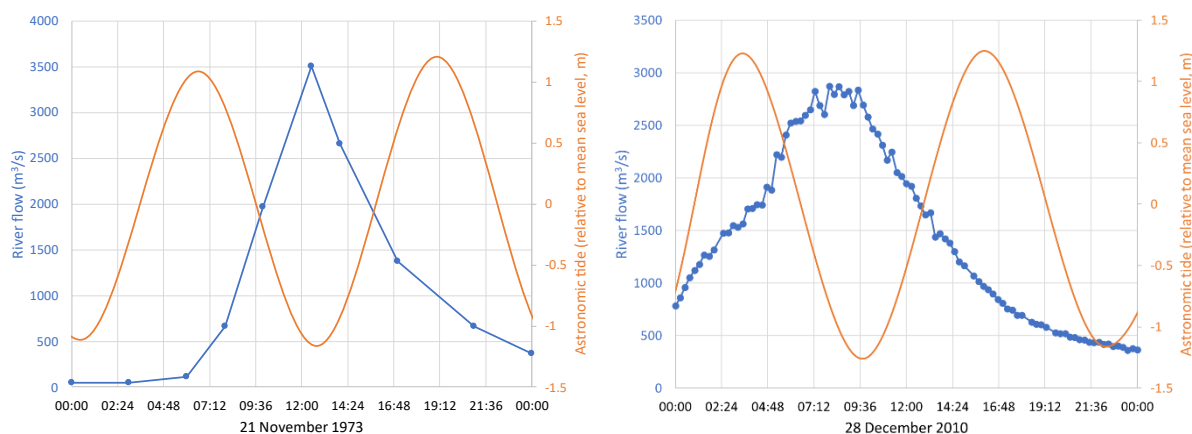
Figure 2-5: River flow hydrograph and tide level during the two largest Mokihinui River floods on record. Rivers flows recorded approximately 10 km upstream of Mokihinui Township, flood peak likely to reach township 1–2 hours after passing flow recorder. Astronomic tides from [NIWA Tide Forecaster](#).

Flood levels in the Mōkihinui River at the township occur due to a combination of river flow and tide/sea level, and are also influenced by the river mouth configuration. This differs from further upstream (e.g., in Seddonville) where there is no tidal influence and flooding is only dependent on river conditions. Figure 2-5 shows the timing of the flow peak relative to the tide for the 1973 and 2010 floods. It is notable that the timing of the flood peak for both the 1973 and 2010 events (at the flow recorder approximately 10 km upstream of the township) was around 1–3 hours before low tide, so the flood peak at the township likely coincided with relatively low sea levels. This suggests that flood levels during these events could have been 1–2 m higher if the timing had been different and the flow peak coincided with high tide.

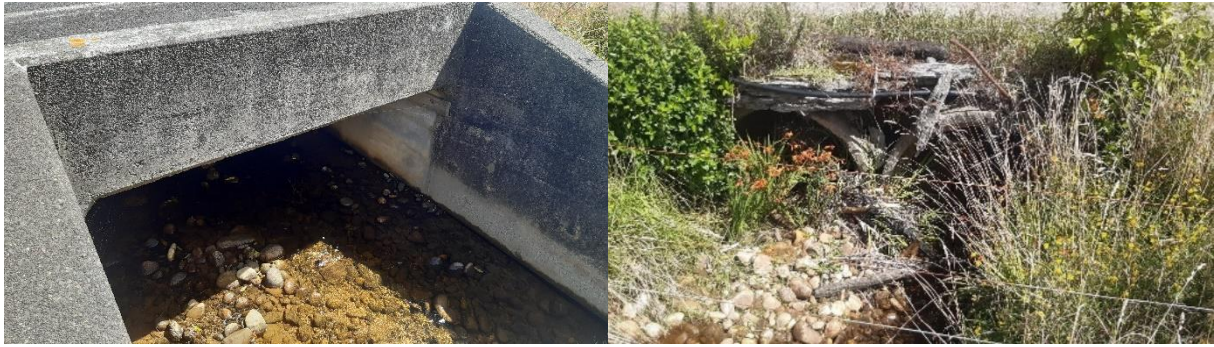
Figure 2-7: Culverts on Chatterbox Stream. Left photo: State highway bridge/culvert. Right photo: twin barrel farm culvert immediately downstream of highway. During the February 2022 flood, the farm culvert blocked and caused water to spill into the Township Catchment.

farm culvert on Chatterbox Stream blocked and caused water to spill into the Township Catchment, significantly increasing flooding in the township. Inspection of this twin barrel culvert showed that it had much smaller capacity, and greater likelihood of snagging debris, than the culvert immediately upstream under the state highway (Figure 2-7). Brewery Stream flows similarly close to the Township Catchment and any blockage could cause similar issues, although there are no records of this being an issue in past floods.

Another issue during the February 2022 flood was the farm culvert on Chatterbox Stream located downstream of the highway bridge (Figure 2-7). This culvert remains highly vulnerable to debris blockage which can then divert water from Chatterbox Stream towards the township. Modifying this culvert to mitigate this risk is recommended. Modifications could include one or more of:

- Replacement of the existing twin culvert with a larger single culvert more able to pass debris (similar to the highway culvert upstream).
- Replacement of the culvert with an appropriately designed ford.
- Removal of the culvert (i.e., no crossing point over the stream, alternative routes used to access land either side).
- Moving the culvert downstream to a location where blockage is less likely to divert water into the Township Catchment.
- Increasing bank height on the true right to prevent spill into the Township Catchment (blocking the low spot/drainage channel on the true right of Chatterbox Stream between the highway and farm culverts).

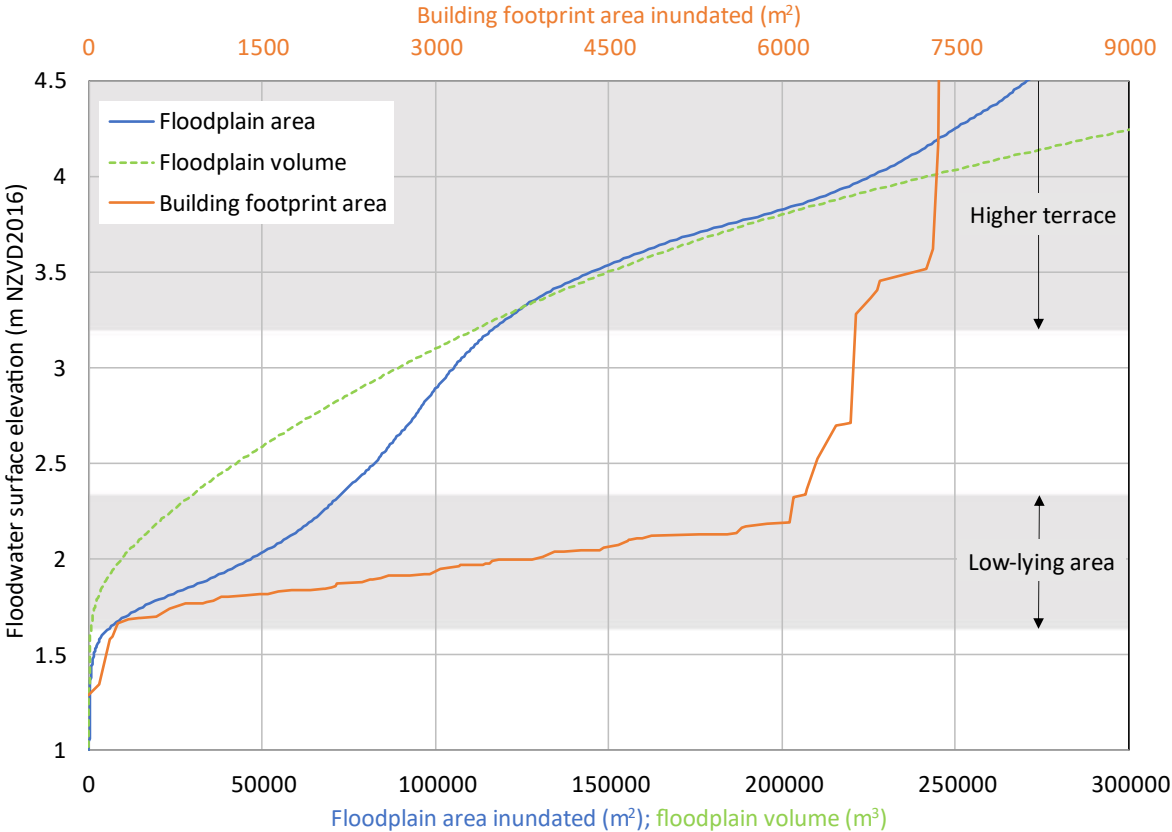
Figure 3-2: Relationship between flood volume, floodwater elevation, and building footprint area inundated. No data is available on building floor levels so building footprint elevations are simply taken from surrounding ground elevations.

The LiDAR data provides information on the extent of land and buildings which would be flooded by different volumes of floodwater pooling behind the stopbanks (Figure 3-2). This plot shows that the land around buildings in the township starts to be flooded once water levels reach approximately 1.7 m NZVD2016, and land around the majority of the buildings in the township is flooded by floodwater levels of approximately 2.2 m. A flood level of 2.2 m corresponds to a total floodwater volume of 27,000 m³ behind the stopbanks. This is equivalent to 19 mm of rain across the 144-ha Township Catchment, a volume of rain which fell in less than 1 hour during the February 2022 flood event (Figure 2-8).
