AGENDA AND SUPPORTING PAPERS FOR COUNCIL'S JUNE MEETINGS

TUESDAY, 13 JUNE 2017

This report has been prepared for West Coast Regional Council (WCRC) to aid the decision-making processes associated with management of Cobden Beach. The investigations undertaken as part of this assessment includes a site visit, review of aerial photographs and recent literature. WCRC requested advice on 1) the likely implications of recent in-situ coastal protection works, and 2) recommendations for effective and feasible options that allow long-term management and protection of infrastructure and properties along the Cobden Beach foreshore.

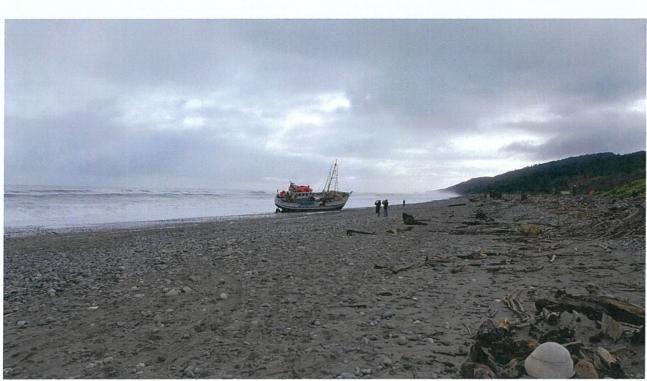
Photograph 1: Morning of the incident taken around 08.30.

Sea conditions were reported as being calm at the time of the grounding and remained so when the incoming tide peaked at 1:30pm, therefore the boat did not breakup and remained intact.

The boat was assessed by the insurance company who determined that due to structural damage it could not be refloated. The boat has now been pulled further up the beach above the high tide area where it is in the process of being deconstructed in situ and taken away by trucks.

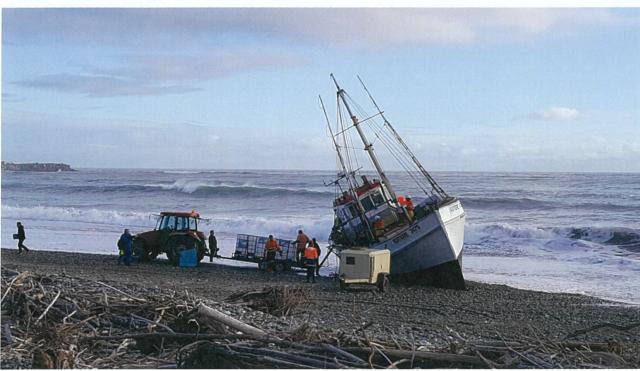
Photograph 2: Recovering the fuel from the Kutere into 1000 litre pods.

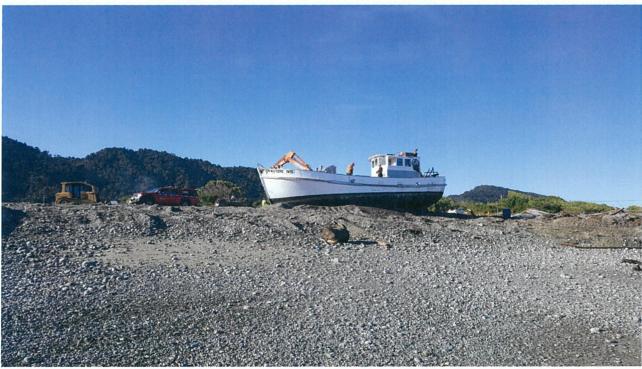
Photograph 4: The Kutere pulled up the beach above the high tide line where it will be dismantled and trucked away.

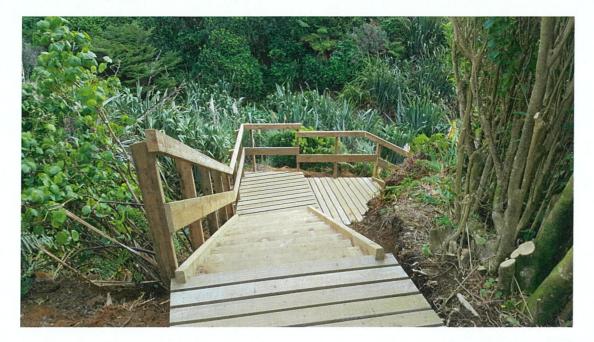
Photograph 3: Wooden staircase installed down to the beach replacing the previous arrangement

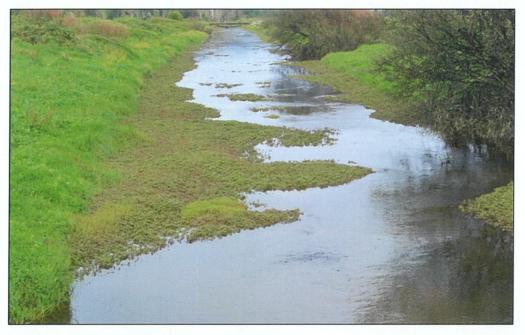
Contour Channel, looking upstream prior to the clean-out

Significant weed build-up in the Contour Channel (Blackwater Drain) in the Kongahu Swamp was restricting flow out to Granite Creek. SM Lowe Contracting Ltd removed the weed up to the cattle bridge on the western side, and half-way up the eastern side (access is restricted along this bank). The works were undertaken for \$402.50 (2.5 hours).

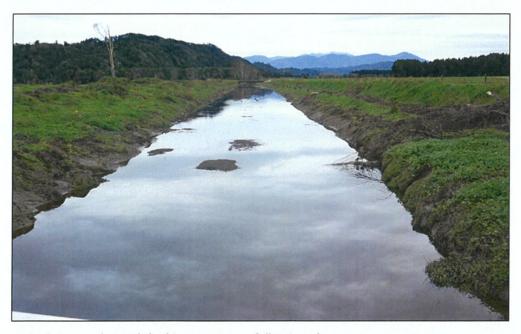
Contour channel, looking upstream following clean-out.

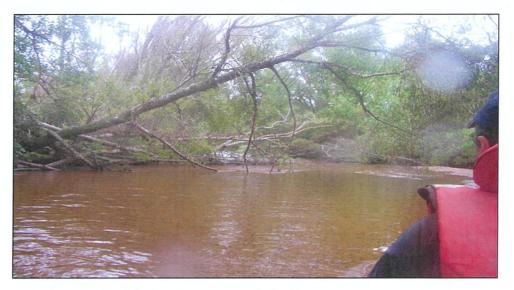
Granite Creek bed, prior to removal of willows.

During April 2017, on behalf of the Karamea Rating District, SM Lowe Contracting Ltd removed willows along the banks of Granite Creek from above the Blackwater Drain Bridge (Contour Channel outlet) to approximately 1.5km upstream. The willows were growing out into the channel and were holding up sediment, and causing an increase in flood heights. The willows below the Contour Channel outlet were cleaned out in November 2015.

The willows were first cut off at the base, then an excavator was used to drag the tops out and placed in several stockpile areas back from the creek. The work was completed, as per the quote, for \$6,315(GST exclusive).

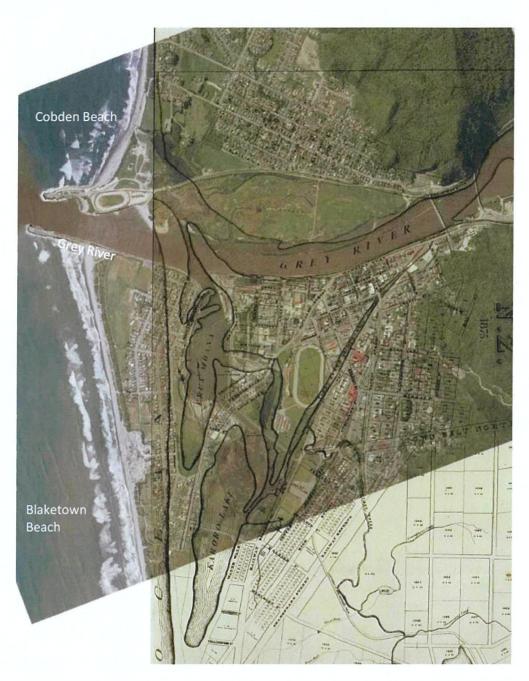
Figure 2-2: Changes to the coastline at Greymouth 1875-2014. [Credit: West Coast New Zealand History¹].

The Grey River training works, constructed over 100 years ago, extend approximately 1 km from the 1884 shoreline (see Figure 2-2), and they significantly altered the coastline by modifying sediment supply to the adjacent beaches. To the south of the river (Blaketown and South Beach), since constructed massive accretion occurred as the northerly littoral drift was trapped against the river training works. Conversely, to the north of the river at Cobden, significant historical erosion occurred as the beach was starved of the sediment that had been trapped on the south side of the river training works (Gibb 1978, Pfahlert 1984, Benn & Todd 2003).

Mapping of the coastline position from aerial photographs and cadastral maps showed that from 1884 to 1981 Blaketown beach prograded (advanced seaward) about 300 m at a rate of 2.9 m/year, while the southern part of Cobden Beach retreated about 130 m at a rate of 1.35 m/year (Pfahlert 1984).

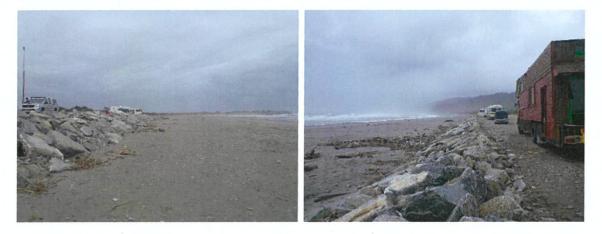
Figure 2-3: Jellyman Park rock protection and beach front. Left: view south to tiphead from northern end of structure. Right: view north towards Point Elizabeth from southern end of structure. [21 Nov 2016. *Credit*: M. Allis (L), M. Hicks (R)].

The carpark occupies the broad crest of the beach, with the car park surface approximately 1.5 m above the beach level (Figure 2-3). The seaward edge of the carpark is protected by a rock revetment composed of small-medium granite rocks (0.3-0.7 m diameter) at a slope of 1:1.5 to 1:2. We understand that the rocks were added when the carpark was resized in 2015, resulting in the seaward edge of the carpark being pushed further over the beach. No geotextile underlay is apparent beneath the rocks. The crest of the revetment is only one rock wide (0.5 m), and it sits nearly flush with the carpark elevation (Figure 2-3). The carpark now protrudes onto the active beach face 3-5 m from the adjacent vegetation lines and adjacent beach crest. There is no vegetation on the beach in front of the carpark. The seaward edge of the carpark has been repaired several times after storm erosion has undermined the rubble revetment (pers. comm. P. Birchfield). The carpark remains a popular overnight stop for freedom campers.

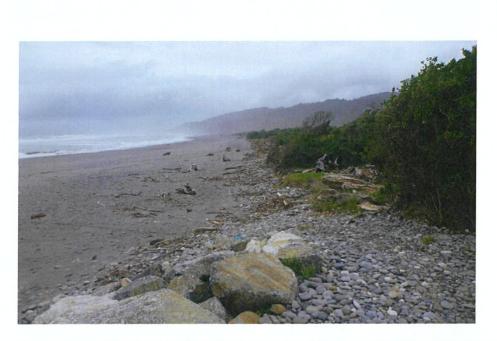
Figure 2-4: Cobden Beach at 0.6 km from the tiphead, (at carpark), looking north towards Point Elizabeth. Note vehicle tracks past the end of carpark protection rocks [Credit: M. Hicks, 22/11/2017].

To the north and south of the carpark, the beach shows evidence of wave/gravel overwash and vegetation dieback. Immediately north of the carpark, retreat of the beach crest has caused vegetation dieback (gorse/flax, see Figure 2-5). This retreat is likely due to overwashing events, with overwashed gravels reaching 5 m inland from the beach face and up to 10 m inland at access paths. There is also vehicle access at the northern end of the carpark structure, with wheel rut disturbances to sediment and vegetation (Figure 2-4).

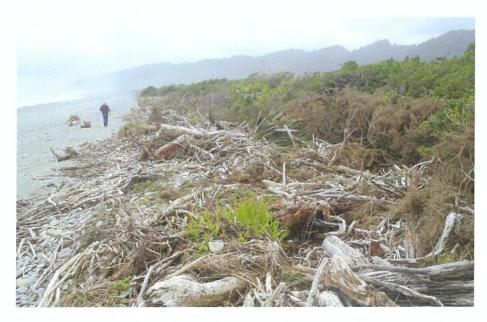
Figure 2-5: Cobden Beach at 0.7 km from the tiphead (100 m north of carpark), looking north toward Point Elizabeth. [*Credit*: M. Allis, 22/11/2017].

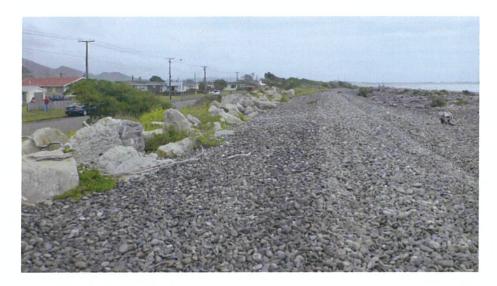
Figure 2-6: Cobden Beach at 1.4 km from the tiphead (opposite Monro Road) looking south. Note darkgrey lichen growth on gravel outside vehicle tracks, and note historic rock protection alongside roadway [Credit: M. Hicks, 22/11/2017].

Closer to Monro Road, there are historic protection works alongside North Beach Road (Figure 2-6), however, these have been buried by more recent accretion and growth of the beach. At present, the inner gravel is elevated 1.5-2 m above the roadway, with one or two storm-berms (terrace-like ridges parallel to the shoreline). Vegetation and lichen (slight discoloration on gravel) have colonised the gravel berms (Figure 2-6), suggesting that these gravels have not been re-worked for over 30 years (other than vehicle and foot traffic – see Figure 2-6).

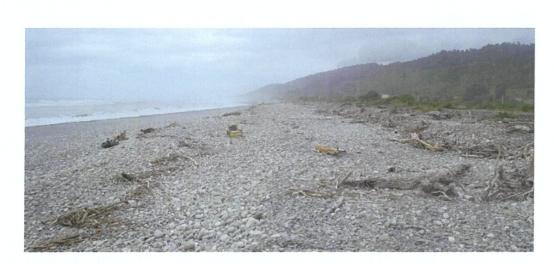
Figure 2-7: Cobden Beach at 1.4 km from tiphead (opposite Monro Road) looking north towards Point Elizabeth. [*Credit*: M. Allis, 22/11/2017].

This section of the beach typically has three storm-berms (terrace-like ridges parallel to the shoreline). Collectively, these ridges represent a recent accretionary phase, with sufficient sediment available to create a berm during storms and then to build-out the beach face during benign conditions. A fourth berm may be forming at present. Stranded driftwood, lichen growth and advancing vegetation all indicate that this accretionary phase has been of the order of 30 years or more.

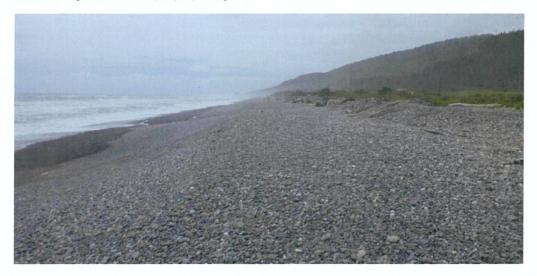
Figure 2-8: Cobden Beach at 2.9 km from tiphead (opposite 162 North Beach Road) looking north towards Point Elizabeth. [*Credit*: M. Hicks, 22/11/2017].

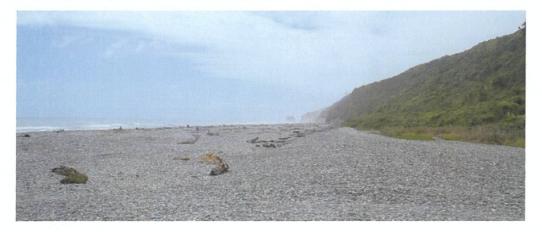
Figure 2-9:Cobden Beach at 5 km from tiphead (end of North Beach Road) looking north towards PointElizabeth.[Credit: M. Allis, 22/11/2017].

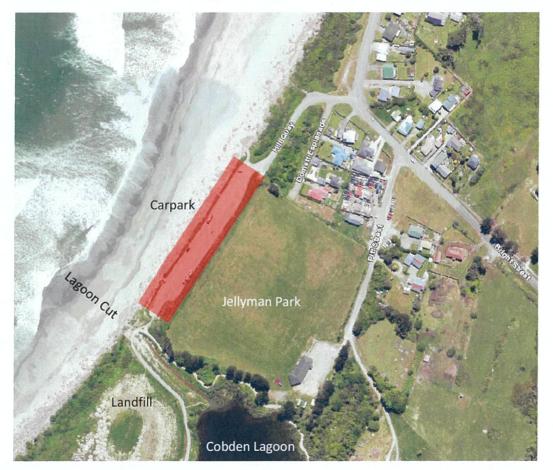
Figure 3-1: Jellyman Park, Cobden. Background photograph dated 2013. [Credit: WCRC Westmaps].

The Jellyman Park carpark (Hill Quay) occupies the seaward edge of Jellyman Park, as shown in Figure 3-1 (red shading). The carpark acts as both a vehicle carpark, freedom camping site, and coastal defence for the Cobden community and Jellyman reserve. The carpark stretches approximately 200 m along the shoreline between from Cobden Cut (a mechanically-managed channel for drainage of the Cobden Lagoon during high rainfall or river floods) and connects to Hill Quay.

We understand the carpark was previously² a narrow gravel extension to Domett Esplanade positioned on the vegetated gravel barrier. This has been gradually enlarged, with the vegetation lost (either through vehicular trampling or deliberate removal)³ so the gravel barrier berm no-longer had the capacity to accommodate natural fluctuations in shoreline position due to storm events. We understand that the seaward rock protection was added when the carpark was resized in 2015.

The carpark runs parallel along the top of the beach crest and protrudes onto the active beach face 3-5 m further than the adjacent beach crest and vegetation lines to the immediate north and south. Wave action appears to reach the base of the carpark revetment on most high tides.

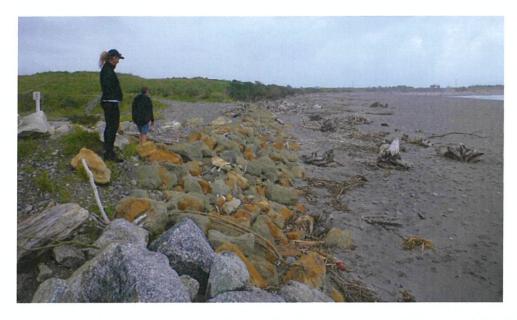
Figure 3-2: Rock extension south of the carpark to protect the Lagoon Cut entrance. [Credit: M. Hicks, 21/11/2017].

- To the south of the carpark structure, the edge effects are less pronounced, perhaps due to increased wave sheltering from the tiphead. However, GDC have extended the rock protection at the Lagoon Cut (Figure 3-2) to prevent waves eroding the cut and entering the lagoon (pers. comm. P. Birchfield). The rock protection has a slope from 1:1.5 to 1:2 and is comprised of small (<0.4 m diameter) rocks.</p>

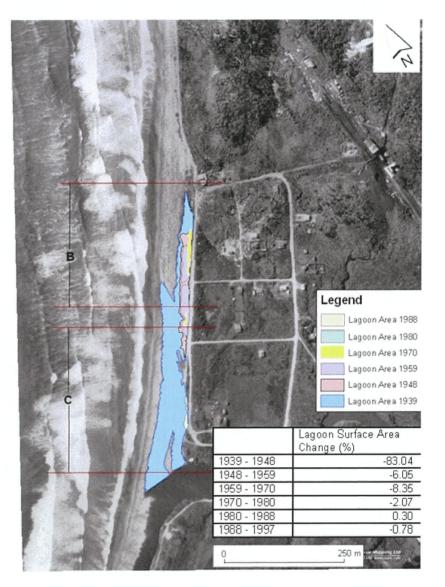
Figure 2-1: Historic hāpua extents and historic aerial photograph (1939). [*Credit*: NZ Aerial Mapping Ltd, Ishikawa (2008, Figure 3.9)].

This information shows that the present-day erosion issue has a longer recorded timeline than previously summarised in the 2006 report. The former hāpua acted as a buffer between the sea and the village. The retreat of the vegetation line (inferred to be the landward berm beneath Beach Road and the present-day shoreline) has been slower but steady at 0.3 m/year since 1959. It is this ongoing retreat which is causing the heightened risk to property by reducing the buffer between the sea and development.

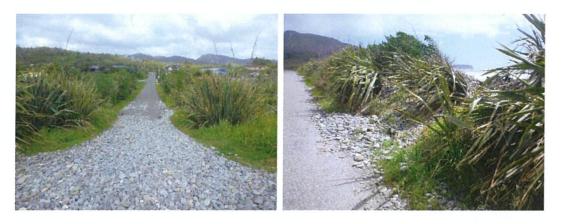
Figure 3-2: Continued overwash deposits onto Morpeth St (left) and Beach Rd near Statham St (right). [Credit: M. Hicks].

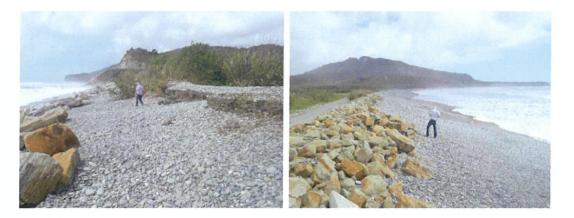
Figure 3-3: Continued erosion behind the rock revetment along the former Beach Rd between Morpeth St and Holland St (left) and recent protection works alongside Beach Rd south from Statham St (Right). Left: note former Beach Rd tar seal and basecourse layers at right of image. [*Credit*: M. Allis].

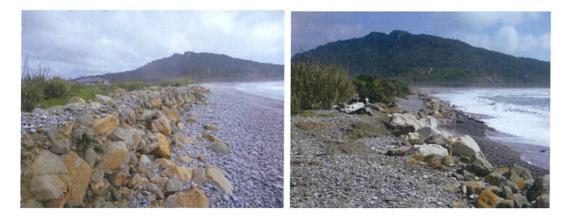
Figure 3-4: Continued beach retreat against rock berm (left) and along the entire foreshore (right). [Credit: M. Hicks].

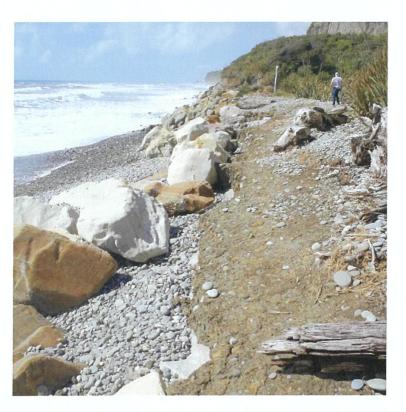
Figure 3-5: Current condition (21 November 2016) of the northern end of the rock revetment. [*Credit*: M. M. Allis].

- Erosion of the bluff is due to both the gradual loss of protection provided by the beach material fronting the bluff and the undermining and slumping of the larger rocks in the revetment which decreases the level of protection to the bluff behind.

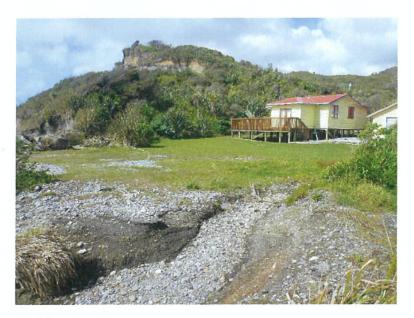
Figure 3-6: Relocated Forbes house, Holland St. Former foundations and driveway are just visible 20-25 m seaward (left) from house [*Credit*: M. Hicks].

- The Forbes house and garage at the far northern end of Rapahoe beach front (unnumbered, on Holland Street, see Figure 3-1) have been relocated 20-25 m inland on the same section in response to the ongoing erosion threat. The former foundations and driveway have since been partially lost to erosion. Large (>1m diameter) boulders have been placed along the beach front linking to the NZTA protection of the northern Rapahoe bluffs (Figure 3-6).
