Report to: West Coast Regional Council	Meeting Date: 3 May 2022 Extraordinary Meeting
Title of Item: Retrospective flood protection maintenance works	
Report by: John Hutchings, Matt Gardner, Gary Williams, and Paulette Birchfield	
Reviewed by: Heather Mabin, Chief Executive	
Public excluded? No

O'Connor Rest Home Bank Erosion Retrospective Maintenance Works

Organ's Island Rockwall Realignment to Overcome Erosion Scour Damage

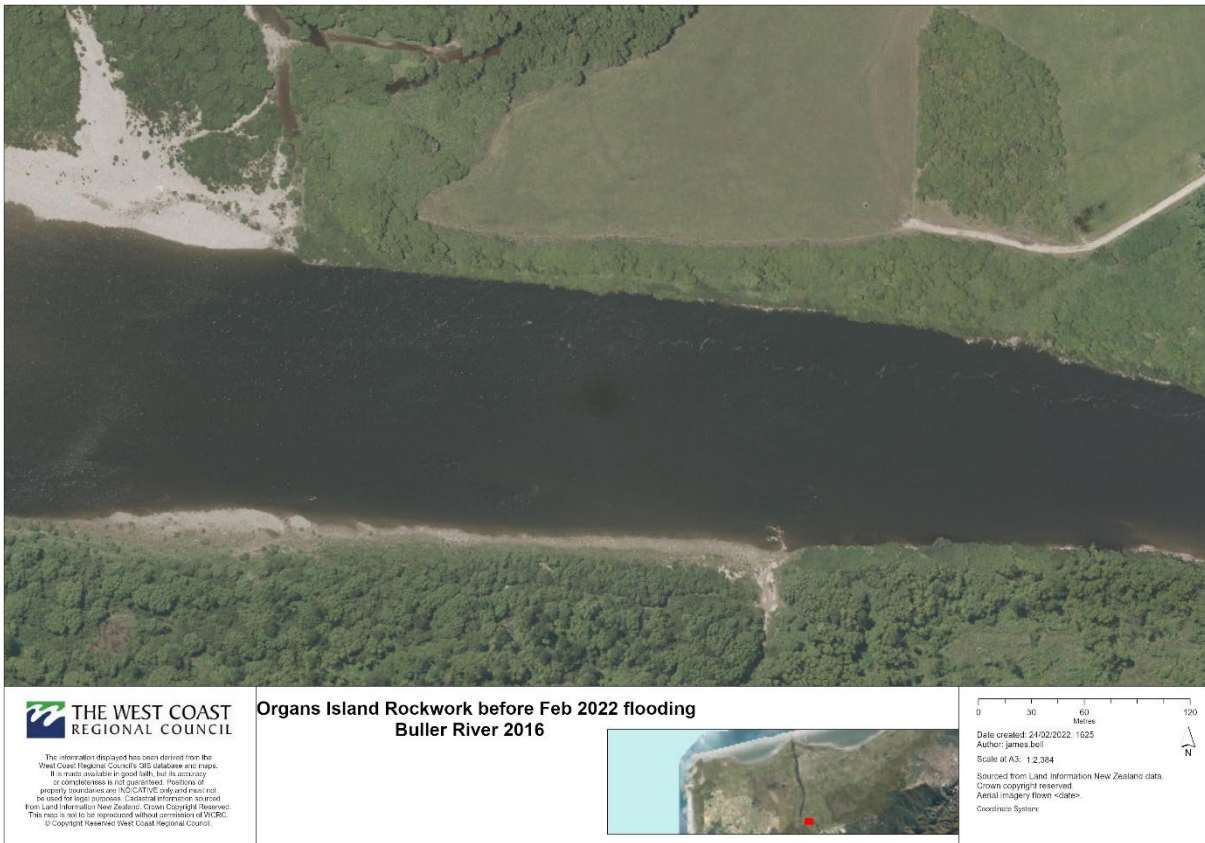
Figure 5: 2016 aerial view of riverbank at Organ's Island.

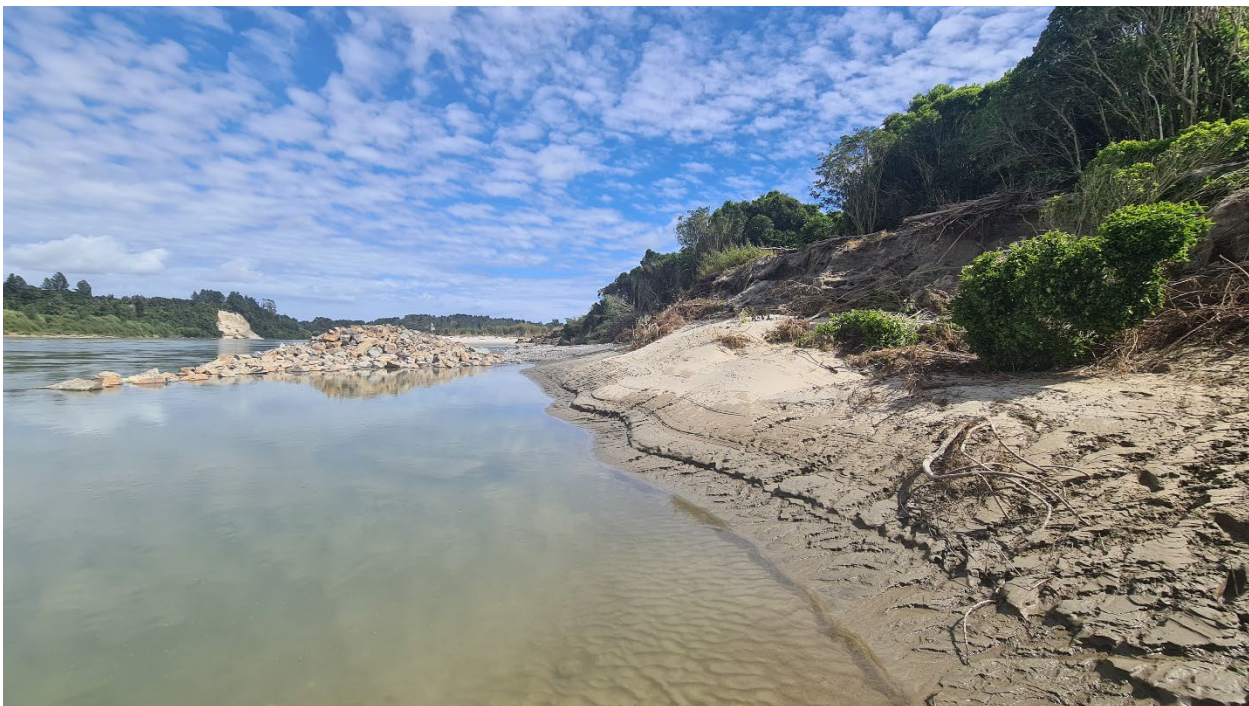
Figure 7: Looking downstream showing erosion of bank and scour behind rock training wall

Consultant engineer Gary Williams and the TAG recommend the now deteriorated Organ's Island Rock-wall be moved back to a new alignment and fortified with new rock armour, and two spur structures to deflect flow. As noted previously, the estimated cost of this work is \$1,701,762.
