Managing and adapting to coastal erosion at Carters Beach

2017 review and update

Prepared for West Coast Regional Council

NIWA CLIENT REPORT No: 2017119HN Report date: June 2017 NIWA Project: ELF17209

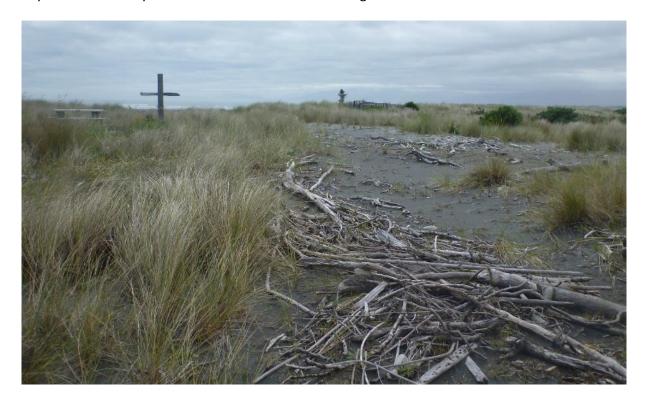
Figure 2-2: Stranded debris within vegetated backshore area, typical of Buller Bay west of Bulls Road. View north (seaward) from 50 m from active beach face. Access from Farm Track 1.4 km east from Larsen Street. [*Credit*: M. Hicks, 23/11/2016].

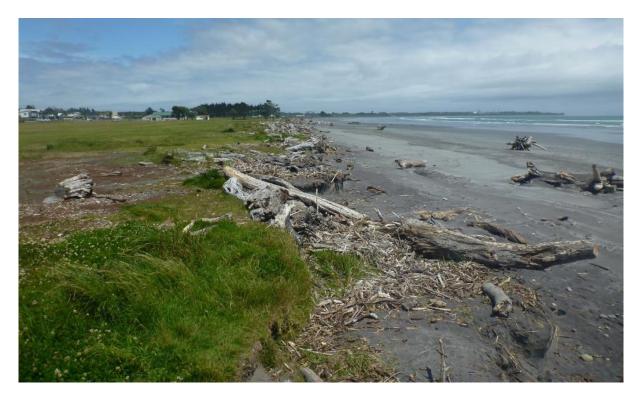
Figure 2-3: Evidence of coastal retreat at Carters Beach foreshore. Accessed at Golf Links Road. [*Credit*: M. Hicks, 23/11/2016].

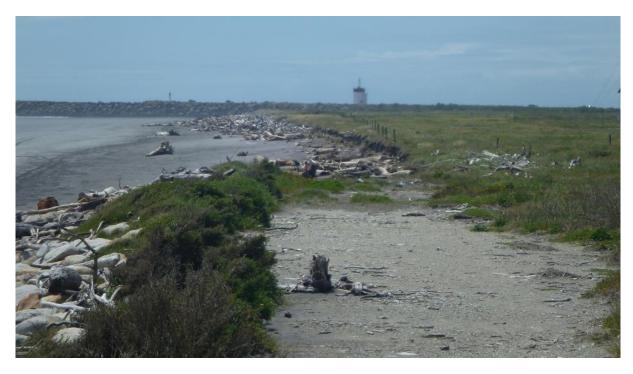
Figure 2-4: Erosion notch outflanking eastern end of airport revetment. Access from Rotary Road. [*Credit*: M. Hicks, 23/11/2016].

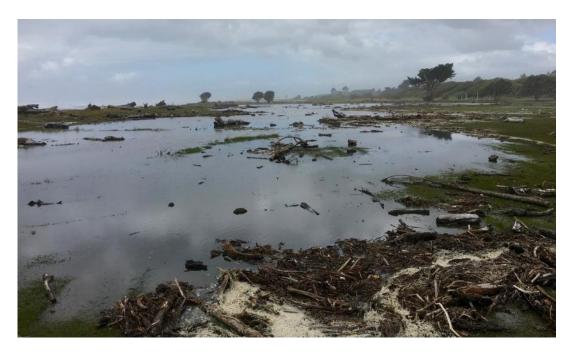
The community has regularly documented coastline changes along the Carters Beach shoreline by measuring the retreat rate and photographing the erosion events. Several times between November 2016 and April 2017, waves have spilled over the beach crest, depositing swathes of driftwood debris and causing sea water to locally pond in areas 10-30 m inland from the beach crest (Figure 2-5). An exceptional wave event was reported to cause water to rush across much of the domain reserve¹, ponding in the low-lying areas next to Marine Parade, as seen in Figure 2-6.

Figure 2-5: Debris and ponding in the Carters Beach domain reserve after 16 January 2017 wave overtopping event. [Credit: C. Cooper, 16/01/2017].

As seen in the January 2017 wave event (Figure 2-5, Figure 2-6 and reported in the media⁶), there is a public safety risk from waves overtopping the beach crest and casting logs and other debris into the domain reserve area. The principle cause of the wave overtopping hazard in the domain is absence of a dune system on the foreshore to restrict the wave runup and overtopping flows. Note that these overwashing events are part of the natural land-building process through the deposition of sediment on the backshore which builds up hinterland elevation.

A small vegetated dune set back from the beach face will mitigate the wave overtopping hazard and restrict water and debris from spreading inland. Such a dune is not anticipated to address the erosion hazard, being designed principally to mitigate the overtopping hazard (although, it will act as a small buffer from erosion should the erosion reach it). Figure 4-4 indicates the scale and position of this feature.

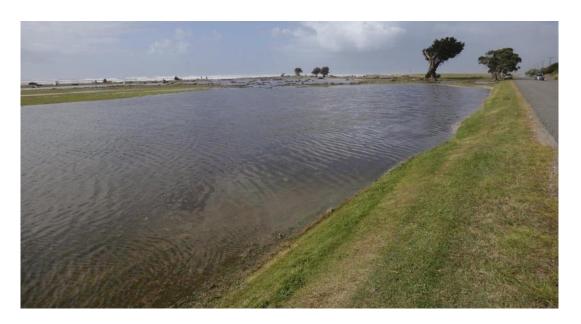
Figure 2-6: Sea water ponding in the Carters Beach domain reserve after 16 January 2017 wave overtopping event. Note Marine Parade at right. [*Credit*: C. Cooper, 16/01/2017].

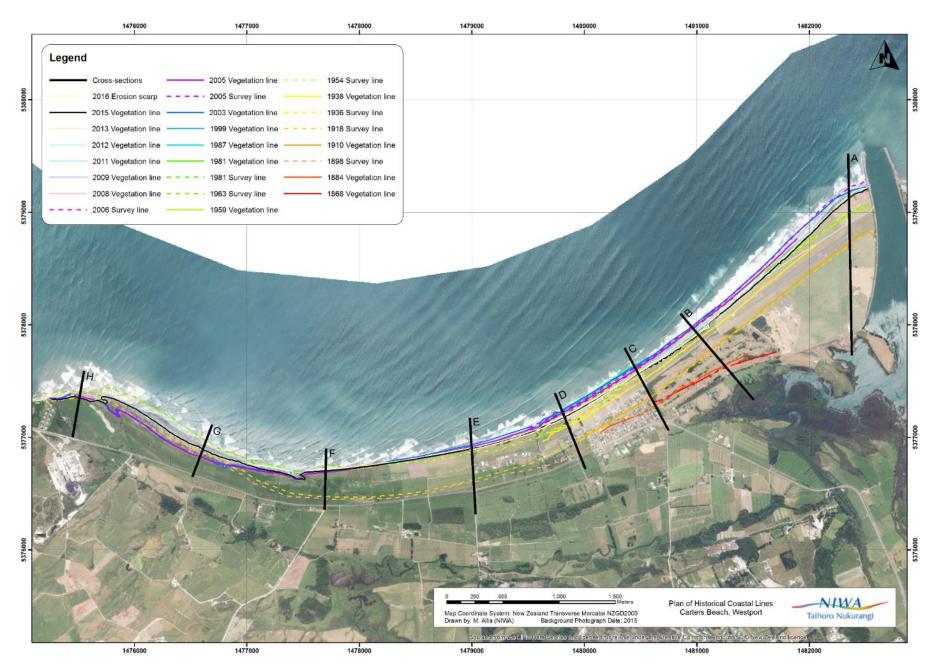
Figure 3-1: Carters Beach historical shoreline positions. Bold black lines (A-H) locate cross-sections analysed for historical trends. Note obliquely-breaking waves angled to drive an eastward littoral drift along entire shore. Coordinate system NZTM. [*Credit*: NIWA; Image sources: Google Earth, OCEL (2006), BDC, WCRC.]

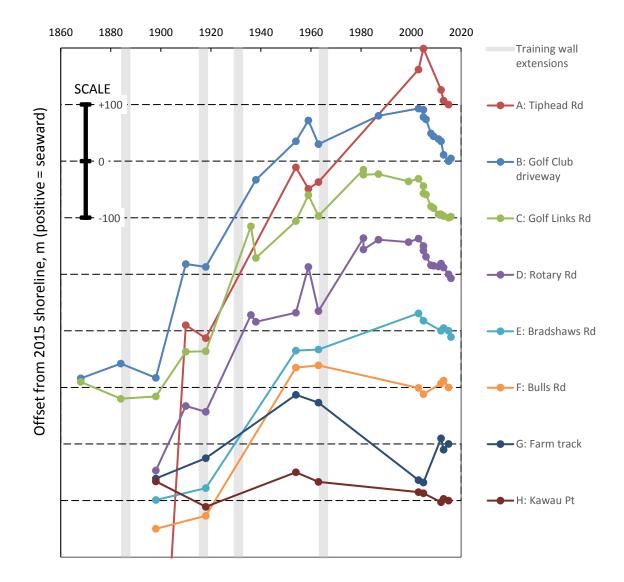
The overall effect of the training wall construction has been for substantial land building across the wider Buller Bay, with the maximum seaward advance reaching 1350 m in the east and reducing to approximately 0 m at the western limit of Kawau Point. The majority of this shoreline advance occurred up to 1981, occurring in spurts following stages of training wall construction. About 20

years after the final wall extension the shorelines on the eastern side of Buller Bay stabilised for approximately 20 years (1981-2003) but since then shoreline retreat has commenced and continues today. Note that the western half of the beach has limited data from 1963-2003 so any stabilisation pattern is not clear. Since 2003 a pattern of east-west delineation between erosion (east) and accretion (west) has appeared, confirming observations from the site inspection.

Figure 3-2: Historical shoreline positions at cross-sections within Buller Bay. Offsets are with respect to 2015 shoreline position for each cross-section. A rising line indicates shoreline advance (sediment accretion); a falling line indicates retreat. Lines separated by 100 m for plotting clarity (thus the scale bar, drawn for cross-section B, should be moved up or down to align its zero with the 2015 point on the other cross-sections). Cross-sections located on Figure 3-1. Grey bars indicate phases of training wall construction.

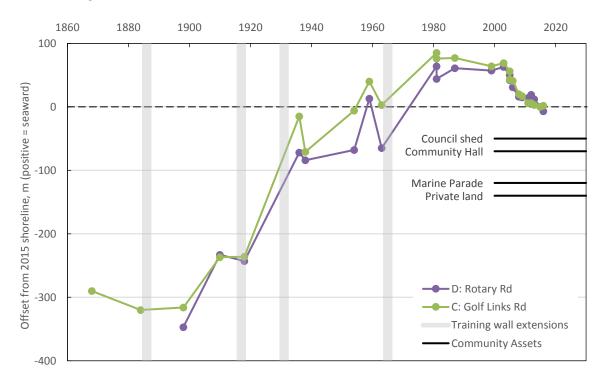
There is nothing to suggest the erosion rate at Carters Beach has increased since the 2006 assessment (OCEL 2006), rather, it is the awareness of the erosion problem that is increasing as the coastline retreats towards urban development. While up to 80 m of beach has been lost since 1980, the shoreline analysis shows the erosion rates have been reducing in the vicinity of Carters Beach since 2003 (Figure 3-3).

Figure 3-3: Historical shoreline positions along Carters Beach as offset from 2015 shoreline position. See Figure 3-1 for cross-section locations within Buller Bay. Vertical grey bars indicate phases of training wall construction. Black horizontal lines show offsets of assets and features relative to 2015 shoreline.

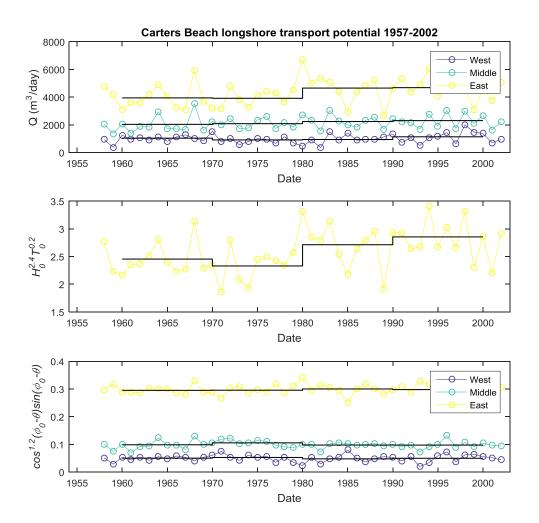
Figure 3-4: Preliminary analysis of longshore transport potential Q (m³/day) and contributions from wave energy and wave direction at three sites in Buller Bay. [Top] annual (coloured lines) and decadal (black line) average of daily Q at each site in Buller Bay. [Middle] annual (coloured line) and decadal (black line) average of daily wave energy contribution to Q. [Bottom] annual (coloured line) and decadal (black line) average of daily wave direction contribution to Q. Wave data from WASP record and using Ashton and Murray (2006) equations. [Credit: NIWA]

Figure 3-4 (top) illustrates the daily-average and decadal-average LST potential at each Buller Bay site. The results show a 10-15% step-change increase in LST centered around 1979/1980 for the eastern beach site only (i.e., Carters Beach area). Such a shift in LST has the potential to swing a beach away from an accretionary phase towards a stable or eroding phase.

Figure 3-4 (middle) illustrates that the cause of the LST shift appears to be aligned with a change in incident wave energy (largely determined by wave height, shown as the $H_0^{2.4}T_0^{0.2}$ term in the Ashton and Murray equation) as there is not an obvious swing to incident wave direction at any site (shown as $\cos^{1.2}(\phi_0-\theta)\sin(\phi_0-\theta)$ where ϕ_0 is the breaking wave crest angle and θ is the shoreline orientation) around this time (Figure 3-4, bottom). The effect of increased wave energy is more pronounced in the eastern portion of the Bay, i.e., Carters Beach to the Tiphead, due to its increased exposure to the higher wave energy.

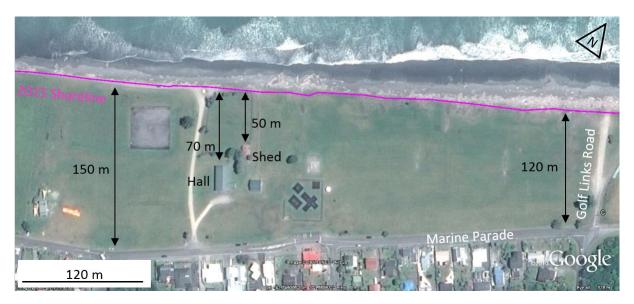
The assets at highest risk are the council/community facilities on the domain reserve (Figure 4-1). These are offset about 40-50 m (old shed, Figure 4-3) or 60-70 m (Community Hall, Figure 4-2) from the present day erosion 'scarp. Marine Parade and the nearest private land are about 110-120 m from the beach along the Carters Beach domain reserve at Golf Links Road, increasing to 140-150 at Tasman Street (Figure 4-1). This is a fortuitous situation for both the community and the council, as this 50-150 m space can act as a buffer against future erosion with minimal impact on the community. This assessment assumes the old shed (Figure 4-3) could be rebuilt elsewhere without much difficulty.

Figure 4-1: Features and facilities on Carters Beach domain reserve. Measurements show distance inland from 2015 shoreline position. Between 4 and 10 m of additional retreat has occurred in the 18 months since this photograph was taken. [*Credit*: Google Earth, Imagery Date: 25/12/2015].

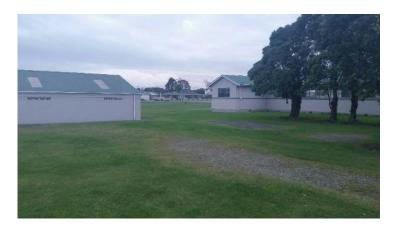
Figure 4-2: Community hall facilities on Carters Beach domain reserve. [Credit: P. Birchfield, 10/05/2017].

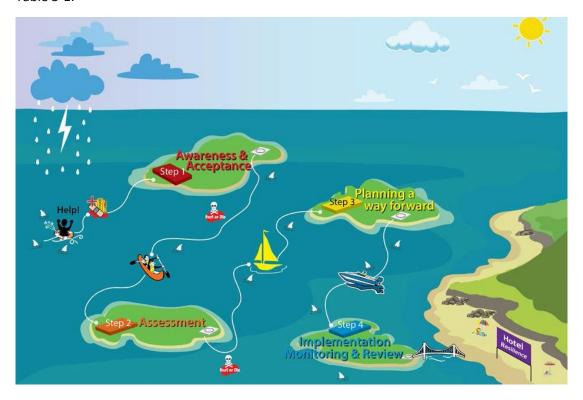
Figure 5-1: Illustration of Pathways to Change – 4 steps on the coastal adaptation journey. From Britton et al. (2011, Figure 3.1).

The adaptation pathway for coastal change is illustrated schematically in Figure 5-1 and is detailed in Table 5-1.

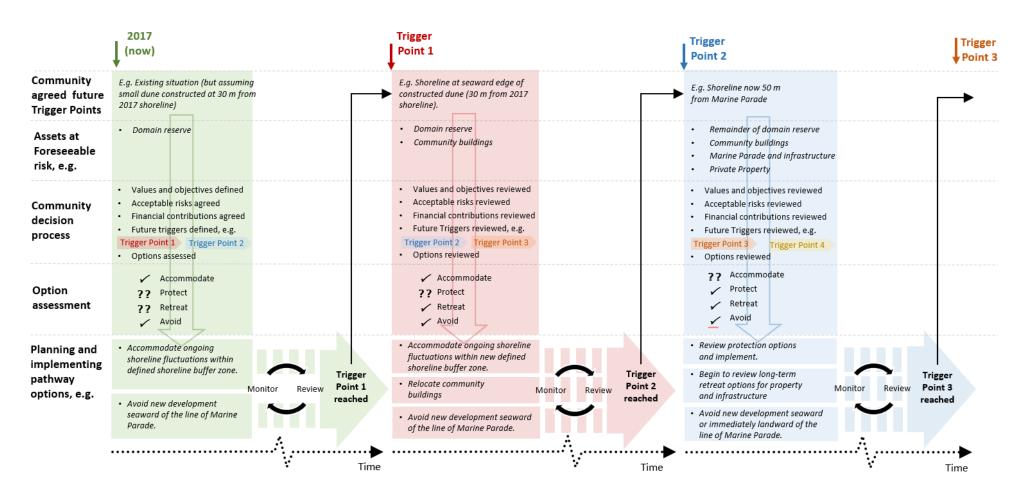
Figure 5-2 below outlines a suggested adaptation pathway sequence for Carters Beach. In this diagram, we have pre-filled sections with options specific to Carters Beach (italics) to help direct the pathway and exemplify the process described above. This initial section of the pathway assumes the small dune is constructed in the near future along the Carters Beach domain (see Section 0), no further development is permitted on the domain and that shoreline movements continue to be accommodated until the next defined trigger point is reached.

Figure 5-2: Example adaptation pathway sequence for Carters Beach. See text for full description of each step and options. Note that italics represent examples specific to Carters Beach which may be appropriate but should be reviewed by the community and council.

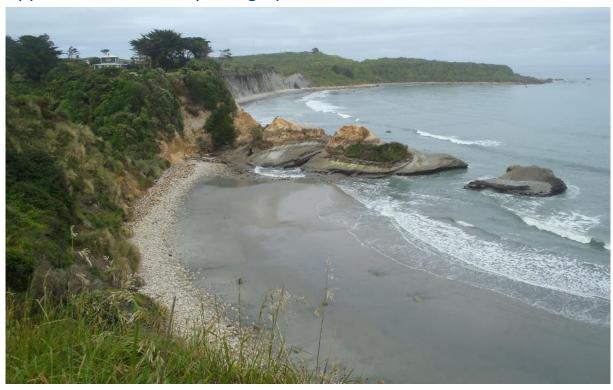
Figure A-1: Omau Bay looking west towards Cape Foulwind (access from Domain Road). [*Credit*: M. Allis, 23/11/2016].

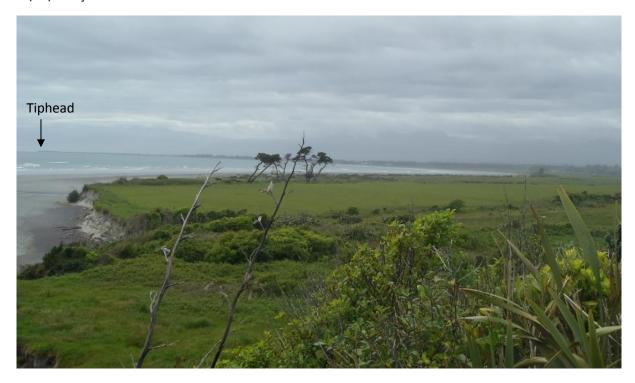
Figure A-2: View east across Buller Bay from Kawau Point. Buller River tiphead just visible (at left – see arrow). Access from Larsen Street. [*Credit*: M. Allis, 23/11/2016].

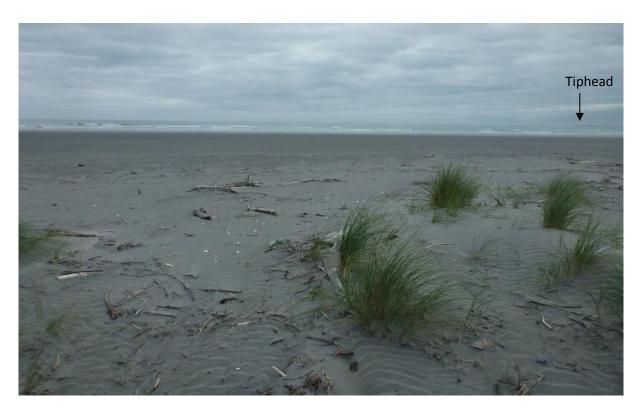
Figure A-3: View northeast across Buller Bay towards tiphead. Buller River tiphead just visible (at right – see arrow). Access from Farm Track 1.4 km east from Larsen Street. [*Credit*: M. Hicks, 23/11/2016].

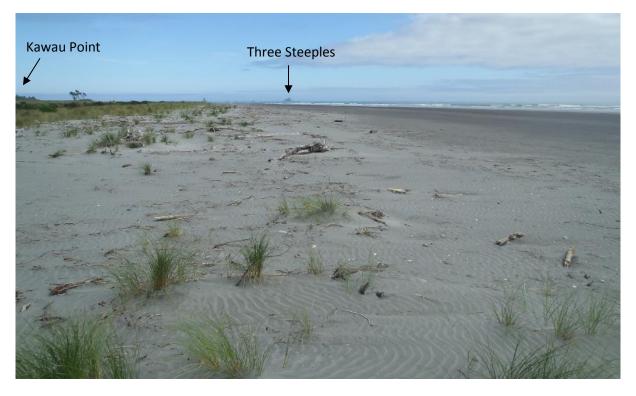
Figure A-4: View northwest past Kawau Point towards the Three Steeples. Access from Farm Track 1.4 km east from Larsen Street. [*Credit*: M. Allis, 23/11/2016].

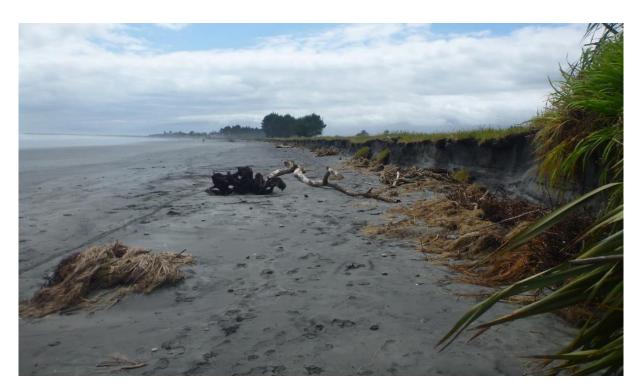
Figure A-5: View east towards Carters Beach (trees). Access from Bradshaw's Road. [*Credit*: M. Hicks, 23/11/2016].

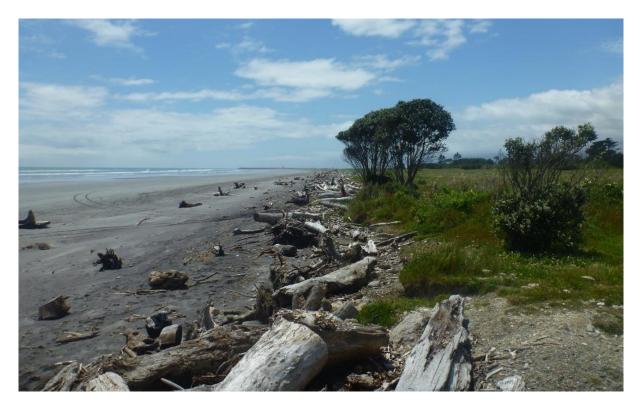
Figure A-6: View east from Carters Beach. Access from Golf Links Road. Tiphead visible in centre at distance. [*Credit*: M. Hicks, 23/11/2016].

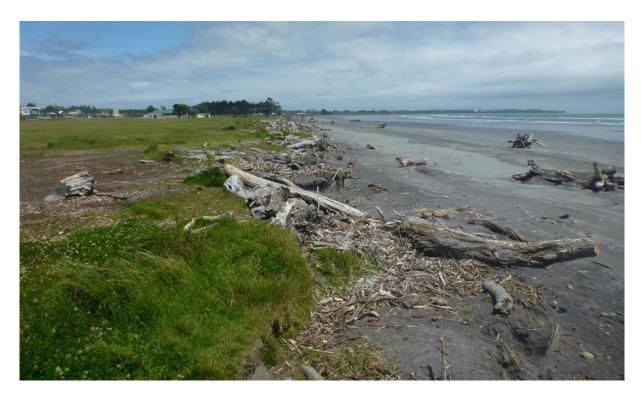
Figure A-7: View west towards Cape Foulwind from Carters Beach. Access from Golf Links Road. [*Credit*: M. Hicks, 23/11/2016].

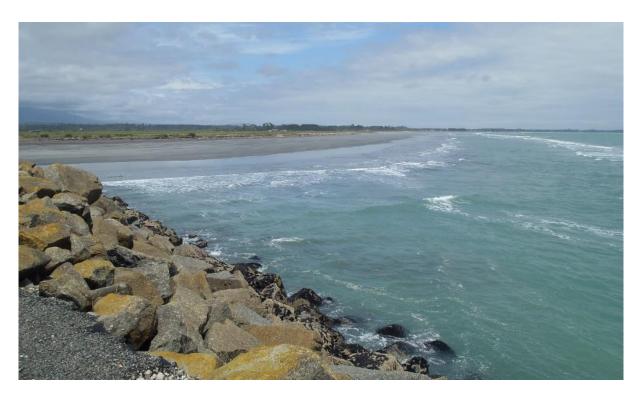
Figure A-9: View southwest towards Carters Beach from tiphead at mouth of Buller River. Access from Tiphead Road. [*Credit*: M. Allis, 23/11/2016].
