**Grey River at Greymouth**

**Hydraulic Review and  
Assessment of Effects of  
Options to improve  
Flood Capacity for estimated  
T50 & T150 flood discharges**

**Report for the West Coast Regional Council and Grey District Council**

**Report 3/2002**

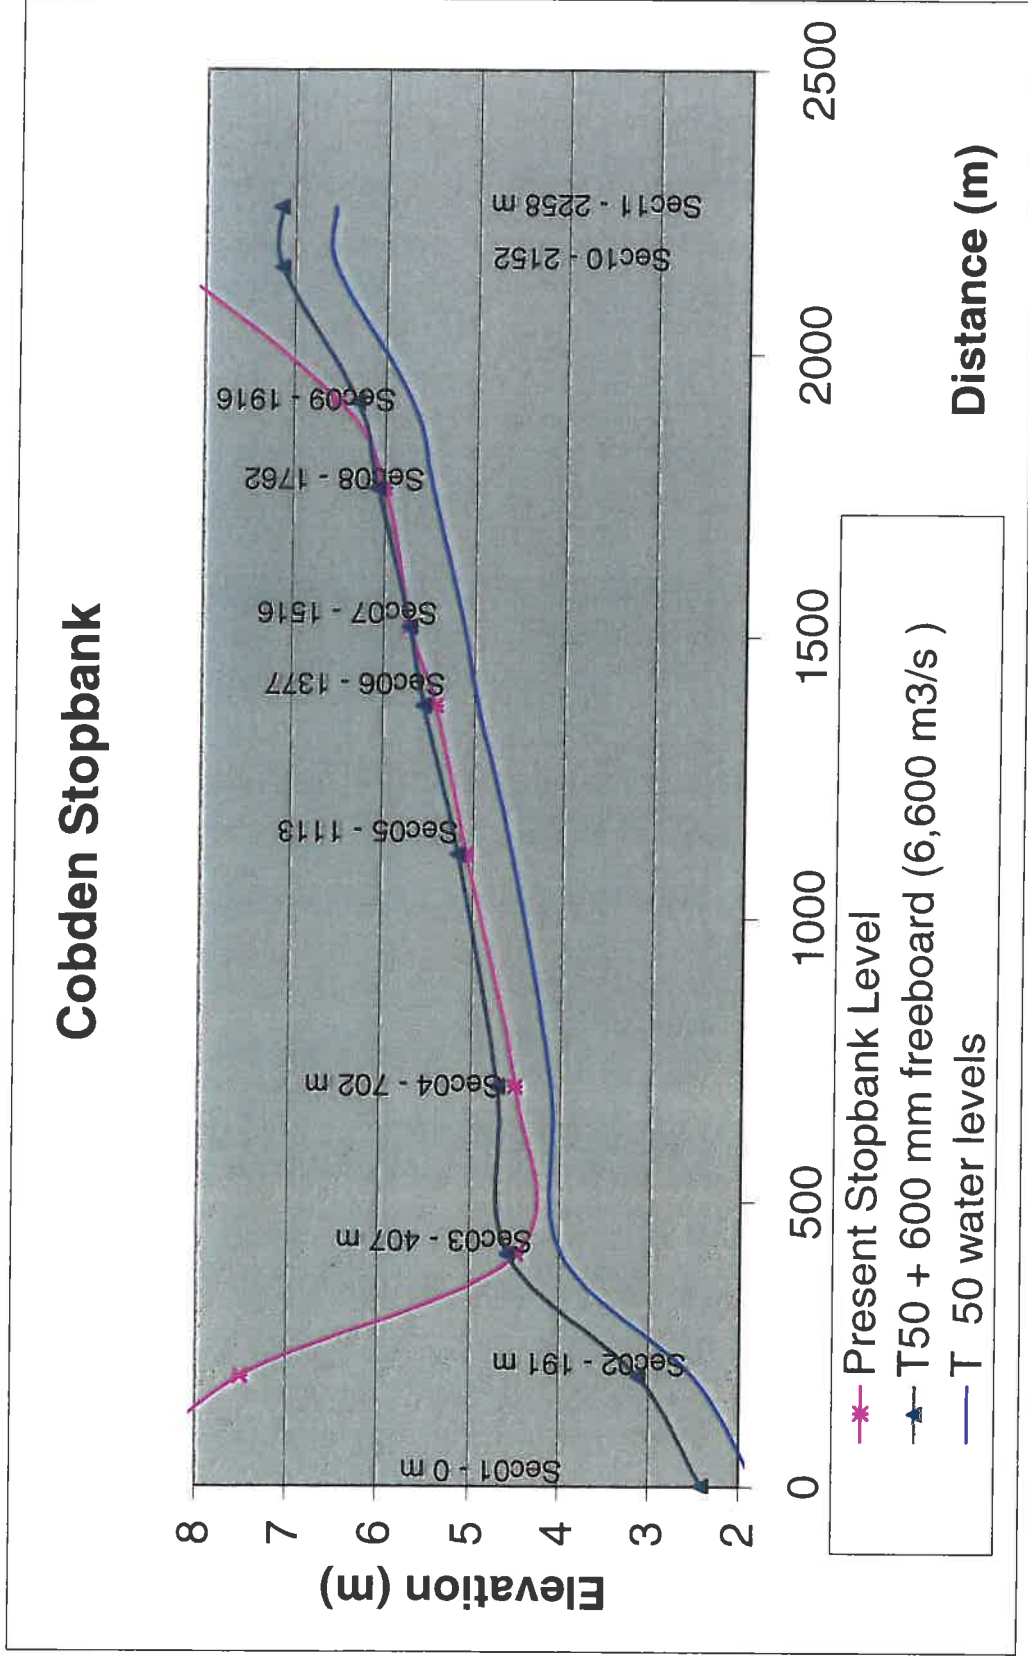
Figure 3: Long Section of Cobden Stopbank showing T50 + 600 mm freeboard levels (6,600 m<sup>3</sup>/s)

Figures 1 to 3 show graphically how these flood levels and their associated stopbank levels with 600 mm freeboard compare with the present stopbank heights and therefore where the stopbanks need raising. Note that the Hydro2de results were adopted for the levels in Erua Lagoon and Lake Karoro. (See discussion in the Appendix in section A2.4.)

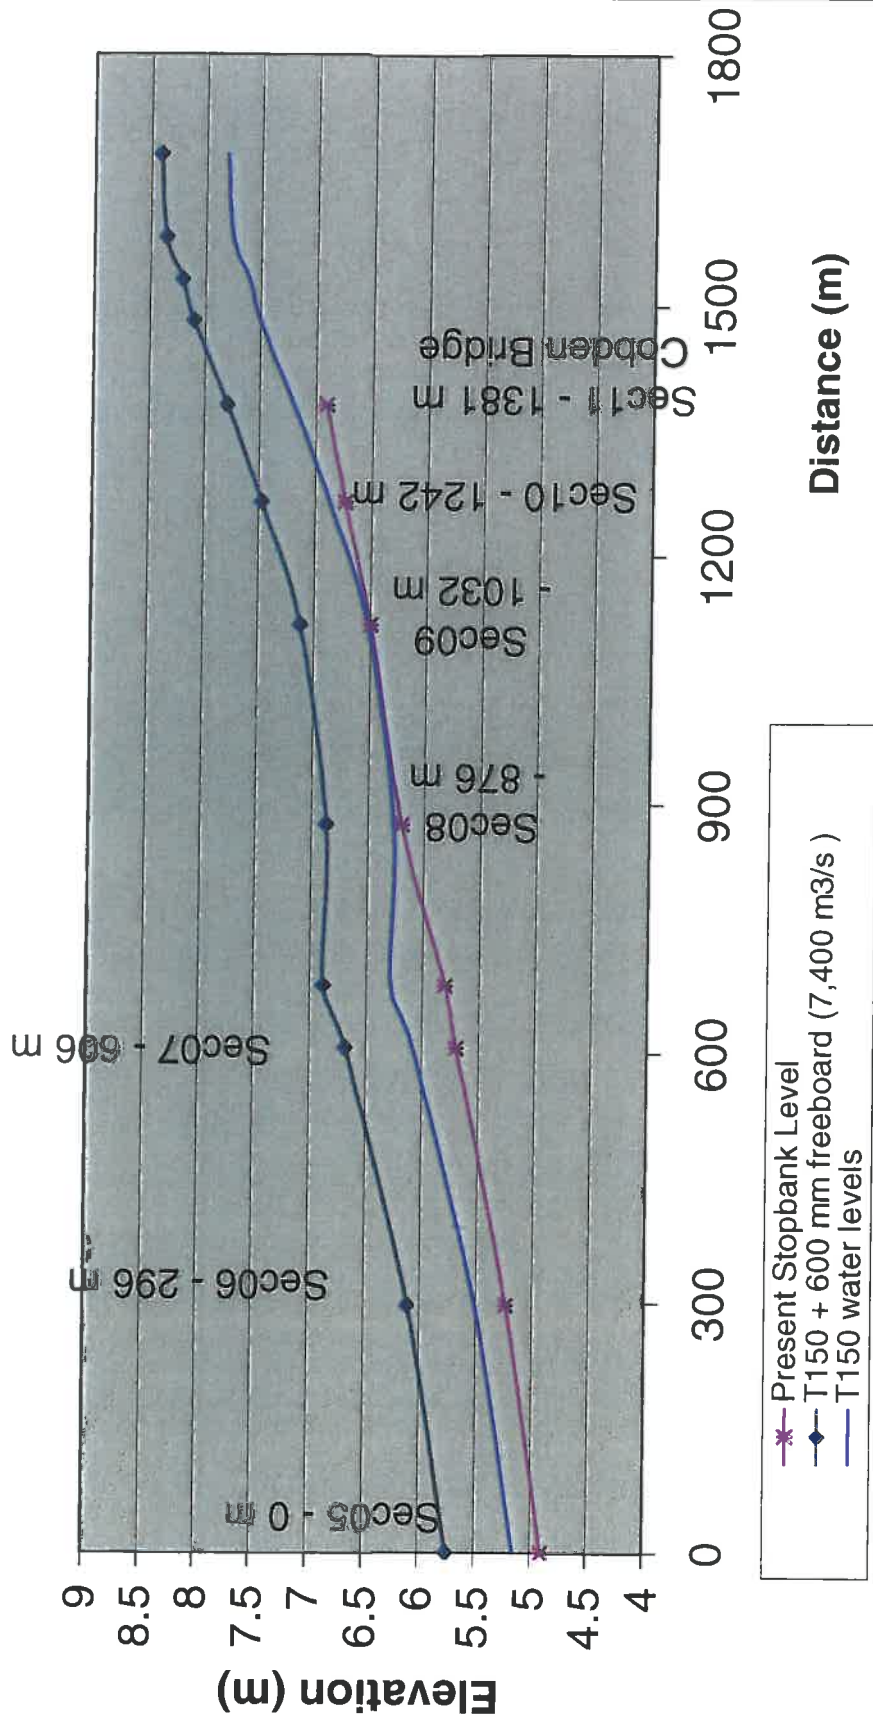
Figure 6: Long Section of Commerical Area Stopbank showing T150 + 600 mm freeboard levels (7,400 m<sup>3</sup>/s)

Figures 5 to 7 show how these flood levels and proposed stopbank levels (with 600 mm freeboard) relate to the present stopbank levels. Where the proposed stopbank levels are above the present stopbank levels the stopbanks will need to be raised.

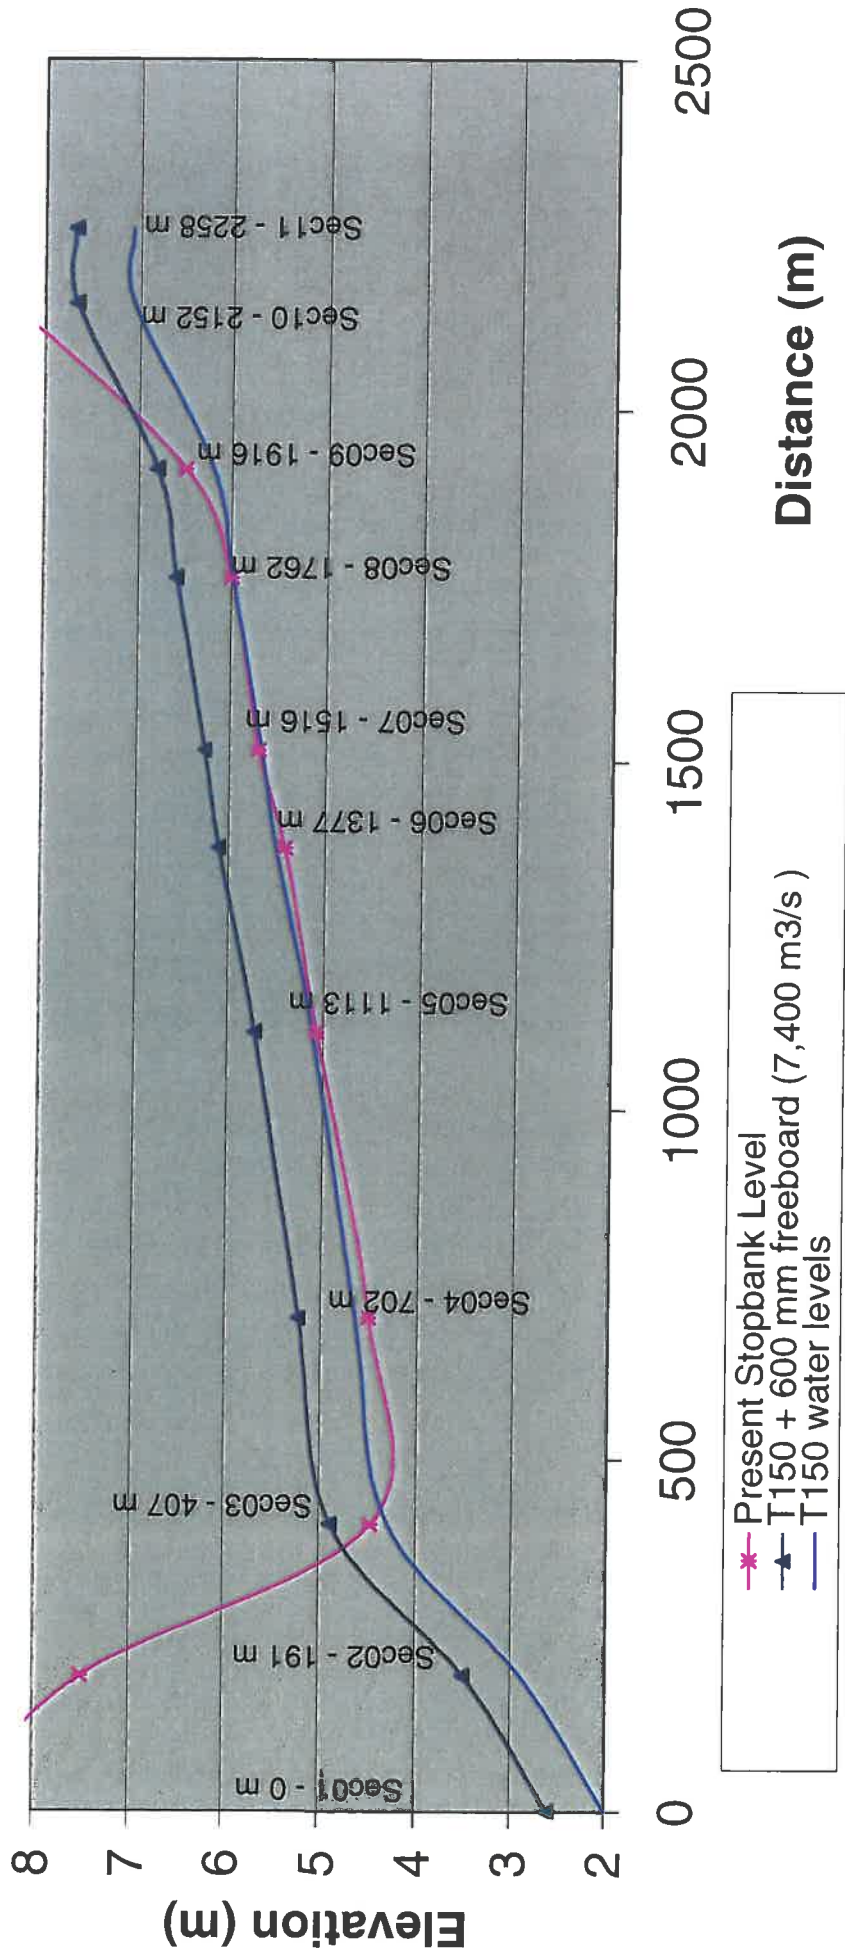
Figure 7: Long Section of Cobden Stopbank showing T150 + 600 mm freeboard levels (7,400 m<sup>3</sup>/s)

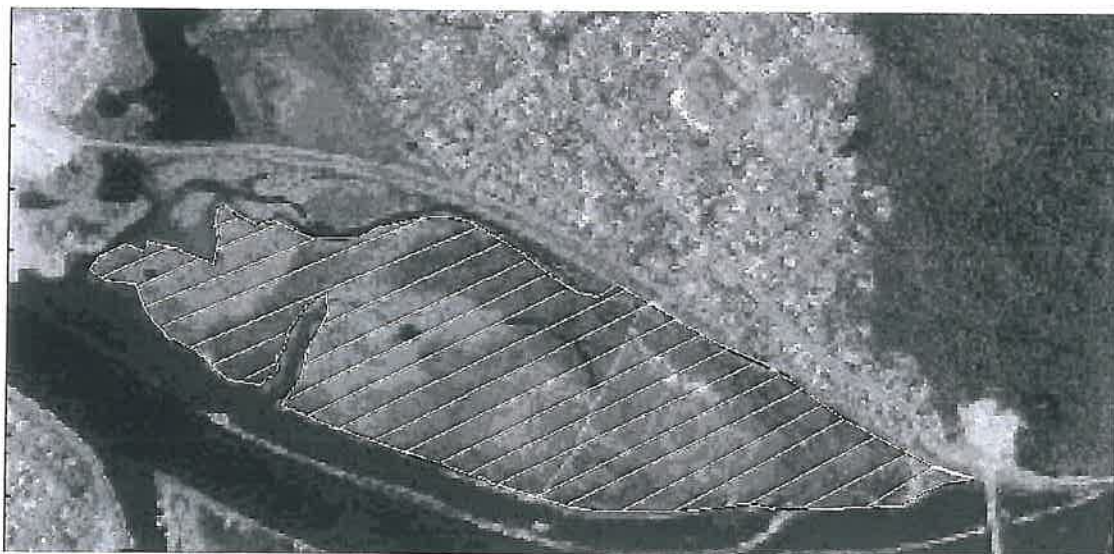
**Figure 8: Clearance of Cobden Island used in Modelling.**

For the purposes of modelling the area of Cobden Island that was cleared is shown in Figure 8 below.

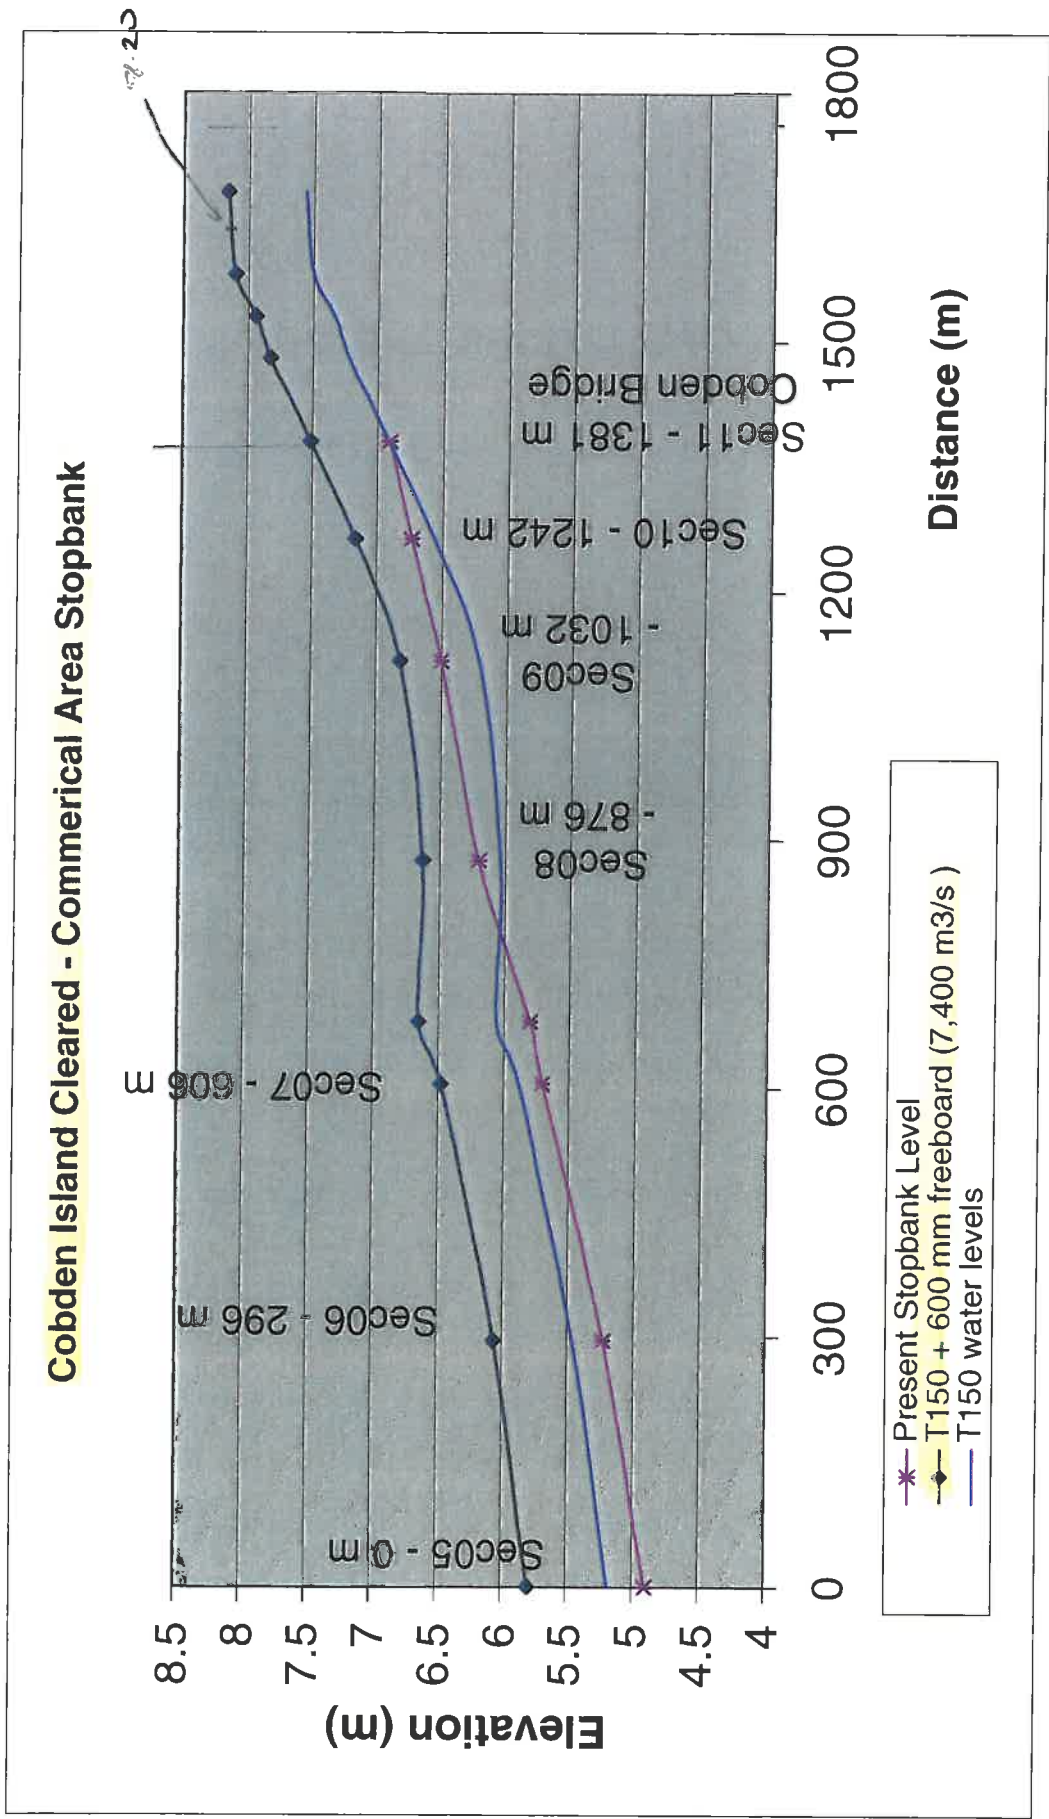
Figure 13: Cobden Island Cleared - Long Section of Commercial Area Stopbank showing T150 + 600 mm freeboard levels (7,400 m<sup>3</sup>/s)

Figures 12 to 14 show how these flood levels and proposed stopbank levels (with 600 mm freeboard) relate to the present stopbank levels. Where the proposed stopbank levels are above the present stopbank levels the stopbanks will need to be raised.

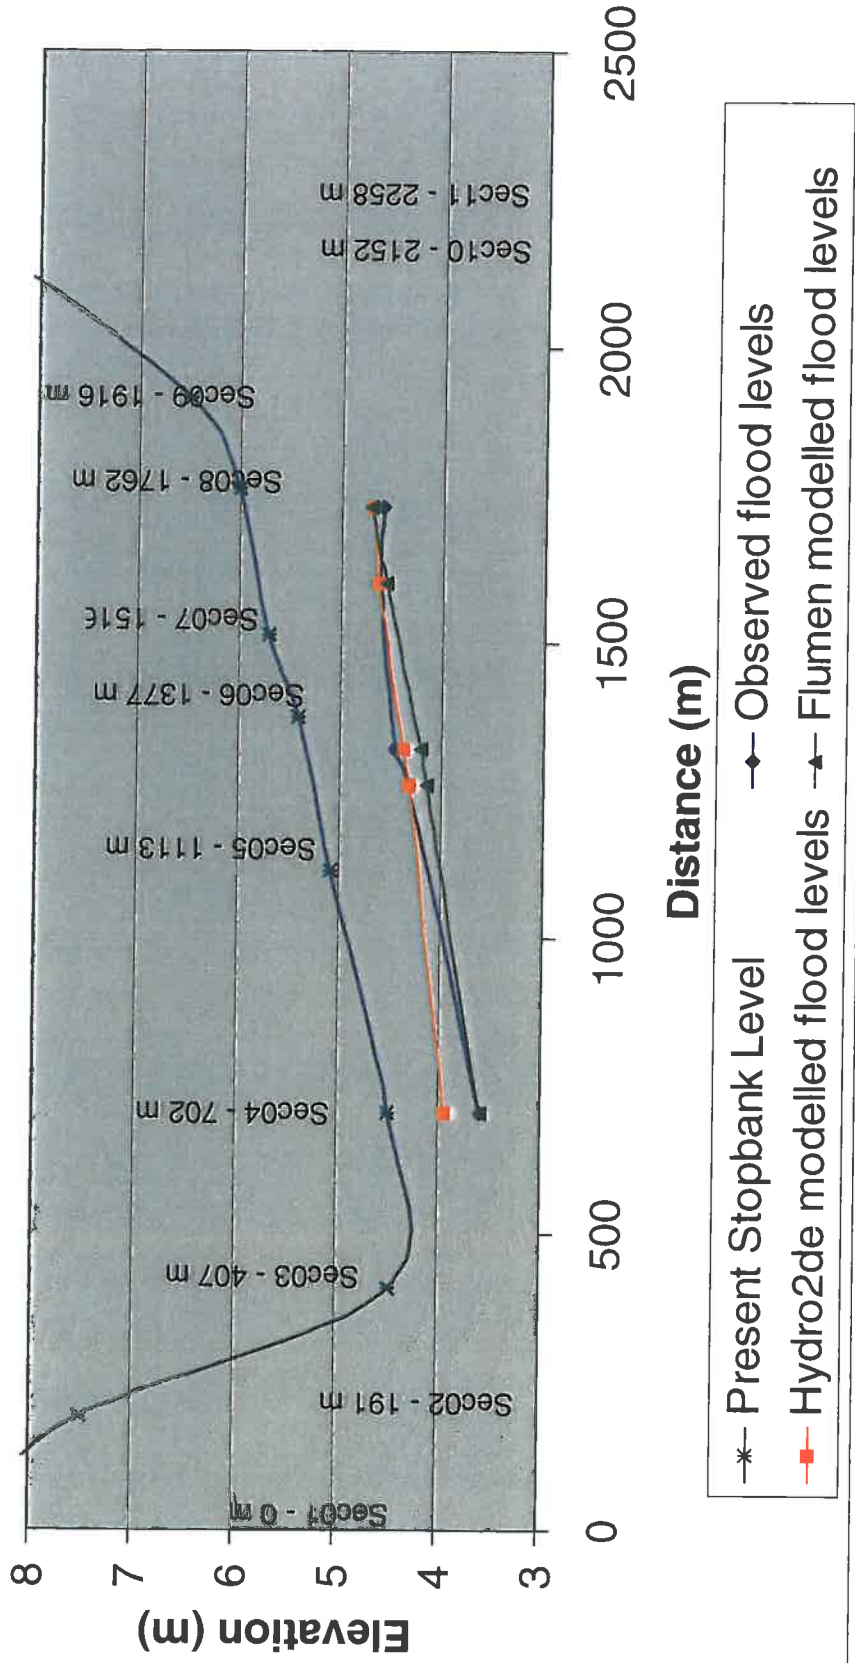
Figure A3: Observed flood levels vs Hydro2de and Flumen Calibrations - Cobden Stopbank

The differences shown in Table A3 can be more clearly seen in the long sections of the three stopbanks at Greymouth as shown in Figures A1 to A3. Note that the levels shown in the figures are plotted against the modified observed flood levels

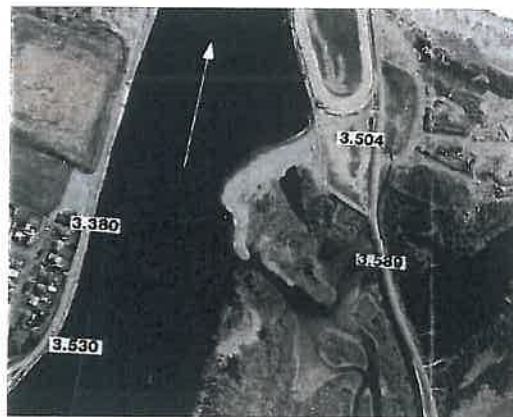
**Figure A6: Observed flood levels 13<sup>th</sup> September 1988 flood on lower Grey River (part of plan by Wayne Moen 1998).**

The levels on the Cobden Side upstream of Cobden Raceway on the initial runs were lower than the observed levels. In the final calibration using the 1998 topography, the bar just upstream of the track (see photographs 1 and 2 of the 2001 report and Figure A6 below) was reinstated into the model. This gave a better fit to the observed levels shown in Figure A6.
