Managing and adapting to coastal erosion on the West Coast: Rapahoe

2017 review and update

Prepared for West Coast Regional Council

NIWA CLIENT REPORT No: 2017072HN
Report date: April 2017
NIWA Project: ELF17211

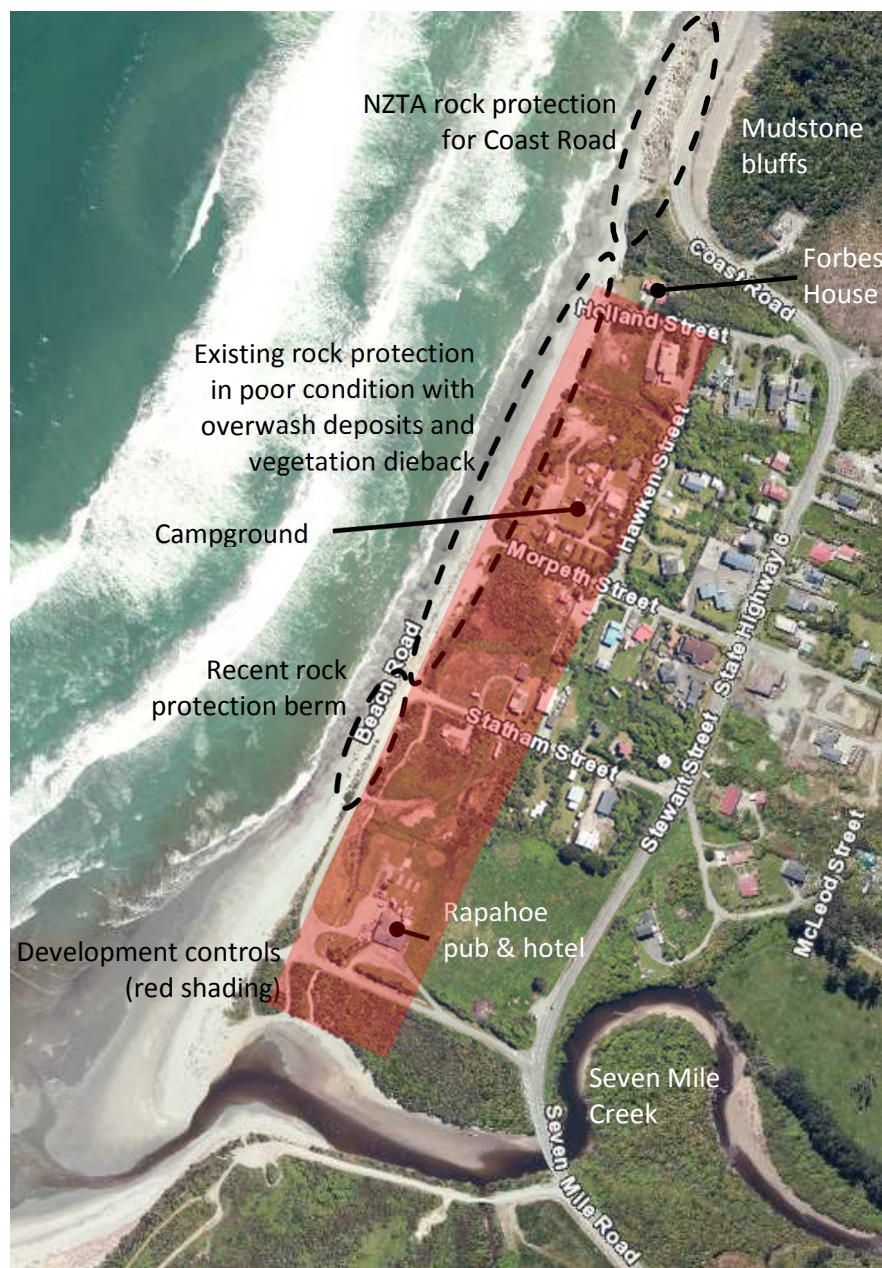
Figure 3-1: Rapahoe location diagram. Imagery 2013. [Credit: gis.westcoast.govt.nz].

The most effective way to manage risk to private property in the future is accommodating the potential beach retreat through controlling any further development in the area between Beach Road and the shore-parallel line of Hawkens Road - see red shaded area in Figure 3-1. This low-lying area is also being increasingly exposed to storm-related flooding due to wave overtopping, potential breaching of the shoreline berm, or from high river levels, and will increasingly experience drainage and more frequent flooding during storm events as sea-levels rise.

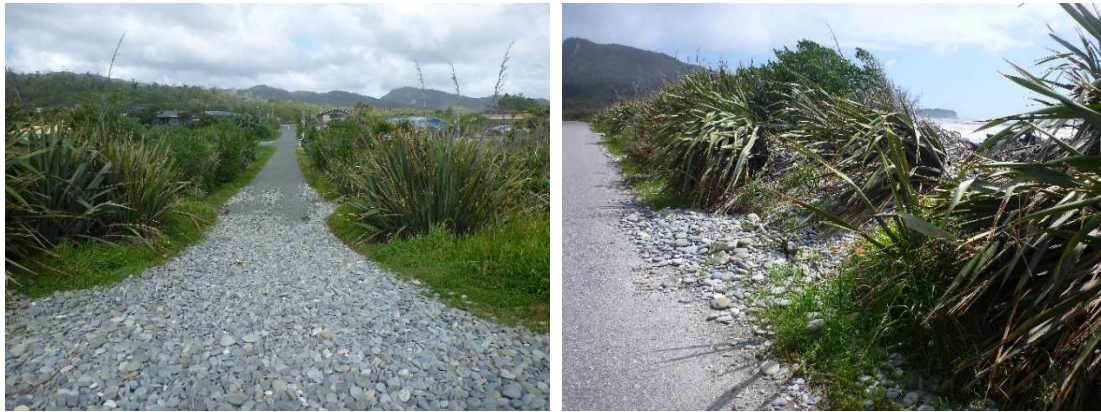
- Ongoing wave overwash of gravel is evident at all locations along the Rapahoe beach front (Figure 3-2). Wave overtopping, saltwater spray and gravel movement are affecting beach-crest vegetation and roadways (Beach Road and the seaward ends of

Statham, Morpeth and Holland Streets, see Figure 3-2), with evidence of periodic council sweeping and clean-up on Beach Road. Nearer to high tide (within 90 minutes) at the end of the inspection, the relatively benign waves and uprush regularly submerged and covered much of the rock protection on the beach face, but waves were not able to reach the beach crest. Evidence of storm overwash into the coastal fringe of inland private properties was also observed.

Figure 3-2: Continued overwash deposits onto Morpeth St (left) and Beach Rd near Statham St (right). [Credit: M. Hicks].

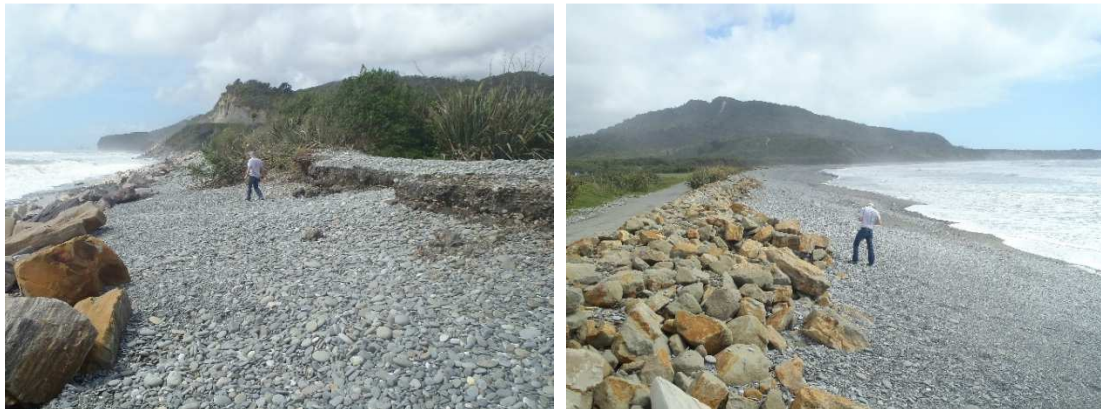
- Beach Road remains closed between Stantham St and Holland Rd, with no additional lengths closed since 2006. This is probably due to the protection provided by a small rock/rubble berm placed alongside Beach Rd, extending approximately 100 m south from Statham St (Figure 3-1, Figure 3-3 (right), Figure 3-4). The berm is composed of small mudstone cobbles and boulders (<0.5 m diameter) mixed with sands and gravels. The rock berm appears to have been placed on the beach crest without any geotextile underlayer or toe embedment, and is only 1-1.5 m wide and reaches 1 m above ground level. The council appear to maintain this after erosion and overwash occurrences (Figure 3-2, right). This berm is a poor quality, short-term coastal defence which is much smaller than protection works at the northern end of Rapahoe. The berm has already suffered erosion/undermining from wave attack and is not expected to survive large storm erosion or to protect against wave overtopping.

- Continued beach retreat along the entire foreshore. Although there have been no additional closures of Beach Rd, the entire beach is narrowing and the beach crest continues to retreat landward. This is evidenced in the exposed and eroding former road base (Beach Road between Morpeth St and Holland St, Figure 3-3, left) and the lowering and retreat of the upper beach increasing the space between the top of the rock armour and beach crest (Figure 3-4, right; Figure 3-5).

Figure 3-3: Continued erosion behind the rock revetment along the former Beach Rd between Morpeth St and Holland St (left) and recent protection works alongside Beach Rd south from Statham St (Right). Left: note former Beach Rd tar seal and basecourse layers at right of image. [Credit: M. Allis].

The risk to the remaining section of Beach Road south of Statham Street remains high, as the narrow vegetated gravel barrier and poor quality (size, position, material strength, and material composition) rock/rubble berm are insufficient to withstand long-term beach retreat. The council and community should expect to relinquish Beach Road in the near future. Fortunately, this section of Beach Road is not required for property access.

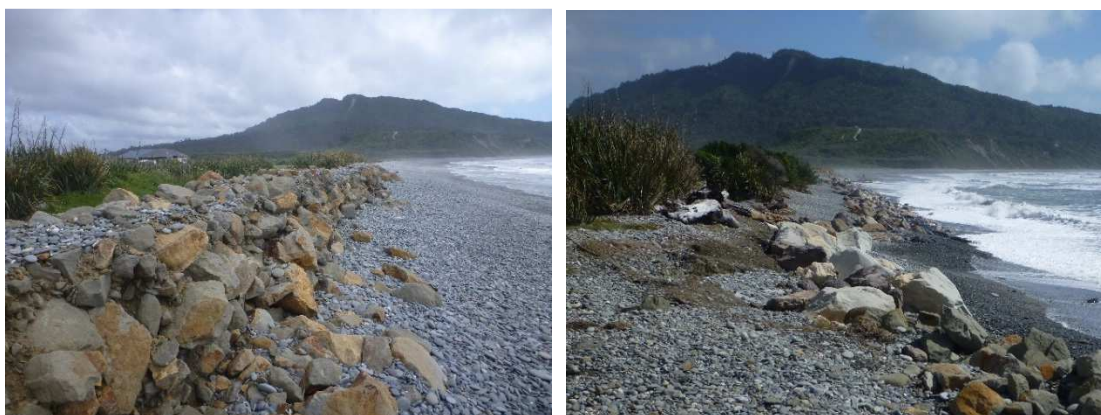
- Retreat of the beach along the Rapahoe frontage north of Statham Street (Figure 3-1) is now undermining the existing rock protection, causing it to subside. The crest of the rock protection is now >1 m below, and 3-5 m from, the beach crest (Figure 3-4, right; Figure 3-5). The amount of recent erosion and subsidence reduces at the north end of Rapahoe, with <1 m retreat over the last 10 years at the low mudstone bluffs (Figure 3-1, Figure 3-5 and Forbes house). Despite the ongoing erosion, the relatively low retreat rate since 1997 (< 0.5 m/year) compared to the 1939-1988 retreat rate (1.5 m/year) is due to the protection provided by the merged gravel barriers and to some extent the rock revetment.

Figure 3-4: Continued beach retreat against rock berm (left) and along the entire foreshore (right). [Credit: M. Hicks].

The existing rock protection suffers from ongoing wave attack causing undermining, abrasion and material losses. Without additional rock and maintenance works, this ongoing degradation of the existing defences may well cause erosion rates to increase - and consequently the remaining lifespan of the protection will be shortened. The cost of a substantial upgrade to the rock protection works is unlikely to be economically viable for the community, given the development at risk. Thus medium to long-term relocation of the most seaward buildings and associated development will be required.

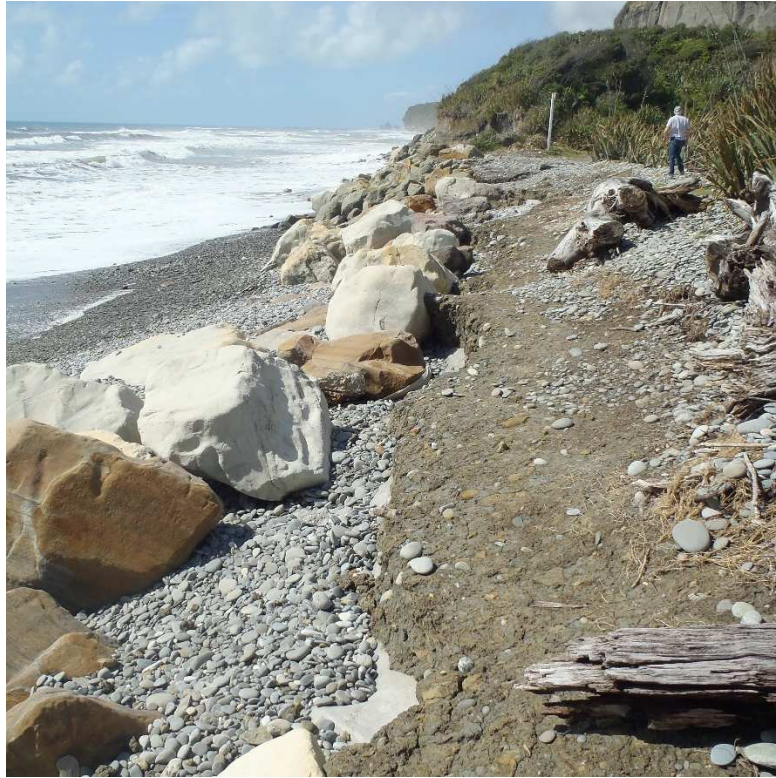
- Erosion of the bluff is due to both the gradual loss of protection provided by the beach material fronting the bluff and the undermining and slumping of the larger rocks in the revetment which decreases the level of protection to the bluff behind.

Figure 3-5: Current condition (21 November 2016) of the northern end of the rock revetment. [Credit: M. M. Allis].

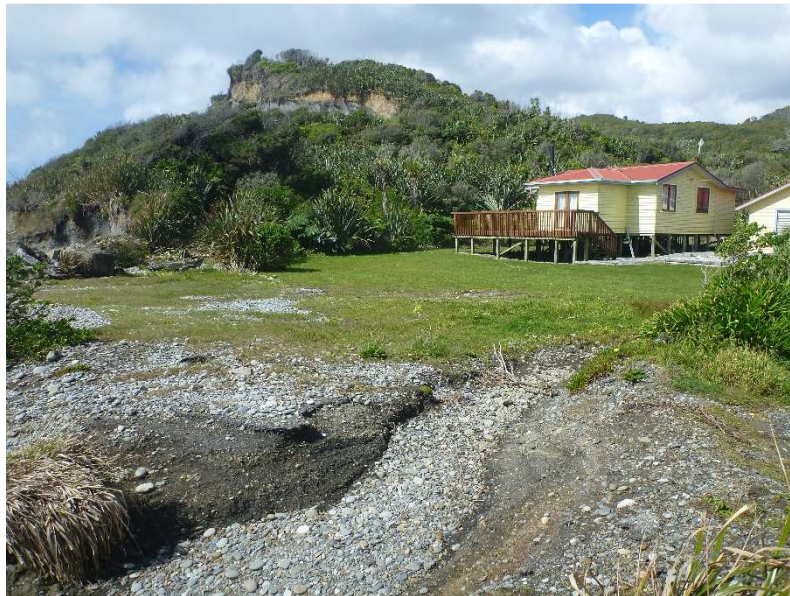
- The Forbes house and garage at the far northern end of Rapahoe beach front (un-numbered, on Holland Street, see Figure 3-1) have been relocated 20-25 m inland on the same section in response to the ongoing erosion threat. The former foundations and driveway have since been partially lost to erosion. Large (>1m diameter) boulders have been placed along the beach front linking to the NZTA protection of the northern Rapahoe bluffs (Figure 3-6).

Figure 3-6: Relocated Forbes house, Holland St. Former foundations and driveway are just visible 20-25 m seaward (left) from house [Credit: M. Hicks].

The Forbes property (far northern end, previously at critical risk) provides an effective example of managing development risk from coast erosion and flooding at Rapahoe (Figure 3.5). The relocation of the property has substantially reduced the risk of damage to the property and increased the future timeframe over which the property can be effectively used.
