## COASTAL HAZARDS IN THE WEST COAST REGION,

SOUTH ISLAND, NEW ZEALAND.

J.L. BENN

The West Coast Regional Council P.O. Box 66 Tainui Street Greymouth April 1992

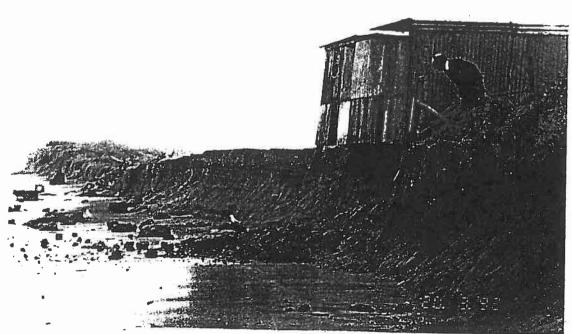
Looking South Towards Richard's Drive Groyne. Note the Wooden Fence in the Top Centre and the Concrete Floor and Rails from and Old Shed in the Right Foreground.

The Old Night Cart Shed, Near the Settling Ponds.

Photographs of Recent Coastal Erosion at Hokitika. (West Coast Regional Council Photographs 20.3.1992).

On several occasions properties in Beach Street and Revell Street have been destroyed or badly damaged during erosion phases. More recently the ocean outfalls from the Hokitika oxidation ponds and from Seaview Hospital have both been badly affected by erosion, and the oxidation ponds themselves may be affected in the near future (Appendix 5).

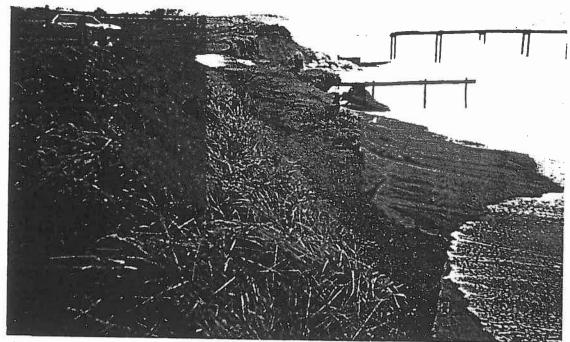
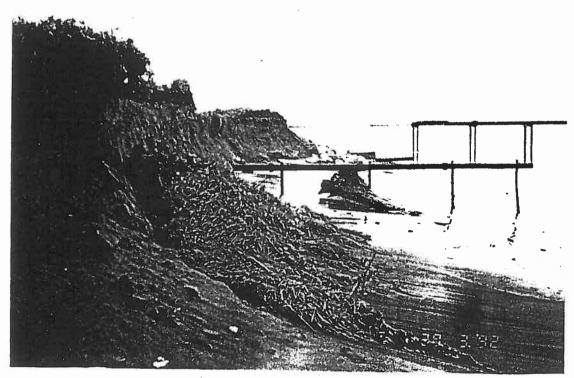
The Seaview Hospital Outfall Pipes. Note the Road - This Road went on the Seaward Side of the Night Cart Shed (Previous Page), and was Passable Two Days Prior to the Photography Date.

The Seaview Hospital Outfalls. The Short Pipe in the Foreground was Completely Exposed in Only Two Days.

Photographs of Recent Coastal Erosion at Hokitika. (West Coast Regional Council Photographs 20.3.1992).

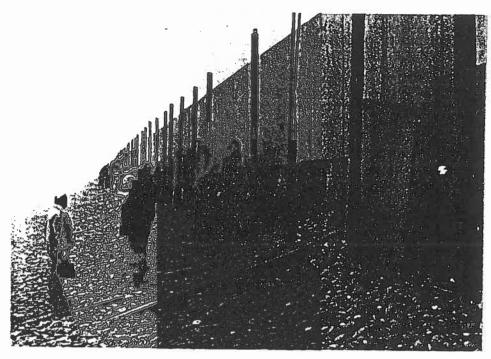
Granity Seawall, October 1988. Note the undercutting of the structure by wave action (Photograph - Don Neale, D.O.C. Hokitika)

Some buildings have been affected by recent erosion and sea flooding, notably Granity School and parts of Ngakawau. A seawall built at Granity School in 1960 fell into disrepair and was replaced by a gravel mound faced with concrete slabs, in favour of other protective measures that were considered (Appendix 9). Ad hoc dumping of railway irons and coal wagons on the Ngakawau beach have proven unsuccessful.
