SH6 Route Security Strategic Study Project Summary

Managing Route Security from Buller Gorge to Haast Pass

STATE HIGHWAY 6 BULLER GORGE TO HAAST PASS ROUTE SECURITY STRATEGY CONSULTATION

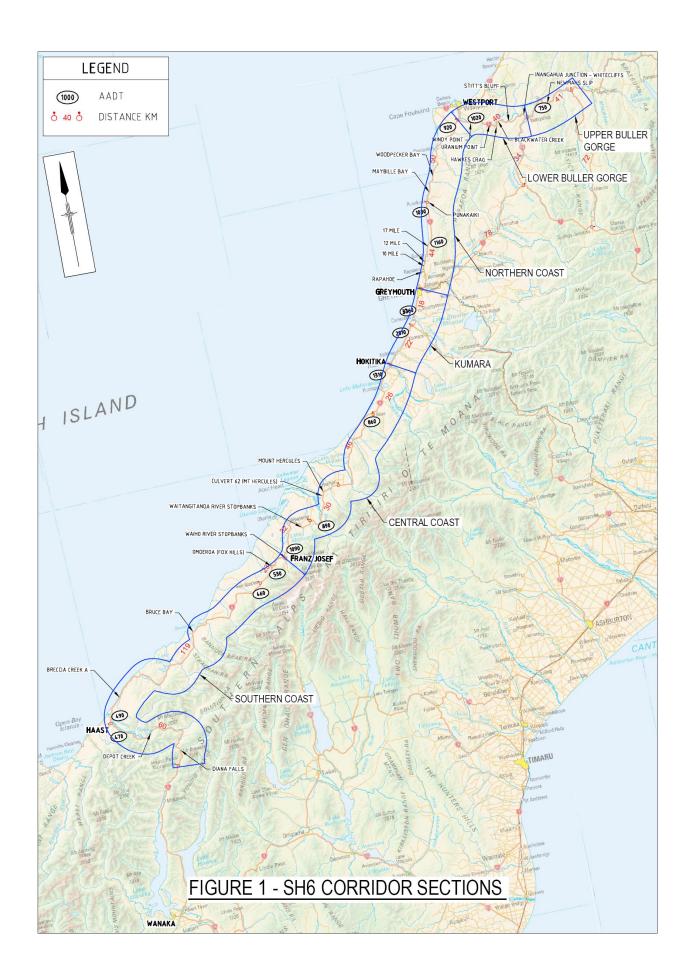
Sites Identified as Potentially At-Risk During the SH 6 Strategic Study

At-risk sites have been identified through document and report review, consultation and a drive-over exercise. In total, twenty three sites have been recognised as potentially problematic, comprising rock fall, landslide, flooding, coastal erosion and debris flow hazards. The sites are shown on the map presented as Figure 1.

The section of SH6 covered by this Study has been subdivided into six continuous sub-sections, as shown in Figure 1 and described in Table 1. The table also summarises the typical issues and management Strategy to be adopted for each section.

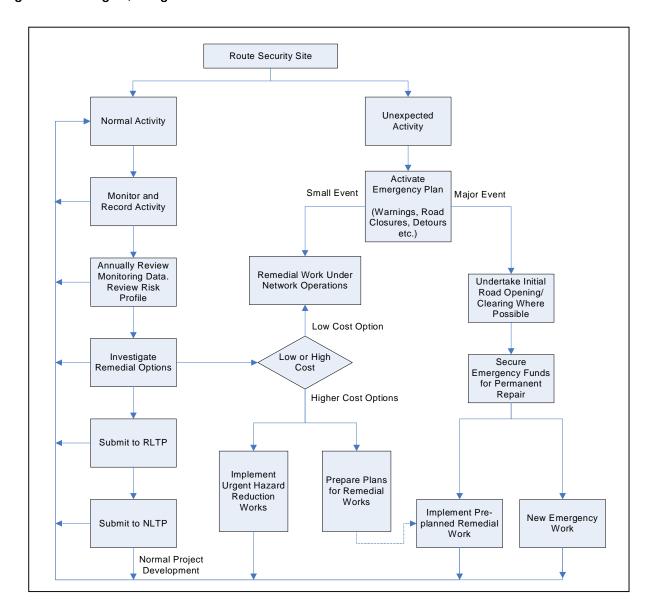
Figure 2: Investigate, Design and Construct Process

- Detect and Identify risks to road users, route security and the environment through improved monitoring and surveillance by the Network Consultant and Contractor.
- Notify risks to NZTA Regional Engineer, management and affected Stakeholders as appropriate.
- Action Plan development including emergency response plans, investigation of highest risk sites, exposure and hazard reduction plans. See Figure 2 for the process to be adopted for determining appropriate action.
