Report on West Coast Weather Event 27 & 28 December 2010

The 27 / 28 of December 2010 rainfall event produced flooding coast wide, affecting areas from Haast to Karamea. Analysis of the event shows that throughout the region it ranged between a 1 in 5 year event and 1 in 50 year event depending on the catchment. This event was unique in that it did not just affect a localised part of the West Coast but instead affected the whole region, and also the Tasman, Marlborough, Canterbury, and Otago regions making it an almost South Island wide event. In Tasman District it resulted in a 1 in 150 year event on the Aorere River, in Marlborough District it was a 1 in 60 year event on the Pelorus River, and in Canterbury between 1 in 50 and 1 in 100 year event for the Rakaia River.

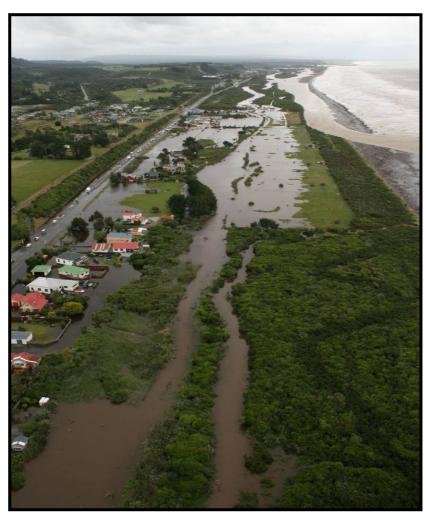
Flooding at Saltwater Creek, Paroa, 28 December 2010 photo courtesy of Jason Boddy

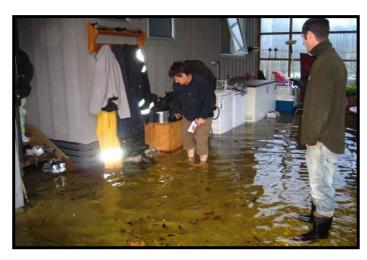
Flooding of property at Hannahs Clearing, photo courtesy of Brian and Phillipa Glubb

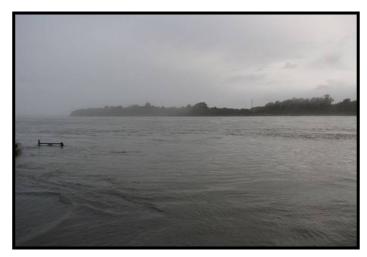
More flooding around Hannahs Clearing, photo courtesy of Brian and Phillipa Glubb

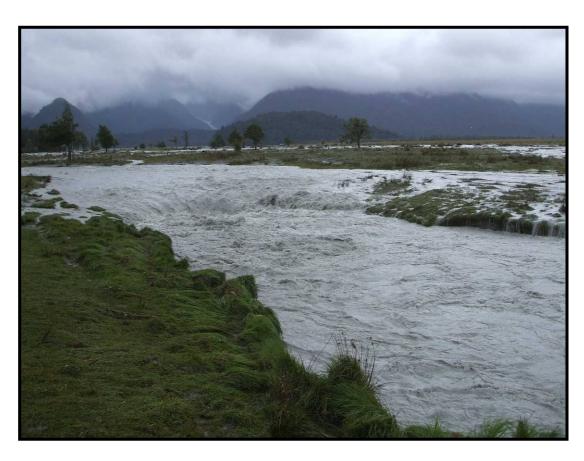
Waiho River where it cut through to the Tatare Stream in Figure 1, photo courtesy of Robert Fulton

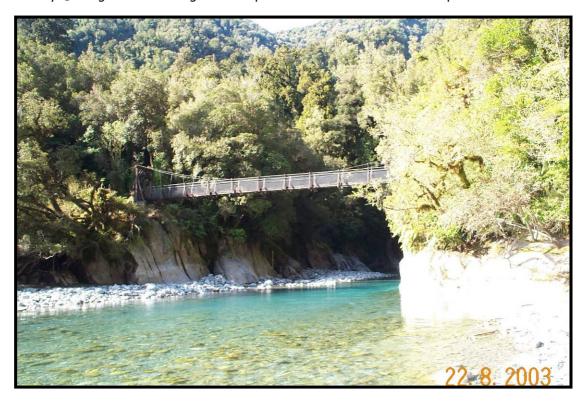
Callery @ Gorge flood warning site in September 2003. Note the 6 m drop to water.

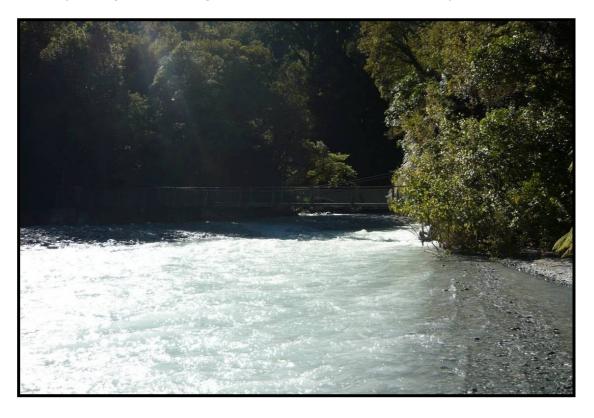
Callery @ Gorge flood warning site in March 2011. Note 0.75m-1m drop to water.

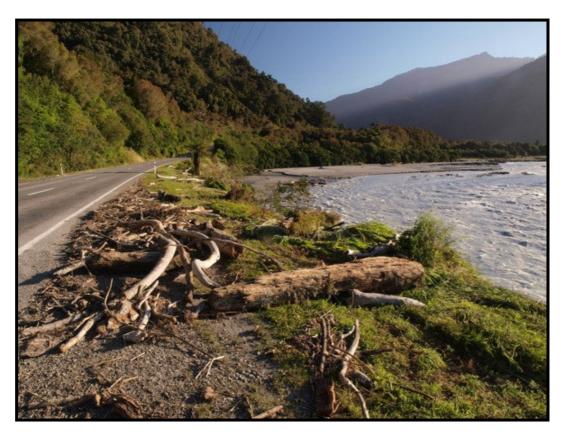
Whataroa River, photo courtesy of Martin London

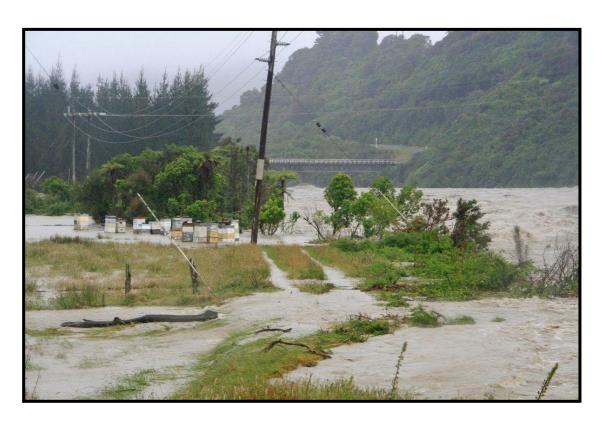
Flooding downstream of the Stanley Gooseman Bridge, photo courtesy of Gary Glasson

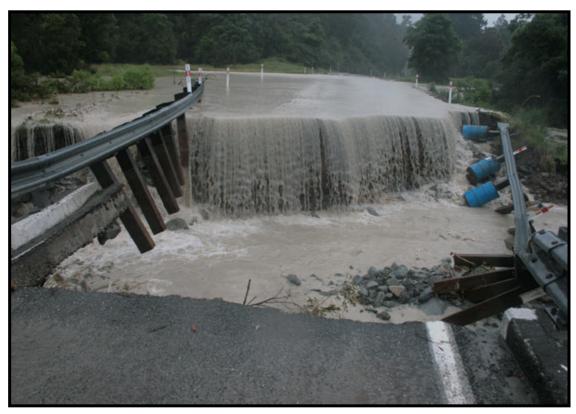
Wash out of state highway 73 at Kelly Creek. This is near the Taipo Rain gauge where 248mm of rain fell in 12 hours. Photo courtesy of NZTA

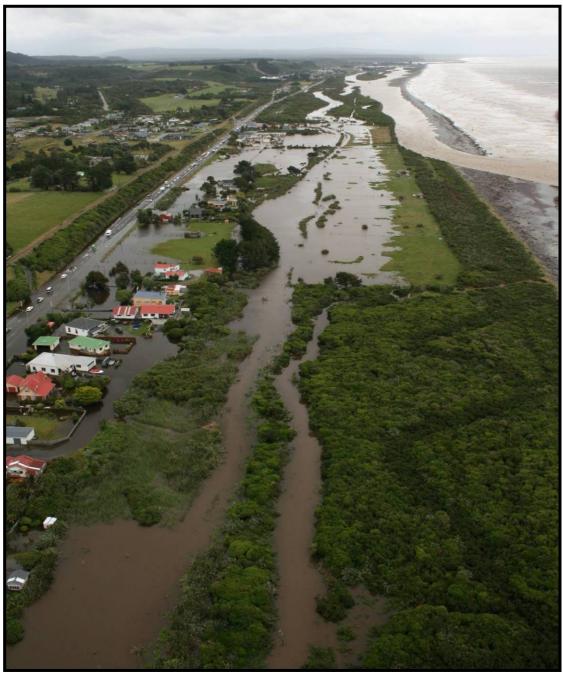
Photo showing extensive flooding caused by backing up of water in the drain system north of Saltwater Creek, and the dominant flow of New River, photo courtesy of Jason Boddy

Since the flood event Grey District Council, has undertaken emergency works to move the outlet of Saltwater Creek and New River constructing a rock wall to prevent New River and Saltwater Creek mouths breaking back into their old channel.

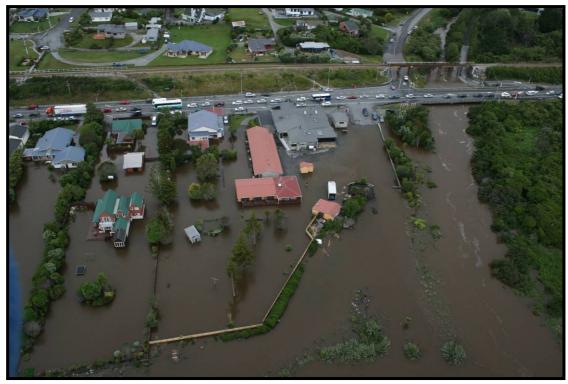
Flooding of Paroa Hotel, shop, and houses. Note the traffic backup on State Highway 6, photo courtesy of Jason Boddy

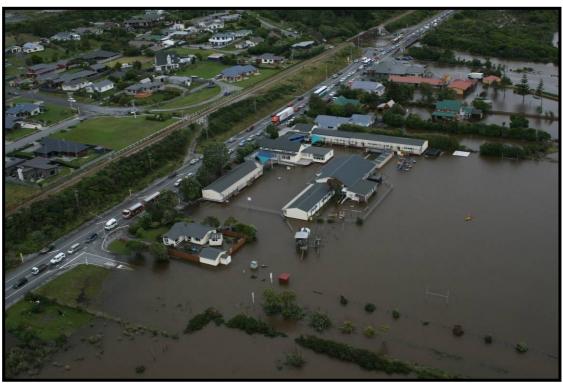
Flooding at school and surrounding properties, photo courtesy of Jason Boddy

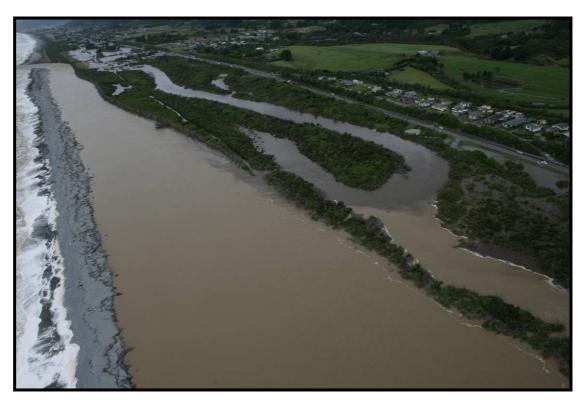
New River (light brown colour) meeting Saltwater Creek during the event, photo courtesy of Jason Boddy

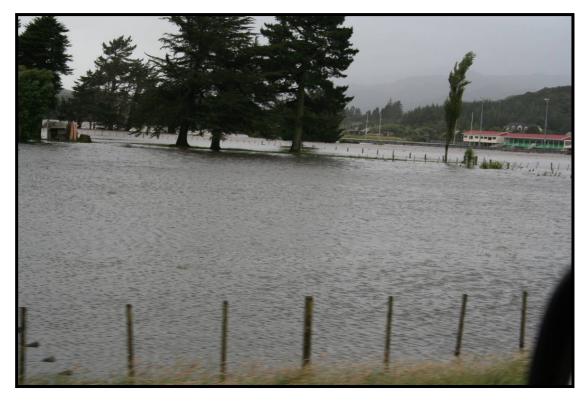
Flooding around Wingham Park, photo courtesy of J Reese.

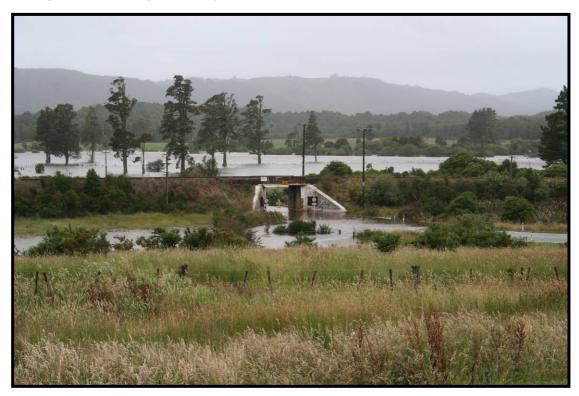
Flooding at Stillwater from the Arnold River, photo courtesy of J Reese

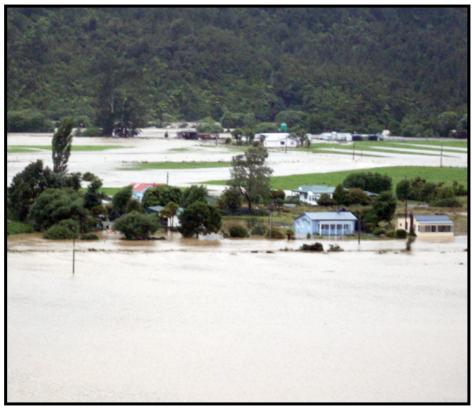
Mohikinui River in flood around Seddonville. Morning of 28/12/201

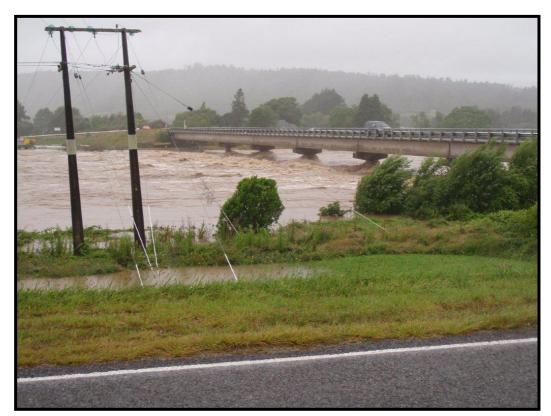
Karamea River bridge looking north 28/12/2010. Photo taken by Hamish Macbeth.
