Review of West Coast Region Coastal Hazard Areas

Prepared for West Coast Regional Council

June 2012

NIWA Client Report No: CHC2012-081
Report date: June 2012
NIWA Project: ELF12226

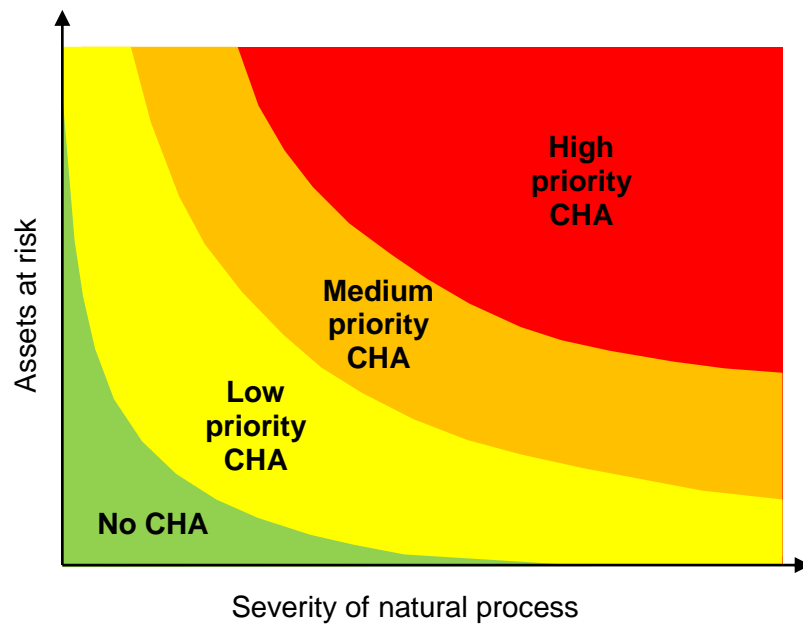
Figure 2-1: Schematic representing prioritisation process used in this report.

After mapping and recording the 'new' recommended CHAs, we applied a simple qualitative prioritisation of the hazard risk that they present (see Figure 2-1). This used 'expert opinion' to implement the simple definition that $\text{Process} \times \text{Assets} = \text{Hazard}$, or, in other words, the severity of process (likelihood) and the assets at risk (consequences) equal the risk. This prioritisation should be considered a 'first-pass' at identifying high, medium and low priority CHAs. The focus is on identifying high risk areas (NZCPS Policy 24) to allow for appropriate management of high risk areas and communities.

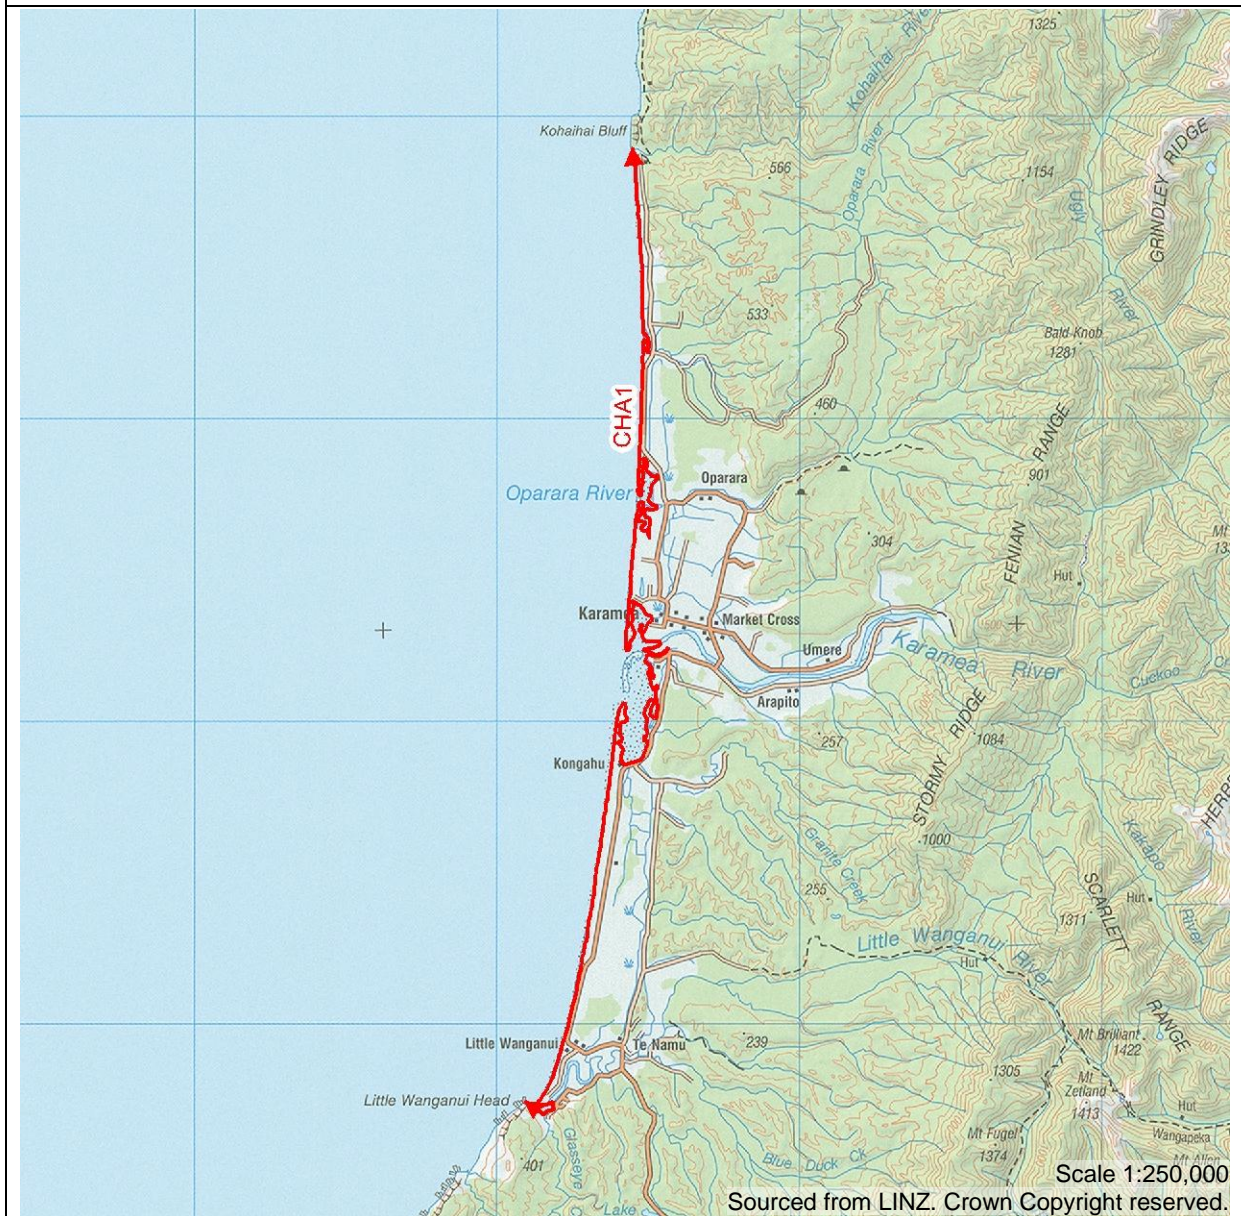
CHA1 extends from Kohaihai Bluff (**BP22 244 489**, 1524460mE, 5448930mN) to Little Wanganui Head (**BQ22 208 174**, 1520890mE, 5417460mN). It includes the Break Creek mouth, Oparara River mouth and Estuary, the Karamea River mouth and the Karamea/Otumahana Estuary, and the Little Wanganui River.

CHA1	Karamea
Assets at risk	<p>Buildings: Residences around the Karamea/Otumahana Estuary are threatened by erosion and flooding.</p> <p>Road: SH67 Karamea Highway is exposed to erosion as it passes around the backshore of the Karamea/Otumahana Estuary. Sections of the Karamea-Kohaihai Road are exposed to erosion where it passes the Oparara Lagoon and Break Creek.</p> <p>Recreation: DoC Heaphy track facilities are threatened, as is the Golf Course at Karamea.</p> <p>Farmland: Farmland is at threat from erosion and flooding.</p>
Hazard processes	<p>Erosion: Migration of the Karamea River mouth, Oparara River mouth and Break Creek mouth can directly erode land during migration as well as change the exposure of the backshore to erosion from swell and storm waves. There is also erosion of the open coast by storm waves.</p> <p>Flooding: Wave washover flooding can affect low lying land during storms. The estuary mouths close infrequently but when they do it can result in flooding due to back up of water behind them.</p> <p>Dune blowouts: Dune blowouts can deposit large amounts of dune sand on to land immediately behind the existing dune line.</p>

Priority assessment	<p>Medium: moderate numbers of assets are at risk. Existing management measures are reasonably effective at reducing hazard.</p>
Existing management	<p>River/lagoon stopbanking exists around Karamea to provide protection from river floods. There are also some short sections of erosion and/or flood protection around other parts of the Karamea lagoon. Part of the Karamea-Kohaihai Road is protected by rock armour adjacent to the Oparara Lagoon. The Karamea River mouth has been mechanically opened in the past to alleviate flooding caused by mouth closure.</p>

CHA1	Karamea
Relevant references	<p>Goss, I. W. (2004) <i>Review of coastal conditions – Resource Consent RC04/14</i>, prepared for Mr Steve Payne by OCEL Consultants NZ Ltd.</p> <p>Goss, I.W. (2005) <i>Review of coastal erosion – property at Beach Road, Birchfield</i>, prepared for Mr Blair Colligan by OCEL Consultants NZ Ltd.</p> <p>Goss, I.W. (2005) <i>Review of coastal erosion – property at Manns Road, Birchfield</i>, prepared for Mr Mark Rapley by OCEL Consultants NZ Ltd.</p> <p>Goss, I. W. (2008) <i>Review of coastal erosion hazard – Property at Oparara Estuary</i>, prepared for Kowhai Farms Ltd by OCEL Consultants NZ Ltd.</p> <p>Rose, R. (2006) <i>Hazard Report Kongahu Beach Karamea</i>, CRL Energy Ltd, Report Ref: 06-41141</p>
Notes	<p>This CHA is based on the previous CHA 1. The northern limit has been extended from Oparara up to Kohaihai Bluff to include the road and DoC Heaphy Track facilities.</p>

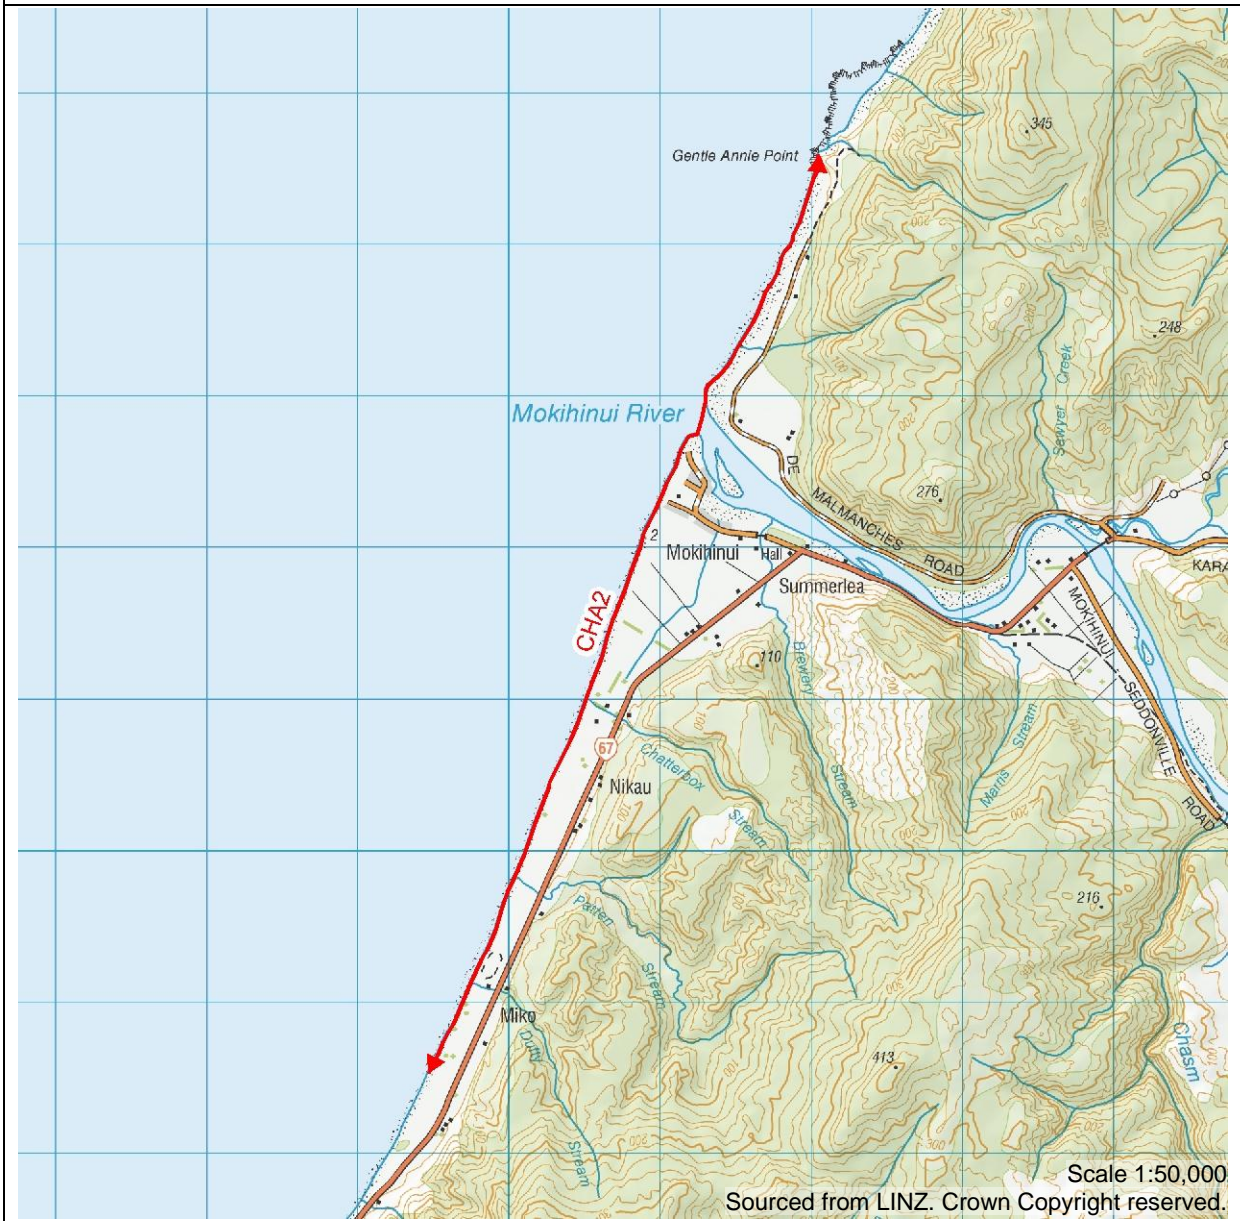
CHA2 extends from Gentle Annie Point (**BR21 120 046**, 1512040mE 5404600mN) to the south of Miko (**BR21 094 985**, 1509460mE 5398530mN)

Buildings: Residences at Mokihinui and Gentle Annie are threatened by erosion and flooding.

Erosion: Long term erosion affects the coastline along this CHA. Erosion rates are higher nearer the Mokihinui River mouth. Mouth migration also threatens to cause erosion to the north bank of the Mokihinui River mouth.

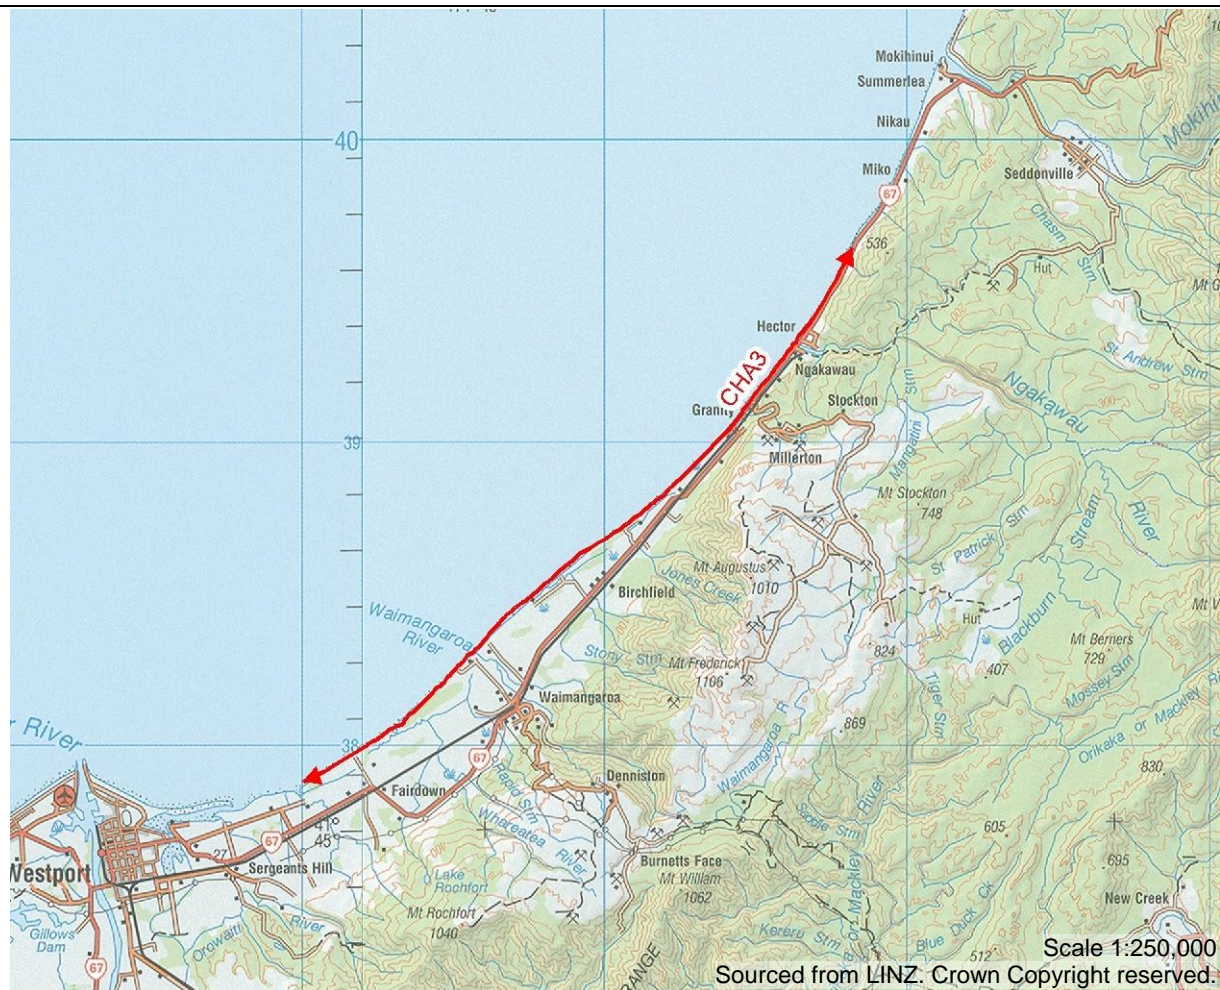
CHA3 extends from 400m north of Lamplough Stream (**BR21 081 964**, 1508180mE 5396440mN) to the mouth of the Orowaiti Lagoon (**BR20 900 788**, 1490040mE 5378800mN). The CHA includes Hector, Ngakawau and Granity as well as the Ngakawau and Waimangaroa Rivers and several smaller creeks.

Buildings: Residential properties and school in Granity, Hector and Ngakawau are affected by erosion and flooding. In general, property to the west of SH67 in Hector, Ngakawau and Granity is very vulnerable to erosion and flooding. New subdivisions at the south end of the CHA have been set back to allow for continuing erosion.

CHA3	Hector, Ngakawau and Granity
Hazard processes	<p>Erosion: The shoreline in CHA3 is experiencing long term erosion combined with short-medium term (1-20 year time frame) cycles of accretion and erosion. Erosion is caused by wave driven abrasion and transport of material northward exceeding sediment supply from rivers and from the coast to the southwest. Erosion rates vary over the length of the CHA as well as over time due to varying wave conditions and sediment inputs from rivers. Temporal variability is greatest near the mouths of the Ngakawau and Waimangaroa Rivers. Erosion rates in this CHA are sensitive to changes in sediment supply from the southwest (for example: sea-level rise resulting in build-up of beaches and storage of sediment west of the Buller River training walls). Any management practices which affect sediment delivery or movement along the shore within this CHA (i.e. groynes, beach mining or seawalls) have potential to impact on erosion rates/patterns.</p> <p>Flooding: The low lying coastal land in this CHA is subject to wave washover flooding during storms. This risk is increased by erosion of the gravel barrier at the back of the beach.</p>

Priority assessment	<p>High: Many buildings are at risk from coastal erosion in the near future (notably the Granity School). Coastal hazards are having a severe impact on the communities along this CHA.</p>
Existing management	<p>At various properties in Hector, Ngakawau and Granity, sea walls or bunds have been constructed. These are highly variable in design and condition. Whilst effective in the short term, these structures will not provide long term protection. Vegetated buffer zones have been planted along some parts of the coast to help slow erosion. At some river/creek mouths rip-rap armouring has been used to prevent mouth migration.</p>

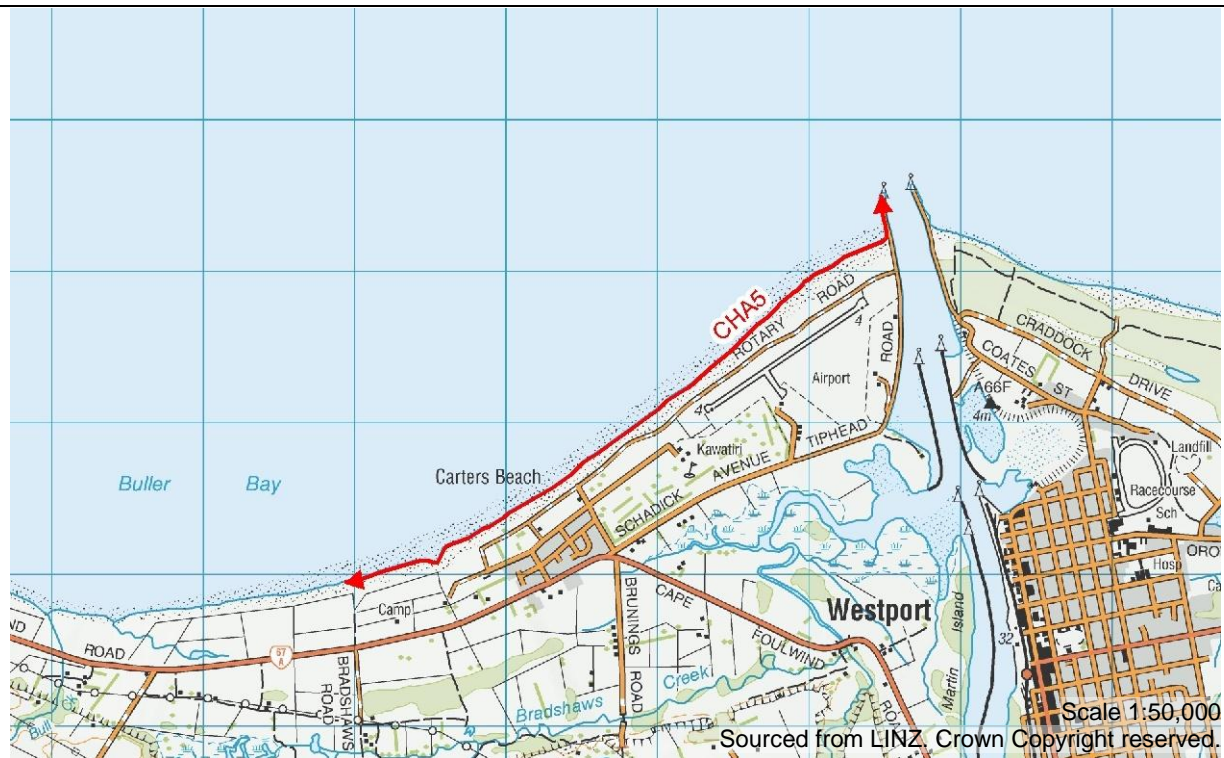
This CHA extends from the Buller River mouth (**BR20 824 795**, 1482470mE 5379510mN) to a point level with Bradshaws Road, west of Carters Beach (**BR20 789 769**, 1478930mE 5376950mN).

Recreation facilities: The sports fields of the domain are being affected by erosion and wave overtopping. The unsealed access road between the sports fields and beach (Rotary Road) has been truncated and closed due to erosion.

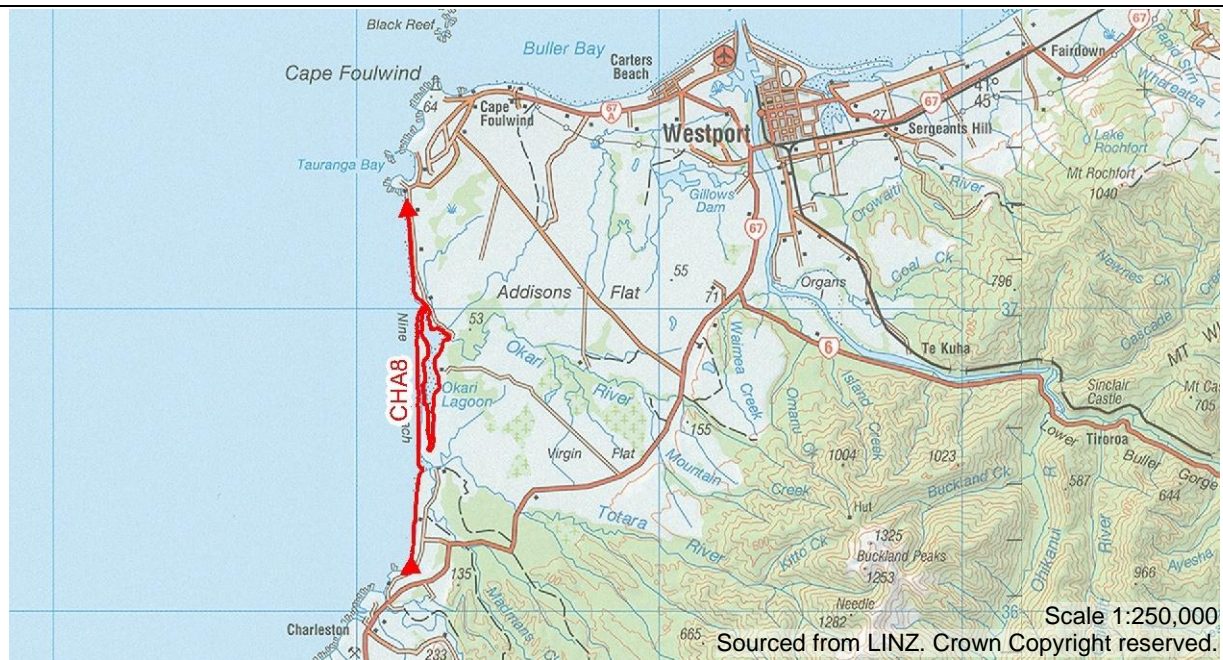
The Nine Mile Beach CHA stretches from near the north end of the beach (**BR20 716 736**, 1471680mE 5373610mN) to Parsons Hill at the south end of the beach (**BS20 715 612**, 1471550mE 5361270mN). The CHA includes the Okari Lagoon and the mouth of the Totara River.

Buildings: Generally, buildings along this stretch of coast are adequately set back to manage their exposure to coastal hazards. With further development and continuing erosion there may be increasing hazards to buildings in the future.

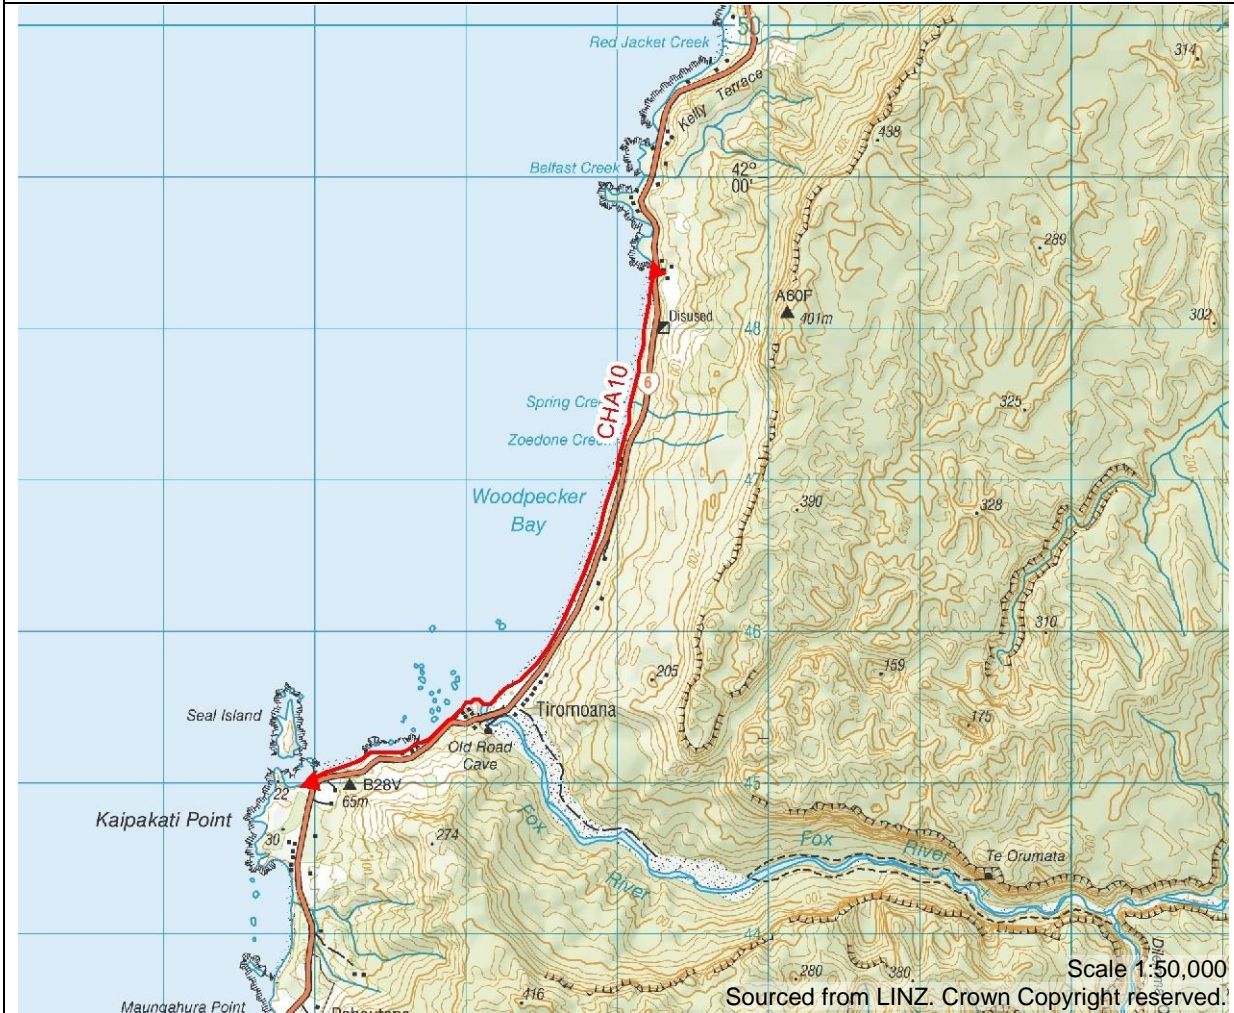
The Woodpecker Bay CHA extends from **BS19 672 484** (1467220mE 5348440mN) to **BS19 649 449** (1464910mE 5344980mN). This CHA includes Tiromoana and the mouth of the Fox River.

Assets at risk	<p>Road: SH6 is threatened by erosion and flooding at several locations.</p> <p>Buildings: Baches are threatened by erosion and flooding.</p>
Hazard processes	<p>Erosion: Woodpecker Bay is a pocket beach with limited sediment supplies (main source Fox River). The erosion focus is towards the centre and northern parts of the bay because these areas have greater exposure to south westerly and westerly swells, and experience greater northerly drift.</p> <p>Flooding: Wave washover flooding affects the land immediately behind the beach.</p>
Priority assessment	<p>Medium: SH6 is severely threatened by erosion for an extended distance within this CHA but there are few other assets at risk.</p>

CHA10	Woodpecker Bay
Existing management	Rock protection/seawalls have been installed to protect some existing baches and parts of SH6.
Relevant references	<p>Benn, J. (2004) <i>Assessment of Environmental Effects of Proposed Gravel Extraction from the Fox (Potikohua) River: Resource Consent Application RC03329</i>, prepared for Fitzcarraldo Investments Ltd (Wellington) by DTec Consulting Ltd</p> <p>Ward, H. (2010) <i>Assessment of Environmental Effects – Woodpecker Bay Rock Protection</i>, prepared for NZTA by Opus International Consultants Ltd</p>
Notes	There is little change to this CHA from the previous CHA 6 except to extend its southern end to Seal Island to include additional locations where SH6 is at risk.

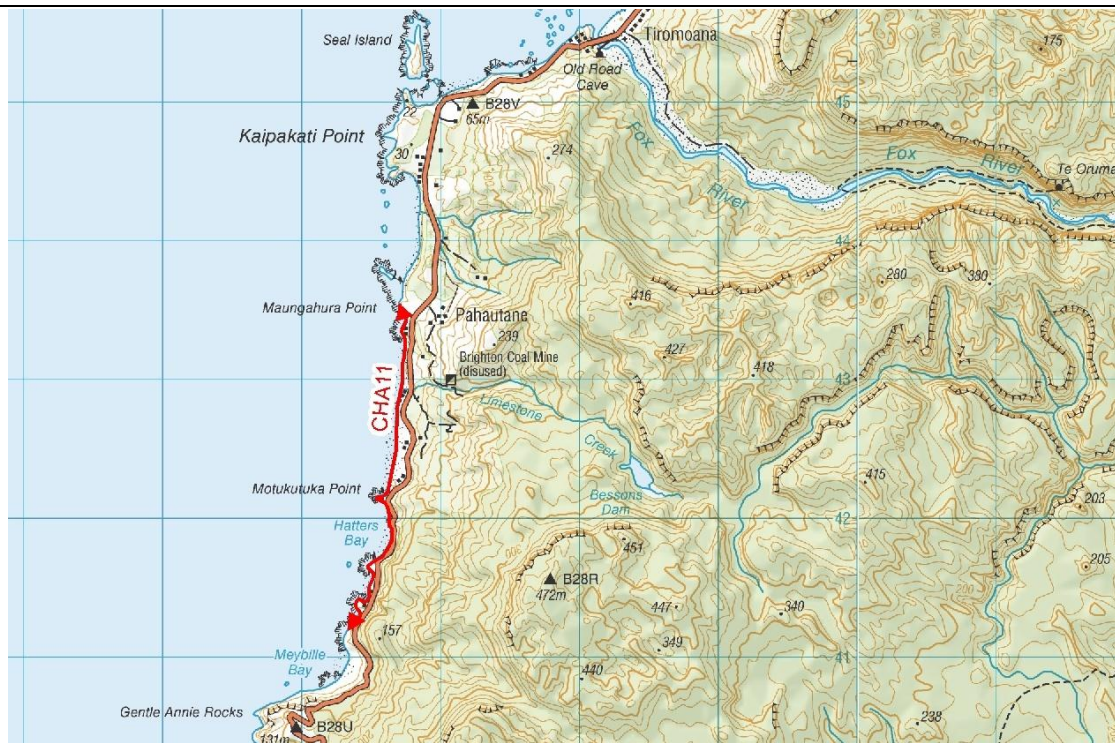
Maungahura Point to Meybille Bay

CHA11 encompasses an exposed section of coast consisting of narrow beaches between small rocky outcrops. This CHA extends from Maungahura Point (BS19 647 435, 1464700mE 5343550mN) to the rocky outcrop at the north end of Meybille Bay (BS19 643 412, 1464330mE 5341200mN)

Road: SH6 is very close to the shoreline along the length of this CHA and is threatened in several places. Scale 1:50,000 Sourced from LINZ. Crown Copyright reserved.

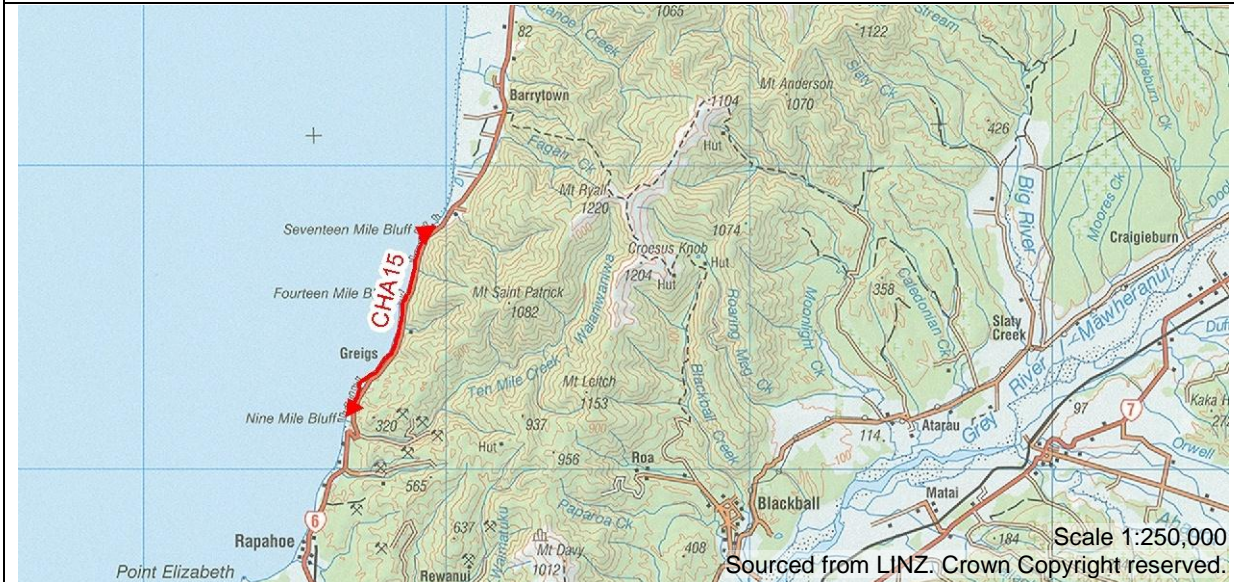
CHA 15 stretches from the end of CHA 14 at 17 Mile Bluff (**BT19 596 180**, 1459640mE 5318010mN) to 10 Mile Creek (**BT19 567 117**, 1456720mE 5311720mN). The CHA includes the small settlement of Greigs.

Assets at risk	<p>Road: SH6 is threatened in several locations along this CHA.</p> <p>Buildings: Several houses/baches to the west of SH6 are at risk.</p>
Hazard processes	<p>Erosion: Erosion of low lying areas fronted by beaches as well as slope erosion of steeper parts of the coastline can affect parts of this CHA. Erosion risk is very variable along the CHA depending on local geology and wave exposure.</p> <p>Flooding: Wave washover flooding can affect lower lying portions of this CHA.</p>
Priority assessment	<p>Low: Erosion rates are generally low and the hazard is currently being adequately managed through the use of short sections of armour/seawall.</p>
Existing management	<p>Rock armour has been placed to protect the highway in several locations. At least one house owner has also installed a short section of concrete seawall to protect their property.</p>
Relevant references	<p>Cave, M.P. (2007) <i>Natural Hazard Assessment of Section 1, 12 Mile Beach Community, Greymouth</i>. Resource Solutions</p> <p>Todd, D. (2006) <i>Coastal Hazards Assessment: Wild Weka Limited Property (RS3629), 13 Mile, West Coast</i>. Report for John and Karen Warren by DTec Consulting Ltd. (Peer reviewed for Grey District Council by I.W. Goss, OCEL Consultants NZ Ltd.)</p>

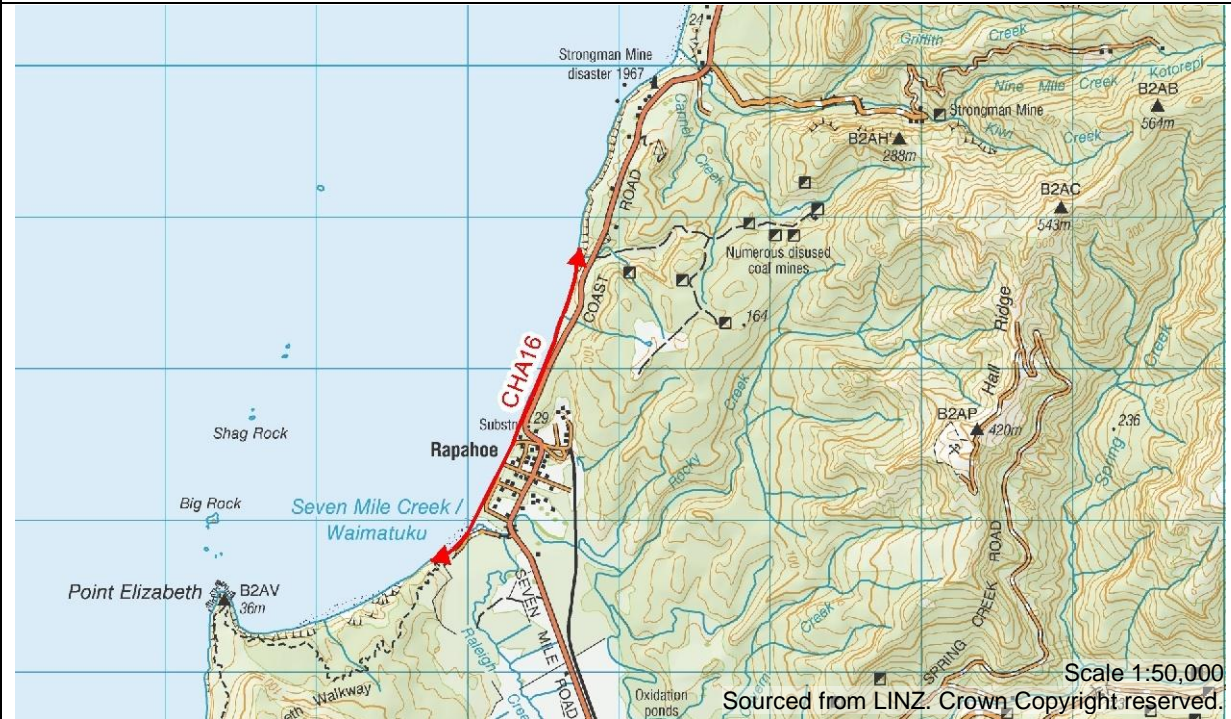
The Rapahoe CHA stretches from about 1.5km north of Rapahoe (**BT19 557 088**, 1455740mE 5308810mN) to south of Seven Mile Creek (**BT19 547 067**, 1454750mE 5306740mN).

Buildings: Several properties in Rapahoe are at risk of erosion including residences, the pub and campground. Several undeveloped sections are also at risk.

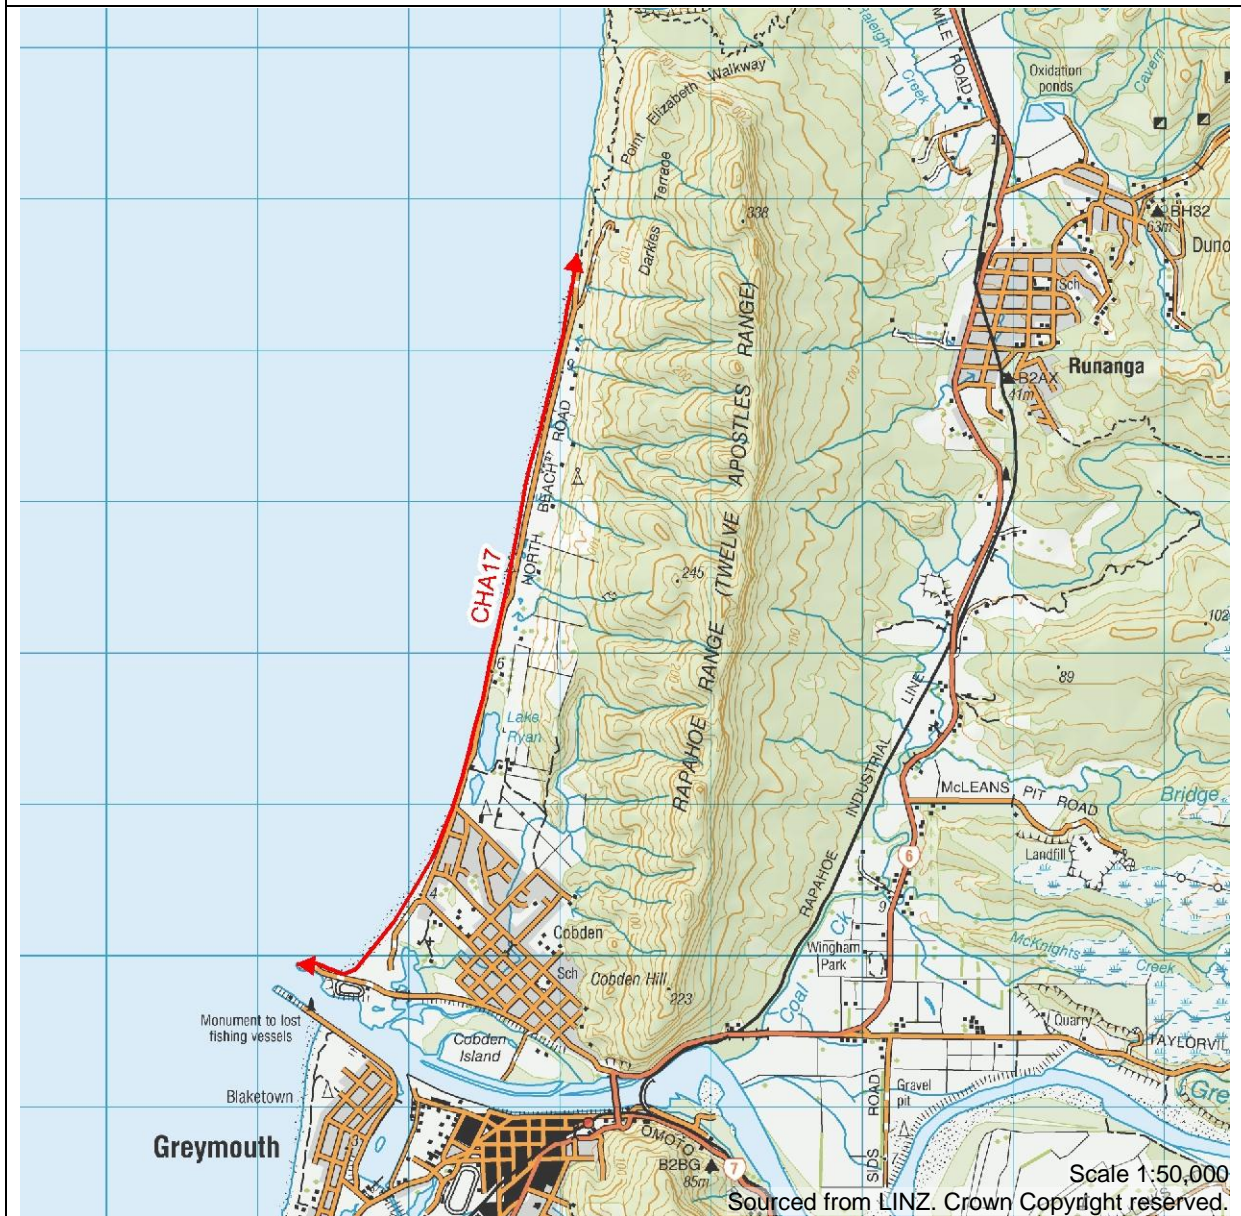
CHA 17 extends from the end of North Beach Road, north of Cobden (BT19 531 046, 1453110mE 5304640mN) to the mouth of the Grey River (BT19 512 999, 1451260mE 5299950mN). The CHA includes Cobden Beach.

Buildings: Houses in Cobden are threatened by erosion and flooding.

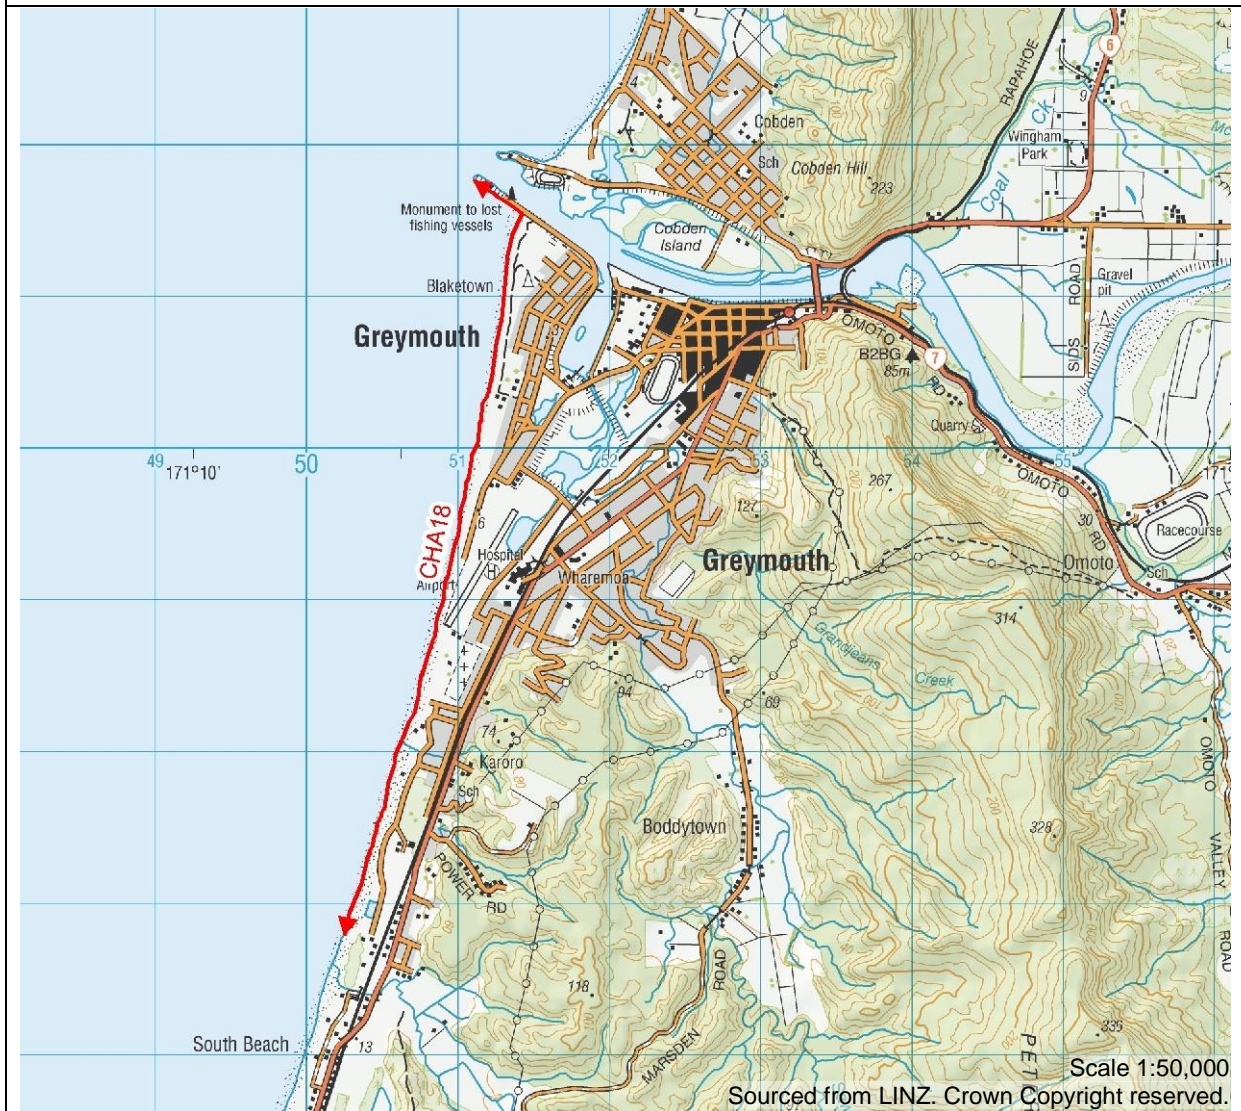
CHA 18 extends from the mouth of the Grey River (**BT19 511 997**, 1451100mE 5299770mN) to between Karoro and South Beach (**BU19 502 947**, 1450250mE 5294790mN). The CHA includes Blaketown Beach.

Airport: The corner of the Greymouth airport runway enclosure at Karoro is threatened with erosion.

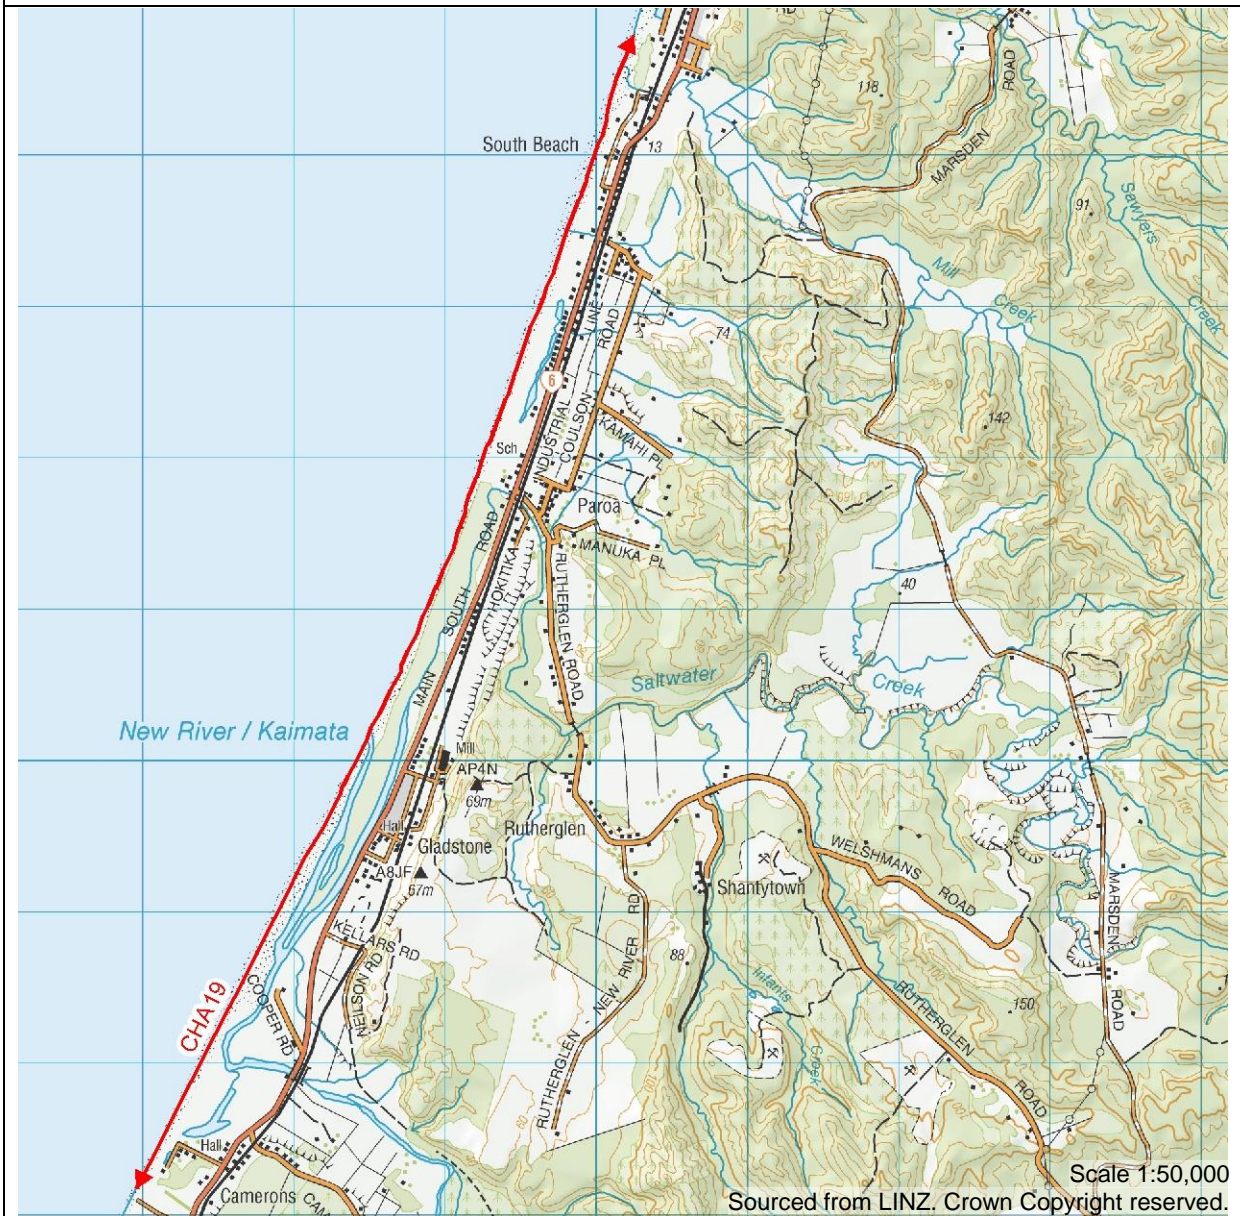
CHA19 covers the stretch of coast from north of South Beach (**BU19 502 947**, 1450250mE 5294790mN) to Camerons (**BU19 469 871**, 1446960mE 5287180mN) including Paroa and Gladstone. CHA19 includes the mouth of the New River / Kaimata.

Buildings: Several properties including the school, hotel and houses have been affected by flooding.

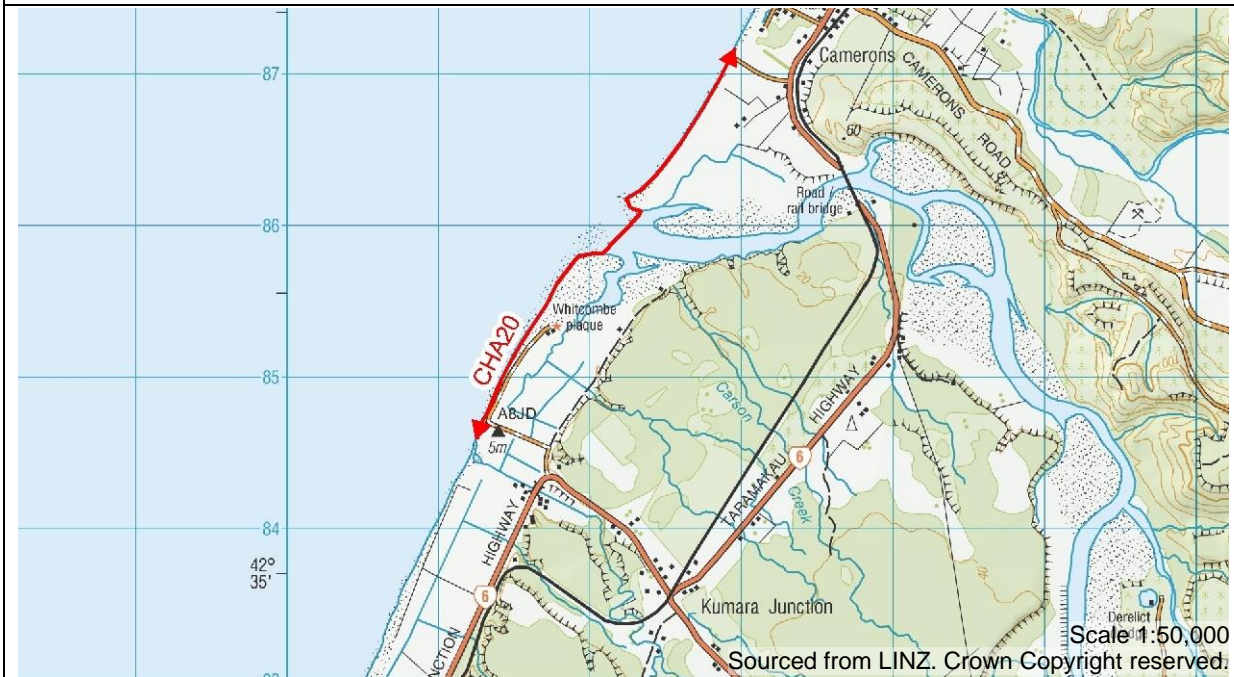
This CHA covers the beach north and south of the mouth of the Taramakau River from (BU19 460 585, 1446080mE 5285820mN) to (BU19 524 846, 1445240mE 5284600mN).

<p>Assets at risk</p>	<p>Buildings: Two houses are at risk on the south side of the Taramakau mouth.</p> <p>Road: The minor access road to the south side of the Taramakau mouth is at risk (Serpentine Road).</p> <p>Farmland: Farmland on the both sides of the Taramakau mouth is at risk from erosion.</p>
<p>Hazard processes</p>	<p>Erosion: Movement of the Taramakau River mouth can cause erosion on either the south or north banks. The mouth is currently offset to the south and the main erosion risk is to the south bank. However, prior to the late 1990's the mouth flowed to the north much of the time with erosion affecting the north bank.</p> <p>Flooding: Flooding due to storm waves affects parts of this CHA.</p>
<p>Priority assessment</p>	<p>Low: There are few assets at risk and the hazard on the south bank is currently being managed though mechanical relocation of the mouth and erosion protection measures.</p>

<p>Existing management</p>	<p>Rock erosion protection has been installed in front of the houses and new channels have previously been cut if the mouth becomes displaced to the south to attempt to maintain a more central mouth location. Gravel extraction occurs on the Taramakau River between the road/rail bridge and the coast.</p>

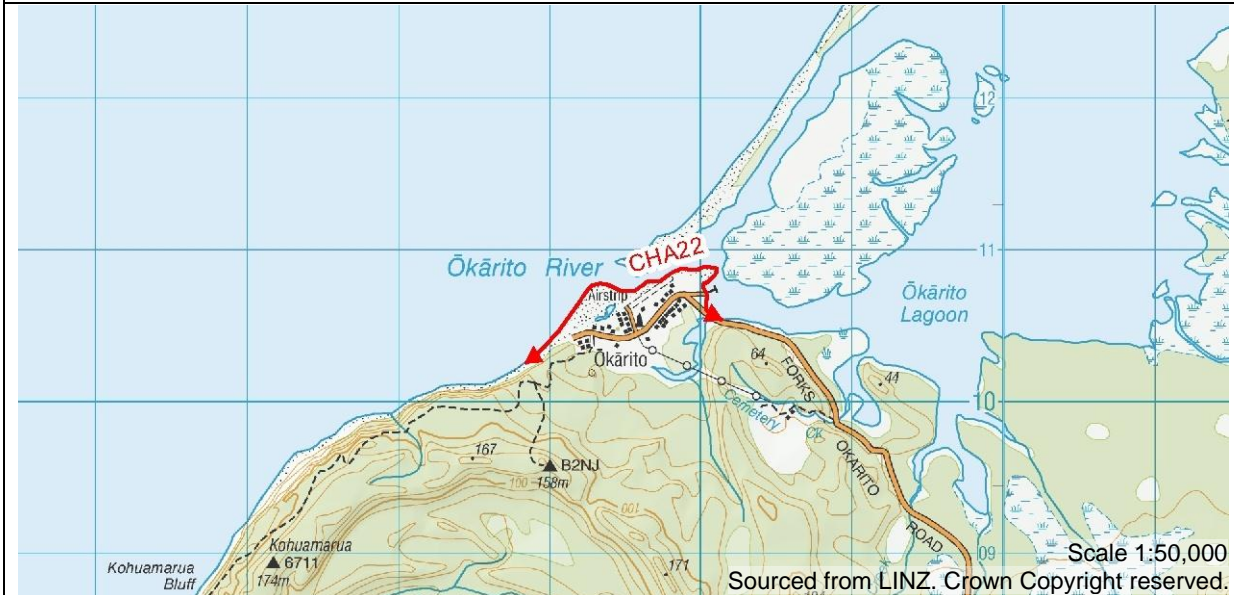
This CHA covers the south side of the Ōkārito Lagoon mouth, around the settlement of Ōkārito (**BW15 701 105**, 1370140mE 5210540mN to **BW15 688 102**, 1368830mE 5210250mN).

<p>Assets at risk</p>	<p>Buildings: Parts of Ōkārito settlement are at risk from flooding and erosion including houses, hostels, campground and the airstrip.</p> <p>Road: Roads within Ōkārito are affected by flooding.</p> <p>Recreation: Recreation opportunities are affected by flooding, including historic sites and tourist accommodation.</p>
<p>Hazard processes</p>	<p>Flooding: Flooding from the Ōkārito Lagoon occurs due to closure of the lagoon mouth. The lagoon can close when waves drive sediment across the mouth.</p> <p>Erosion: Lagoon mouth migration can cause erosion.</p>
<p>Priority assessment</p>	<p>Medium: A moderate number of assets are affected by flooding from the lagoon, artificial opening of the lagoon mouth is used to manage this risk.</p>
<p>Existing management</p>	<p>Since 1993 there has been a consent to mechanically open the Ōkārito lagoon mouth to alleviate lagoon flooding. Culverts are in place to connect the low lying land behind the main settlement with the lagoon. Localised rock protection has been placed at the culvert entrance/exits.</p>

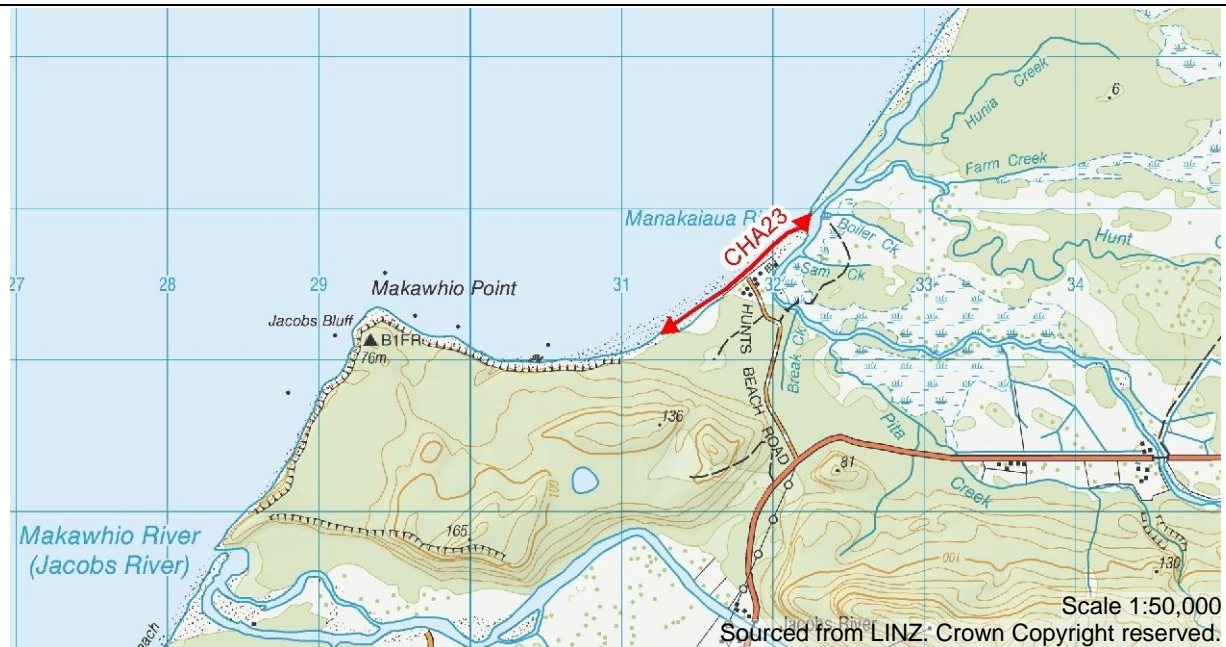
CHA 23 covers the developed part of Hunts Beach from **BX14 322 729** (1332250mE 5172970mN) to **BX14 312 721** (1331260mE 5172180mN).

Assets at risk	Buildings: The settlement at Hunts Beach is becoming more threatened by flooding as the coast continues to erode.
Hazard processes	<p>Erosion: Erosion by storm waves and mouth migration can affect Hunts beach. Erosion of the shoreline has been observed over at least the past 25 years.</p> <p>Flooding: Flooding by wave washover affects land behind the beach. With continuing erosion, flooding is starting to threaten properties at Hunts Beach.</p>
Priority assessment	Low: There are few assets at risk.
Existing management	Parts of the shoreline are protected with a raised earth bund and vegetation has been planted to help maintain it.
Notes	This CHA is based on the previous CHA 16.
