WAIHO RIVER

14 August 2014

Hydraulic Modelling and Analysis

Report prepared for WCRC by Matthew Gardner Land River Sea Consulting Ltd

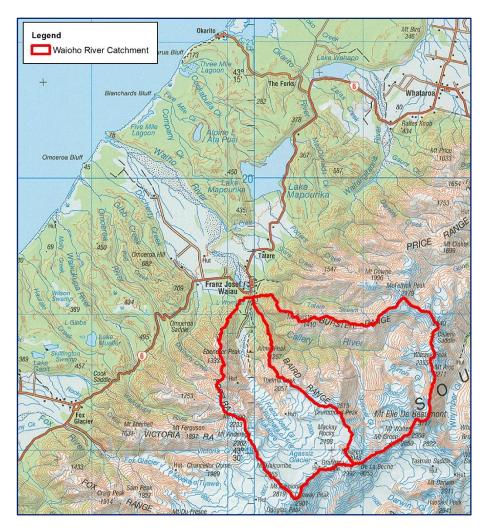
Figure 1-1 – Location and catchment boundary of the Waiho River and the town of Franz Josef

The main tributary of the Waiho River within the study area is the Callery River which enters the Waiho River immediately upstream of SH6. Figure 1-1 shows the location of the Waiho River as well as the catchment boundaries which feed the river within the study area.

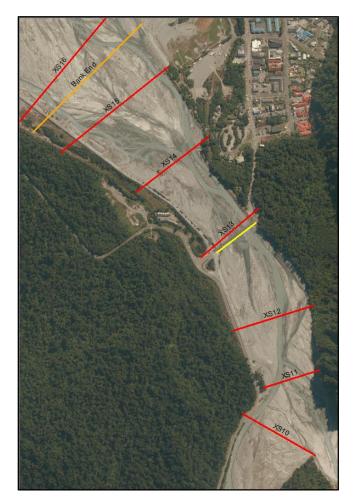
Figure 3-3 - Location of surveyed cross sections used for m.b.l analysis

The report, Waiho River – Future Management (Hall, 2012) discusses changes in bed levels prior to 2011 for the entire reach of the river from the Waiho / Callery confluence down to the Waiho Loop and concludes that bed levels are consistently aggrading over the entire reach. Due to the nature of this study focusing on the stopbanks in the vicinity of Franz Josef / Waiau township, I have looked at changes in bed levels in more detail for each individual cross section from the confluence with the Callery River (XS10) down to the start of the helipad stopbank on the true right bank (XS15) from 2008 to see if the aggradation has continued in recent years as well determine recent rates of aggradation. Figure 3-3 shows the location of the monitored cross sections.

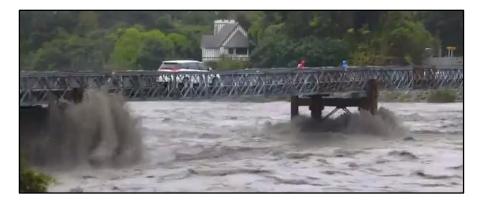
Figure 5 -1 - View of Waiho Bridge in flood (view looking downstream)

Due to the lack of flow data and the constantly changing bed levels, it has not been possible to calibrate the model to any known flood events. However, reports of previous flooding have been read and several flood photos have been observed. Of particular use was an online video from January 2013 (Charleston, 2013), showing the river in flood. This event was rated as a 1 in 8 year event in the Whataroa Catchment, however it is likely due to spatial variation in rainfall, that this differed in the Waiho Catchment. This video shows the resistance created by the bridge piers can be clearly seen. There is no blockage visible at the piers in this event and only a small degree of overall headloss is visible at the bridge. Running the model with flows less than a 10 year event without any blockage also shows only a small degree of head loss at the bridge. Figures 5-1 to 5-3 show a range of useful screenshots during a flood event.

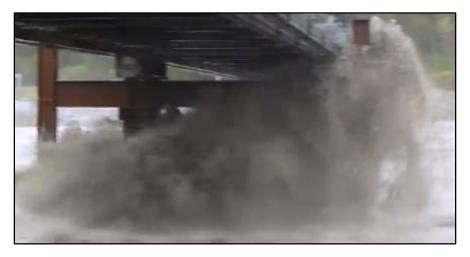
Figure 5-2 – View showing resistance at Waiho Bridge Pier during flood event

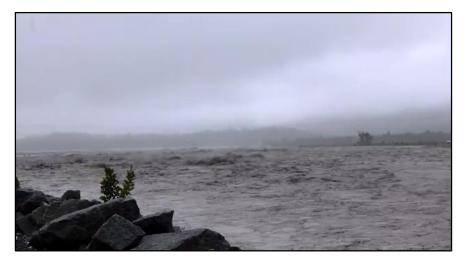
Figure 5-3 – View of Waiho River in flood downstream from SH6 Bridge

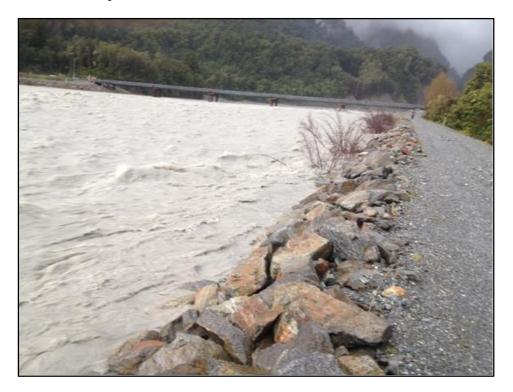
Figure 5-4 – Water level adjacent to motel units on the 23rd May 2014

Photos of the river in flood were also obtained from the owner of the motel units (Arbuckle per coms, 2014) from a small flood event on the 23 May 2014. Civil Defence staff are reported to have said that this event equated to 75 mm of rainfall in 24 hours. Whilst it is difficult to gauge a precise level from these photos, it can be seen that the water has risen fairly high up the stopbank adjacent to the motel units. Figure 5-4 shows the water level adjacent to the motel units during this event.

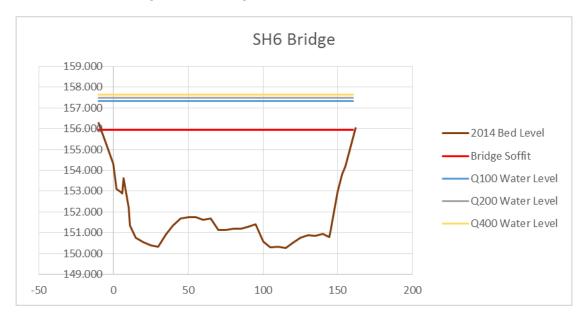
Figure 8-4 – Design water levels at SH6 bridge

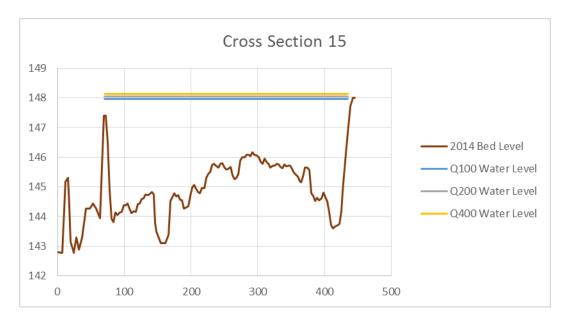
Figure 8-7 – Design water levels at cross section 15

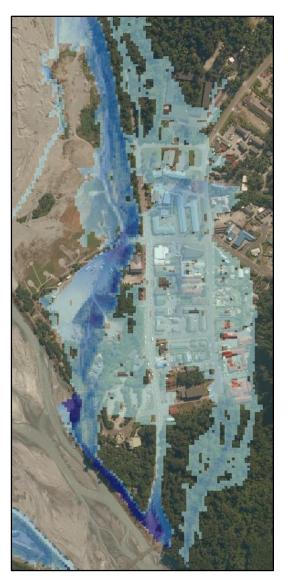
Figure 9-4 – Flood extent for a 100 year event with bed levels raised by 4m from the 2014 survey levels in the vicinity of Franz Josef town.

In order to determine how much aggradation is necessary to create an overtopping scenario, the model was run a number of times with varying degrees of aggradation. The model runs assumed as the bed levels aggrade, the current bridge will either be raised significantly to prevent overtopping or replaced and therefore the bridge deck has been removed from the model.

Figure 9-4 shows the potential flood extent for a 100 year event with bed levels being 4m higher than the 2014 survey levels.
