HOKITIKA BEACH SEA EROSION
Application for Grant Assistance

ROCK GROUYNE PROPOSAL

September 1986

HOKITIKA BEACH SEA EROSION
APPLICATION FOR GRANT ASSISTANCE
ROCK GROUYNE PROPOSAL - SEPTEMBER 1986

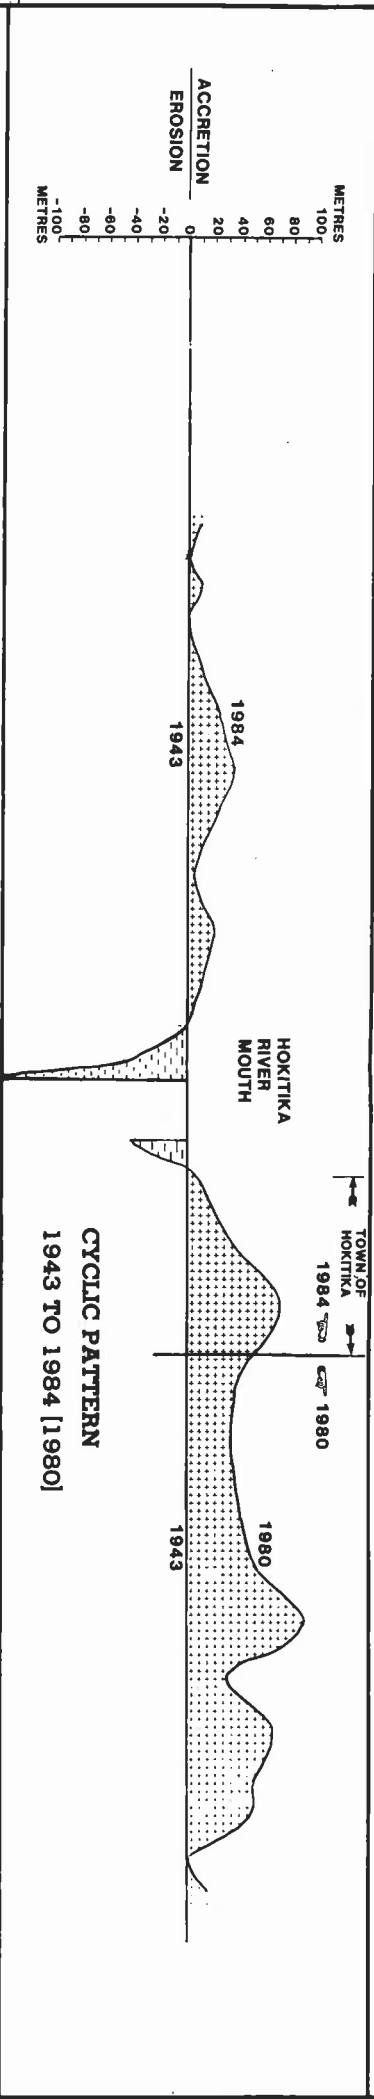
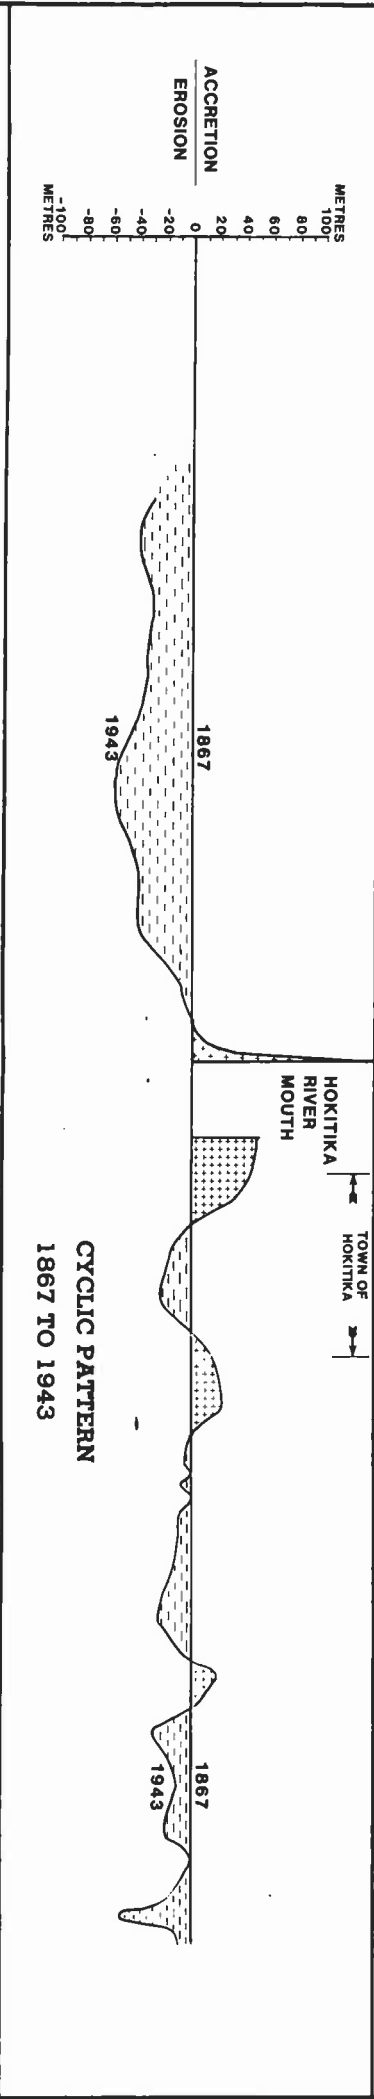
906/209 A1
 SHEET 3 OF 5 SHEETS

906000 HOKITIKA SEA EROSION
 Historical Shoreline Movements 1867 - 1984

Plan numbers 906/209/2,3 & 5, pages 16 to 18, show historic shoreline and toe of foredune movements, 1867 - 1984.

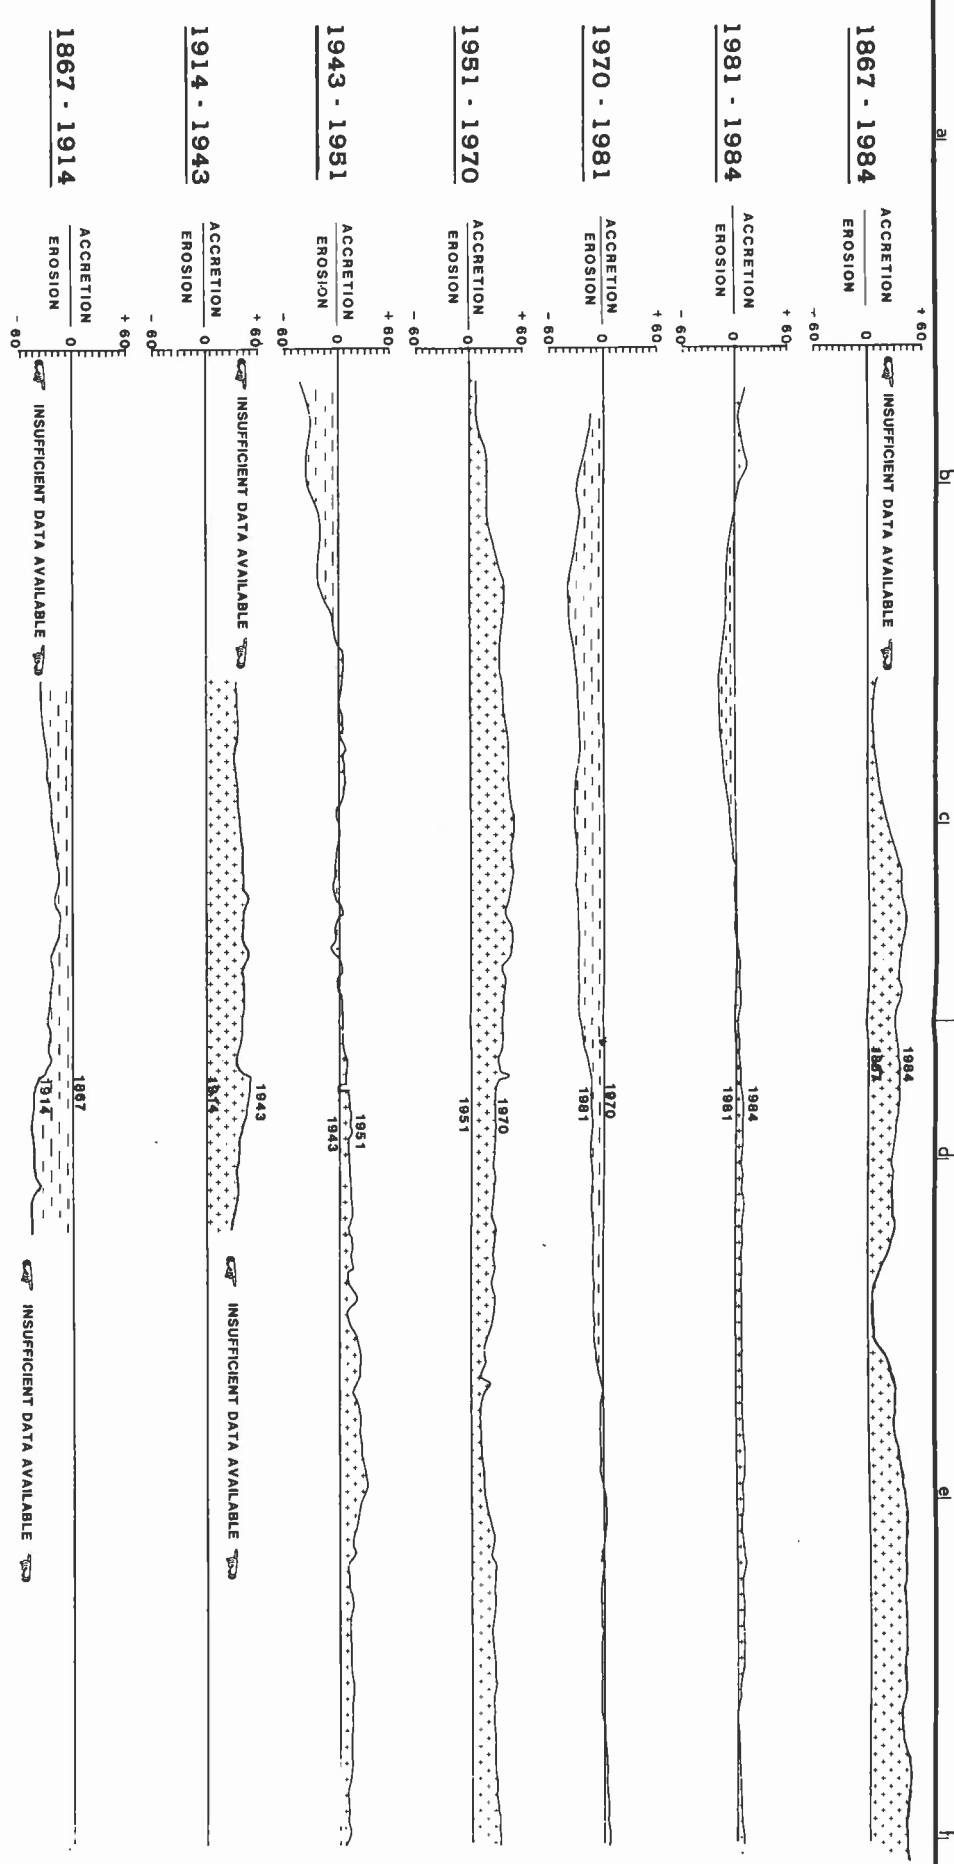
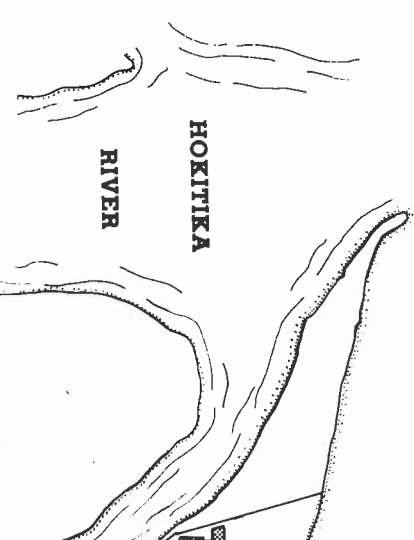
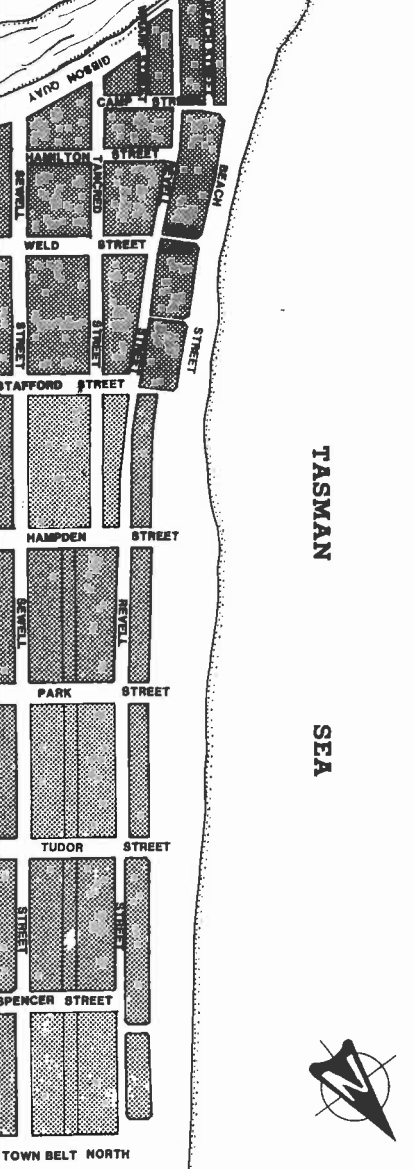
Author	W. Moen
Reference	10/9/86
Scale	1:500
Sheet	5
OF	5
SHEETS	
Project No.	906/209 A1

WESTLAND CATCHMENT BOARD
 906000 HOKITIKA SEA EROSION
 Foredune Toe Movements. 147m = 100ft

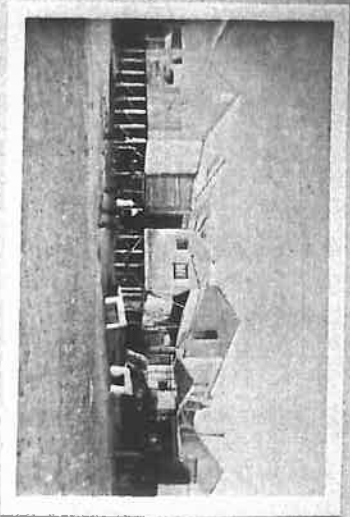
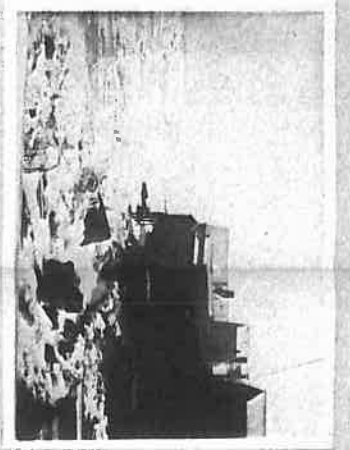
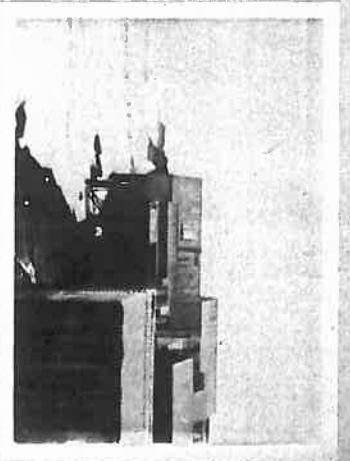
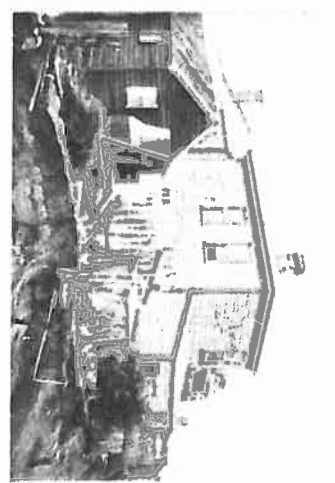
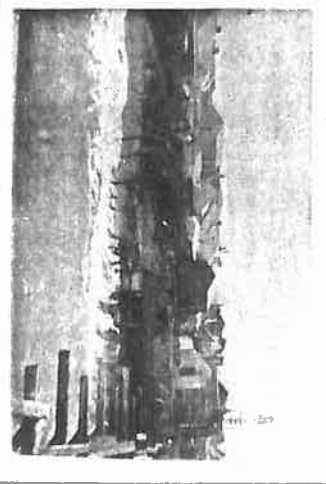
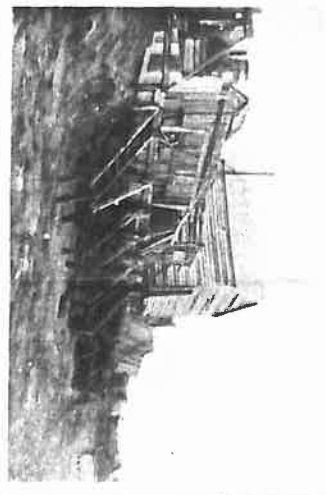
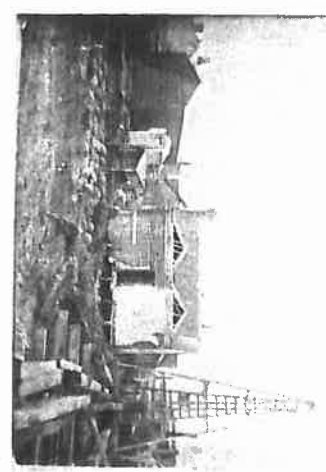
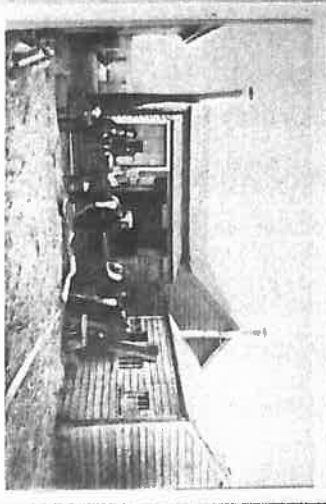
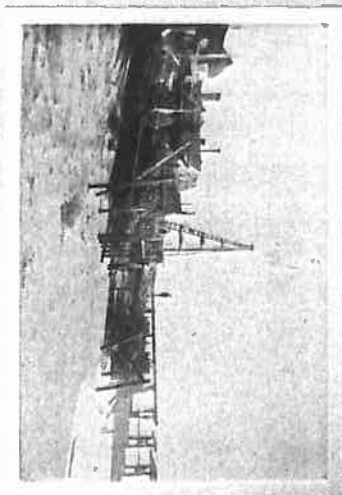
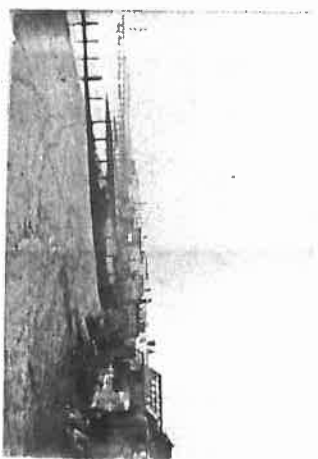
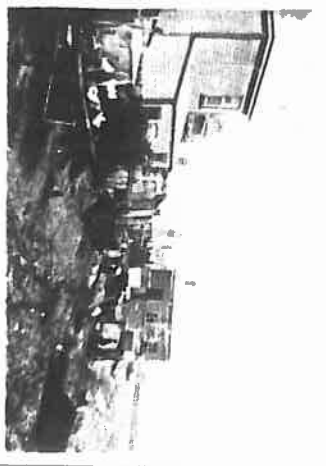
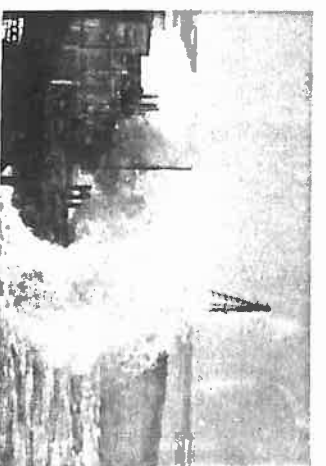
HOKITIKA BEACH EROSION

10 MAY 1914

Ben Thiem Collection

In 1914 timber groynes were constructed normal to shoreline to the design of Sharpe. See photos from "Ben Their collection" dated 10 May 1914, pages 19 and 20.

From papers by Sharpe, reference 2, groynes appear to have been very successful, the beach is reported to have aggraded rapidly. A key factor, identified by Sharpe, was the raising of the groynes one plank at a time as the beach built up. This reduced scour due to wave reflection and limited wave loading on the structures.

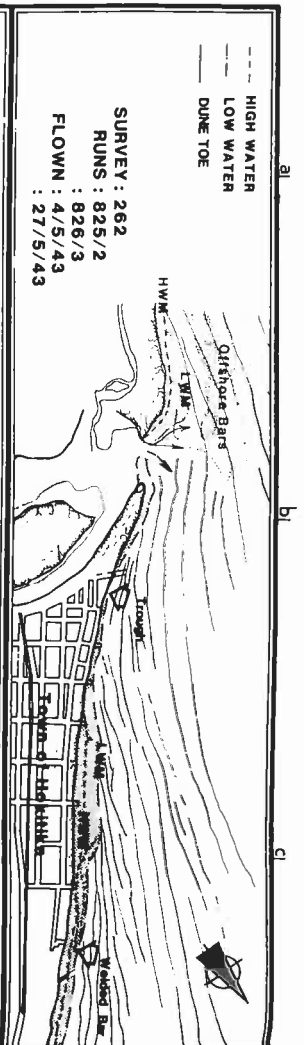
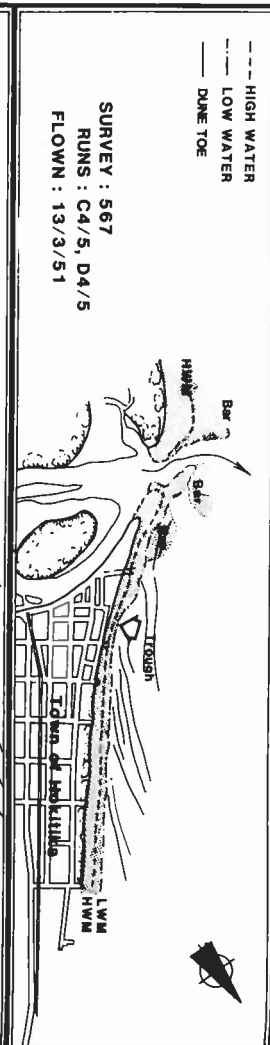
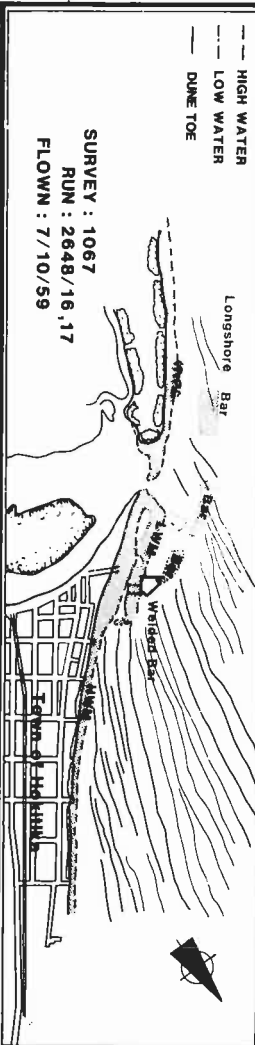
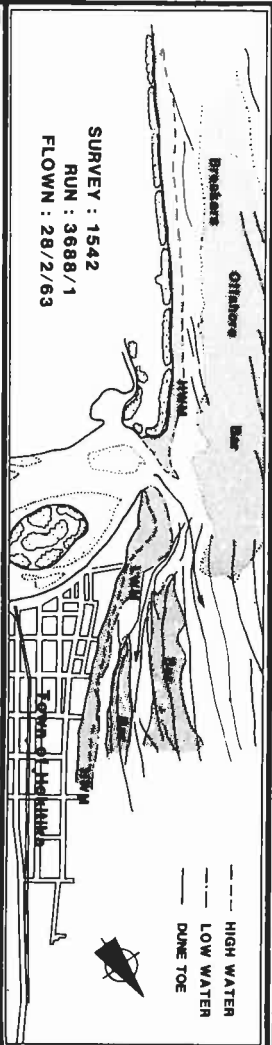
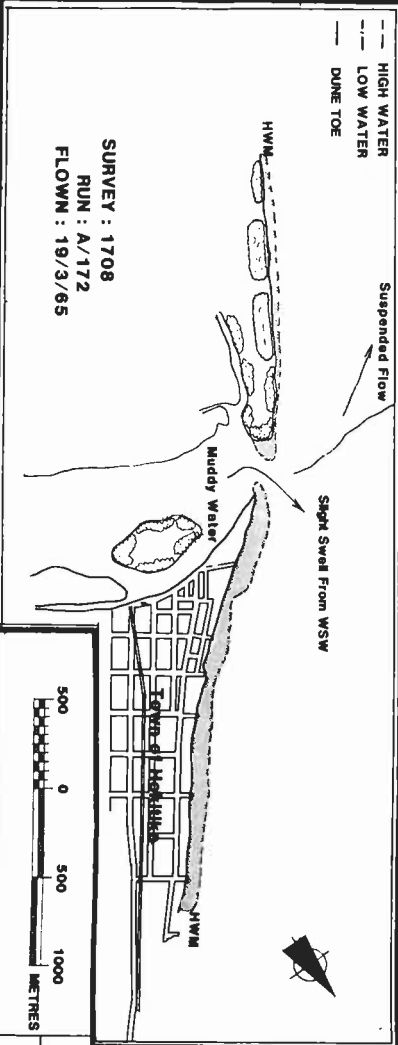
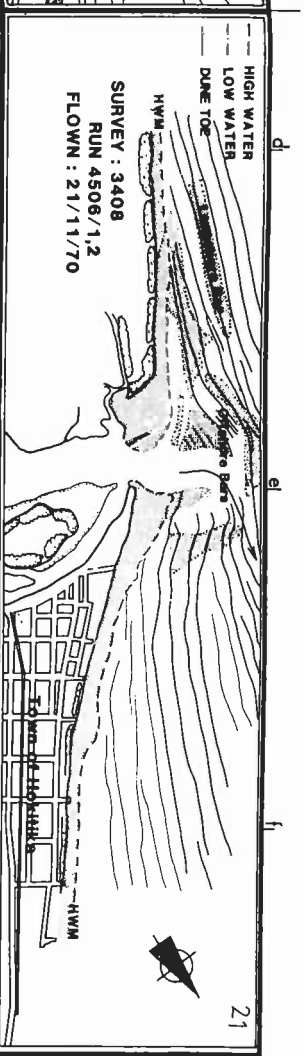
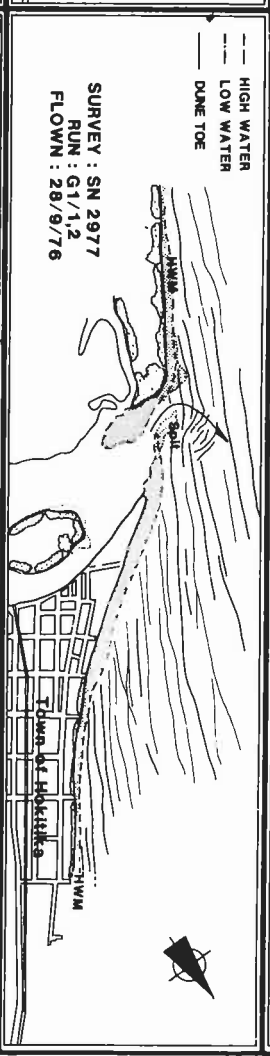
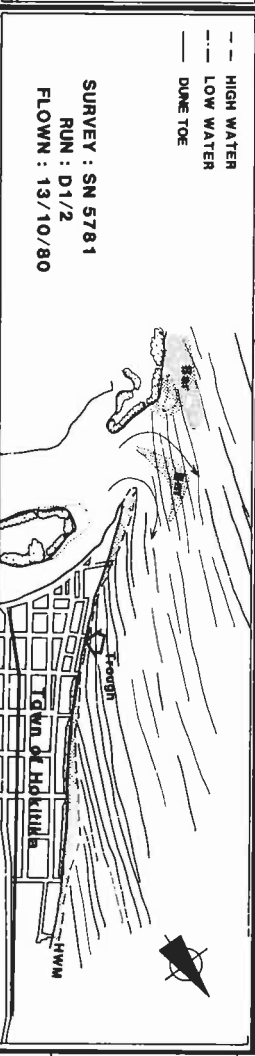
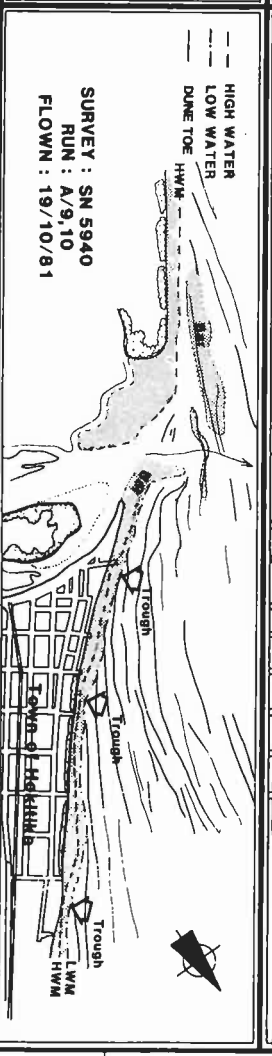
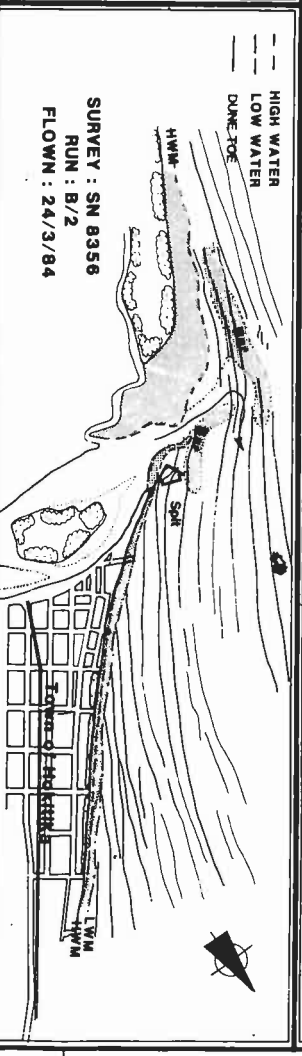
Reference	<i>Magyes-Klein</i> <i>Richard 1982</i>	SHEET	1
No.	906/209	OF SHEETS	5
			A1

WESTLAND CATCHMENT BOARD
906000 HOKITIKA SEA EROSION
Coastal Processes 1943 : 1984

Plan number 906/209/1, page 21, shows the coastal processes over the period 1943 - 1984, in particular, the effect of the river mouth direction on coastal erosion.

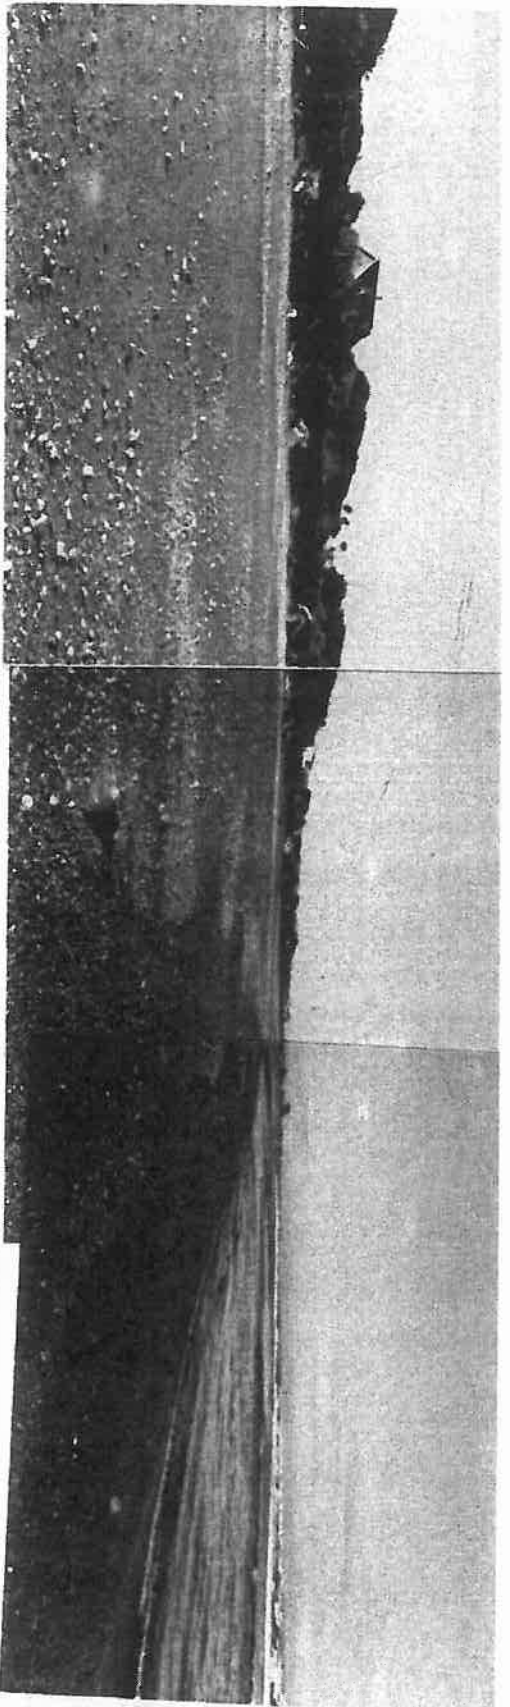
10am TUES . 9 SEPT, 1986

TUDOR STREET LOOKING SOUTH G.NICHOLLS HOUSE ON LEFT

Since April 1984 the northern section has eroded back at rates of up to 45,000 cubic metres per month. Plan number 906/226, page 23, shows beach volume between Hampden Street and Richards Drive. Also see photos showing extent of erosion in Tucor Street area at September 1986, page 24.

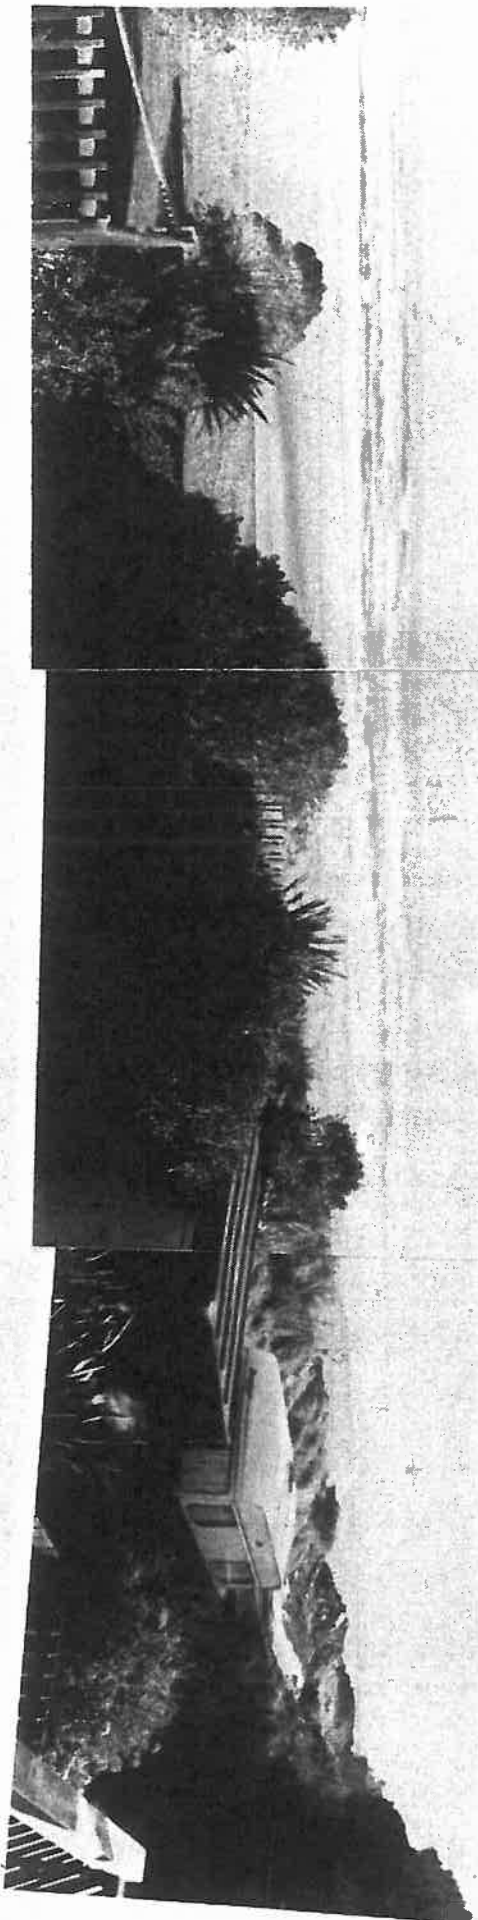
FROM BALCONY OF G.NICHOLLS HOUSE LOOKING N/W

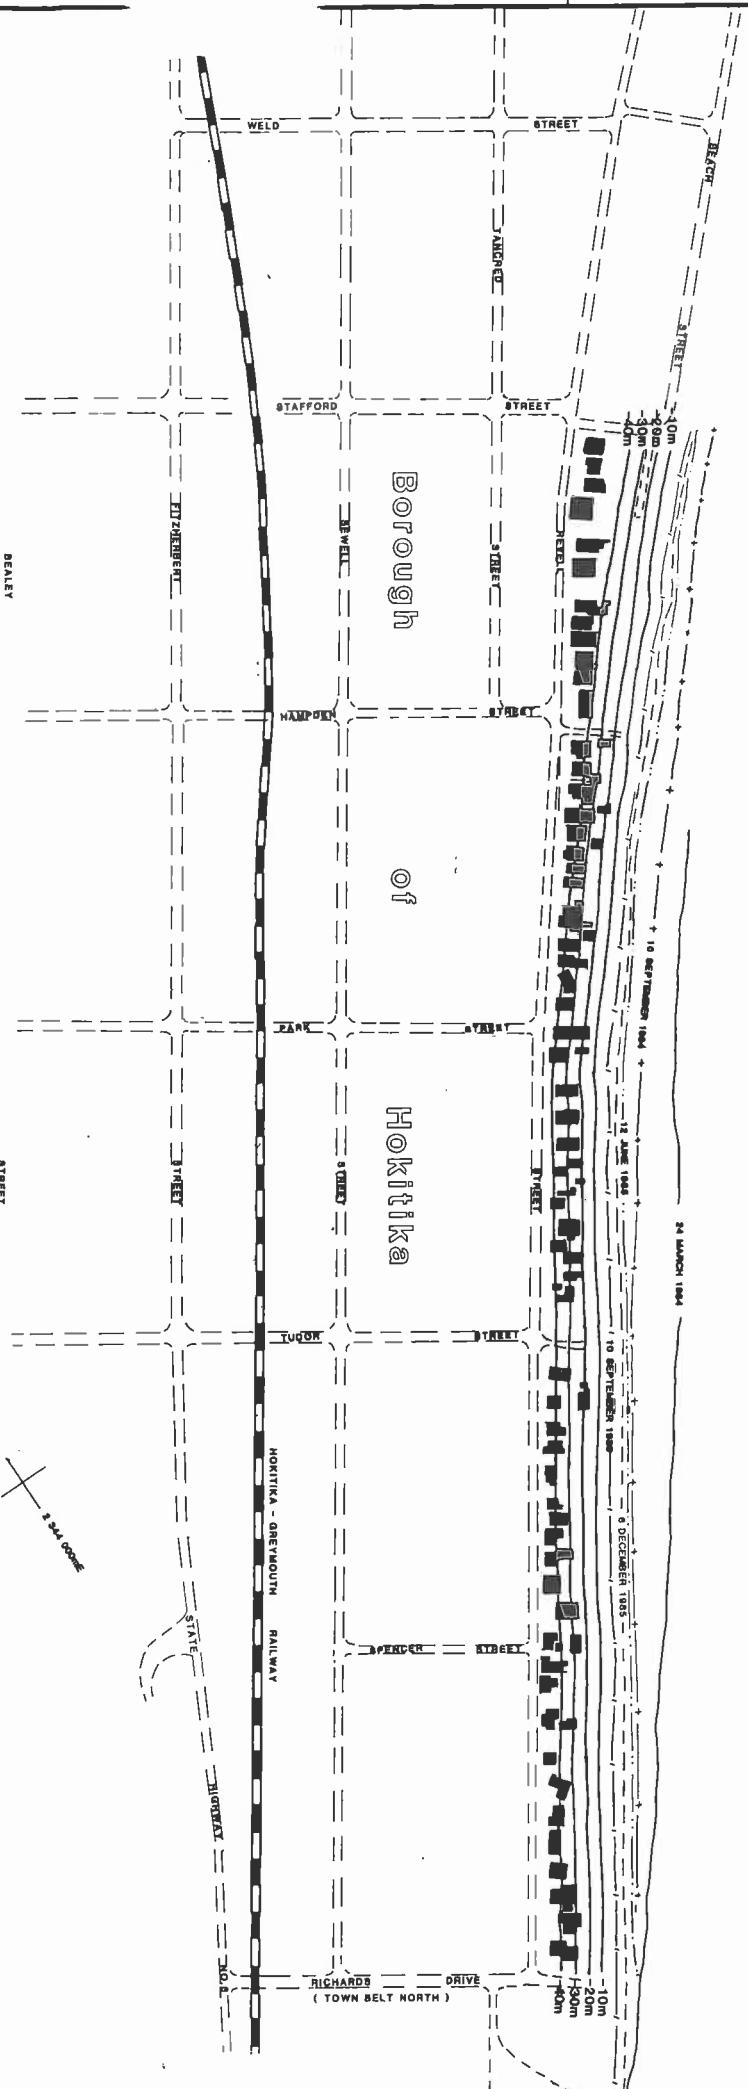
ENGINEER	W. Adams	1988
REFERENCE	NW500 AP 1808A	
SHEET	1	OF 1
NO.	906/227

WESTLAND CATCHMENT BOARD
 906000 HOKITIKA SEA EROSION
 Possible Erosion Effect on Property

Plan number 906/227, page 25 shows the effect of 10, 20, 30 and 40 metres of further erosion on residential property west of Reveil Street.

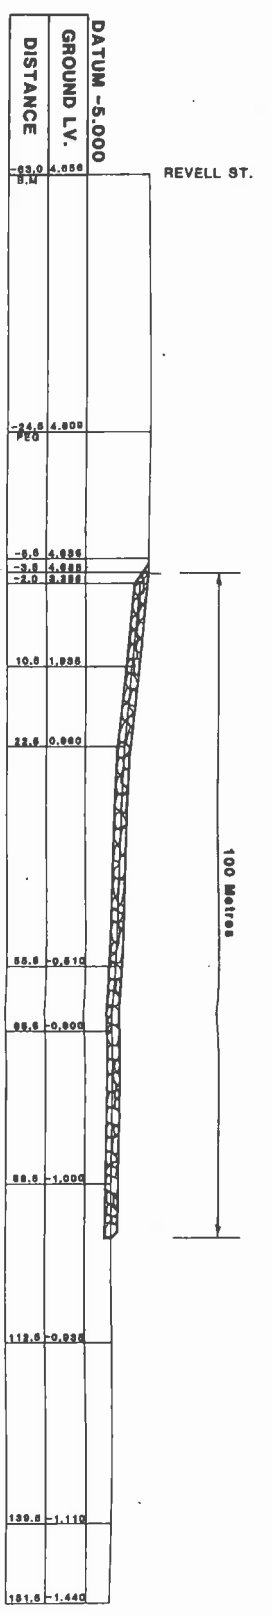
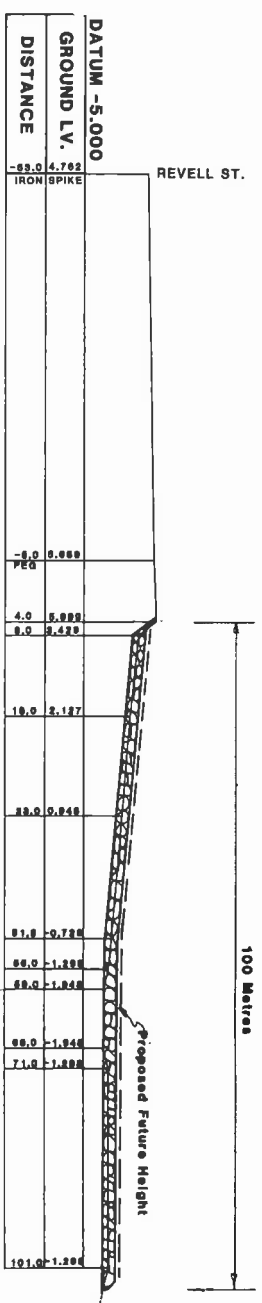
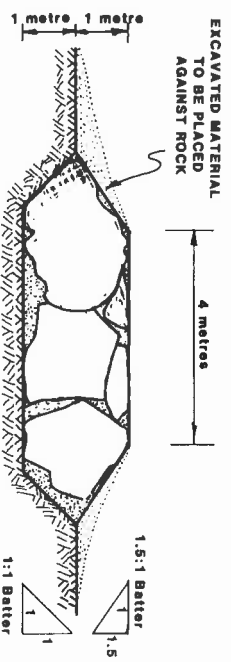
APPROVED	DATE	SCALE	WESTLAND CATCHMENT BOARD	SHEET
DRAWN	BY	1:400	906000 HOKITIKA SEA EROSION	1
CHECKED	DATE	DATUM	ROCK GROYNES PROPOSAL	OF
REVISION	BY	LA8	SEPTEMBER 1986	1
NO.	DATE	BY		1
NO.	DATE	BY		1

- ROCK GRADING**
- 4-5 Tonnes : 20%
 - 5-6 Tonnes : 30%
 - 6-8 Tonnes : 50%

Plan number 906/223, page 27, shows the rock groyne proposal.

GROYNE	A	Richards Drive	100 metres long, 1 metre high initially, 2 metres high ultimately.
GROYNE	B	Tudor Street vicinity	100 metres long, 1 metre high.
GROYNE	C	Sewerage Ponds	70 metres long, 1 metre high.

Rock to be sound, durable and mostly angular. Splitting of rock may be required to provide suitable shape.

Rock shall be placed in a 1 metre deep trench and excavated material then pushed up against side of rock groynes.

Sideslopes above beach level to be 1 vertical to 1.5 horizontal.
