HOKITIKA BEACHFRONT

SEA EROSION

August 1984

FORESHORE PROTECTION - HOKITIKA BOROUGH

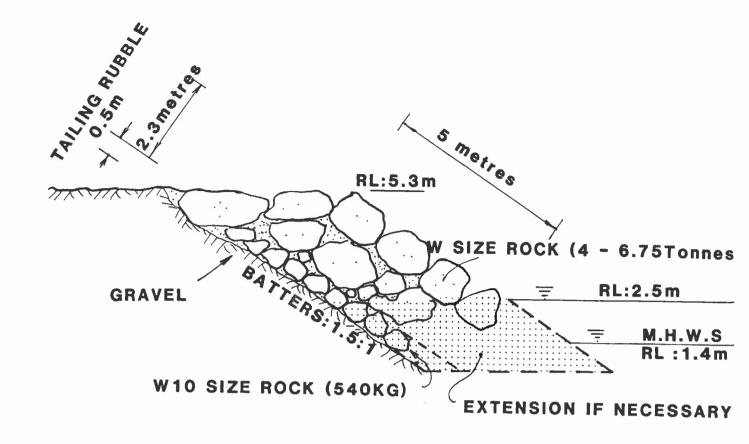
TYPICAL CROSS SECTION THROUGH PROPOSED BANK

It is proposed to place a two rock thick rock revetment wall along the beach front from the existing rock work at the southern end up to Stafford Street at the north end: a distance of 1000 metres. The wall to be constructed on a 1.5 to 1 batter with the toe excavated down into the beach to provide at least one metre depth of covering over the toe. Facing rock size to be in the range 4 to 6.75 tonne. This rock to be laid two rocks deep on top of a 500mm layer of 350 to 550 kilogram quarry rock or tailings. See plan Page 4 (b) over.

The 350 to 500 kilogram rock to be laid on a bull-dozed bed covered with coarse beach gravels.

The long term beach profile appears from old photos to have been as shown on typical cross-section at Stafford Street. See page 4 over.

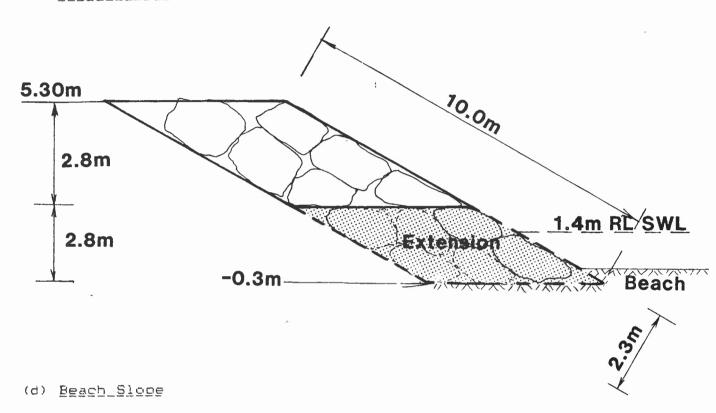
(c) Wall Profile

Cross-sections indicate the beach slope is 1 in 18 S=0.056

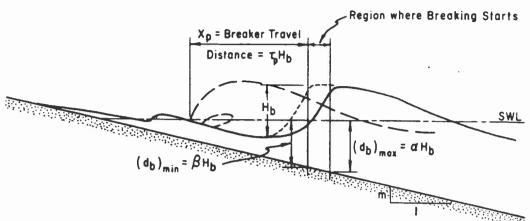
Reference Figure 7 Page 7 - 9

S = 0.056 ds = 1.7 metres (5.58 feet) T = 7.5 seconds ds = -6.57 = 0.00308 $gT \ge 32.2 \times 7.5 \times 7.5$

$\underline{Hb} = 1.58$

Hb = 2.69 metres (8.82 feet)

Need to design for breaking height 2.69 metres.

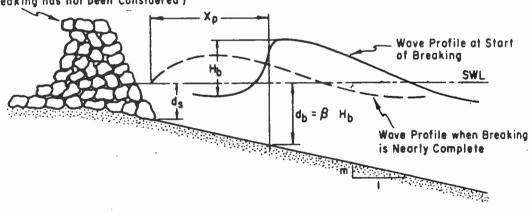
Proposed Structure (Effect of Structure on Breaking has not been Considered)

$$m = \underline{db} - \underline{ds}$$
1 Xp

= 30.36 metres

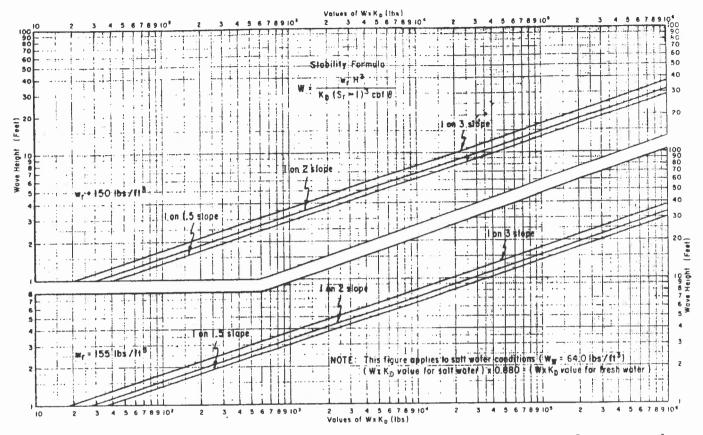
Figure 7-84. Weight of Armor Units x K_D Versus Wave Height for Various Slope Values ($w_r = 150 \text{ lbs/ft}^3$ and 155 lbs/ft^3)

Reference Page 7.169

Wave Height 2.69 metres (8.8 feet)

WKD = 30000 11s

KD = 2.5 rough duarry stone

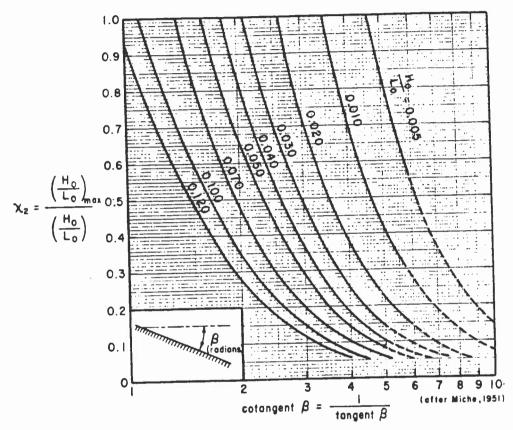
Figure 2-63. χ_2 Versus Beach Slope for Various Values of H_0/L_0

$H_0 = 9.3 = 0.106$ Lo 87.8

from 2-63 $\times 2 = 0.05$

x1 = 0.5

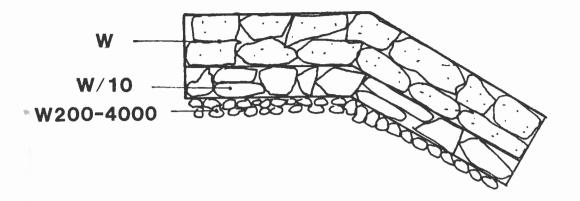
Design of 3 layer wall

Reference P 7-193

W = 5.4 tonnes W/10 = 540 kilograms W/200 = 27 kilograms thickness 2.3 metres thickness 0.5 metres thickness 0.1 metres

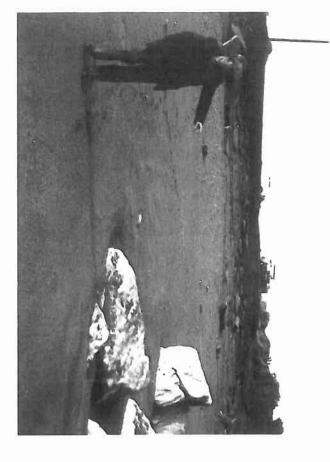
HIGH TIDE:30 JULY 1984

EROSION: SOUTH END
