**West Coast Regional Council
Hokitika Township**

Hokitika River Design Flood Levels

December 2010

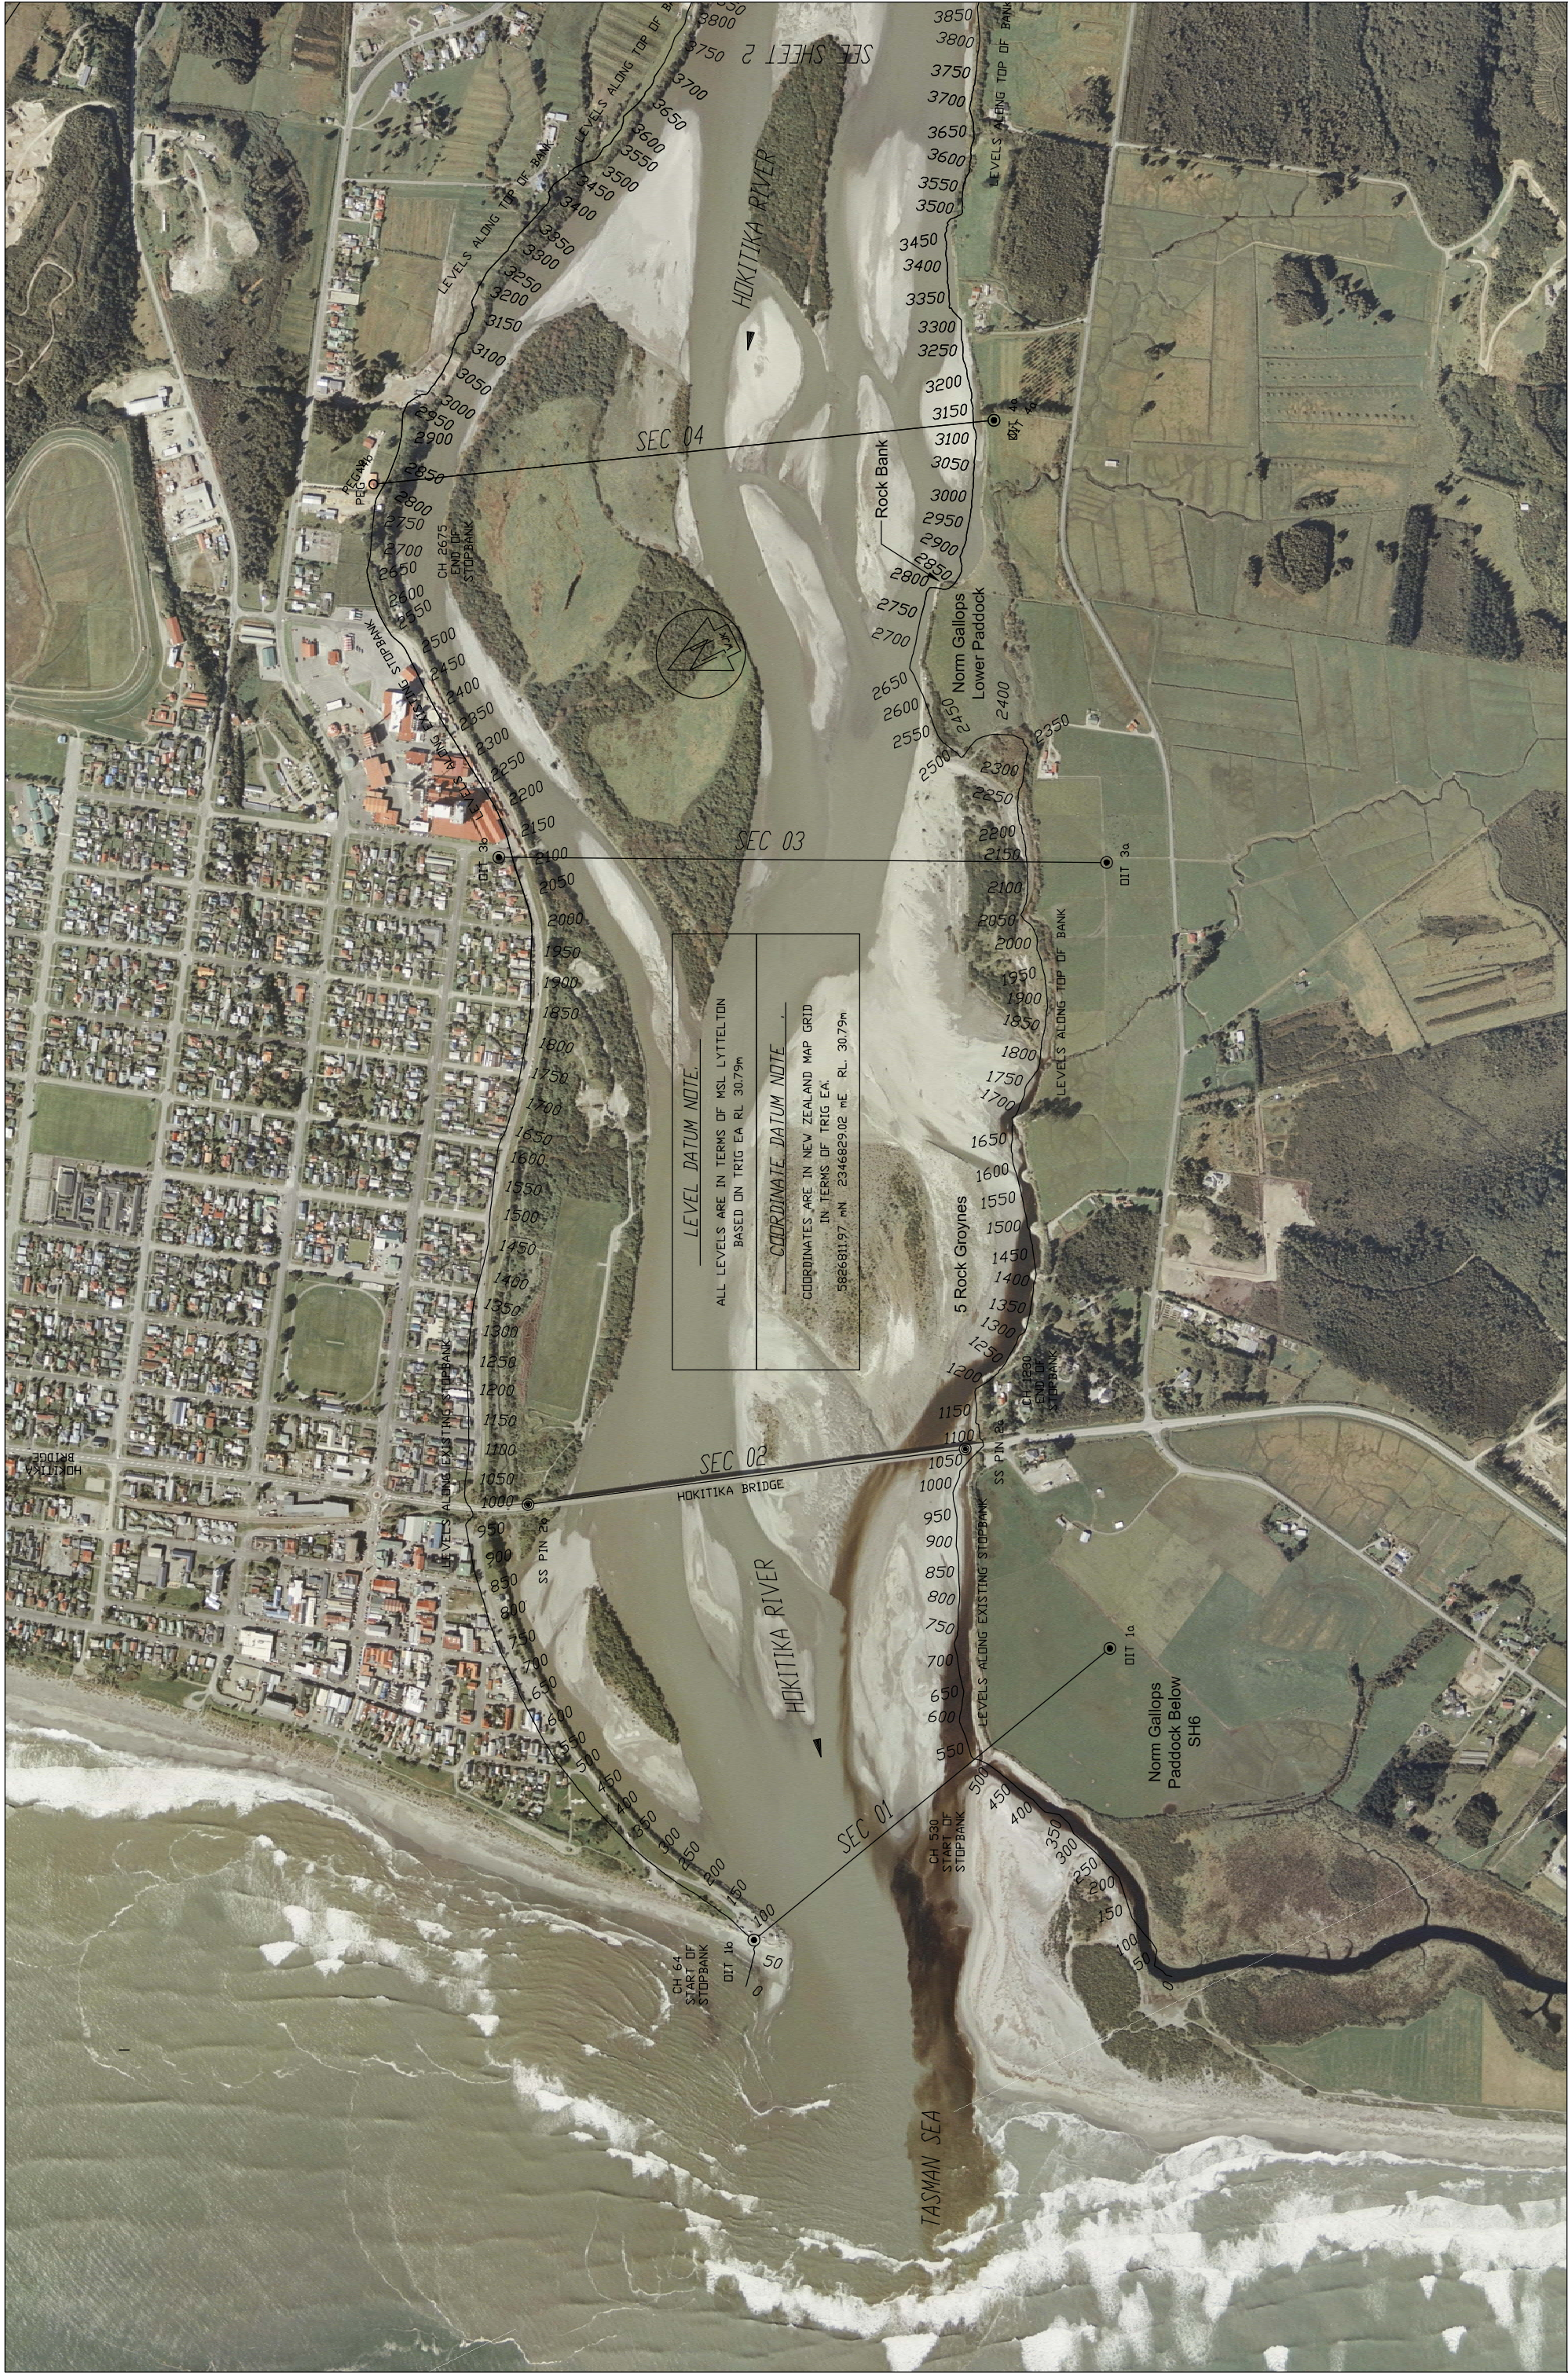
AERIAL PHOTOGRAPH

HOKITIKA RIVER RATING DISTRICT
STOPBANK CHAINAGE AND CROSS SECTIONS

An aerial photograph of the area is given in Appendix A, while the levels along the banks are shown on drawings 1 - 6 in Appendix B.

The model was established to route a steady state (constant) flow through the channel. The model was created over the project area, constructed using the six surveyed river cross sections representing the 2010 bed levels. The model was set up to follow the river channel and berm areas represented on the aerial photograph shown in Appendix A.

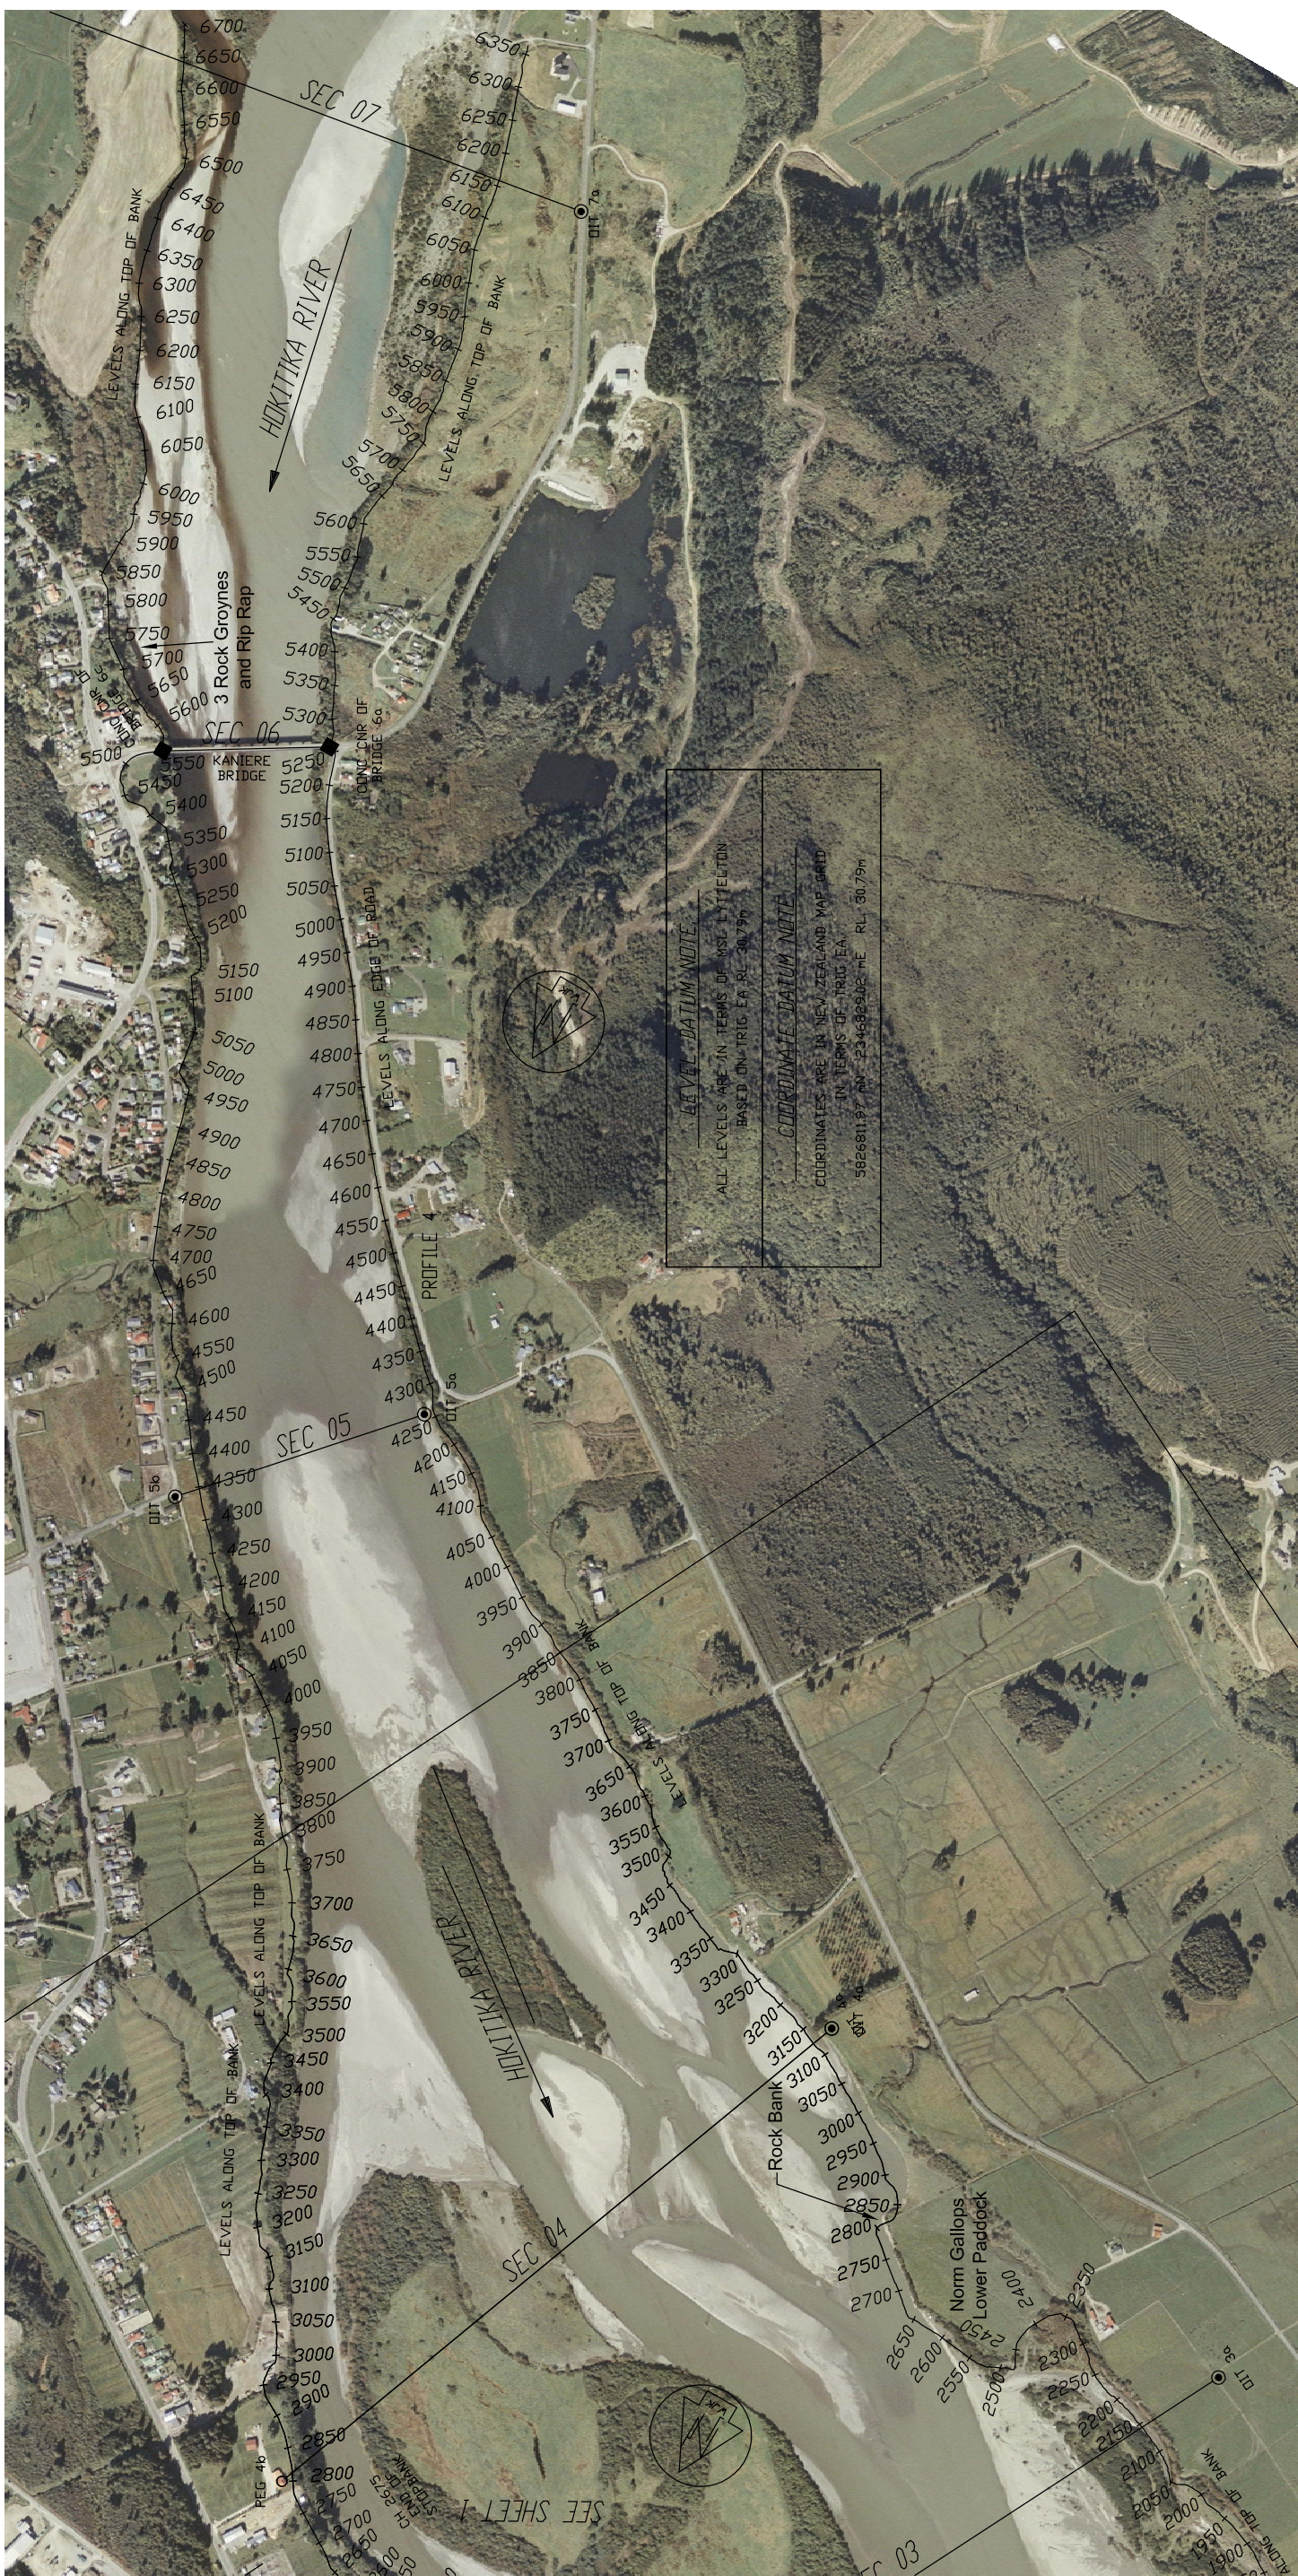
HOKITIKA RIVER RATING DISTRICT
 STOPBANK CHAINAGE AND CROSS SECTIONS

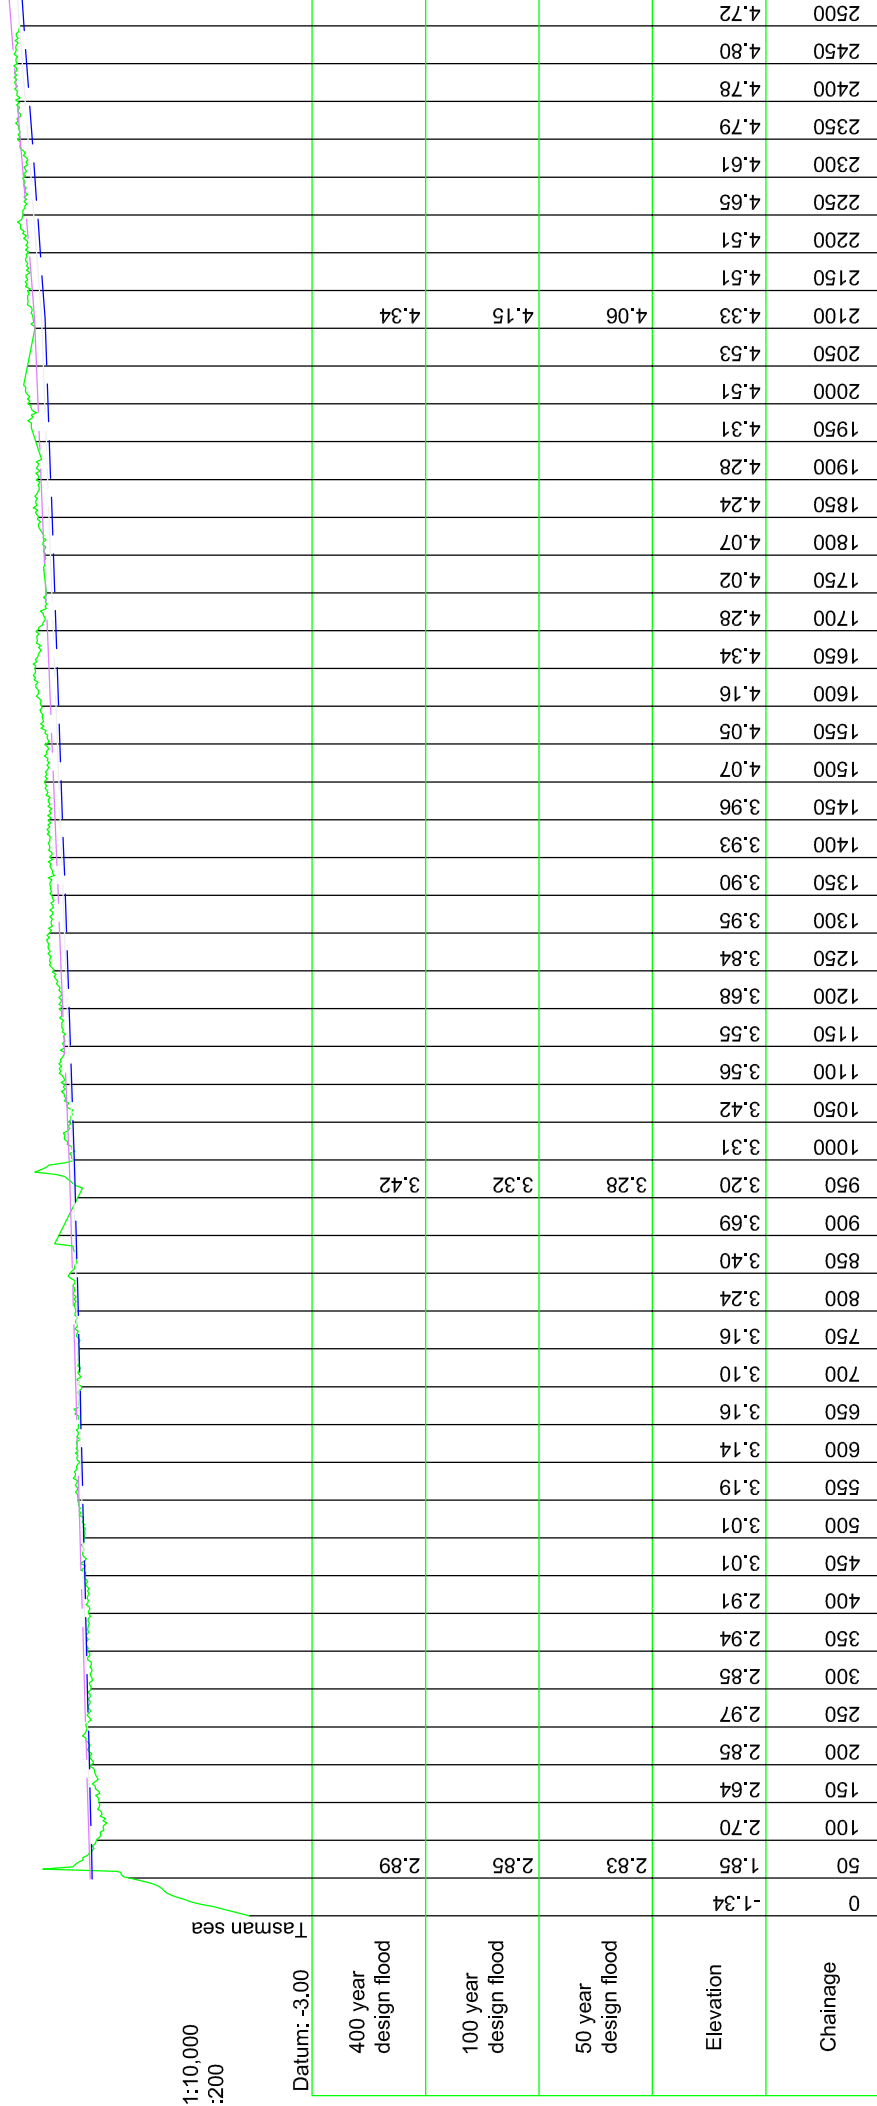
RIGHT BANK LONG SECTION CHAINAGE 0.00 TO 2500.00

400 Year Design Flood Level (5400 Cumecs + 900mm Freeboard)
-

100 Year Design Flood Level (4720 Cumecs + 900mm Freeboard)
-

50 Year Design Flood Level (4390 Cumecs + 900mm Freeboard)
-

Bank height

The long sections given in Appendix B show that the right bank of the Hokitika has a capacity equal to the 1 in 100 year storm, from the Hokitika Bridge to chainage 400. Below this point (recreation land and tip head) the bank capacity is mostly below the 50 year design level. The stopbank in this area is typically 0.1m below the 50 year design level (inclusive of 0.9m freeboard) between chainages 450 and 150. From chainages 100 downstream (ie at the downstream extremity of the system), the stopbank is approximately 0.25m below the 50 year design level (inclusive of 0.9m freeboard). In this downstream section there is also very little difference between the 50 and 100 year flood event due to the influence of sea level conditions.

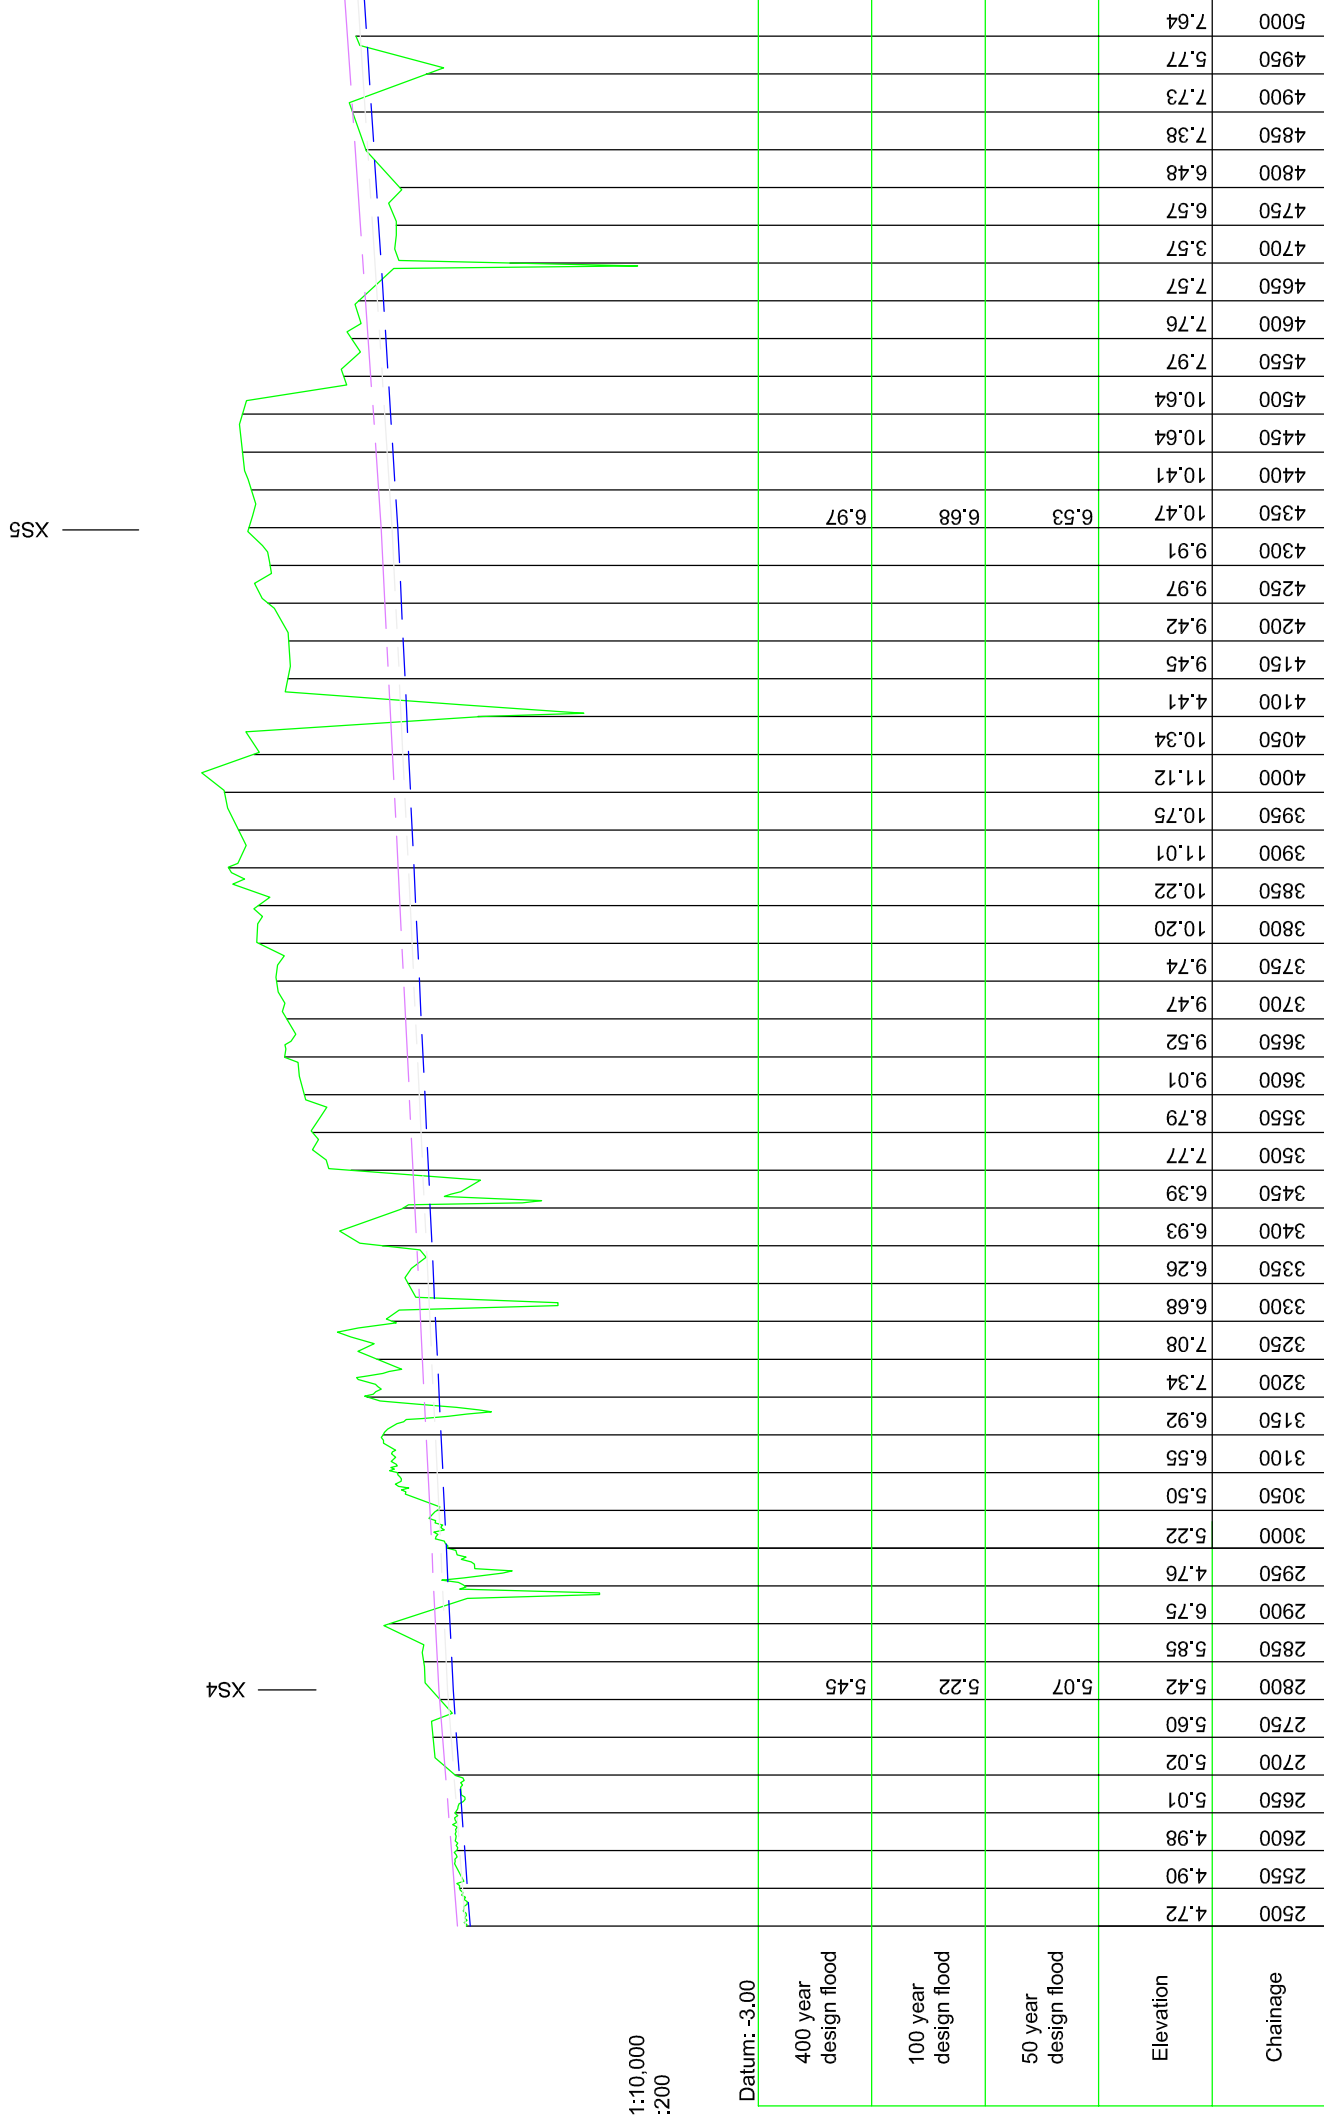
RIGHT BANK LONG SECTION CHAINAGE 2500.00 TO 5000.00

- 400 Year Design Flood Level (5400 Cumecs + 900mm Freeboard)
- 100 Year Design Flood Level (4720 Cumecs + 900mm Freeboard)
- 50 Year Design Flood Level (4390 Cumecs + 900mm Freeboard)
- Bank height

Bank protection from the Hokitika Bridge to cross section 4 is adequate to the 1 in 100 year level. Much of this bank is built above the 1 in 400 year level. The bank has an irregular profile upstream of cross section 4 to Ch 4650. Depressions show tributaries and low points surveyed.
