Rivermouth-related shore erosion at Hokitika and Neils Beach, Westland

Prepared for West Coast Regional Council

February 2016

NIWA CLIENT REPORT No: CHC2016-002
Report date: February 2016
NIWA Project: ELF16506

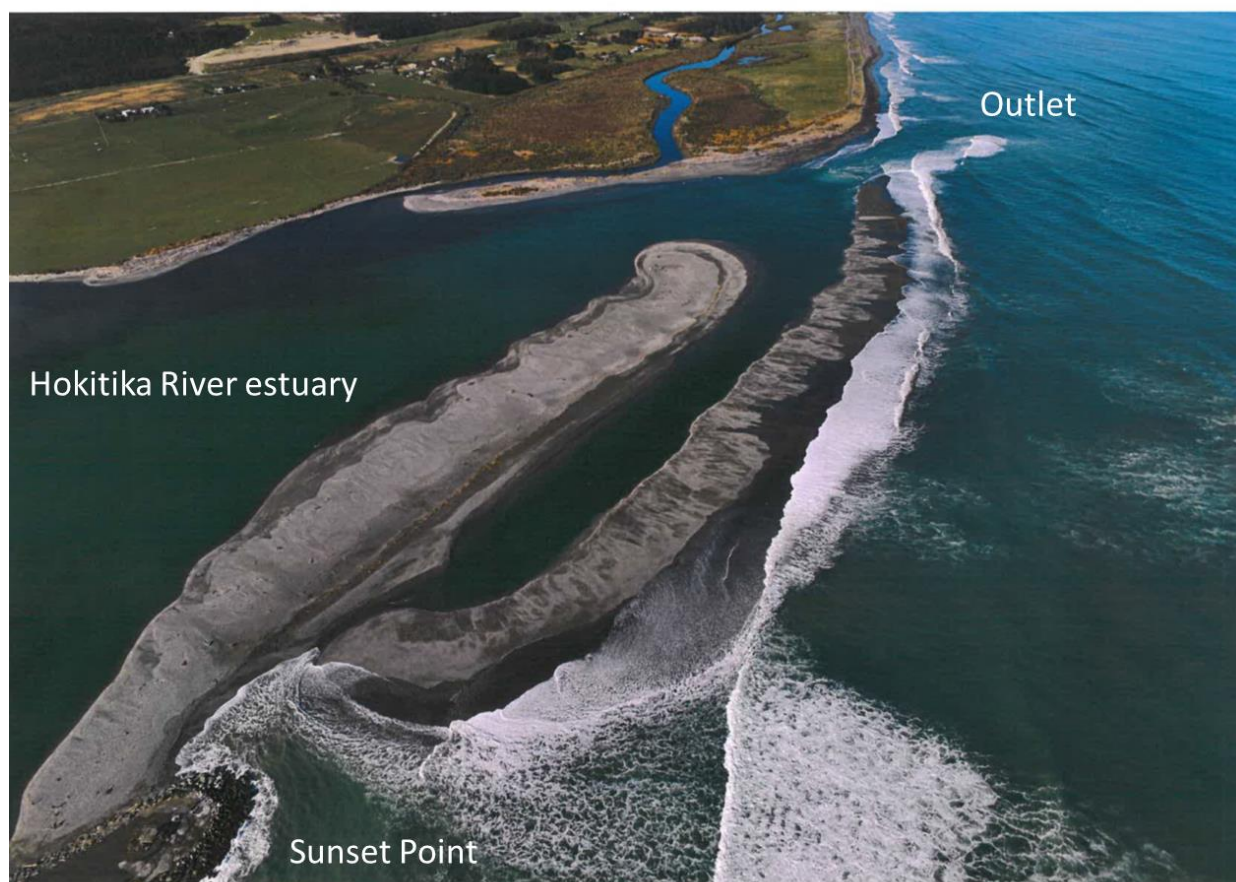
Figure 2-1: Bars partially blocking Hokitika River mouth, September 2015. View is to southwest. Note obliquely-approaching waves. Photograph supplied by WCRC.

- Do nothing about the river mouth bar immediately, but monitor its form and if it grows substantially from its present state consider an artificial cut past Sunset Point. Leaving it as-is would appear to assist sediment transfer onto the Hokitika foreshore.
- Monitor water levels in the estuary at the Hokitika wharf on an ongoing basis to inform on the extent of outflow impedance provided by river mouth bars. After some years, the record will provide useful guidance on how to respond to situations like the present one.
- The robust seawalls at Sunset Point and fronting Hokitika town centre should be joined into a continuous wall along a smooth line, with the linking section built to the same standard as the two existing end segments.

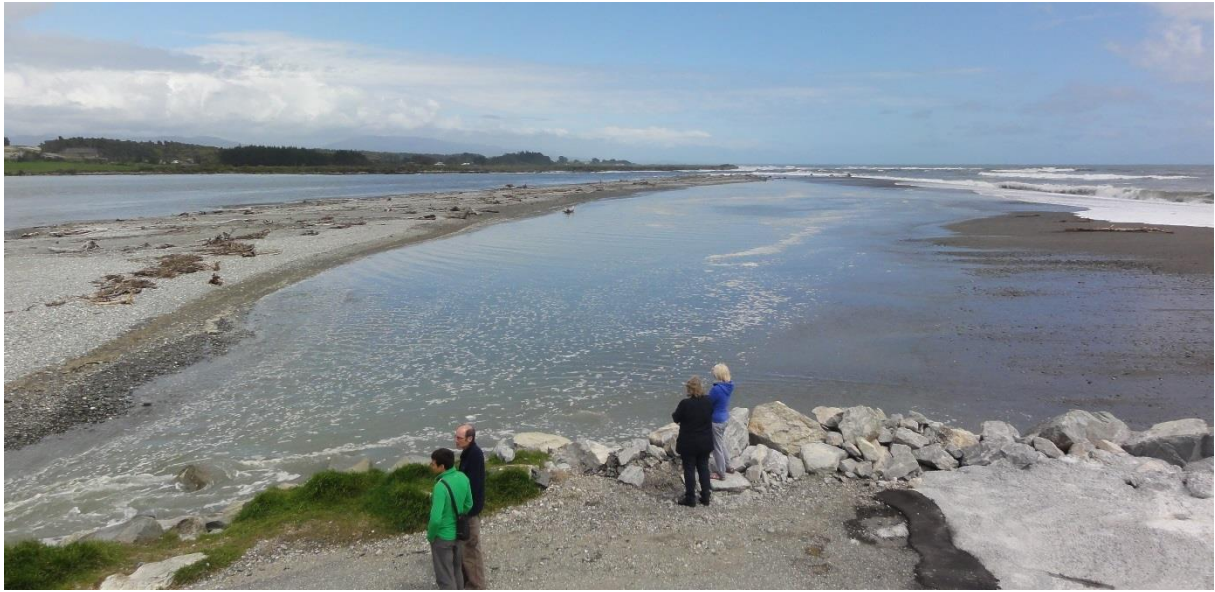
- The main river outflow channel remained deflected to the southern side of the river mouth.
- The river mouth bar was a double bar (including an inner and outer bar as in Figure 2-1 and Figure 2-2). Wave swash was collecting in the runnel between these bars and was flowing into estuary (Figure 2-2). This had cut a channel some 10 m wide hard against the rip-rap at the tip of Sunset Point. This conveyed more flow as the tide-level rose. The outer bar appears to have been swept inshore off the broad area of river mouth shoal.

My assessment is that the river mouth bar is not likely to significantly affect flood levels in the Hokitika River estuary. This is because the additional river path to the south side of the river mouth is not substantial compared to the direct outlet path. Also, a large flood could be expected to quickly enlarge the outlet channel. Moreover, the small swash channel running hard beside Sunset Point (if it remains) would be enlarged during a flood.

Figure 2-2: View south from Sunset Point lookout at Hokitika River mouth on 28 October 2015. Note double bar and swash collecting in runnel between bars and flowing into estuary.

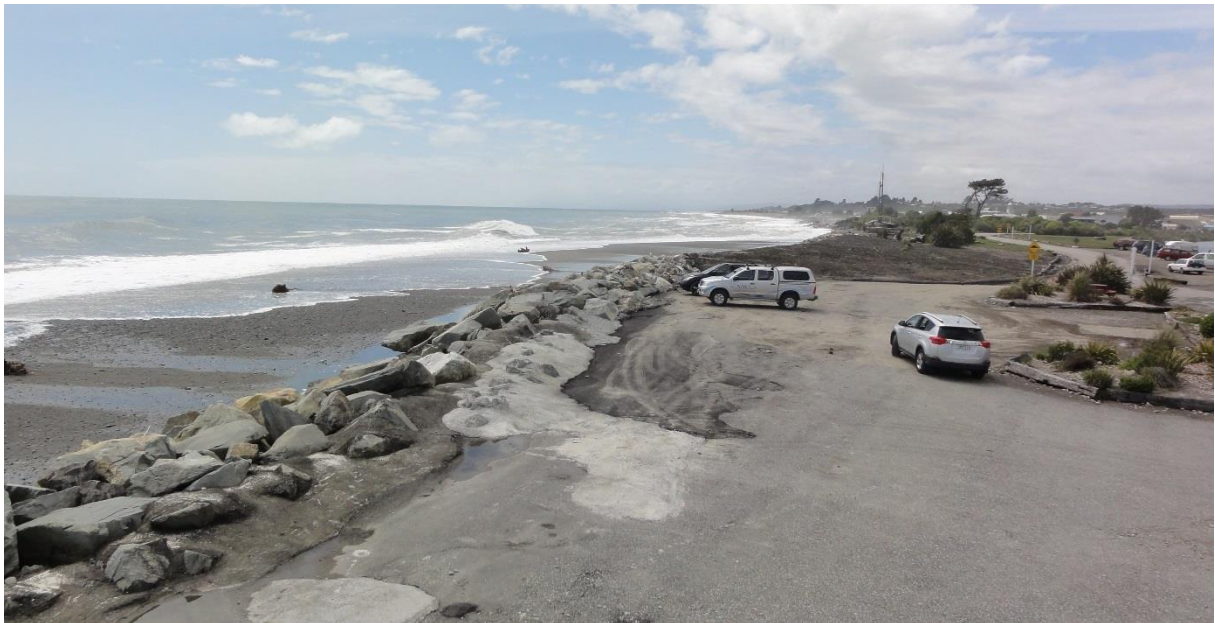
- The seaward side of the Sunset Point carpark was fronted by a broad sandy-gravel beach / foreshore bar that connected to the outer bar across the river mouth. Waves broke obliquely all along the outer bar and this beach and drove a northward drift of beach sediment – thus waves were working sediment off the river mouth bar towards Hokitika (Figure 2-3).

Figure 2-3: View north from Sunset Point lookout at Hokitika River mouth on 28 October 2015. Note beach/foreshore-bar in front of carpark and obliquely-breaking waves driving northward longshore transport.

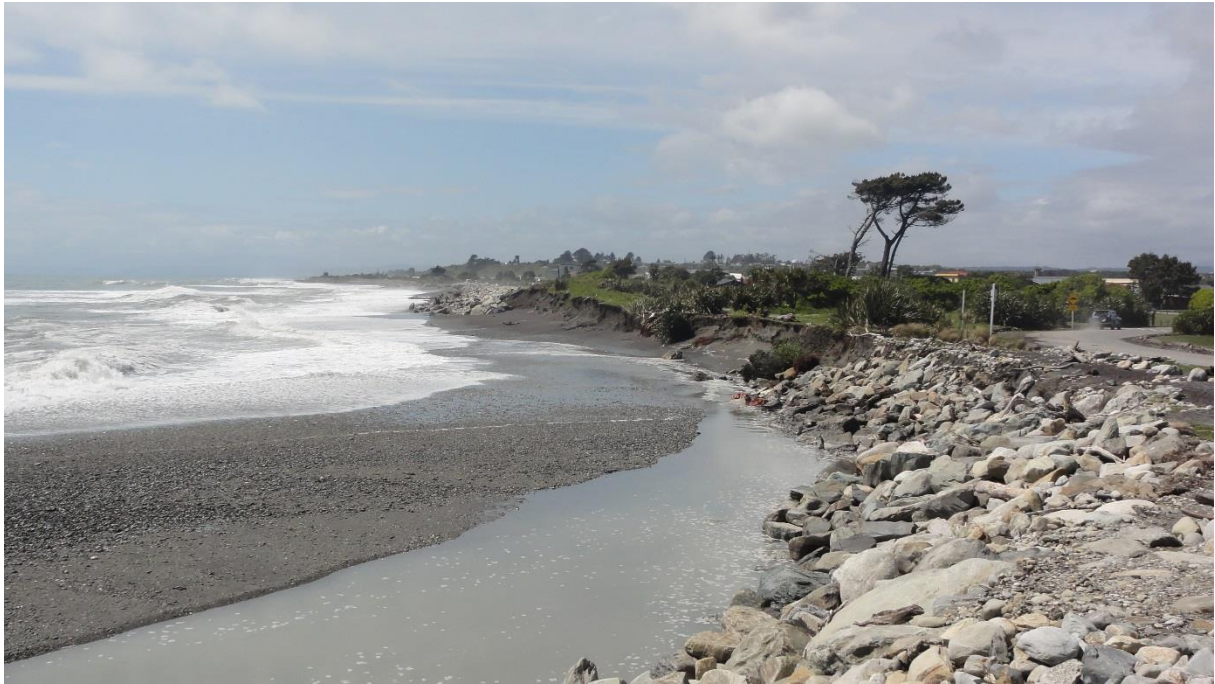
- Immediately north from the “Tambo” at Sunset Point, erosion was occurring in the span of shore between the two well-formed seawalls (Figure 2-4). The span of poorly-constructed rip-rap seawall immediately north of the “Tambo” had experienced partial collapse and wave overwash. The rip-rap in this segment was smaller and placed lower than the more robust segments of seawall. Driftwood litter and sand patches on the berm and road behind this section indicated recent overtopping by waves (Figure 2-5). The worst erosion was to the unprotected segment of shore (Figure 2-6). This suffers from “end effects”, receiving additional attack from waves reflected/funnelled off the ends of the seawall segments. The whole eroding span of shore is indented relative to the enclosing segments of robust seawall. This creates an additional focus for wave energy.

Figure 2-4: View north from “Tambo” at Sunset Point on 28 October 2015. Note terminus of foreshore-bar extending past Sunset Point, erosion in un-protected span of shore between rip-rap seawall segments, finer rock size and lower height of seawall adjacent to eroding section, and channel conveying swash to eroding section.

The eroding span of shore is eroding primarily because it is indented back from the line of the two robust seawalls, which causes end-effects. The fix is to link the seawall at the carpark in a continuous line with the longer seawall extending along to the town centre. The link section should be built to the same standard as the two end segments. Without this, the erosion will likely continue, possibly even resulting in waves cutting off the Sunset Point Road.

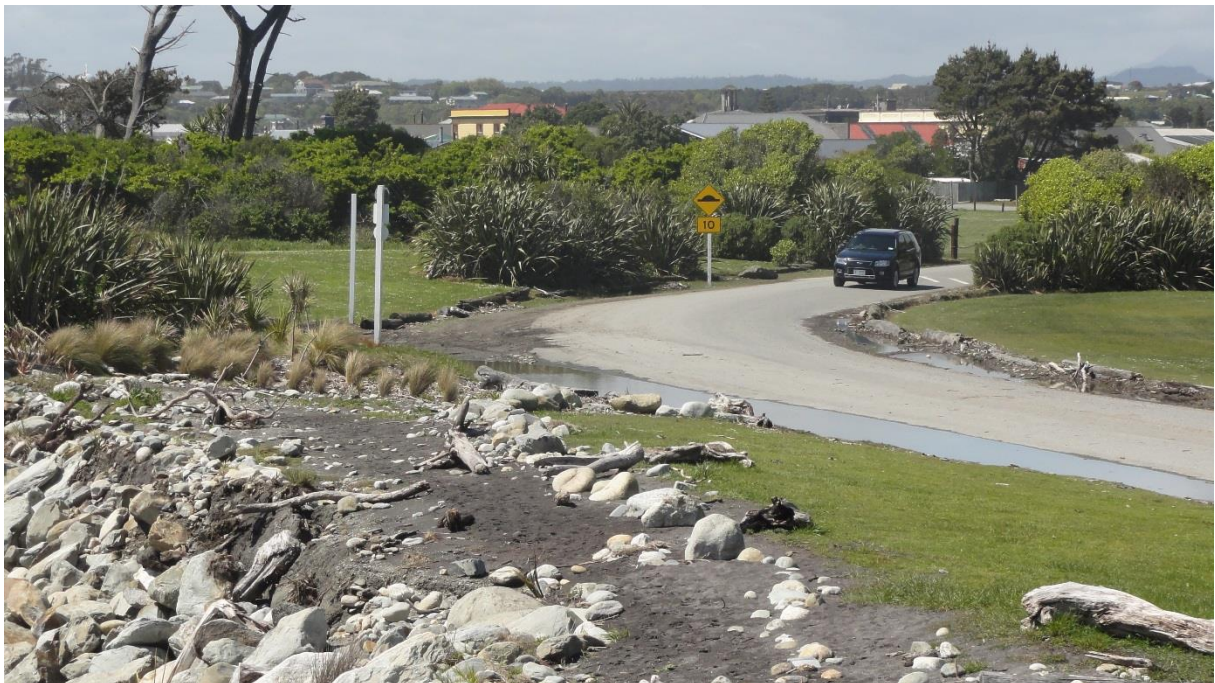
Figure 2-5: View east towards Sunset Point access road on 28 October 2015. Note driftwood litter and sand patches on grassy berm and beside road, placed by wave overwash.

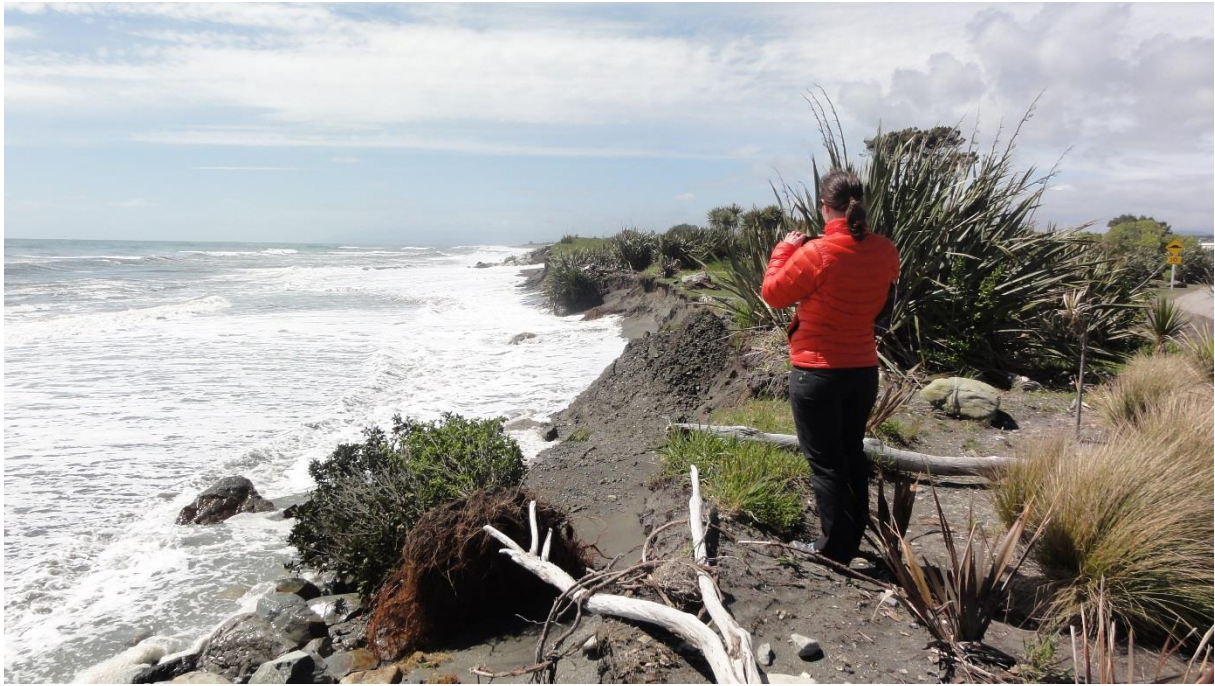
Figure 2-6: View north along eroding, unprotected span of foreshore between seawalls on 28 October 2015. Photo taken just north of “Tambo”.

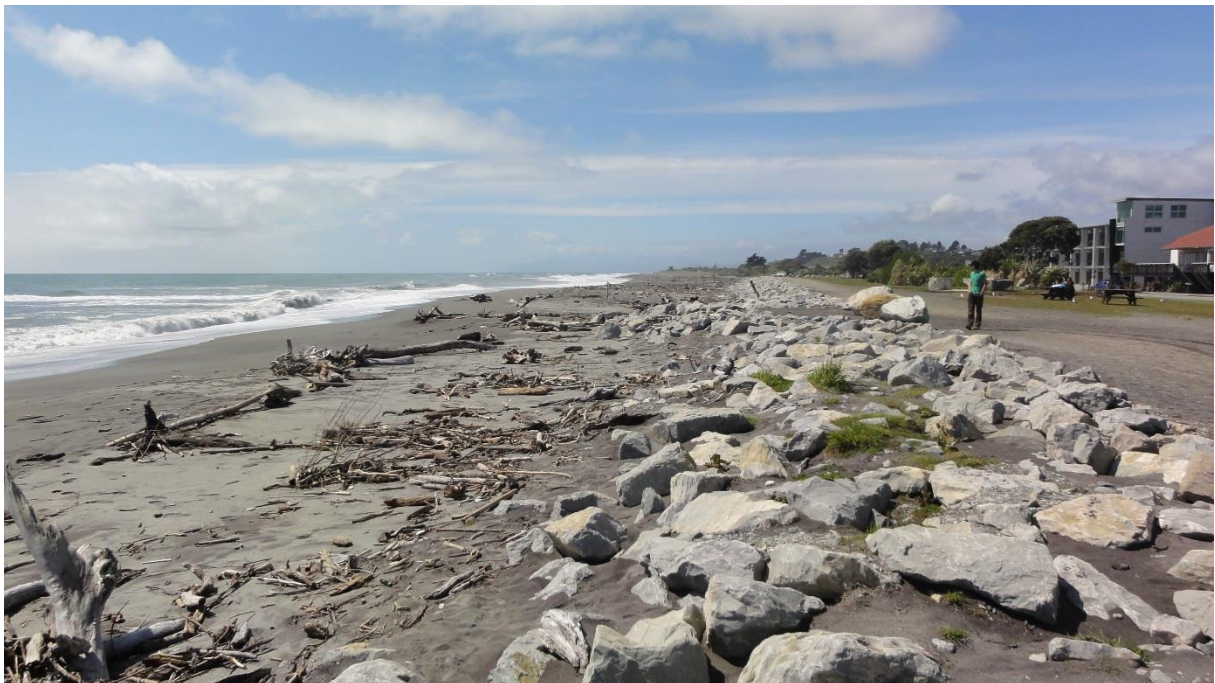
- Further north, past the Hokitika town centre, the beach was sandy and reasonably wide, having accreted over the past year and beginning to lap over the new seawall (Figure 2-7).

Figure 2-7: View north along Hokitika town foreshore on 28 October 2015. Note reasonably well-stocked sandy beach lapping rip-rap seawall.

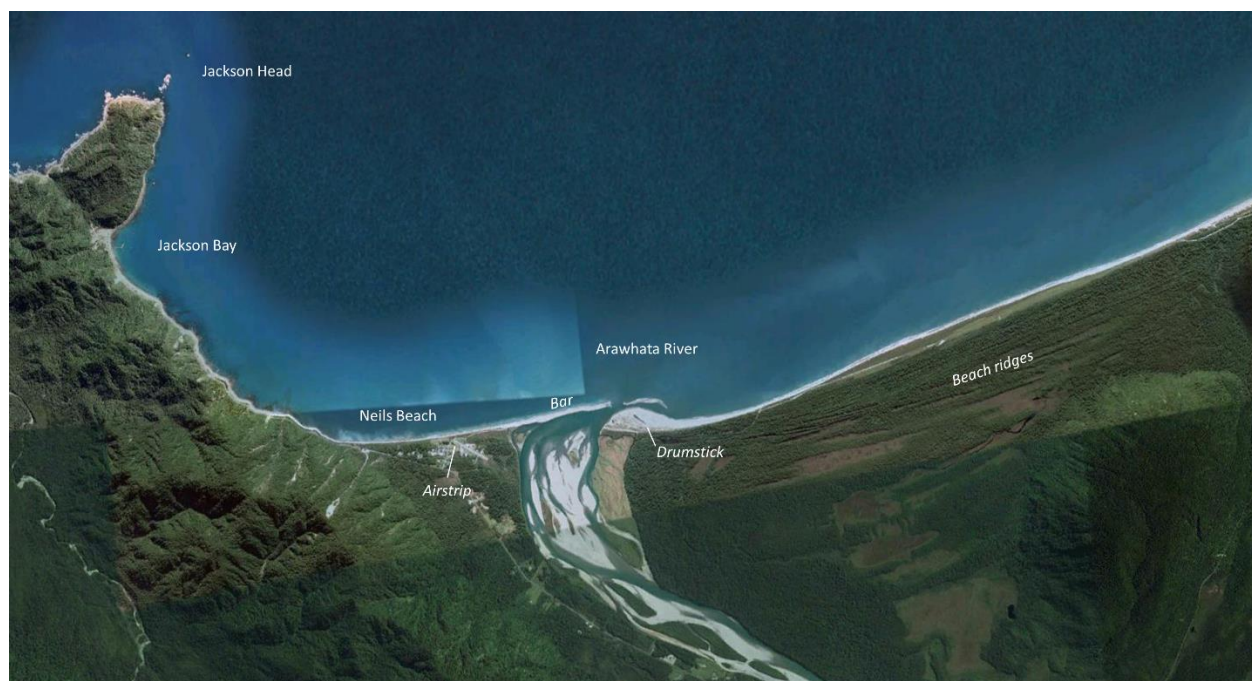
From a geomorphic perspective, Neils Beach spans the western side of the Arawhata River delta in Jackson Bay (Figure 3-1). Waves arriving dominantly from the West refract around Jackson Head and break at an angle to the shore, driving a net north-eastward longshore drift of beach sediment that appears to be sourced mainly from the Arawhata River. Most of the Arawhata sediment is moved north-east, but occasional wave events from the northerly quarter will drive a reverse drift from the river mouth back onto Neils Beach.

To the north-east of the river, a series of backshore beach ridges (Figure 3-1) indicate how the wave-distributed river sediment has built out the Jackson Bay shoreline over the past 8000 years or so (i.e., since sea-level stabilised after its last major post-glacial rise). Most likely, this shoreline advance has occurred on an episodic basis, associated with high sediment discharges from the Arawhata River following Alpine Fault ruptures.

Figure 3-1: Photomap locating Neils Beach on the western flank of the Arawhata River delta. Satellite image from 9 April 2013. West is to the left.

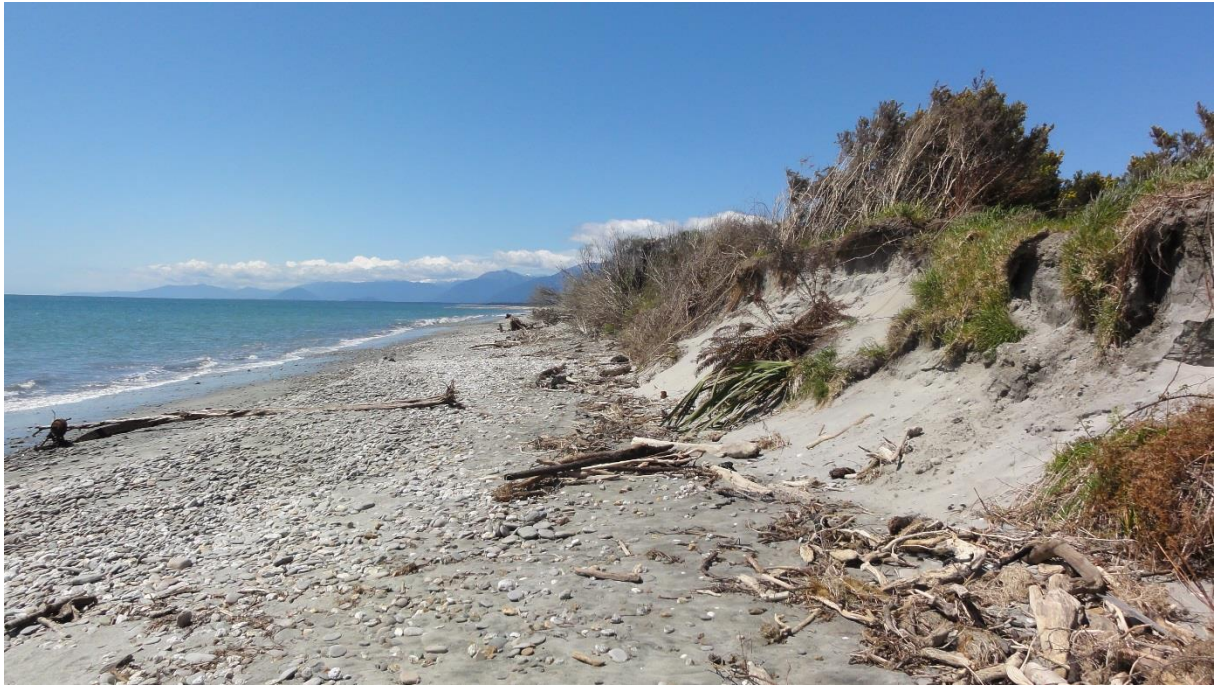
- Active foreshore erosion was occurring from north-east of the airstrip to the Jackson Bay Road (e.g. Figure 3-2). The single sandy foredune fronting the grassy swale in front of the settlement (Figure 3-3) was severely eroded, with the eroding edge part way down the back slope of the foredune. Total loss of this dune would potentially expose the road and some dwellings to sea-flooding.

Figure 3-2: Eroding foreshore of Neils Beach east of settlement. View east towards Arawhata River mouth.

- Importing sandy gravel from the Arawhata River channel to build a protective bund (and at the same time building up beach stocks)
- Monitoring the position of the shoreline fronting Neils beach and the configuration of the Arawhata River outlet, and, if the outlet migrates east, cutting a new western outlet.
- Develop long-term plans for relocating assets beyond the zone at risk from the erosion/accretion cycles, allowing also for the effects of future sea-level rise and possible changes in wave climate.

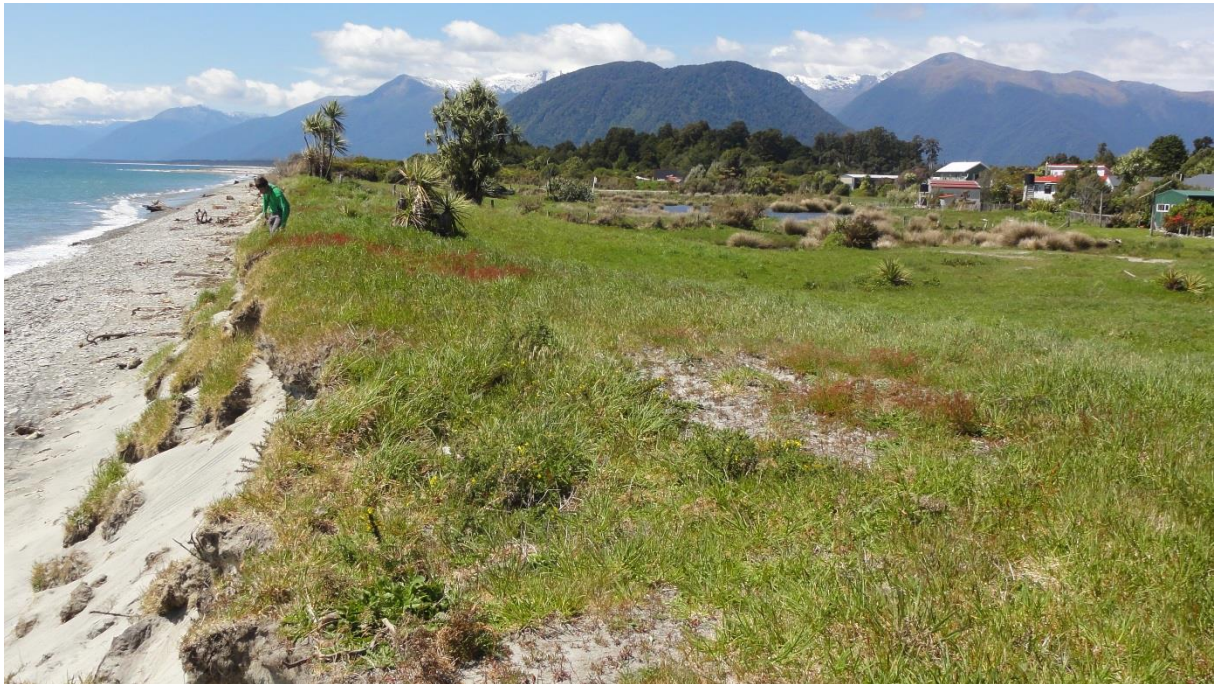
Figure 3-3: Eroding grassed-over sand-dune, Neils Beach settlement. View east towards Arawhata River mouth.

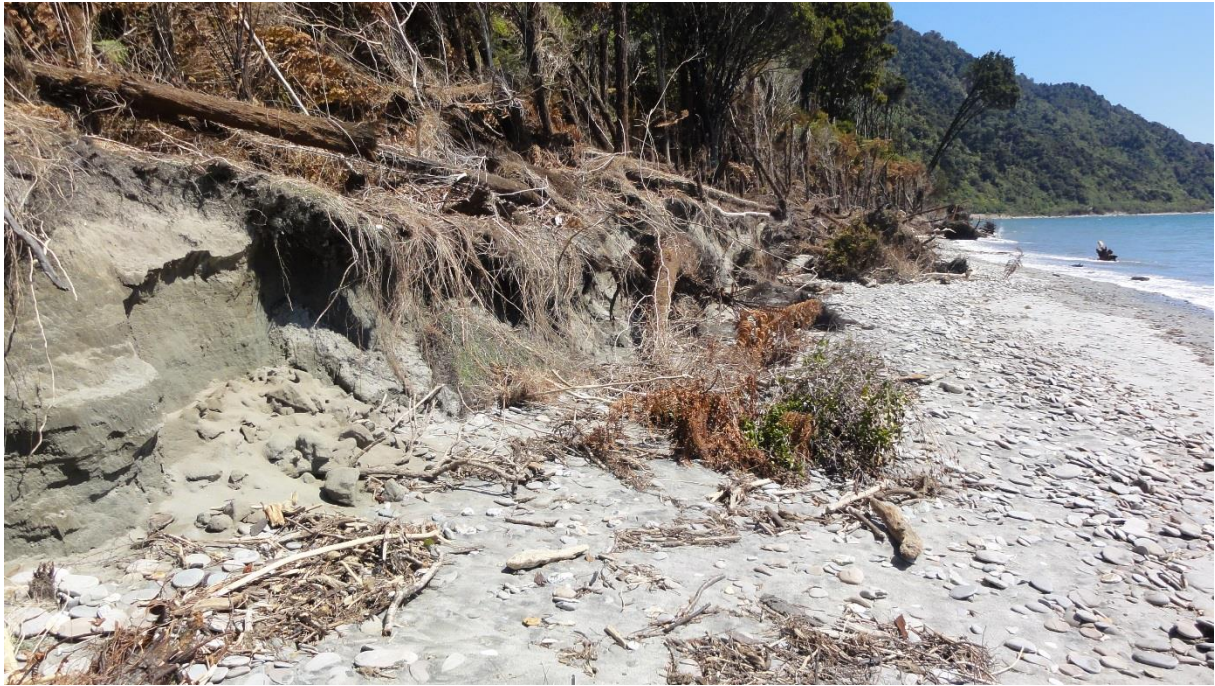
- Further west, the erosion was progressing into bush (but not threatening assets), exposing backshore features such as peat layers and swamp/swale deposits (Figure 3-4). This western shore is naturally partly armoured by a ramp of locally-sourced cobbles, with some of these having been washed by waves into the backshore bush (Figure 3-5). This shore also receives some protection against wave erosion at high tide from exposed tree roots and fallen trees.

Figure 3-4: Eroded, forested shore west of Neils Beach settlement. Note exposed older dune sand with soil and forest cover. View is west towards Jackson Bay.

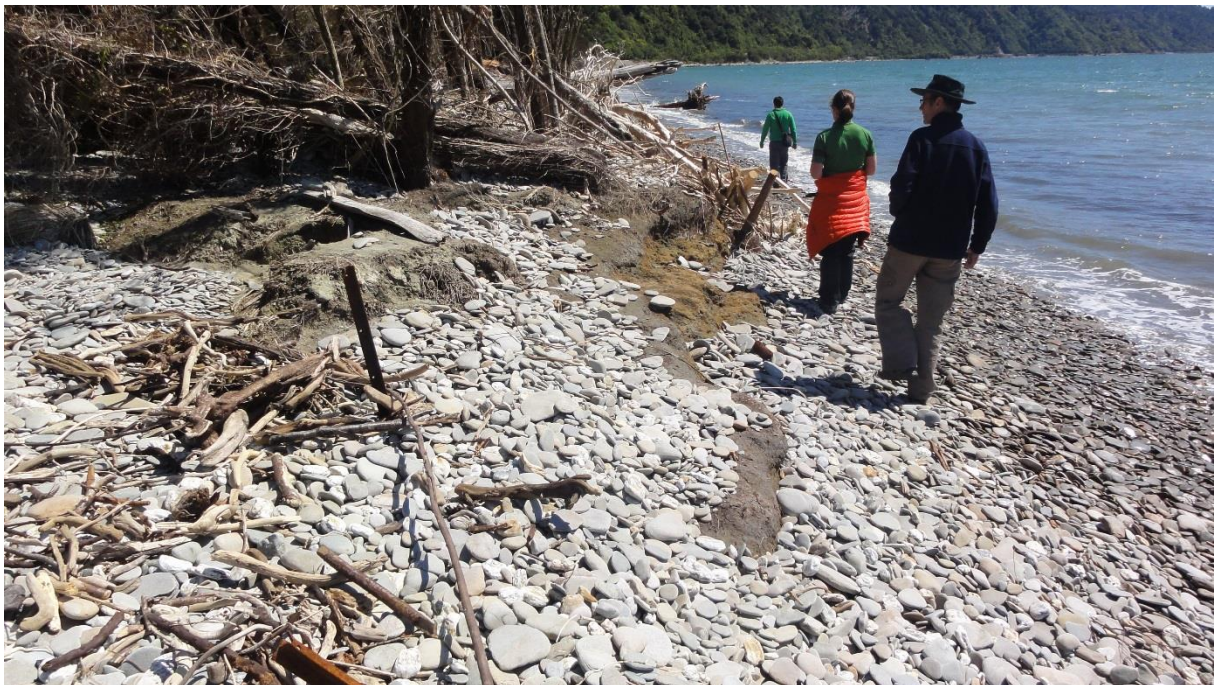
Figure 3-5: Platy shingle wave-washed into bush, west of Neils Beach settlement. Note exposed silt beds from ancient backshore swale. View is west into Jackson Bay.

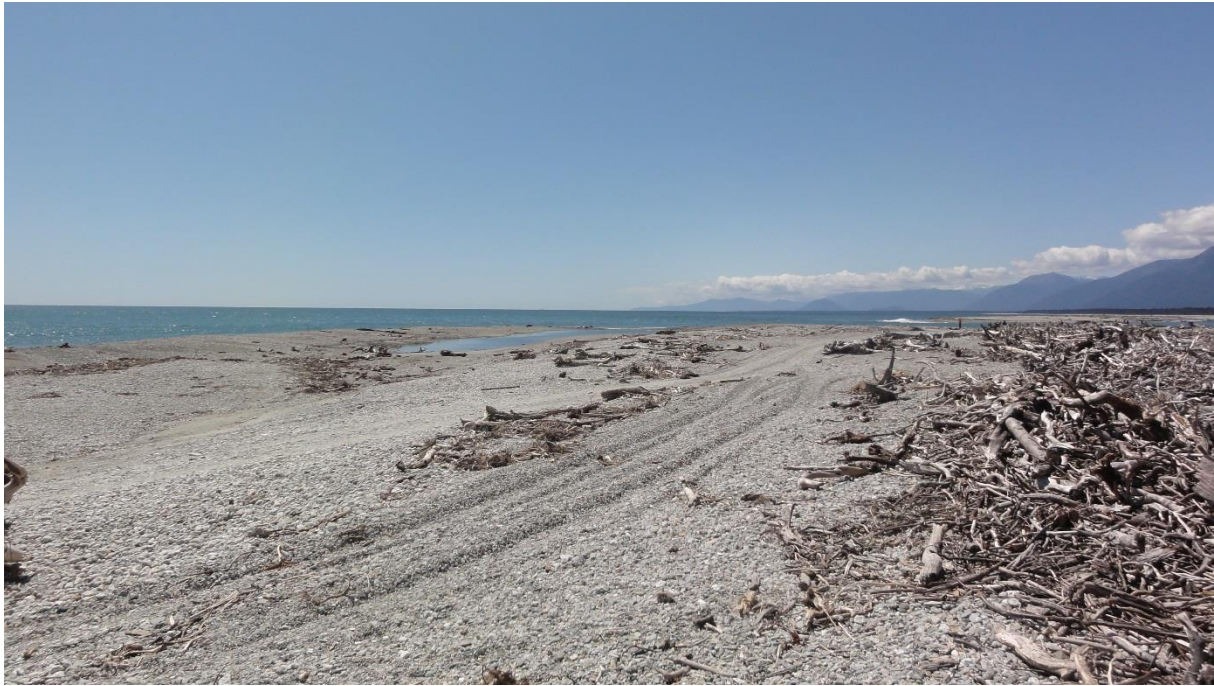
- In contrast, within a few 100 m of the river mouth there appeared to be a relative abundance of river-sourced beach sediment, with accreting bars of fine gravel (Figure 3-6) and wind-blown sand patches.

- The Arawhata River's outflow channel to the sea was located towards the western (Neils Beach) side of its delta area (Figure 3-6).

Figure 3-6: Accreting fine-gravel bar, west side of Arawhata River mouth. View is to north-east. Surf in distance marks river mouth.

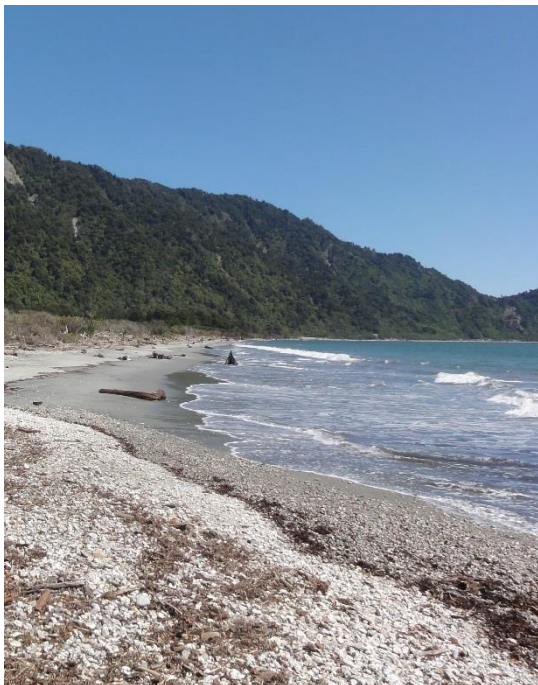
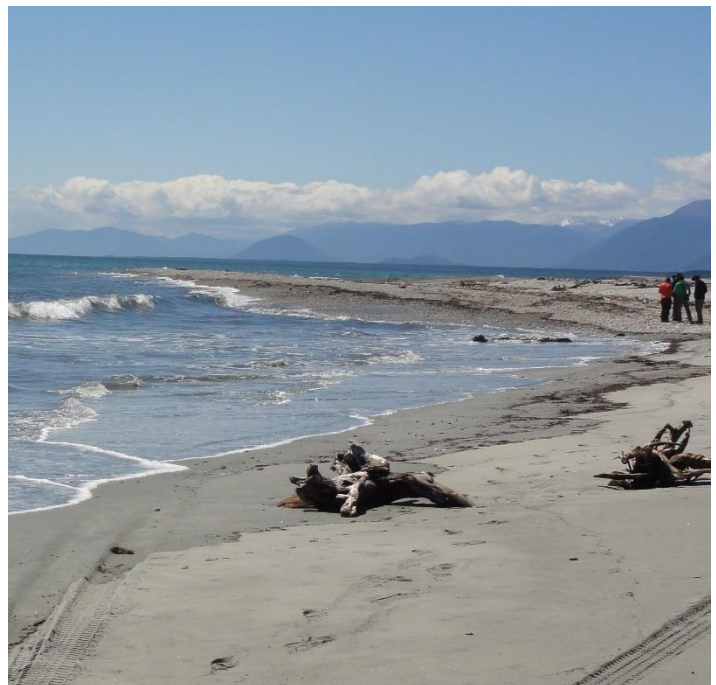
- On the day, the longshore transport in front of the settlement was north-east (as indicated by the angle waves broke against the shore), but this reversed close to the river mouth due to the presence of the large gravel bar building from the river mouth (Figure 3-7). This was trapping sand eroded from further west along Neils Beach.

Figure 3-7: Longshore transport convergence-point west of fine-gravel bars at eastern end of Neils Beach. Left photograph looks west into Jackson Bay from gravel bar; note breaker approaching from west. Right photograph looks back east to same gravel bar; note breaker approaching from east.

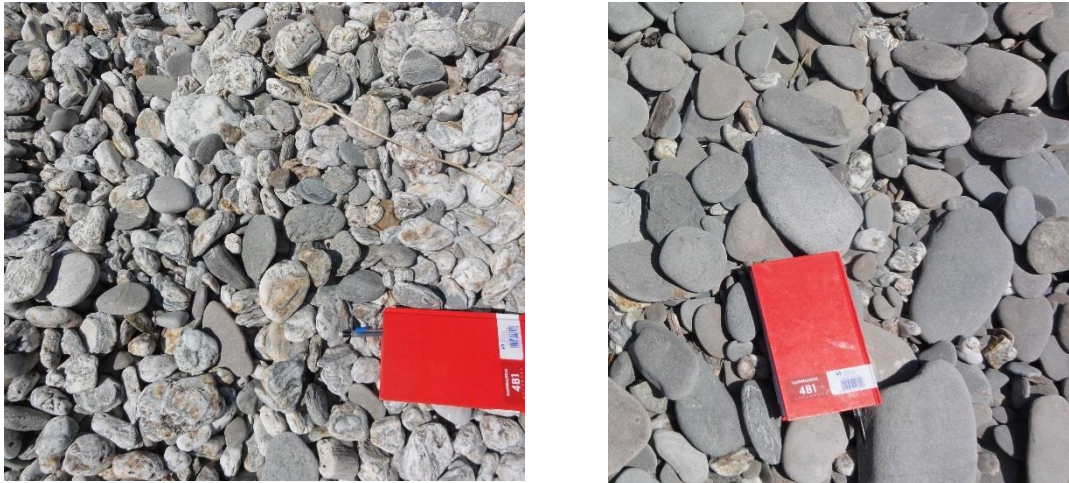
Neils Beach was stocked with two types of sediment: platy, grey-brown pebbles and cobbles of meta-sandstone lithology, and finer, more well-rounded gravel of schist origin (Figure 3-8). The former became dominant, coarser, and more angular towards the west and was clearly sourced from the local gullies incised in the steep moraine slopes on the landward side of the Jackson Bay Road. The latter became dominant closer to the river and was identical to the bed-material of the river itself. We do not expect any beach sediment supply from sediment passing around Jackson Head, since the seabed deepens quickly to over 100 m by some 2.5 km offshore (Rattenbury et al. 2010). Thus the Neils Beach stock appears to be derived from very local stream/gully sources from the west and from the Arawhata River to the north-east.

Figure 3-8: River and locally-sourced beach gravel on Neils Beach. Left shows mainly finer, rounded schist pebbles sourced from the Arawhata River. Right shows platy meta-sandstone pebbles and cobbles sourced from hillside gullies immediately west of Neils Beach.

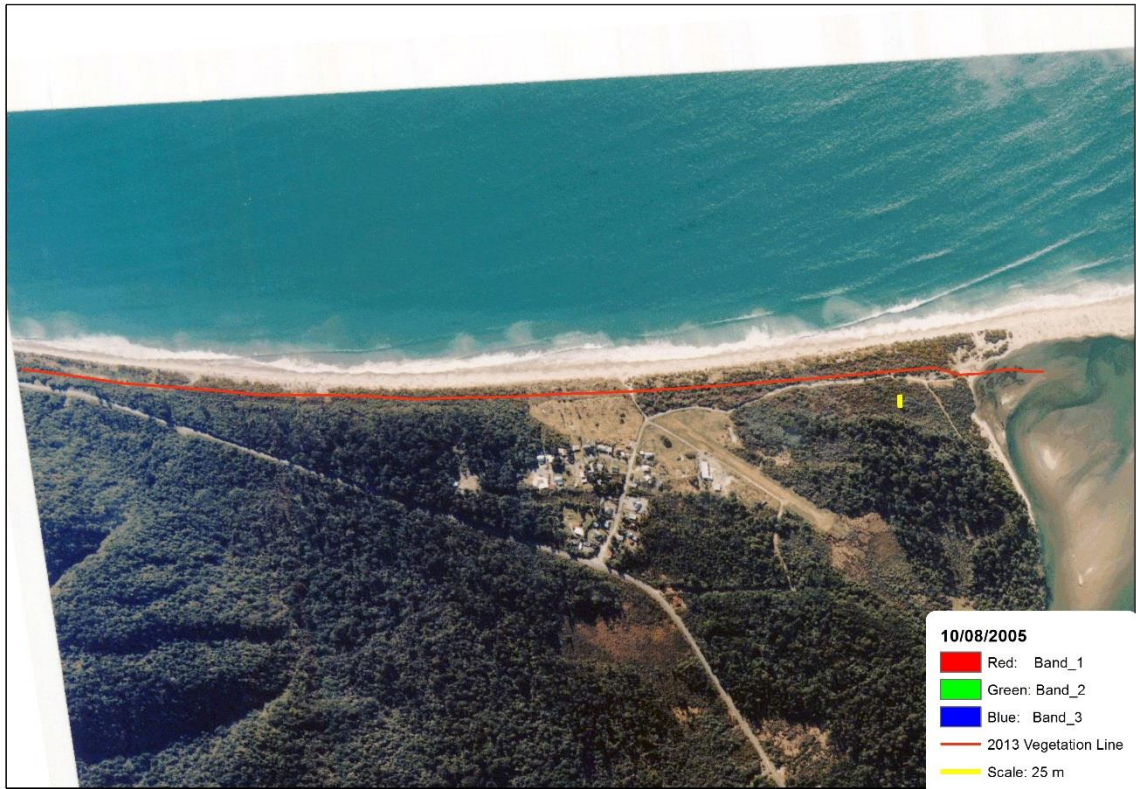
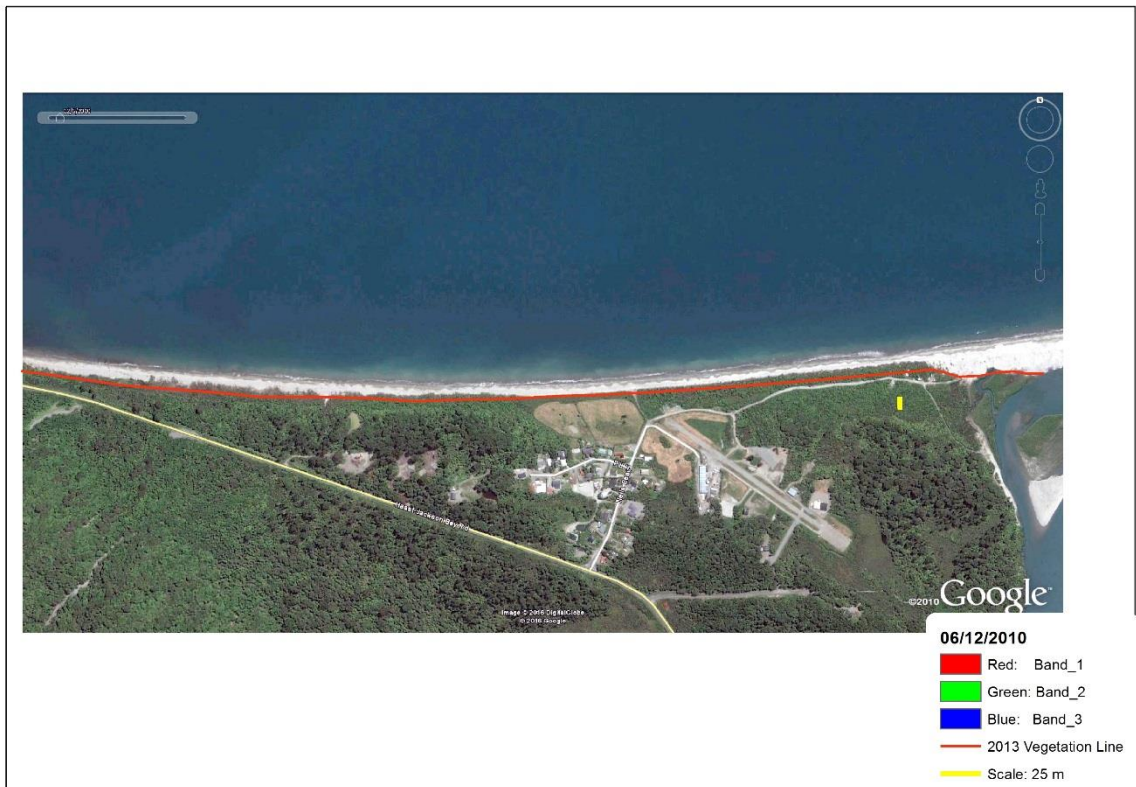
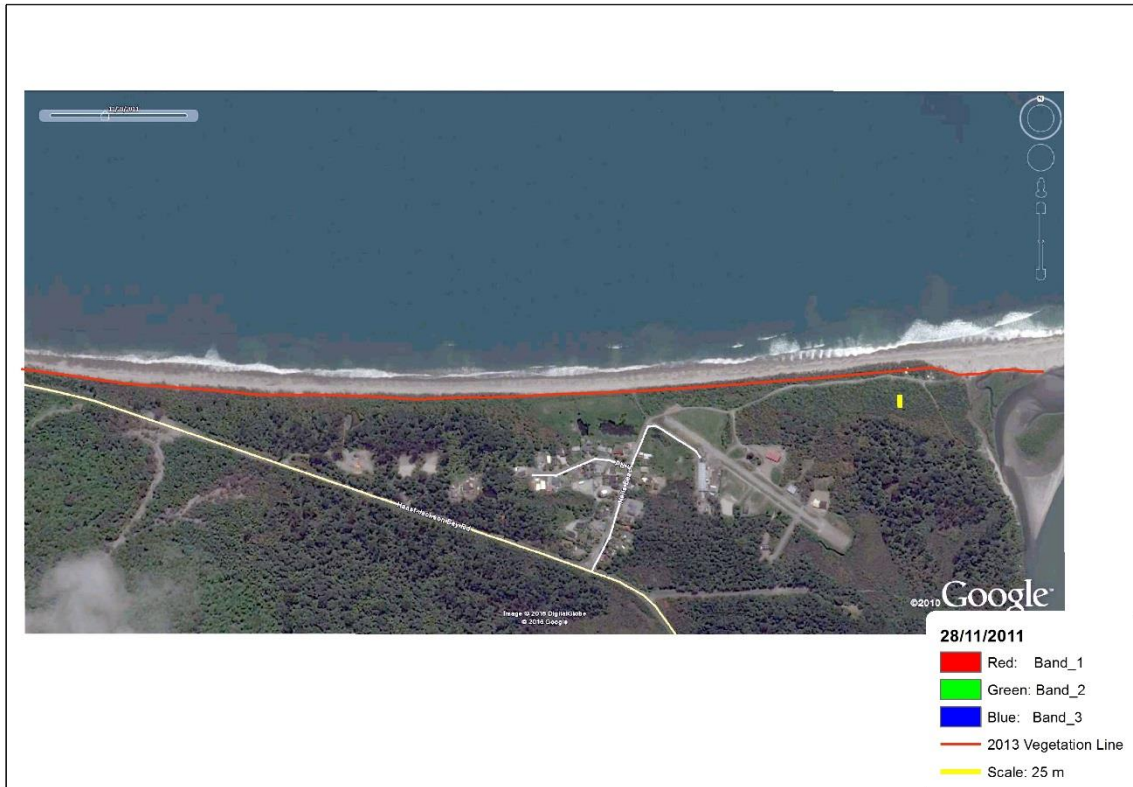
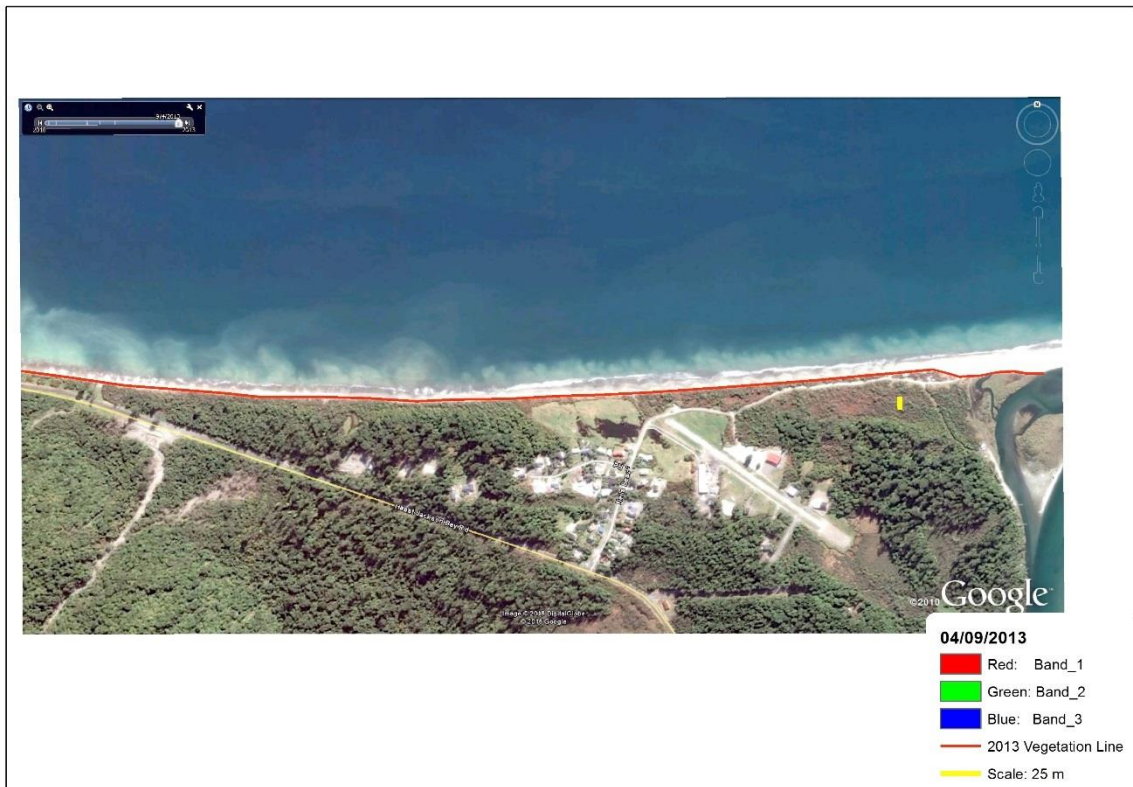
Satellite imagery of Neils Beach and the Arawhata River mouth were sourced from Google Earth, while scanned vertical aerial photographs were supplied by WCRC. Collectively, these provided a sequence from 1977 through 2013 (although some coverage of the area was only partial). The older images were georeferenced and rectified to overlie the 2013 imagery using the ArcGIS software¹. Shorelines, defined by the edge of foreshore vegetation, were digitised on each set of imagery. Figure 3-9 shows a sequence of selected imagery with the 2013 shoreline superimposed. Figure 3-10 shows the earlier shorelines overlaid on the 2013 imagery.

- Since 1977 (at least), the Neils Beach shoreline has experienced advance and retreat cycles. In 1977, the shore in front of the settlement was about where it is now. Between then and now it has built out by ~ 50 m and eroded away again.
- While the 1977 photo stops at the end of the airstrip, we suspect that the 1977 shore position further west may be indicated by a linear feature in the backshore vegetation on the 2013 image (marked with an “O” on Figure 3-10). Despite this erosion phase in front of the settlement in 1977, the 1977 shore was relatively accreted at the Arawhata River mouth.

- By 95, the river mouth corner had been cut back (most likely by the large flood that occurred in 1994 – see Section 3.4.3).
- By 2003-5, however, substantial accretion (~ 50 m) had occurred all along Neils Beach.
- By 2010-11, the shore had retreated again, with a further retreat of ~ 10-15 m in front of the settlement up to 2013.
- Considerable erosion has occurred since the 2013 imagery was acquired. For example, the strip of brush visible on the grassed foredune in front of the settlement in 2013 has now been lost (marked with an “E” on Figure 3-10).
- Through the current retreat period, the Neils Beach shoreline has pivoted clockwise, with the river mouth ‘bulge’ having been progressively trimmed back.

Figure 3-9: Satellite/aerial imagery sequence of Neils Beach, 1977 through 2013. 2013 vegetation-edge shoreline (red line) overlaid on each image.

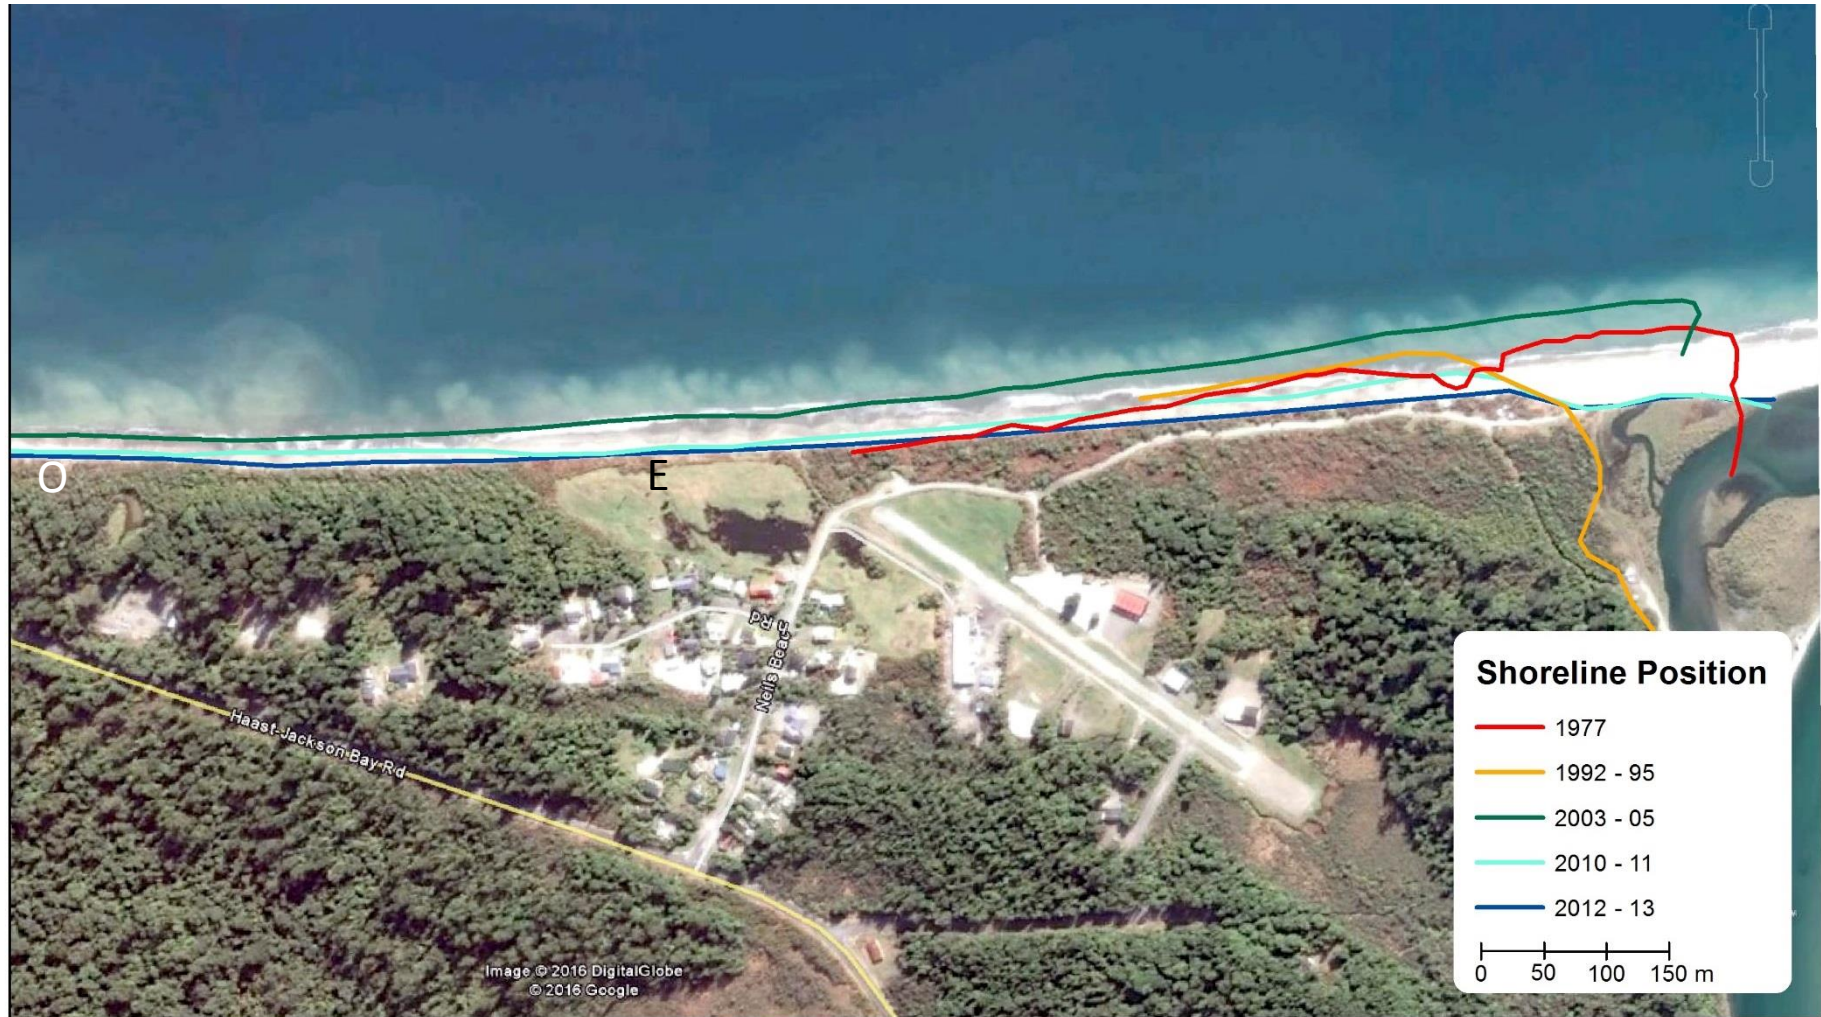
Figure 3-10: Satellite image of Neils Beach acquired on 9 April 2013, with previous shorelines overlaid. Shorelines defined by the edge of vegetation. ‘O’ marks linear feature inferred to be old shoreline (possibly ~ 1977?); ‘E’ shows foredune scrub now lost to erosion. Where there is a date range (e.g. 2003-05) the shoreline changed little between two images and so only one line is plotted.
