Rivermouth-related shore erosion at Hokitika and Neils Beach, Westland

Prepared for West Coast Regional Council

February 2016

NIWA CLIENT REPORT No: CHC2016-002
Report date: February 2016
NIWA Project: ELF16506

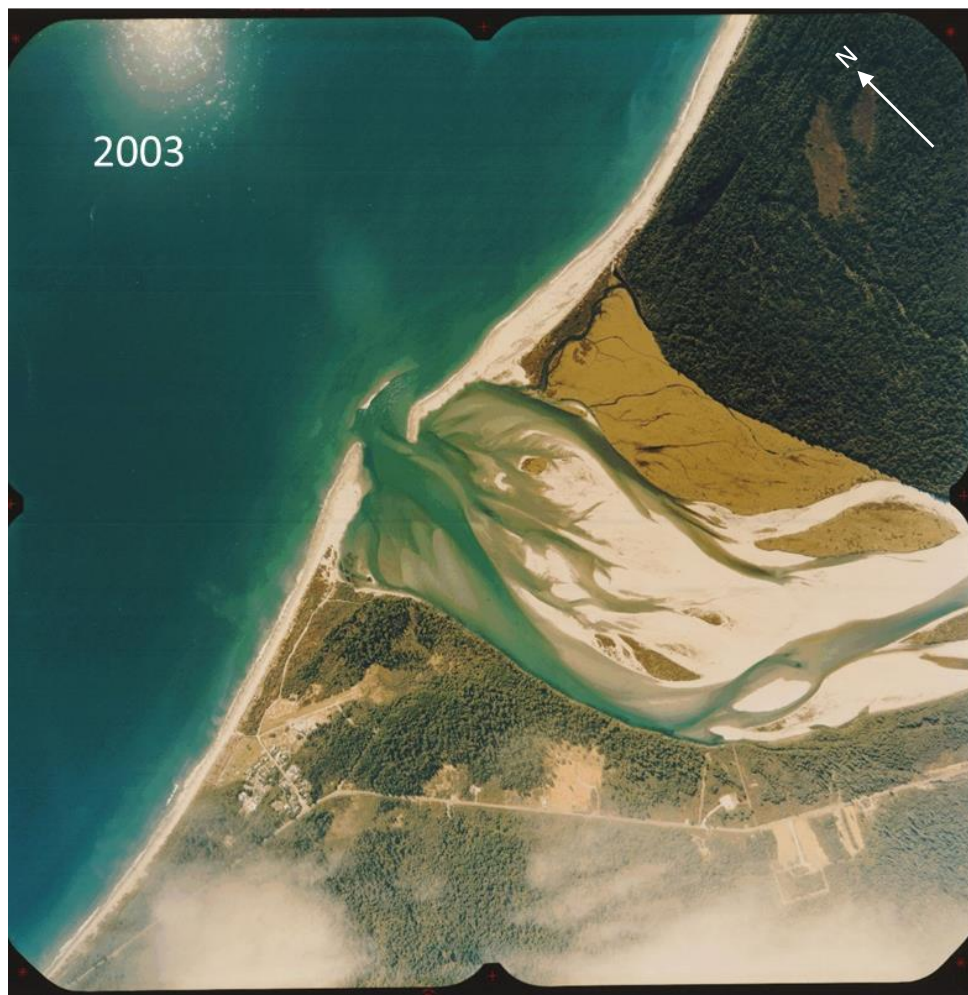
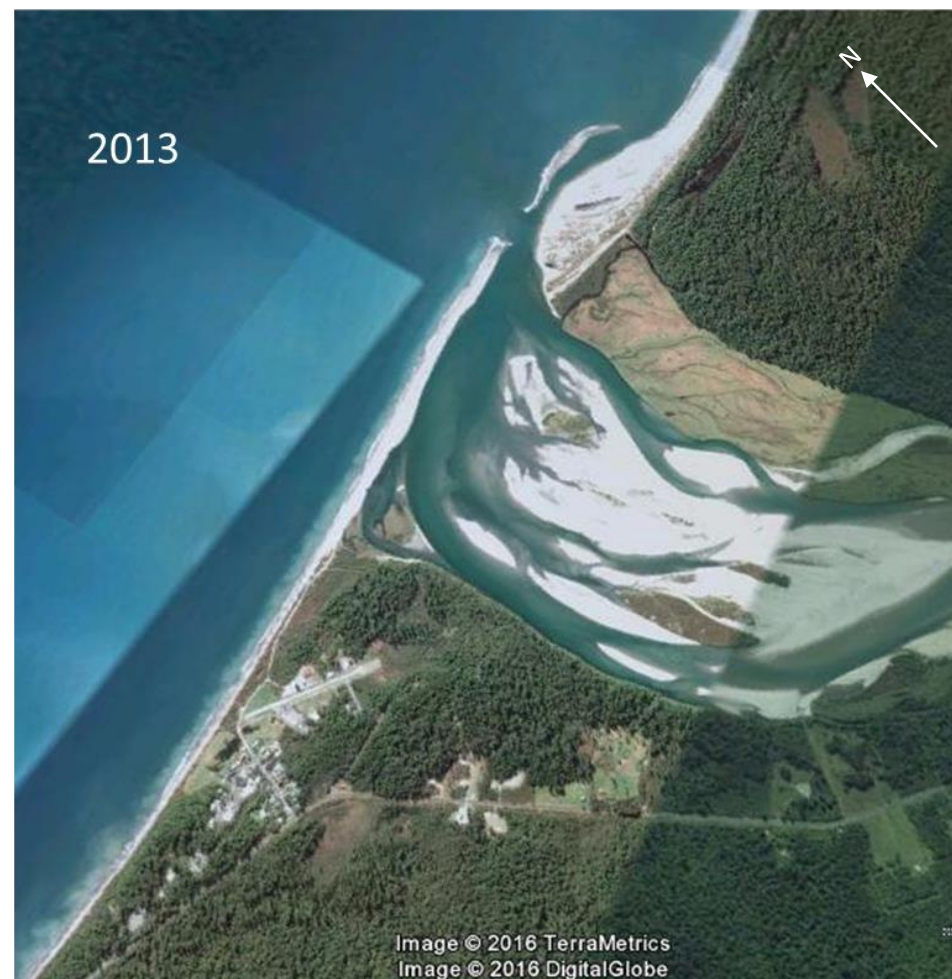
At a wider-scale, changes have also occurred in the configuration of the Arawhata River mouth bar and the alignment of the main river channel. In particular, from 1977 through the mid-2000s (at least when captured on aerial photographs) the mouth bar tended to bulge seaward and the river outflow tended more central or west. In contrast, since 2010 (at least) the bar has tended to run straighter and the river outflow has deflected east behind the bar. This has coincided with river mouth bulge being ‘planed-off’, the clockwise pivoting of the Neils Beach shoreline, the accumulation of a drumstick-shaped sediment deposit on east side of river mouth, and eastward retreat of the right bank of river (compare 2003 and 2013 images in Figure 3-11). Essentially, in this river mouth state the river only feeds sediment to the shore north-east of the river mouth (where some of it becomes trapped on the ‘drumstick’), while the removal of the bulge and shore pivoting enables waves arriving from the west to sweep sediment eastward off Neils Beach.

Figure 3-11: Neils Beach and Arawhata River mouth in 2003 and 2013. Note on 2013 image: flattened delta 'bulge', northward-displaced mouth, 'drumstick' growth on east side of river mouth, and right bank of river trimmed back.

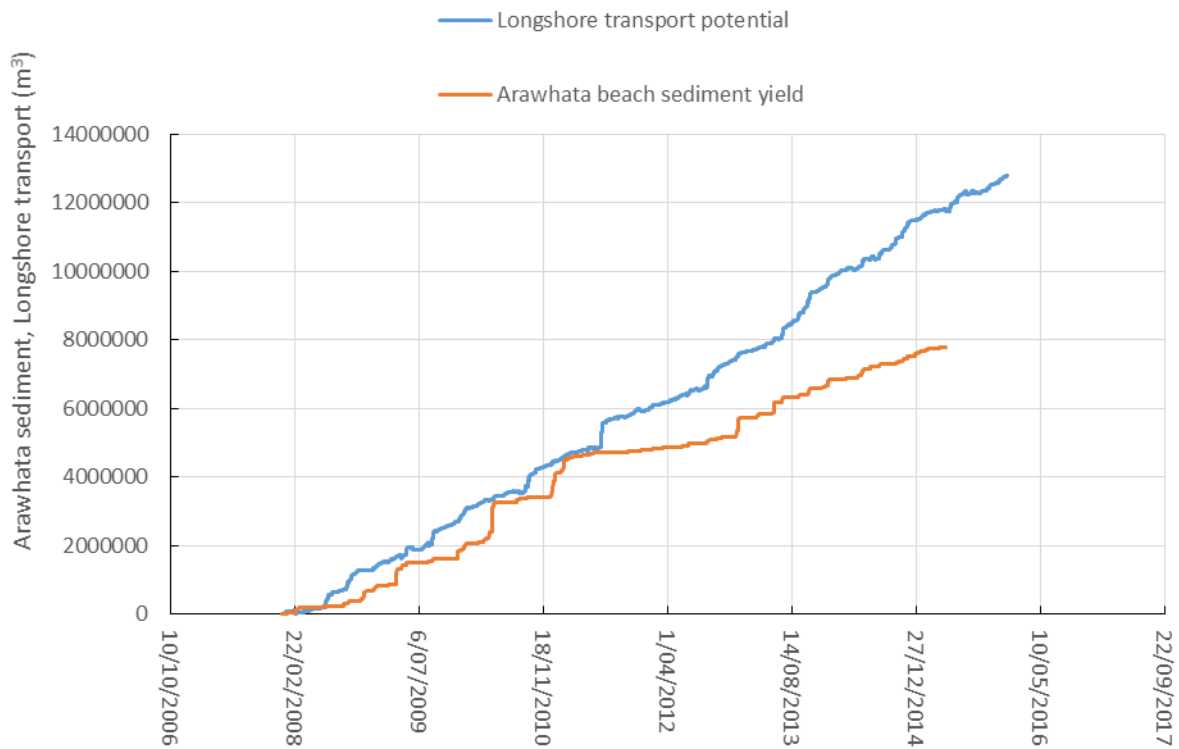
Figure 3-13 also shows the accumulated delivery of Arawhata beach-grade sediment from 2008 through 2015. The average delivery is 1.07 million m^3/yr (assuming a bulk density of 1.7 t/m^3). Note how floods cause jumps in the accumulated sediment delivery while flat parts of the curve indicate periods of minimal delivery. 2011-2012 was such a period.

Figure 3-13: Longshore transport potential at Arawhata mouth and delivery of beach-grade sediment from Arawhata River accumulated since January 2008. Note divergence of the two trends after 2011.

In regard to the current phase of erosion, Figure 3-13 shows a clear divergence between the longshore transport potential and the Arawhata’s delivery of beach-grade sediment from 2011 onwards³ - thus indicating an imbalance in the beach sediment budget. Moreover, the strong coastal wave event of July 2011 was followed by almost two years of relatively benign river flows with low sediment delivery. The dominance of wave-driven processes over this period can be expected to have pushed- and trimmed-back the shoreline at the river mouth and also extended-eastward the river mouth bar (as observed on the aerial and satellite imagery). In turn, this would have directed what river sediment was being delivered to the east side of the river mouth (and remote from Neils Beach), while the straightened, river-mouth shore would have allowed waves to transport sediment eastward off Neils Beach.

³ The two curves in Figure 3-13 may be likened to the “run” curve shown in limited-over cricket match TV commentaries. Diverging curves show where one team is falling behind the target set by the other. In this case, the ‘Arawhata River team’ began losing to the ‘Longshore transport team’ in 2011.

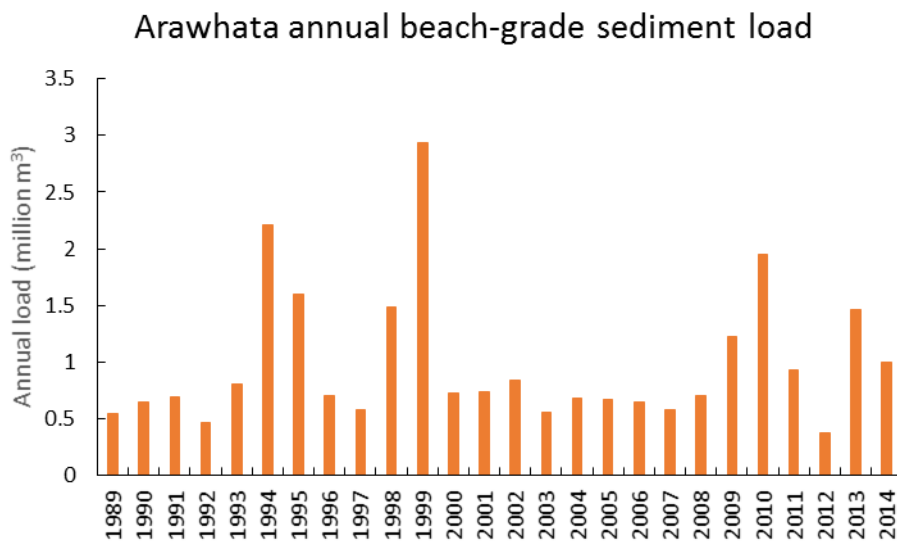
Figure 3-14 plots the annual beach-grade sediment delivery since 1989, when flow recording began in the Arawhata. This shows considerable variability from year to year (0.38 to 2.93 million m^3 , ranging over a factor of 7.7). The two highest annual yields (2.2 and 2.9 million m^3) occurred in 1994 and 1999 associated with the two largest floods on record ($4770 \text{ m}^3/\text{s}$ on 9 January 1994 and $4260 \text{ m}^3/\text{s}$ on 17 November 1999). It is notable that these events immediately precede the 1995-2005 accretion phase along Neils Beach that was identified in Section 3.4.1. Note also a long span of relatively 'modest' annual loads from 2000 through 2008.

Figure 3-14: Annual load of beach-grade sediment delivered by Arawhata River, 1989-2014.
