Franz Josef Rating District 2021-2024 Asset Management Plan

West Coast Regional Council

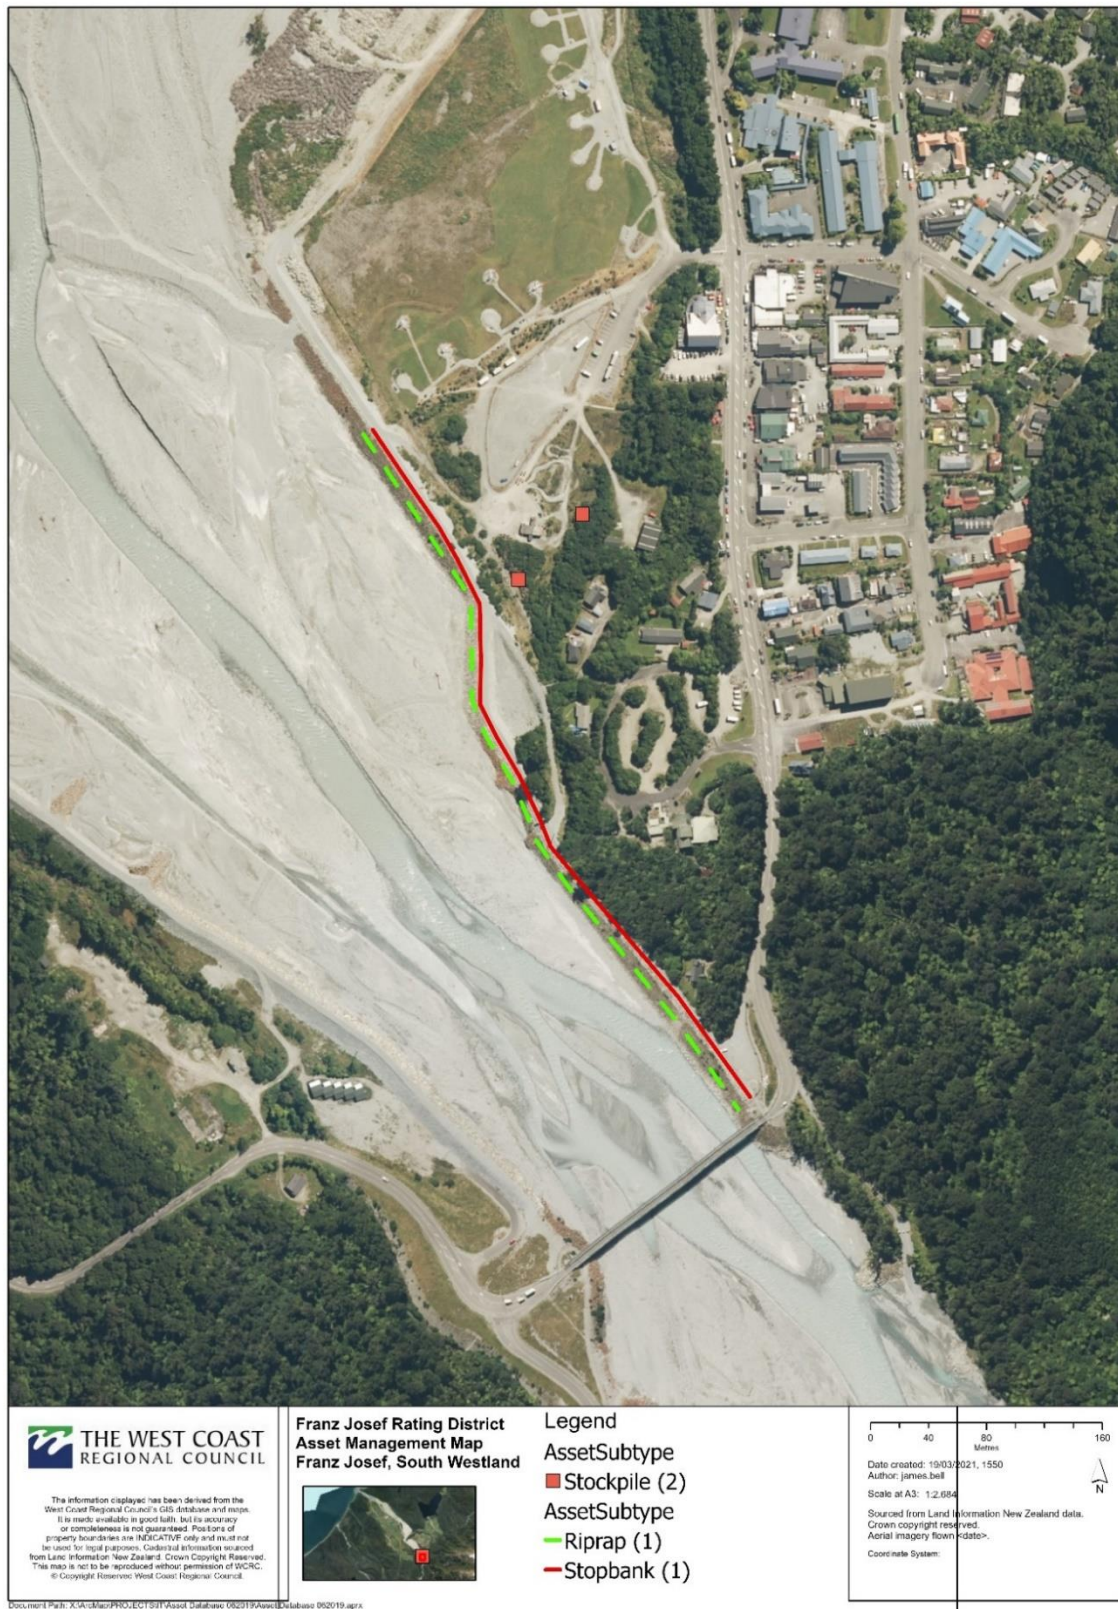
5.5 Asset Map Franz Josef

Note: Not all assets have been added to the asset map due to having no spatial data to represent them.

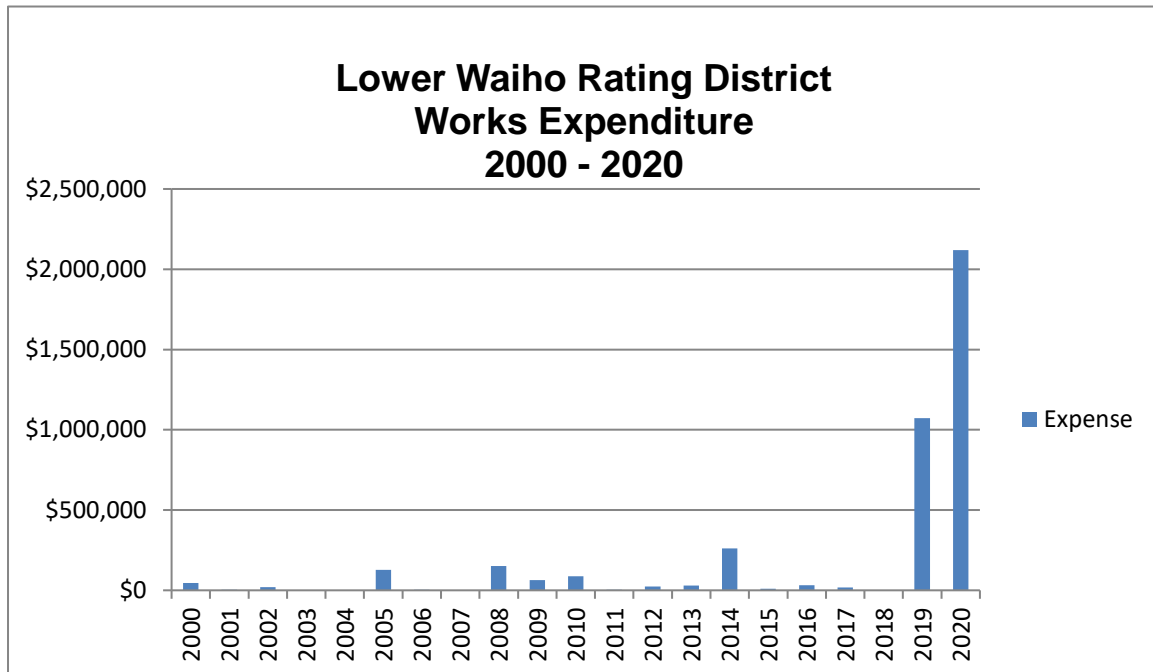
7.5 Works Expenditure Lower Waiho

This chart reflects the construction costs of infrastructure assets on the Lower Waiho Rating District. This chart **does not** reflect the total annual expense incurred by the Lower Waiho Rating District. Please refer to the annual works and financial report for the total expenses.

Expenditure 2000 - 2020	
Total expenditure	\$ 4,071,602
Average expenditure	\$193,885
Total asset value	\$9,500,930.00

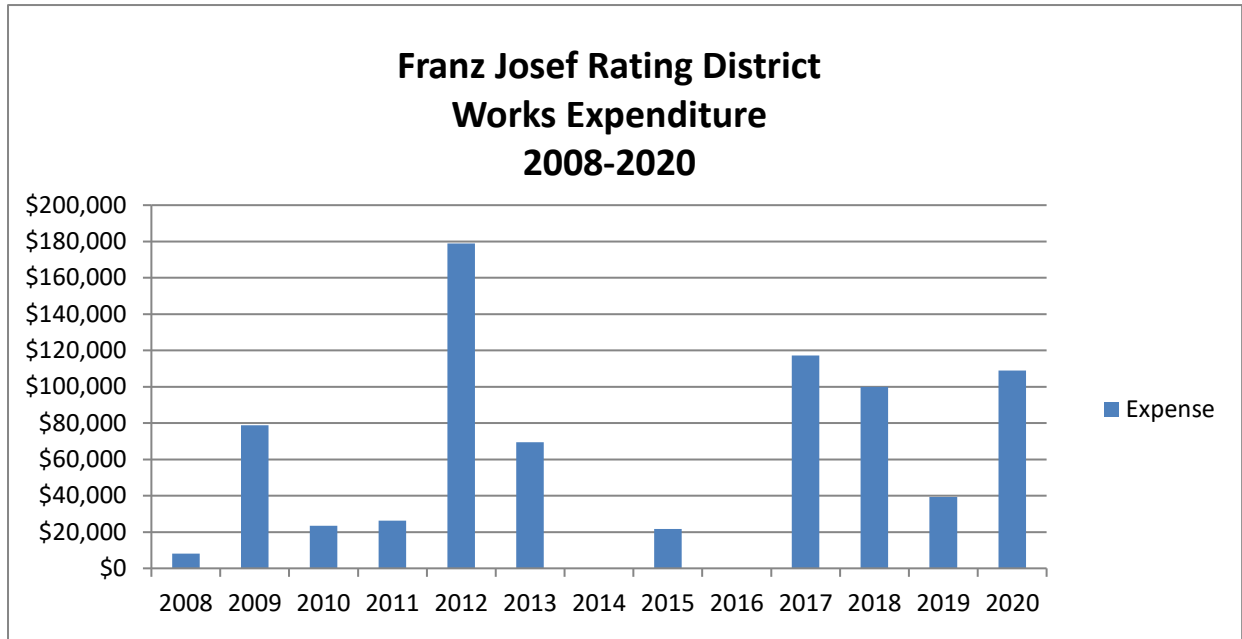
7.6 Works Expenditure Franz Josef

This chart reflects the construction costs of infrastructure assets on the Franz Josef Rating District. This chart does not reflect the total annual expense incurred by the Franz Josef Rating District.

Expenditure 2008 - 2020

Total expenditure	\$ 772,332.47
Average expenditure	\$ 59,410.19
Total asset value	\$4,957,258
