Managing and adapting to coastal erosion on the West Coast: Ngakawau & Hector

NIWA Client Report: HAM2007-007

January 2007

West Coast Regional Council

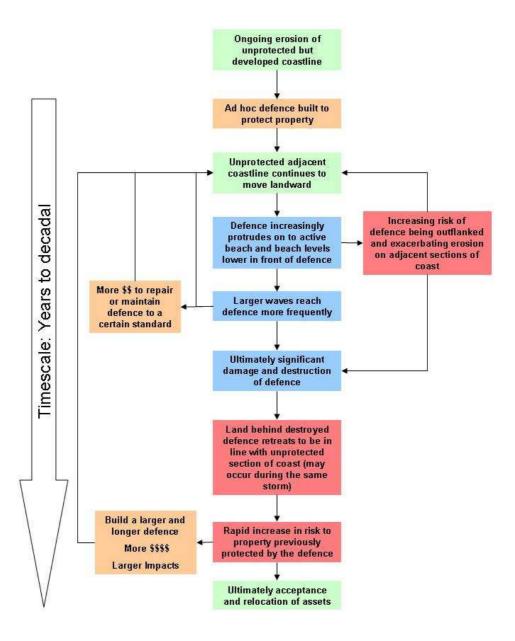
Figure 5: Typical timeline of the protection provided by, and effects of, ad hoc coastal defences on an eroding coastline.

In this situation, coastal defences should only be used as a last resort where property is at direct risk to 'buy some time' to permit a longer-term approach to reducing the risk to such property. This longer-term approach is most likely going to need to involve relocation of existing property along the Ngakawau and northern part (north of 27-29 Main Road) of the Hector frontages over the coming decades. Whilst such actions are unlikely to be required in the immediate future (not withstanding a very severe storm event), property owners along these sections of coast should be mindful that the need to relocate property will ultimately be a reality and that planning an exit strategy over the coming decade or so would be advisable.

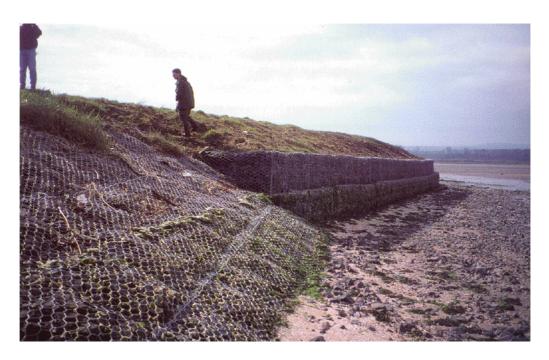
Example of a sloping gabion revetment which tends to have less impact and are more stable than a vertically constructed gabion wall. Blown sand (e.g., along the Hector frontage) is also able to accumulate on such revetments, softening their appearance (Photo: Scottish Natural Heritage, 2000).

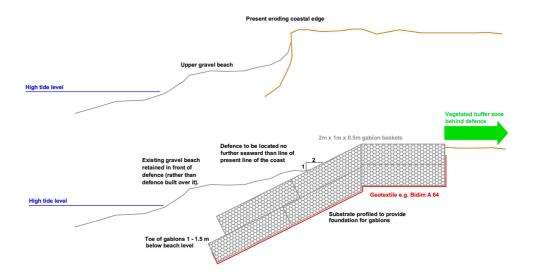
Figure 7: Outline design for a potential sloping revetment along the Ngakawau frontage showing the maximum seaward position of the defence relative to the present day coast. It is vital that the present gravel beach is maintained in front of the defence. Rock armour may also be used but should follow a similar design profile as above. The design is indicative only and will need to be developed for any particular location.

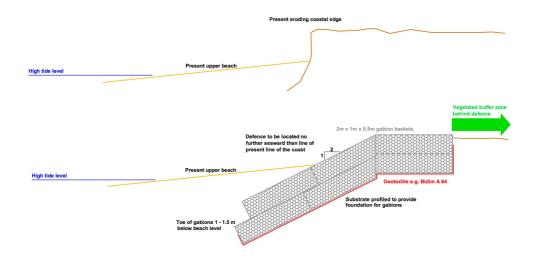
Outline design for a potential sloping revetment along the Hector frontage showing the maximum seaward position of the defence relative to the present day coast. The design is indicative only and will need to be developed for any particular location.
