# The influence of structures on erosion of the north bank of the Mokihinui River mouth

*Prepared for West Coast Regional Council*

*May 2019*

NIWA CLIENT REPORT No: 2019103CH

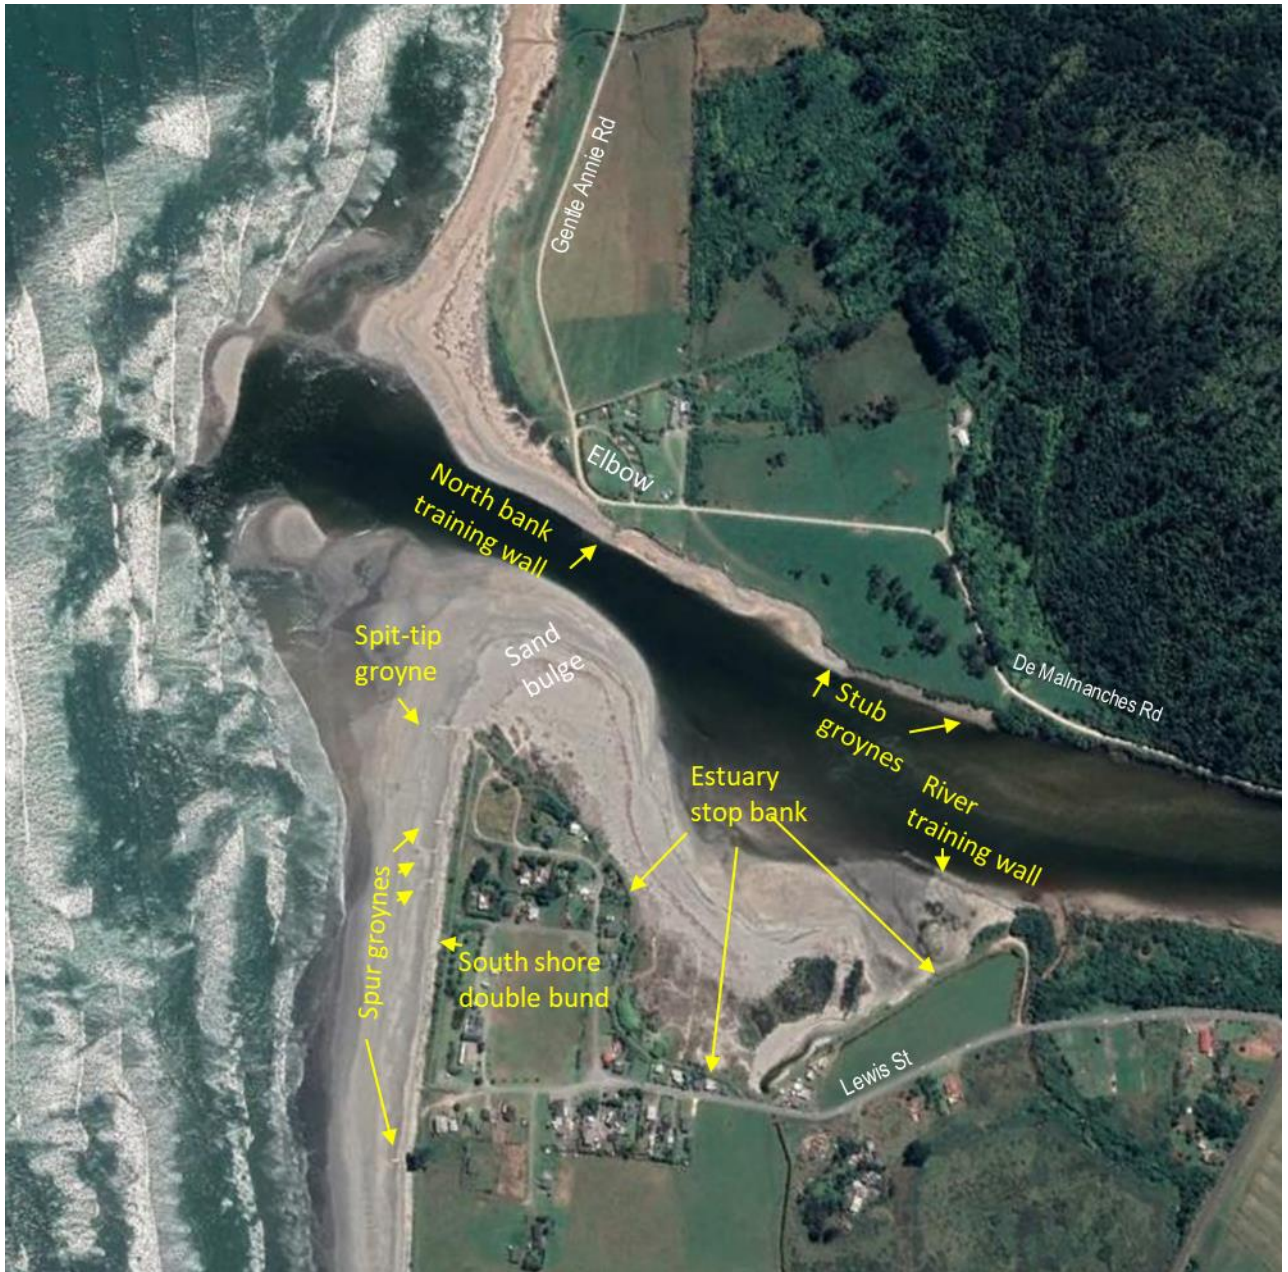
**Figure 2-1: Photo-map locating structures at Mokihinui River mouth.** Image from Google Earth (photographed 2018).

- The spit-tip groyne, while extending 40 m across the mid-upper foreshore, is a small feature at the river mouth scale (Figure 2-1) and is too short to trap much sand – since longshore transport occurs in the surfzone which is only partly penetrated by this feature even at high tide. Thus, while it will be having a small local effect, sand will largely be bypassing it.

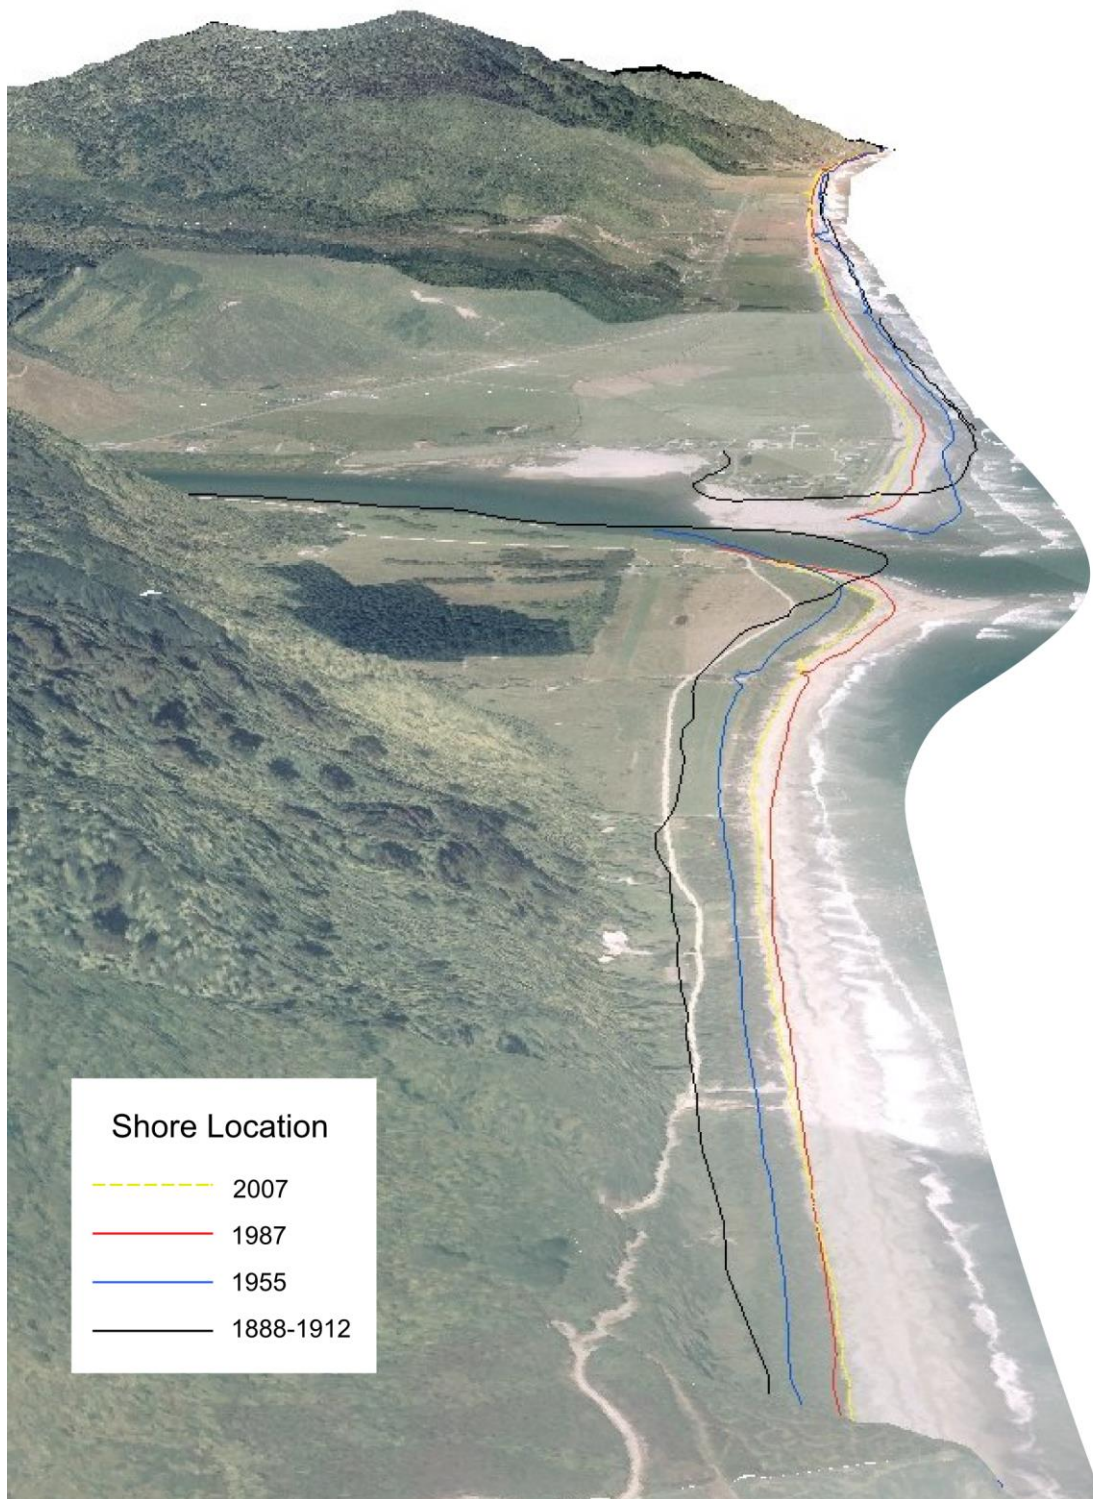
Historical shoreline positions along the Mokihinui embayment, from the late 1800s to 2007, were mapped by Hicks et al. (2007) as part of Meridian Energy's investigations around effects of the proposed Mokihinui hydro project (Figure 4-1). These showed that north of the Mokihinui River the shoreline built seaward between 1906 and 1987 but then retreated. The 1906 cadastral shore/bank line shows that the river outflow then was more normal to the general shoreline trend (i.e., the river flowed straight out to sea), but since around 1955 the outflow has deflected north, with up to ~150 m of erosion off the north bank before 2007. South of the river, the shoreline has experienced ongoing retreat since the first cadastral survey in 1898, with rates increasing after 1955 (from 0.5 m/yr to over 1 m/yr). Shoreline recession rates taper-off with distance north and south of the river.

**Figure 4-1:** Panorama view south from Gentle Annie, showing historical shoreline positions overlaid on 2007 image. From Hicks et al. (2007).

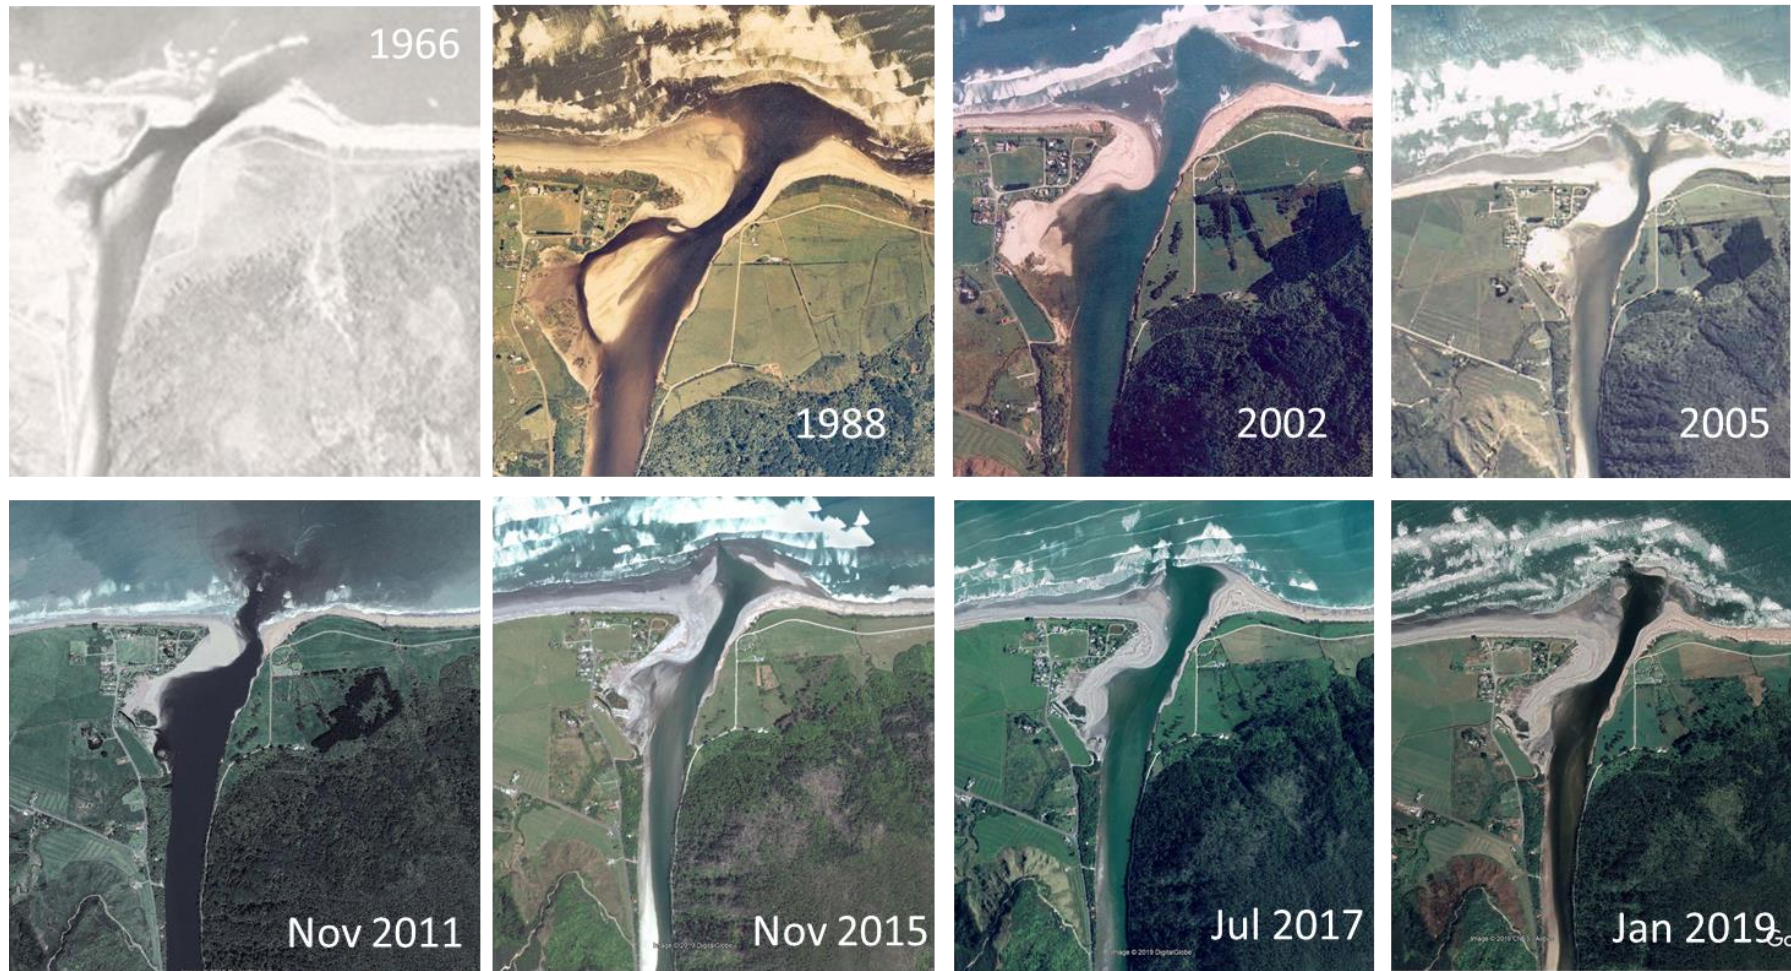
Figure 5-1 shows little change to the basic river mouth pattern since the 1960s, with the river mouth consistently deflecting north of the centreline and a spit (or shoreline bulge) always present on the southern bank. More detailed time-series imagery extracted from Earthengine<sup>2</sup> over the period 2008-2018 shows that the spit waxes and wanes in size, forcing the river more or less towards the north bank, while the outflow across the Rivermouth bar “thrashes around” over an arc of about 40 degrees. The 1966 photograph (Figure 5-1) appears to have the greatest northward deflection, and this concurs with comments made in 1972 that “the present outlet which is well to the north of the township and is resulting in a loss of effective head to the sea”<sup>3</sup>. The construction of the north bank training wall in 1978 would have restricted this northward deflection tendency.

**Figure 5-1:** Aerial photographs of the Mokihinui River mouth from 1966 to January 2019. 2011-2019 imagery from Google Earth.
