pp 174 – 189, Bulletin of the New Zealand National Society for
Earthquake Engineering, Volume 21, No 3, September 1988

Liquefaction in the Buller Region
in the
1929 and 1968 Earthquakes

J. B. Berrill¹, V. C. Bienvenu² and M. W. Callaghan³

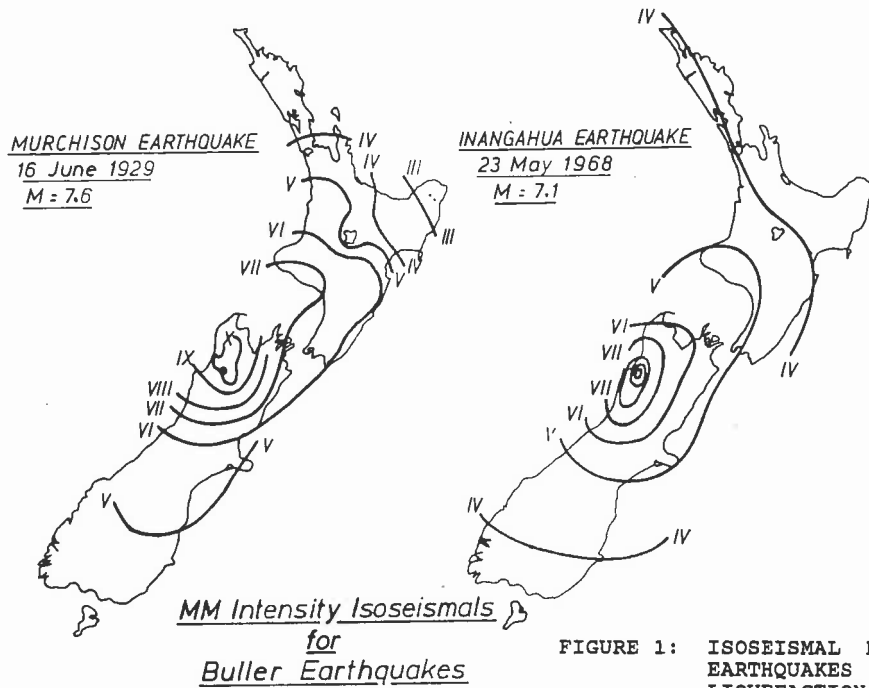
Figure 1 shows isoseismal patterns for the earthquakes. Both were shallow focus events with surface faulting, predominantly in a thrust mode. Brief seismological descriptions of the earthquakes are given in the appendix and further geological and seismological references may be found from the bibliography. It is of interest to note that most of the Inangahua aftershocks lie within the MM IX isoseismal, indicating this was the region of rupture, with rupture propagating southwestwards from a northern hypocentre.

FIGURE 1: ISOSEISMAL MAPS FOR THE TWO EARTHQUAKES IN WHICH LIQUEFACTION WAS IDENTIFIED.

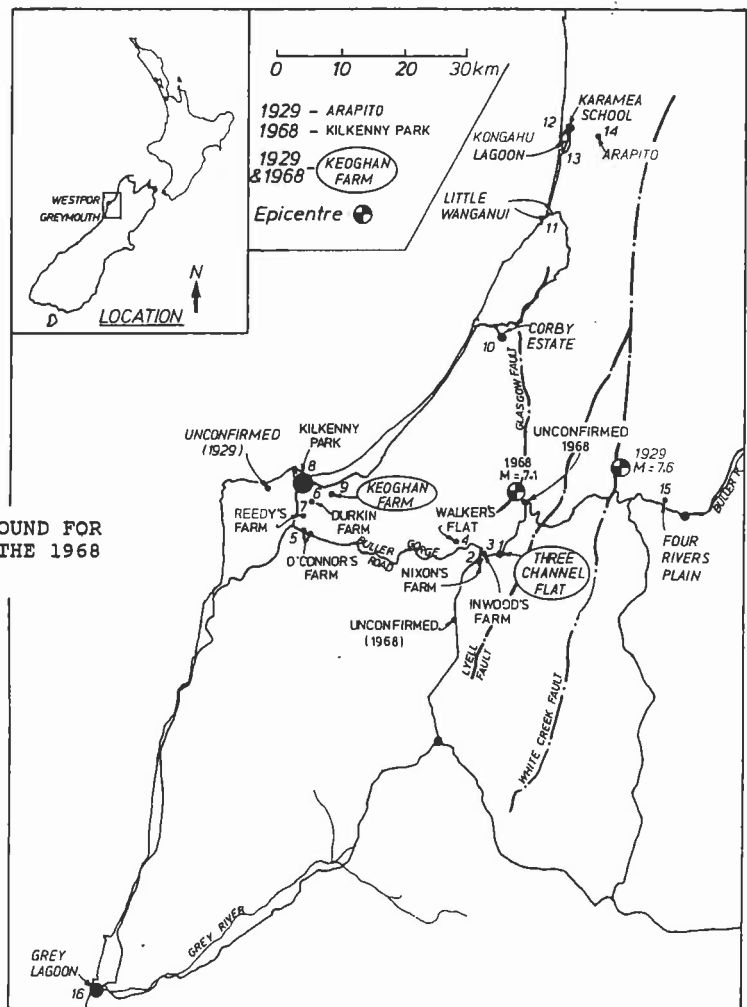
Figure 2 shows the sites of liquefaction that have been positively identified. These sites are listed in Table 1 together with epicentral distances and notes giving the type of evidence found. All sites shown are on level or near level ground.

FIGURE 2: SITES OF LIQUEFACTION FOUND FOR THE 1929 MURCHISON AND THE 1968 INANGAHUA EARTHQUAKES.

Three unconfirmed sites are also marked in Figure 2. For these there is some indefinite evidence for liquefaction in 1968 in the form of vague word-of-mouth reports or apparently ejected sand in aerial photographs that could not be confirmed on the ground.

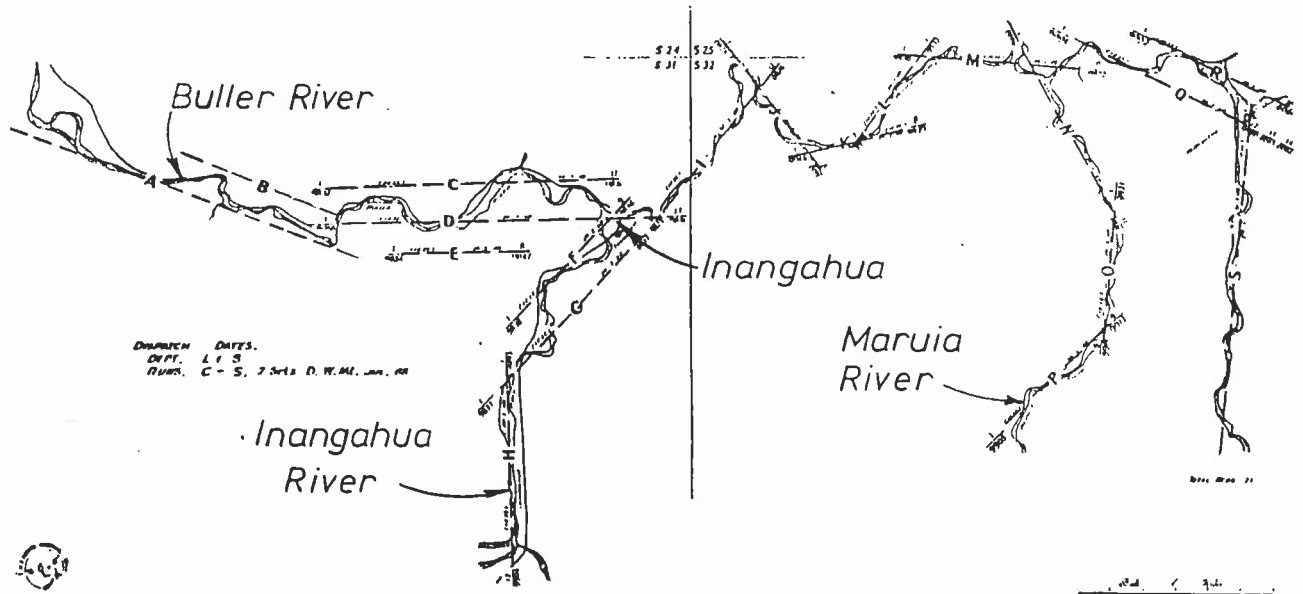
By far the most extensive occurrences of liquefaction were found in the flood plains of the Buller River at Three Channel Flat, about 3km northeast of Inangahua Junction, and at Walker's Flat, about 5km west of Inangahua Junction. Several hundreds of sand boils show up on aerial photographs taken on May 29 and 30 and in terrestrial photographs taken by various observers. In both places, the ejection of sand was quite pervasive. Figure 3 gives the flight plan of the post-earthquake aerial photography flown by New Zealand Aerial Mapping Ltd. The pilot was Mr Cyril Whittaker who confirms that runs A and B shown in the plan were not flown, due to poor weather.

FIGURE 3: FLIGHT PLAN OF AERIAL PHOTOGRAPHY, SURVEY NO. 3086, FLOWN ON THE 29TH AND 30TH OF MAY, 1968.
