**GREYMOUTH FLOOD WALL
UPGRADE DESIGN
GEOTECHNICAL REPORT**

Report prepared for: Good Earth Matters

Report Reference: 09828-A

Date: 9 November 2009

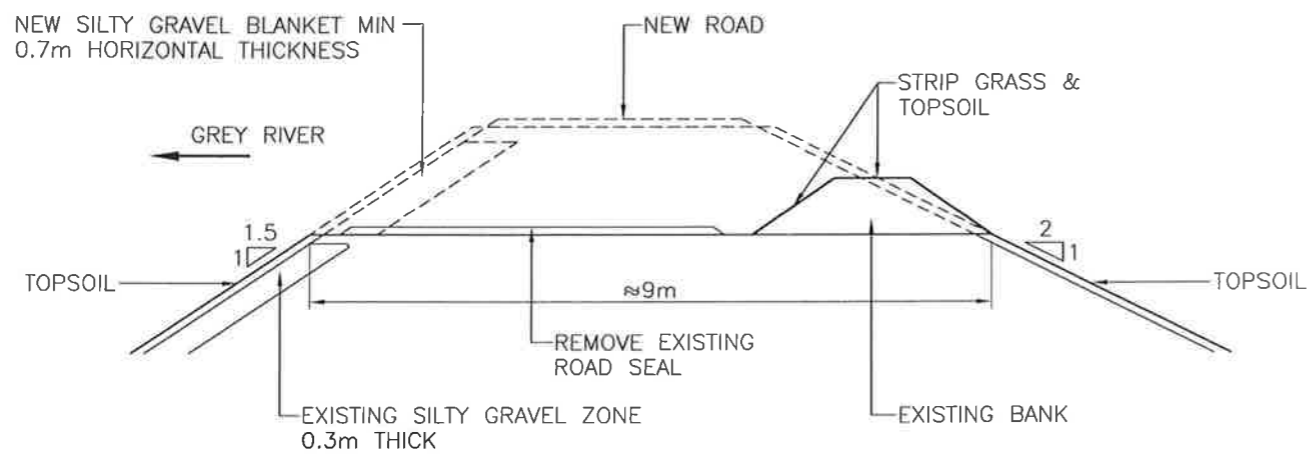
COBDEN NEAR RANGE CREEK CULVERT
SCALE 1:100 (APPROX)

The existing stopbank in the area within around 300 m upstream of the existing Range Creek culvert is very steep, and has a narrow cross section and crest width due to the constraint of the adjacent road. Seepage has been noted around and/or beneath the culvert, and remediation of this structure has been raised as item for consideration in our brief. During the site visit, seepage was observed exiting adjacent to the culvert toward the Grey River. It is therefore likely that the seepage direction will reverse during flooding of the river, and the seepage flows will exit toward Cobden.

The drill hole identified sandy gravel beneath the culvert level (base of stopbank fill). The in situ foundation material is likely to be highly permeable, and it is also considered likely that seepage along the interface of the culverts with natural ground and backfill is occurring. Design details of the wing wall extensions have been sighted, but nothing of the original wing wall and culvert installation which apparently predates the stopbank upgrade of the late 1980's. No internal inspection of the culverts was undertaken however it is considered likely that settlement of the culverts has occurred to some extent, as the stopbank height has been raised at least once following original construction.

At the culvert location, the recommended detail for limiting seepage is a new earth liner layer within the fill surrounding the culvert extension. There is the potential for seepage pressure from either direction (i.e. the Grey River side during flood, and the Cobden side during normal operation/local rainfall events). Therefore the recommended detail incorporates an

internal low permeability core zone on the Grey River side of the culvert, with a supporting shoulder of general stopbank fill material. This arrangement is indicated in drawing 09828-6. It is important that the low permeability core zone is well keyed into the existing low permeability facing layer on the river-side stopbank batter. The previously noted possibility of culvert settlement raises the potential for seepage originating from pipe joints, and it is recommended that an internal inspection of the culverts be completed as part of the structure upgrade.

In the culvert location, the founding level for compacted fill is beneath river level, and occupies the normal drainage path for the Cobden estuary area. Construction will therefore require careful planning and execution, with consideration given to drainage so that fill quality is not adversely affected by water within the excavation. Very high compaction standards are required below and around the pipes in particular.

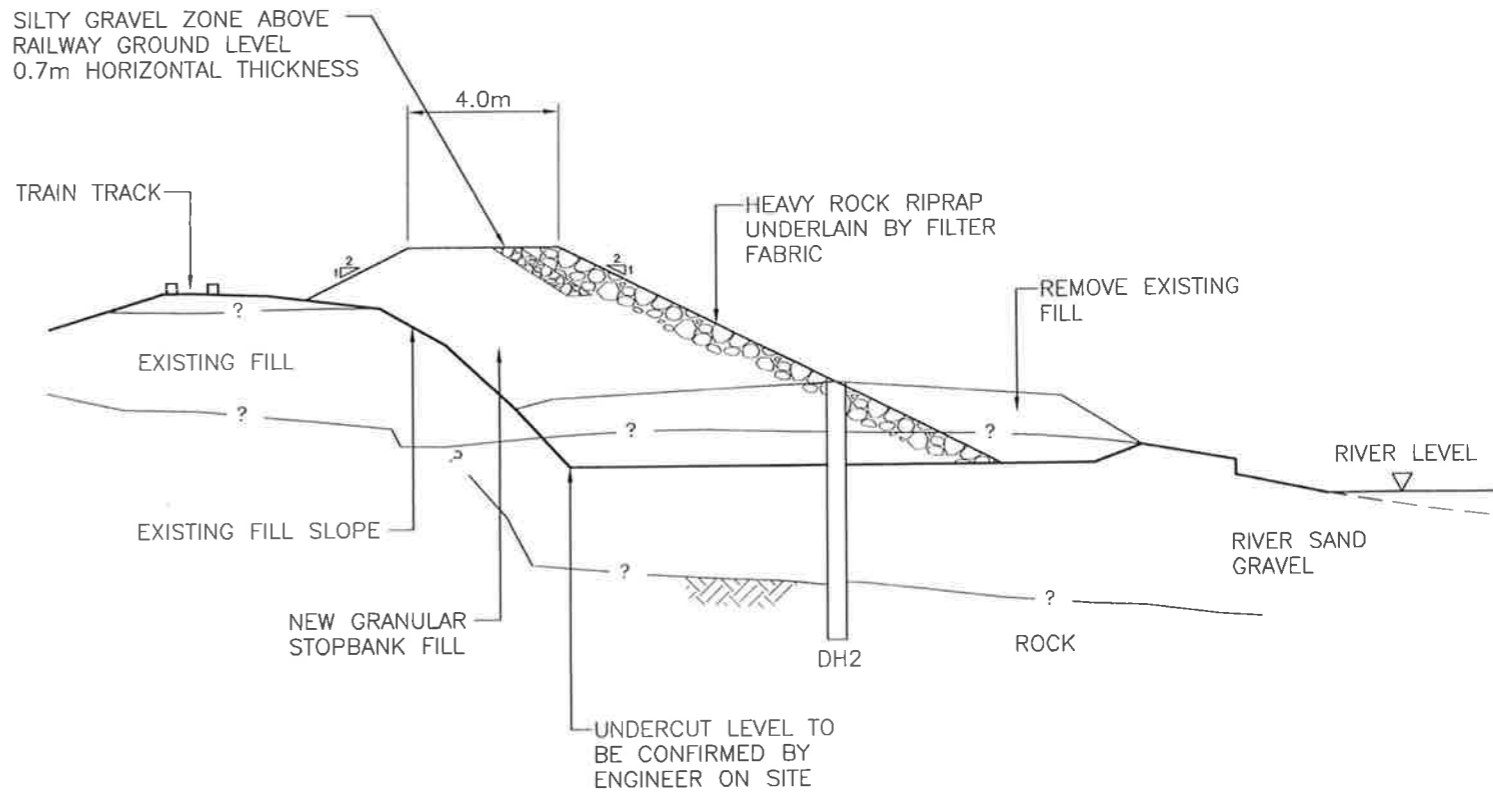
2 BRIDGES AREA
SCALE 1:200

2. As expected the two Bridges section had the most challenging ground conditions, i.e. soft founding soils requiring undercutting and high groundwater levels.

All loose, permeable or soft materials require removal from the stopbank footprint, an undercut over the whole footprint of 0.5 to 1 m is envisaged. In places a deeper sub-excavation may be required either over the whole footprint or as a cut off for seepage control. The typical cross section for the new stopbank should incorporate an upstream silt core and downstream free draining shoulder similar to the existing stopbanks in the area. The upstream core zone should be keyed into in situ ground. The recommended new stopbank cross section is indicated in drawing 09828-5.
