Buller District Council Lifelines Study

Alpine Fault Earthquake Scenario

Buller District Council

Alpine Fault Earthquake Scenario & Lifelines Vulnerability Assessment

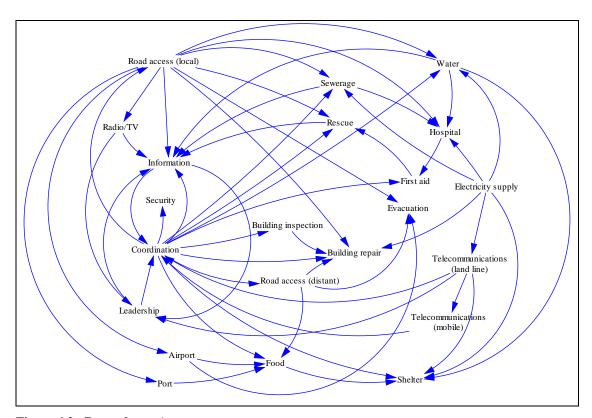
Figure 6.3: Dependency Assessment

A dependency diagram for the response and recovery periods of the Alpine Fault earthquake is shown in Figure 6.3. The convention used is that the need/lifeline at the head of the arrow is dependent on the need/lifeline at its tail.

Generally, the more links to any node in the diagram, the greater its importance. The two most highly linked nodes in the diagram are *Co-ordination* (pre-eminently) and *Information*. But this does not give the whole picture, for *Leadership* actually contributes to all activity, and these contributing links are not shown in the diagram. The next most important need, beyond these three, is *Local road access*. What is missing are the mechanisms by which the necessary information flow for *Co-ordination* is gathered and sent out and also the relative importance as some links will be more important than others.

Based on the simple dependency assessment presented in Figure 6.3 and only considering the dependence of others on a particular lifeline i.e. the number of arrow tails leaving a lifeline, the priority for re-establishing lifelines from the Councils' perspective is as follows:

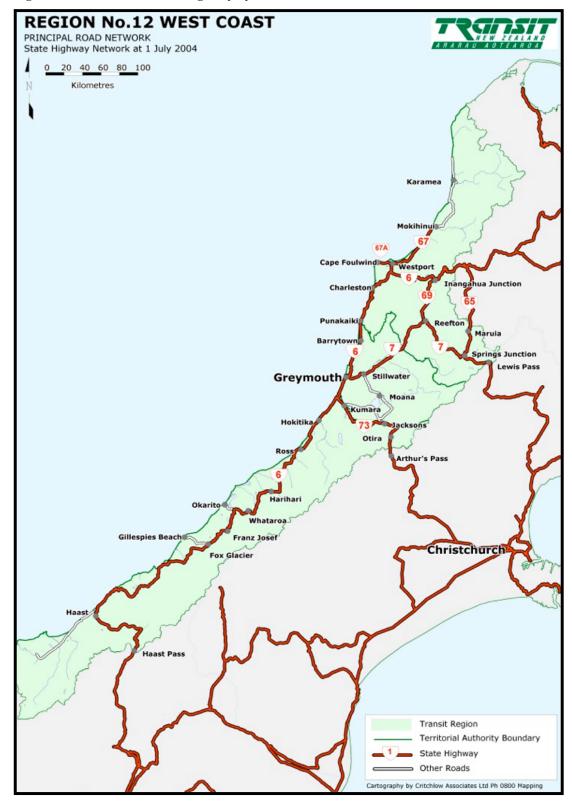
Figure 7.1: West Coast State Highway Sytem

The West Coast State Highway system is shown in Figure 7.1. The State Highway system provides all the external links beyond the Buller District, and the principal network within the District. Although it is not the BDC's responsibility, its performance will impact greatly on the district's resilience to an earthquake event. Transit NZ has carried out a seismic screening of all the bridges on the state highway system. The report on region 12 – West Coast – was prepared in 1999. This study identified the following bridges in the region (Table 7.3) at risk of serious damage or collapse, requiring closure. Other bridges are at risk of damage, but have not been included in Table 7.3, and the table does not include the vast majority of bridges where little or no damage is expected.

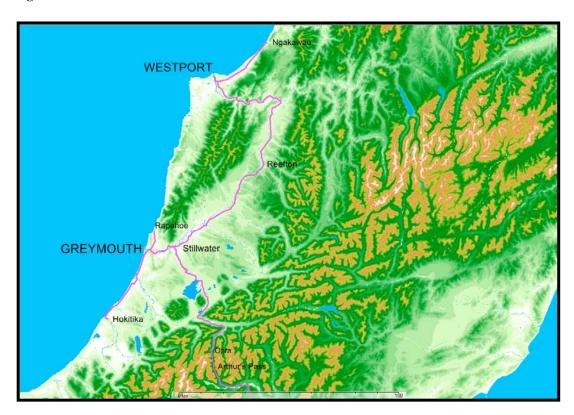
Figure 7.2: West Coast Rail Network

The West Coast railway network is shown in Figure 7.2. The West Coast is linked to the national rail network via the Midland Line from Rolleston (Christchurch). At Stillwater it splits to a north line to Westport and Ngakawau. A south line leads to Greymouth, Rapahoe and Hokitika. The line is single tracked with numerous passing loops and varies considerably in age and condition. The major traffic on the line is coal transport from Ngakawau (Stockton Mine) and Rapahoe (Spring Creek Mine) through Otira to Christchurch.

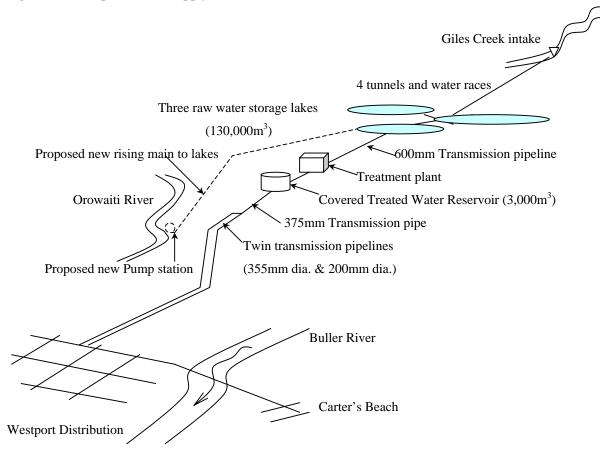
Figure 8.1: Westport Water Supply

The Westport water supply is shown diagrammatically in Figure 8.1 and is described as follows:

- An intake on the south branch of Giles Creek abstracts water which flows through 6,000m of tunnels and water races to three open raw water storage lakes;
- The water flows from the lakes to the treatment plant via a 530mm concrete transmission pipeline;
- The treatment consists of coagulation with alum followed by rapid sand filtration. The pH of the water is adjusted using hydrated lime prior to disinfection with chlorine gas;
- The treated water is stored in a 3,000m³ butynol-lined reservoir with a floating butynol cover.
- The treated water flows from the 3,000m³ reservoir to the reticulation network in Westport via two parallel transmission lines. One transmission line is a 356mm diameter steel pipeline and the other is a 200mm diameter pipe cast iron pipeline.
- The supply to Carter's Beach is via a 100mm AC main attached to the bridge over the Buller River.

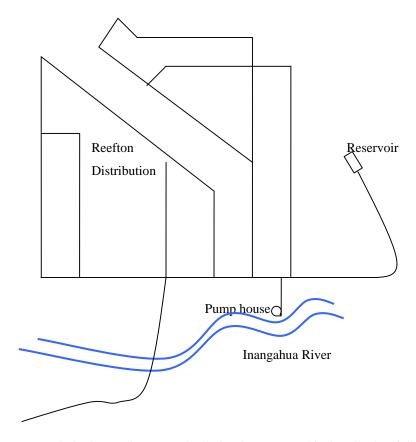
Figure 8.2: Reefton Water Supply

The Reefton water supply is shown diagrammatically in Figure 8.2 and is described as follows:

- Water is pumped from an intake gallery in the Inangahua River using two surface mounted pumps in a pump house adjacent to the river.
- The water is pumped untreated directly into the distribution system.

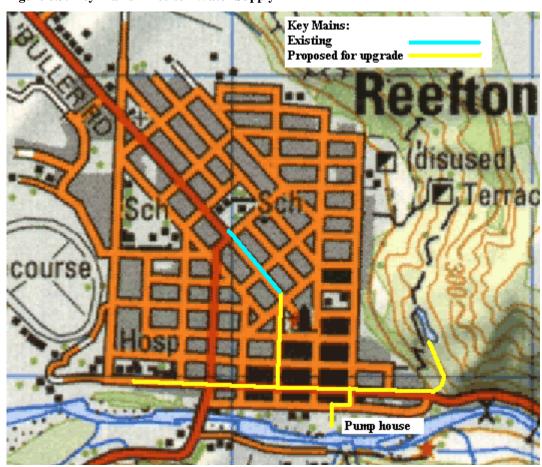
Figure 8.3: Key Mains – Reefton Water Supply

It is envisaged that key mains will be constructed of earthquake resistant pipe material such as polyethylene (PE) or PVC. It is noted that existing key mains will need to be replaced, however, these main pipes are reaching the end of their asset life and are likely to be due for replacement anyway.

- Undertake a geotechnical assessment of the reservoir to determine the risk of failure in a MM VIII
 earthquake and make recommendations on improvements to address these risks;
- Undertake a cost benefit analysis for purchasing a generator to power the water supply pumps during periods when national grid power is not available;
- Improve the capability of providing an emergency level of service after a strong earthquake by improving the ability of key mains to withstand strong shaking. The location of the proposed key mains is presented in Figure 8.3.

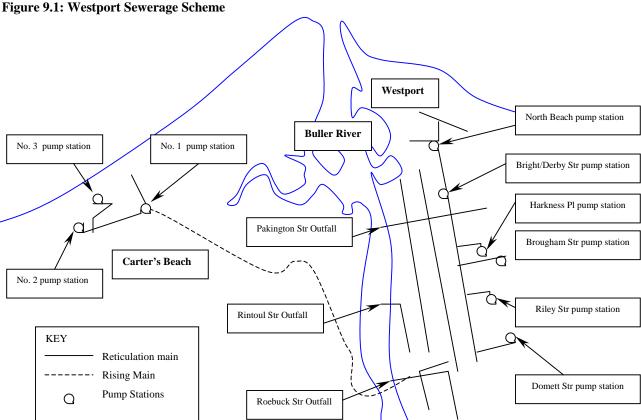
The Westport sewerage scheme is shown in Figure 9.1 and can be described as follows:

- The Westport sewerage scheme collects sewerage from Westport and Carter's Beach. The sewage is not treated and is discharged to the Buller River via three outfalls; Pakington Street, Rintoul Street and Roebuck Street.

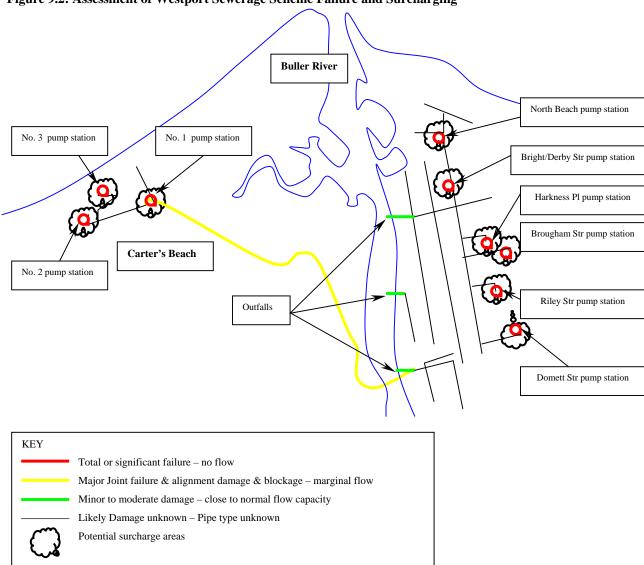
Figure 9.2: Assessment of Westport Sewerage Scheme Failure and Surcharging

An assessment of failure of scheme components and resultant surcharging of sewage (9 locations) is presented in Figure 9.2 and described as follows:

- Surcharging at Pump Stations No. 1 will discharge to a surcharge pond adjacent to the pump station. This is normally pumped out. If the surcharge pond overflows sewage will flow onto the verge and the State Highway.

- Surcharging at Pump Station No. 2 will discharge onto the State Highway where it is likely to pond.
- Surcharging at Pump station No. 3 Carter's Beach, is likely to be minor. The pump station is low lying but only receives a small volume of sewage from the public hall and toilets.

- Power to the sewage pump stations will fail shortly after the earthquake;
- Surcharging is likely to occur to some degree at the nine locations identified in Figure 9.2;

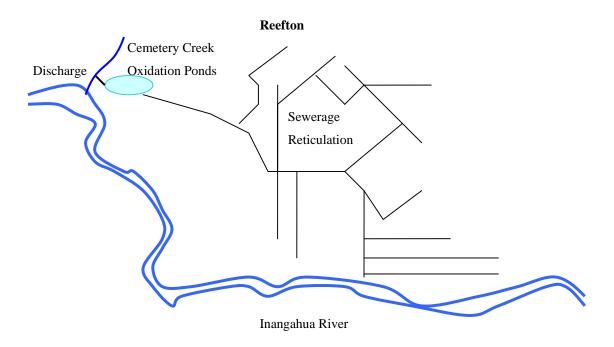
Figure 9.3: Reefton Sewerage Scheme

The Reefton combined sewerage/storm water scheme is shown in Figure 9.3 and can be described as follows:

- Sewage flows under gravity from homes, shops, offices and small businesses through the Reefton sewer network to the Reefton oxidation ponds;
- The Reefton oxidation ponds are under construction at the time of preparing this study. Until now sewage has discharged directly into Cemetery Creek to the Inangahua River. Once complete sewage will be treated in the ponds;
- The ponds consist of an aeration lagoon, followed by two maturation ponds. Treated effluent from the ponds will flow through a rock filter prior to being discharged to Cemetery Creek; and
- During light rain the combined sewage/storm water flow will enter the ponds. However, during
 heavy rainfall events the ponds are bypassed and the combined flow is discharged directly to
 Cemetery Creek.

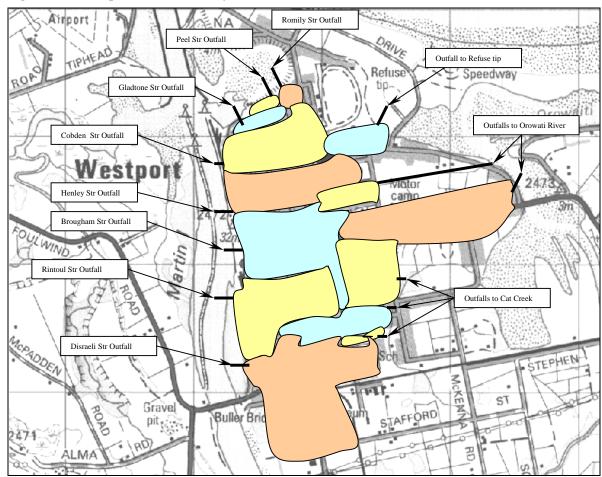
Figure 10.1: Westport Storm Water System

The Westport storm water system can be described as follows:

- Westport storm water either discharges west to the Buller River (or tributaries of the Buller River)
 or east to the Orawati River (or tributaries of the Orawati River).
- Five storm water outfalls discharge directly to the Buller River and three discharge to The Lost Lagoon which flows into the Buller River.
- Two storm water outfalls discharge directly to Orowatti River, three to Cat Creek which flows into the Orowati River and one to the refuse tip which is adjacent to the Orowati River.

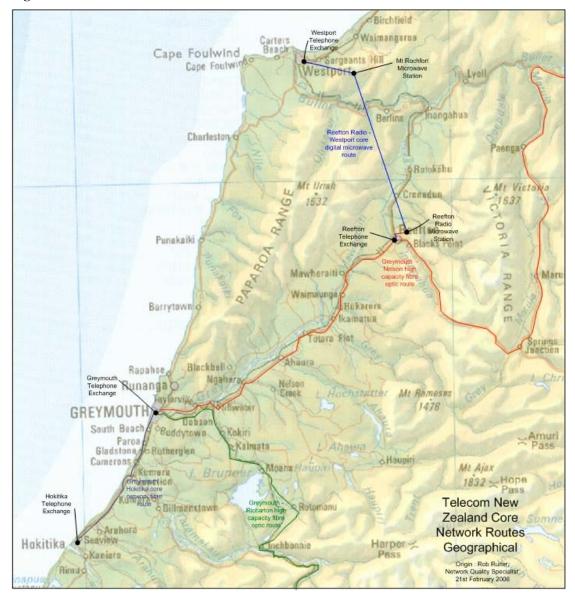
Figure 11.1: Telecom Networks - West Coast

Telecom operates the largest landline system on the West Coast together with a cellular network and support services for other telecommunication companies. The integrity of the Telecom network, both landlines and mobile is managed from from Hamilton. The West Coast area is connected to the

national network by three principal core or transport network paths. These are shown in Figure 11.1 and are described as follows:

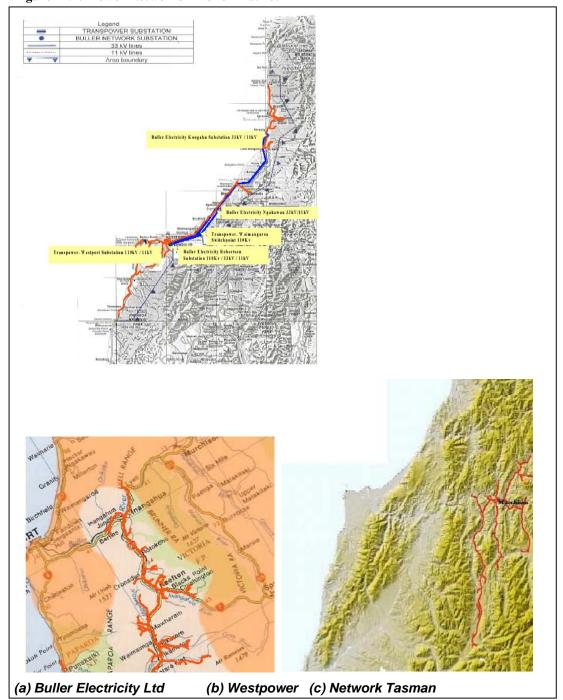
Figure 11.2: Power Networks – Buller District

<u>Transpower</u> supply into the Buller District is from the north east down the Buller valley from the Kikiwa Substation. This supply is by two transmission lines in parallel with substations at Inangahua, Robertson St, and Westport (Cape Foulwind). The latter two substations supply the Buller Electricity network. The Inangahua substation does not supply the northern end of the Westpower network, but switches power to the Transpower 66kV line to Dobson. Transpower is currently upgrading the latter line to 110kV and Westpower is constructing a second 110kV line from Inangahua to Reefton. It is planned to build a new substation from the 110kV lines to the distribution system in Reefton as part of the new work for the Globe gold mine.

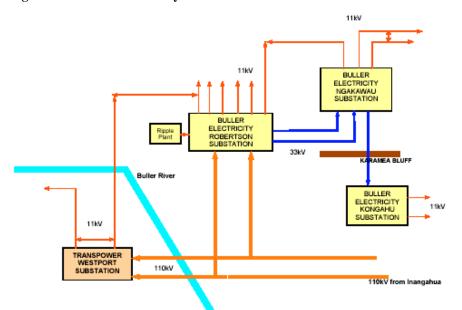
Figure 11.3: Buller Electricity Ltd Network

Flow Chart of Transpower Grid Exit Point and Buller Electricity Zone Substations

BEL receives power from the Transpower grid at Westport, Robertson St and Cape Foulwind (Westport). The Cape Foulwind substation feeds two 11kV feeder lines, one of which is interconnected with a feeder in Westport. Two 33 kV feeders supply the Ngakawau zone substation from Roberston Street, with a tee-off at Ngakawau supplying the Kongahu zone substation near Karamea. The latter line traverses the Karamea bluff
