Grey District Lifelines Plan

Alpine Fault Earthquake Scenario & Lifelines Vulnerability Assessment

Grey District Council

December 2007

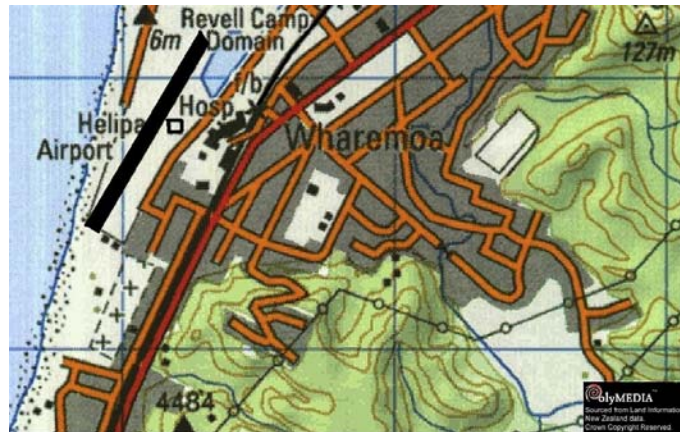
Figure 4.1: Location of Greymouth Airport

The airport is located near the coast and is in an area that is likely to be liquefiable.

There is one aerodrome listed with the Civil Aviation Authority within the Grey district. This is the airport at Greymouth which is owned and operated by the GDC. It consists of a single 1090m by 32m paved runway that is normally used for light aircraft and helicopters, including regular commercial flights to Nelson and Wellington. An important use is the ferrying of patients to and from the adjacent Greymouth Hospital using an air ambulance. The airport is located near the coast and is in an area that is likely to be liquefiable.

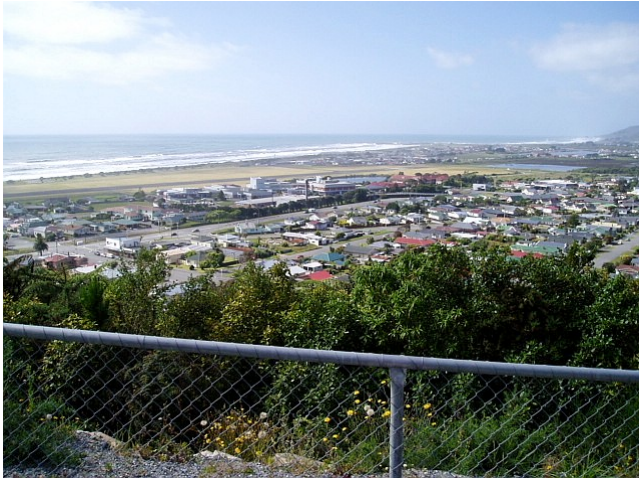
Figure 4.2: Photo of Greymouth Airport from Arnott Heights

The most significant risk is from damage and differential settlement of the runway as a result of the liquefaction of the underlying soils.

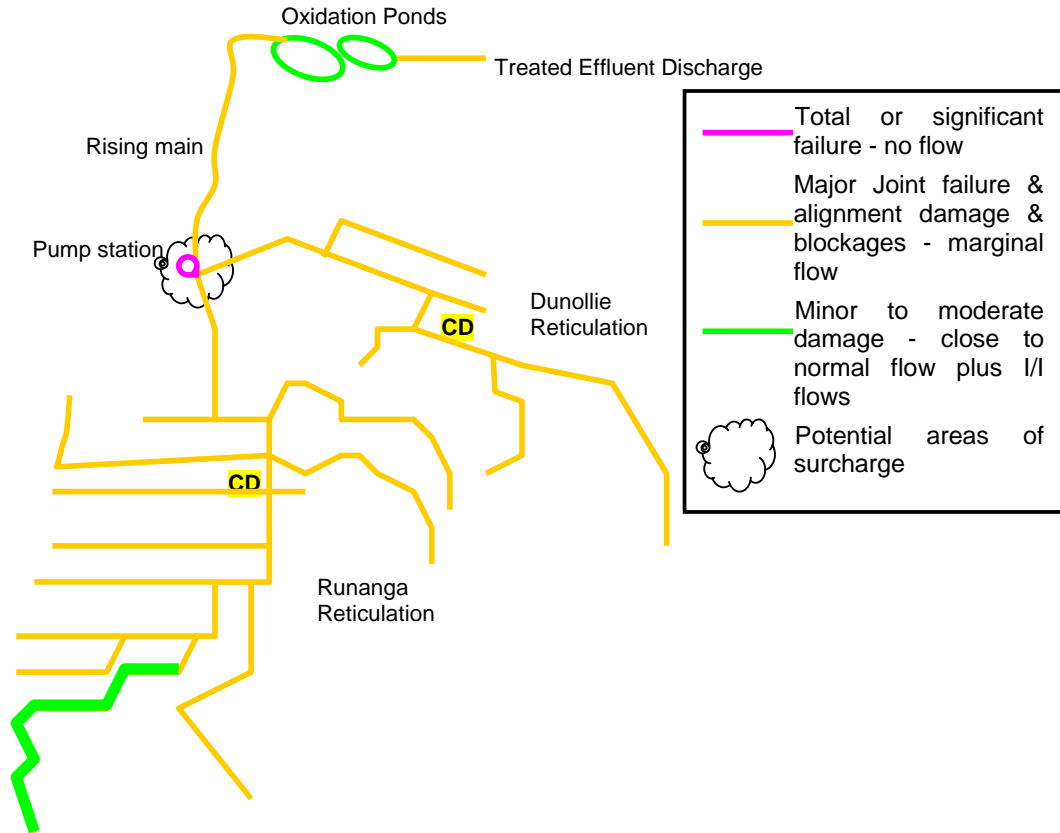
Figure 4.28: Assessed Runanga Sewerage Scheme Failure and Surcharging

The assessed failure of scheme components and resultant surcharging of sewage (1 location) are presented in Figure 4.28. Surcharging is likely to occur at the Dunollie Pump Station when the power supply is lost and the pump stops. The surcharge will discharge to Raleigh Creek.

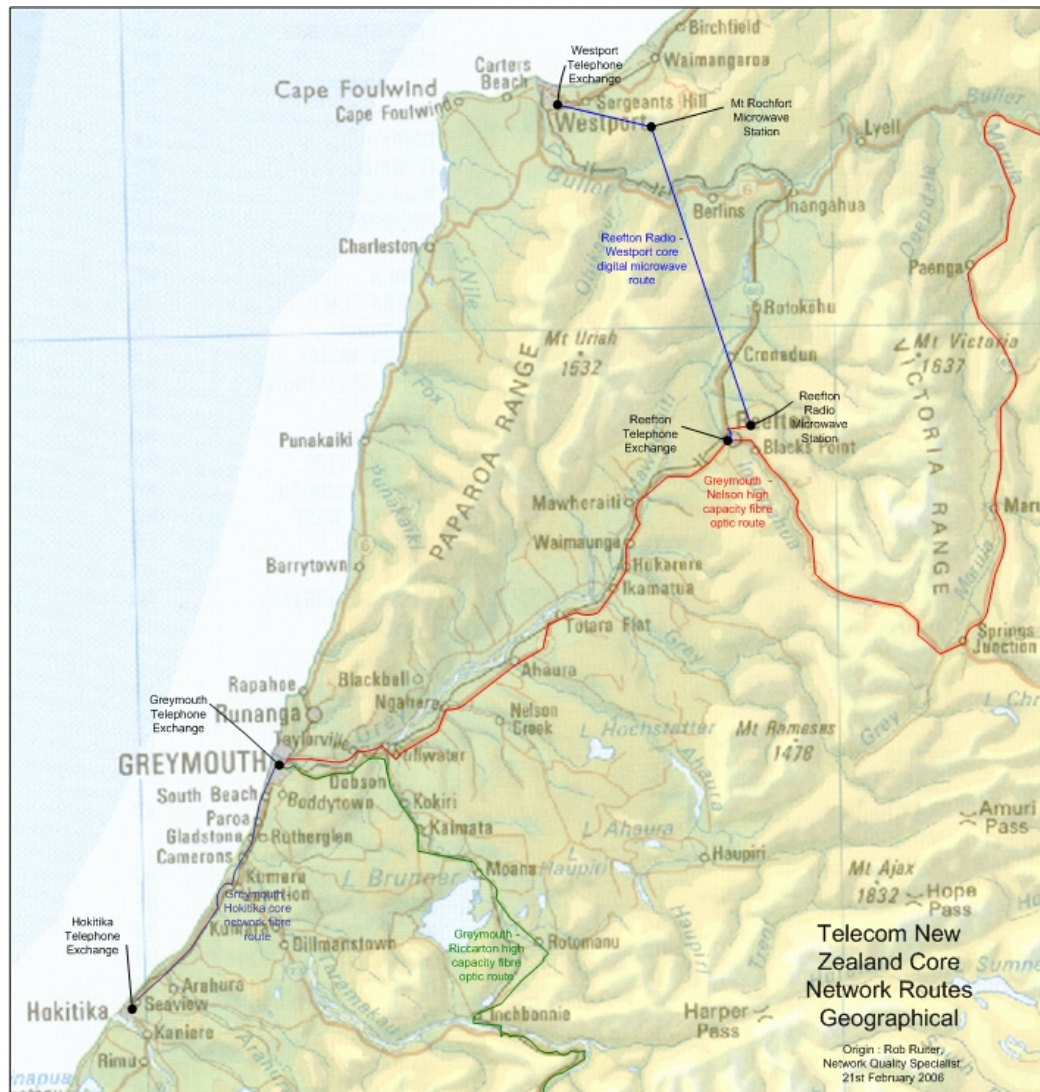
Figure 4.31: Telecom Networks – West Coast

Telecom operates the largest landline system on the West Coast together with a cellular network and support services for other telecommunication companies. The integrity of the Telecom network, both landlines and mobile, is managed from a centre in Hamilton. The West Coast area is connected to the national network by three principal core or transport network paths. These are shown in Figure 4.31 and are described as follows:

- Between Westport and Reefton: Digital Microwave Radio to Mt Rochfort, forwarded on to Reefton Radio and thence over fibre to the Reefton exchange and on via fibre to either Greymouth or Nelson exchanges.

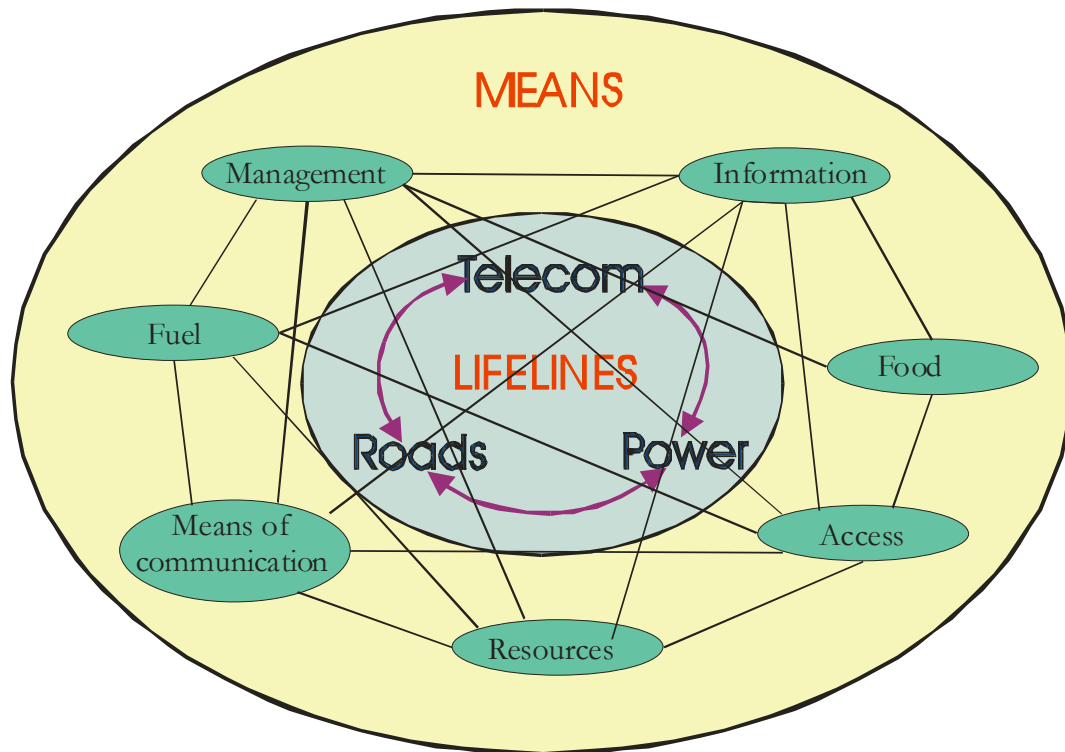
Figure 5.1: Lifelines require means by which they are supported, and the interactions between the lifelines are often through the means.

It is useful to think of each lifeline as needing various means by which its ongoing maintenance is supported. This is illustrated in Figure 5.1, which shows an arbitrary three lifelines in the centre surrounded by “means”; that is, things which are necessary for ensuring the ongoing integrity of the lifelines. The point of the diagram is that the means are highly interdependent on each other as well as on the lifelines, so that the major interdependencies between lifelines are not so much direct interdependencies as those resulting from the interacting means. Note that in the diagram, the network of interconnections is deliberately drawn to seem confusing; this would be the reality in an earthquake. Some of the interconnections that have been identified in this plan are discussed in the
