Westland District Council Lifelines Study

Alpine Fault Earthquake Scenario

Alpine Fault Earthquake Scenario & Lifelines Vulnerability Assessment

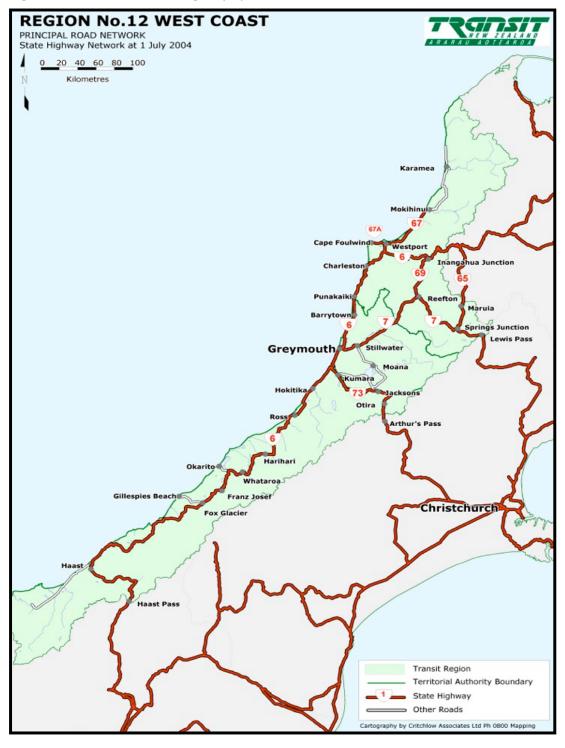
Figure 6.1: West Coast State Highway Sytem

The State Highway system provides all the external links beyond the District, and the principal network within the District. Although it is not the WDC's responsibility, its performance will impact greatly on the district's resilience to an earthquake event. The West Coast State Highway system is shown in Figure 6.1.

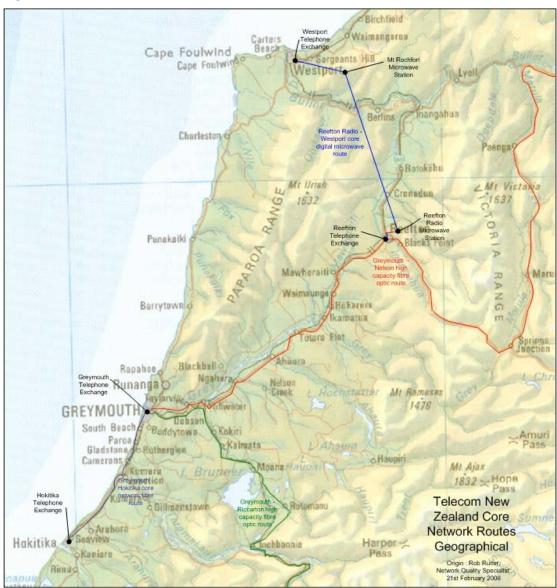
Figure 10.1: Telecom Networks - West Coast

Telecom operates the largest landline system on the West Coast together with a cellular network and support services for other telecommunication companies. The integrity of the Telecom network, both landlines and mobile is managed from a centre in Hamilton. The West Coast area is connected to the national network by three principal core or transport network paths. These are shown in Figure 10.1 and are described as follows:

Between Greymouth and Nelson: a fibre optic cable routed to Stillwater on the Southern bank of
the Grey River and subsequently along the main road of the Grey Valley to Reefton (SH7) thence
to Springs Junction over the Rahu Saddle (SH7)and North to Nelson via Murchison (SH65 &
SH6);
