## **Preliminary Flood Study of the Buller River at Westport**

August 2000  
Reference 5435.40/CN  
Revision 2

**Preliminary Flood Study of the Buller River  
at Westport by Connell Wagner Ltd**

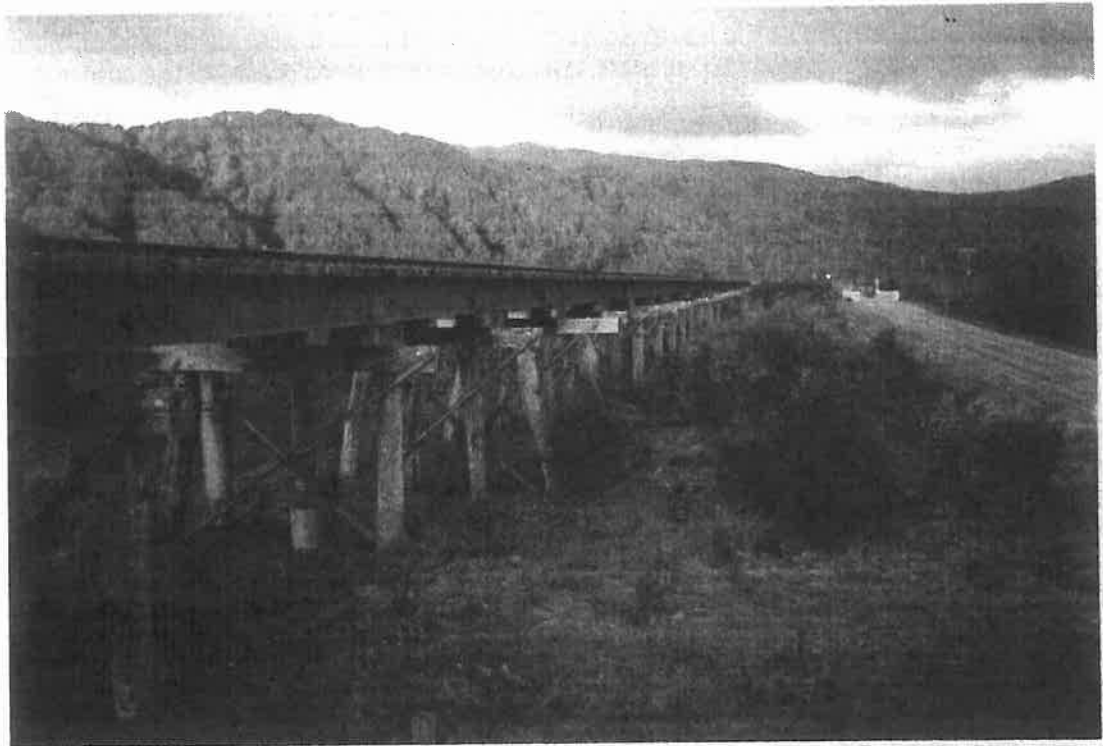
**Photograph 1 - Railway Trestle Bridges Spanning the Orowaiti Overflow**

Note that New Zealand Rail decreased the available waterway area of the bridge in the mid-1980's, replacing a section of the bridge with an embankment and thereby splitting the one trestle bridge into two separate structures. The model has been adjusted to allow for this.

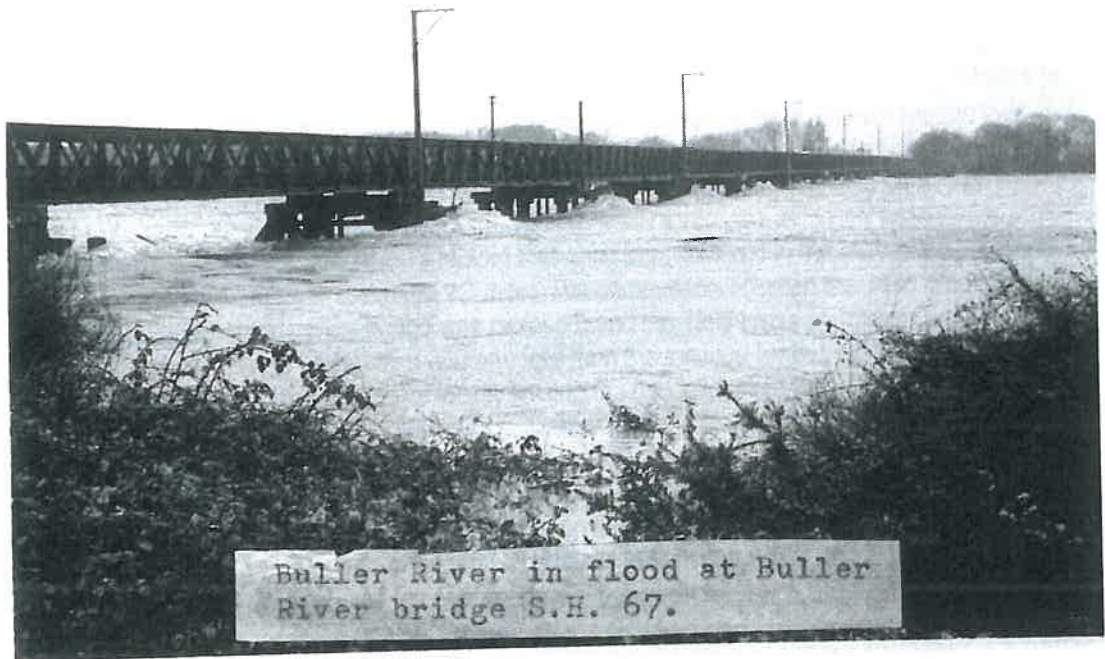
**Photograph 2 - The 1970 Flood at the old Buller Bridge (taken from the left bank facing slightly downstream)**

The two photographs above illustrate the reduction in pier losses associated with the new bridge. To account for the replacement of the bridge two models were developed, the first including losses associated with the old bridge (pre-1976), and the second with smaller losses associated with the new bridge (post 1976).

For the 1970 flood the computed top water level was 5.53m above Mean Sea Level compared with the recorded level of 18.3ft<sup>7</sup> (5.58m) – given the above points the predicted level would seem to match well with that recorded. Hand calculations gave estimated head losses at 250mm, less than Photograph 2 would indicate - the final model has a maximum head loss of 360mm. A debris mark was recorded along Nine Mile Road at the bridge crossing the Overflow. The recorded level at this location was 9.23m, compared with a computed top water level of 9.28. Hand calculations suggest minimal head losses and the model has been adjusted to match this.
