HOKITIKA SEAWALL EXTENSION – CONSENT APPLICATION

RC2022-0039 and 220053

Submission

From: West Coast Penguin Trust

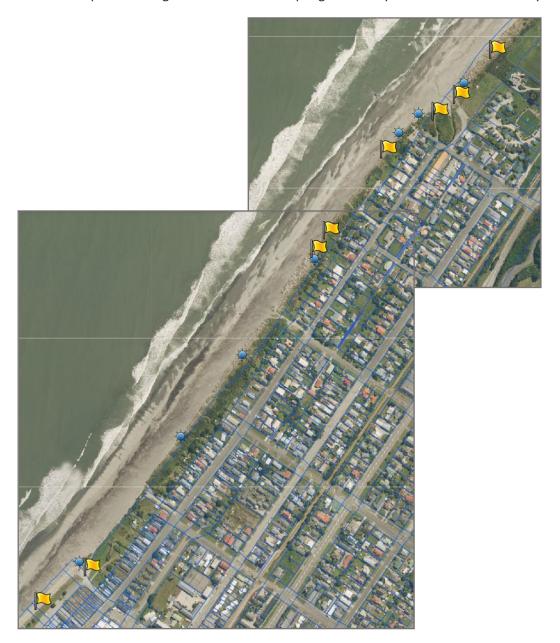
Fig 1: Proposed Hokitika seawall extension area showing penguin sites – penguin reports/tracks and nest sites – blue dots, dead penguin reports – yellow flags.

- 7. We continue to see penguin tracks on the town beach.
- 8. The map below Figure 1 shows known penguin activity and nest sites in recent years.
