Following the 22-Nov-2016 site inspection of the beach front and subsequent community meeting at Granity, Ngakawau and Hector, I consider it prudent to refine some of the advice in the recent report (NIWA, 2016).

Site inspection notes

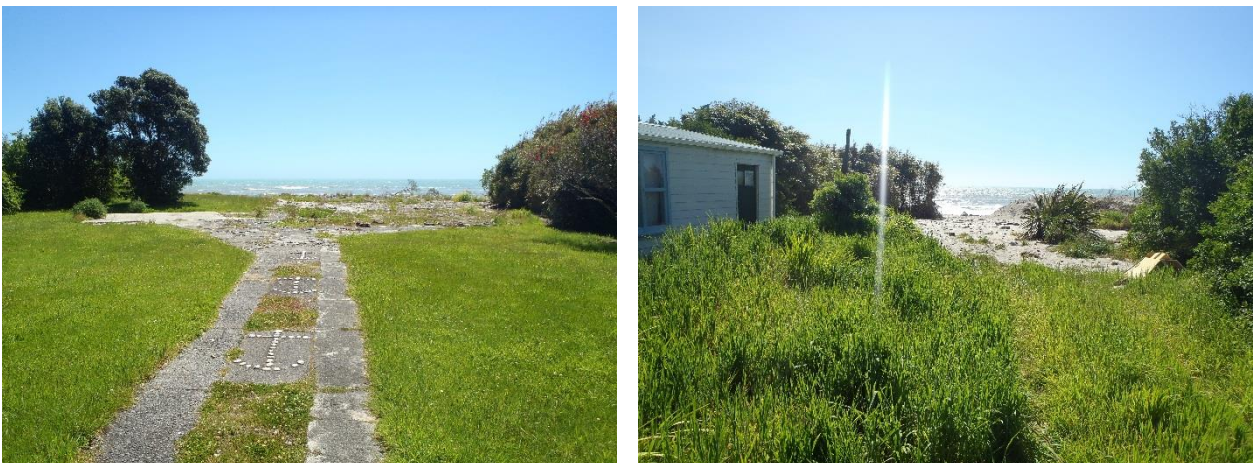
The erosion sequence has continued with winter storms eroding the beach, overwashing into private property and damaging structures – with at least one garage destroyed and another property now deserted (Figure 1). Several new landowners have begun to protect their boundary with rocks and other ad-hoc defences (Figure 2). The existing hard protection structures have withstood the storms well (Figure 2), but the predicted slumping or gabions within rock revetments and lowering of the beach has occurred.

Figure 1 Recently deserted property (Left, 23 Main Rd Hector) and overwash evidence into private property (Right, 151 Torea St, Granity). [Source: M Allis 22-11-2016]

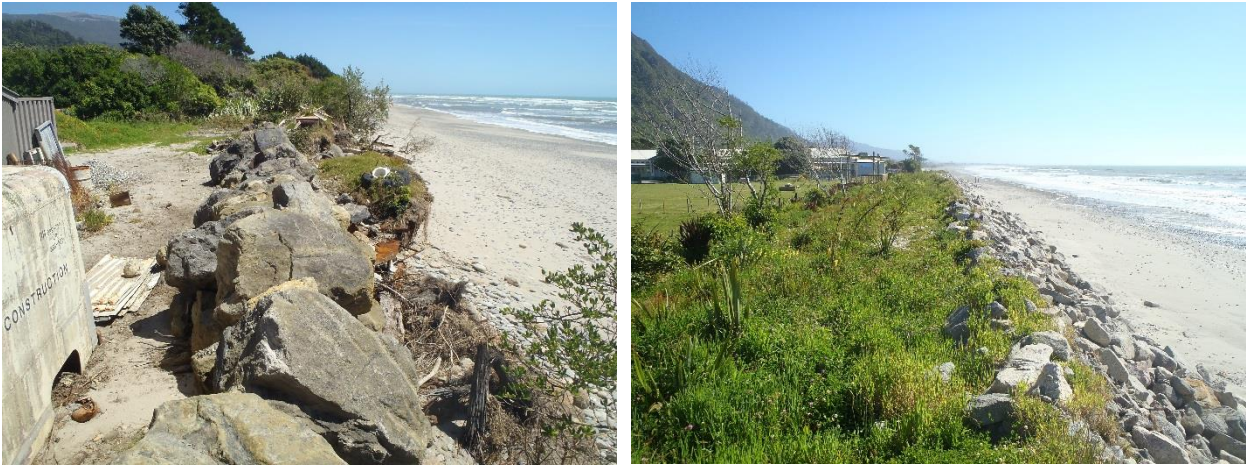
Figure 2 New ad-hoc defence along the beachfront (Left, 7 Main Road, Hector) and existing hard defences in reasonable condition (Right, Granity School). [Source: M Allis 22-11-2016].

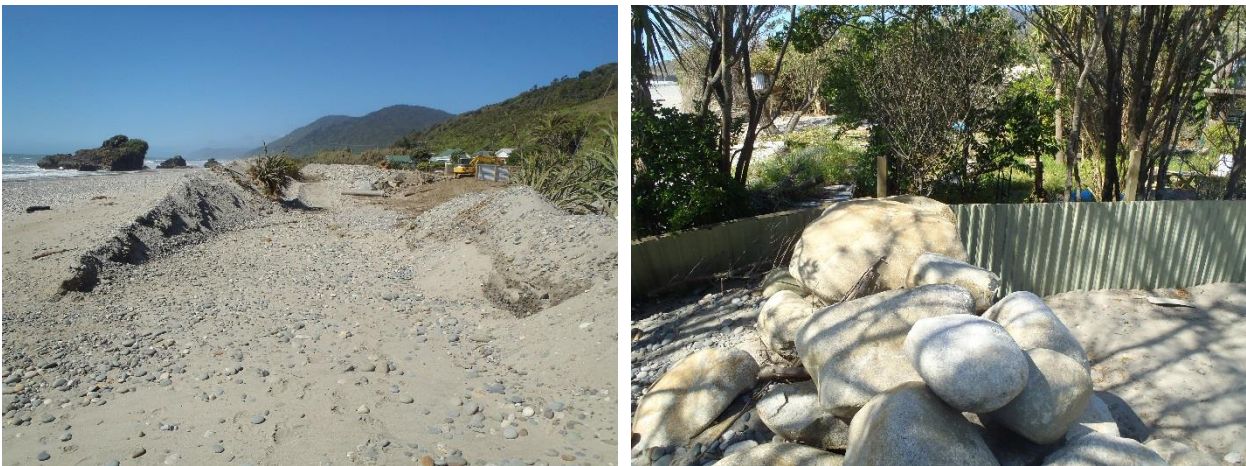
At Granity (154-165 Torea St) the erosion has become critical to several properties, overwhelming the Buller District Council (BDC) managed Bradleys Stream drain and berm (Figure 3). The nearby landowners have begun to protect their properties with rock revetments or vegetation (Figure 3).

Figure 3 Overwhelming of Bradley Stream drain (left, at 154-160 Torea St) and ad-hoc coastal protection (right, 155-156 Torea St). [Source: M Allis 22-11-2016].

This refinement means the exit to Bradley's Stream will predominantly be straight out to sea, but the stream banks will need protection to prevent outflanking and exacerbating erosion of the adjacent properties. Occasional clearance of the stream mouth may be required if beach gravels build up and block the outlet. A culvert onto the beach face is not recommended.

Note about BDC drain clearance: Re-forming and maintaining the Bradley Stream drain will be more expensive in the short term (0-2 years) while allowing the community to design and construct the hard defence. However, the drain itself will act as the base level or key-in for the wall which is essential to the longer-term performance of the revetment. It is anticipated that the drain clearance and diversion could cease after the wall is completed, therefore a saving for BDC over the longer term. However it is absolutely necessary in the immediate period to continue clearance, and even increase the frequency of drain clearances.

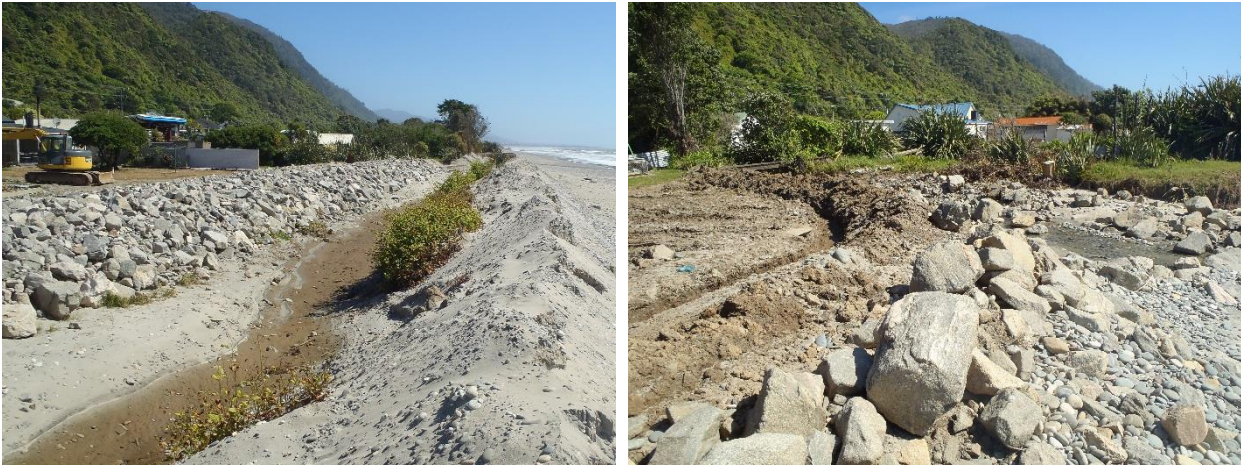
However the advice for one coastal sections needs updating: the northern section of G4 (north of Bradley Stream) is rapidly approaching a critical risk level. The community have had waves and sand wash into their property in the last year and have been galvanised into action. This activity has been most notable around the northern half of frontage section G4 because of the failure and infilling of the Bradley Stream drain diversion (Figure 3). This is a positive move, but action should be taken to ensure the defences are well-constructed, form a consistent line of defence, tie-into existing defences and avoid end effects (i.e. avoiding the historic ad-hoc nature of defences).

Figure 4 Recent hard defences under construction north of Bradley Stream (G4) where the drain diversion bund failed. Left, 158-160 Torea St; Right, 154 Torea St. [Source: M Allis 22-11-2016].

My recommendation should be updated (from backstop defences) because several G4 owners have responded to the erosion by constructing rock revetments (Figure 4), and the drain clearance berm is unable to prevent waves to regularly wash into private property. **The most appropriate action now would be to unify the G4 owners to join and strengthen a single line of defence (both hard revetment and backstop) along this frontage section. However, BDC must reform the Bradley Stream drain and berm ASAP while the community and WCRC prepare (finance, consent, materials) to construct defences and link the under-construction walls.**

A singular rock revetment defence should include all G4 properties north of Bradley Stream (154-165 Torea Street), linking the under-construction revetments, extending along the stream-banks up to the roadway, and include the property immediately south of Bradley Stream (153 Torea Street). The toe of the new rock revetment would be well placed if it were keyed into the drainbed (north of Bradleys Stream) and placed front of the clay/peat outcrops on southern bank of Bradleys Stream. The G4 owners south of 153 Torea Street should also prepare to construct their backstop defence berm in the short-term, this should tie into the southern extent of the rock revetment works, but setback from the present beach face (edge of clay/peat outcrops) by 5 m and aggressively planted. These works would still only be a short to medium term defence for the G4 section.
